GEORGES RIVER MARINA, MOOREBANK

AQUATIC ECOLOGY ASPECTS & ENVIRONMENTAL ASSESSMENT OF MARINA CONCEPT DESIGN

**REPORT PREPARED FOR
BENEDICT INDUSTRIES PTY LTD**

**MARINE POLLUTION RESEARCH PTY LTD
MARCH 2010**

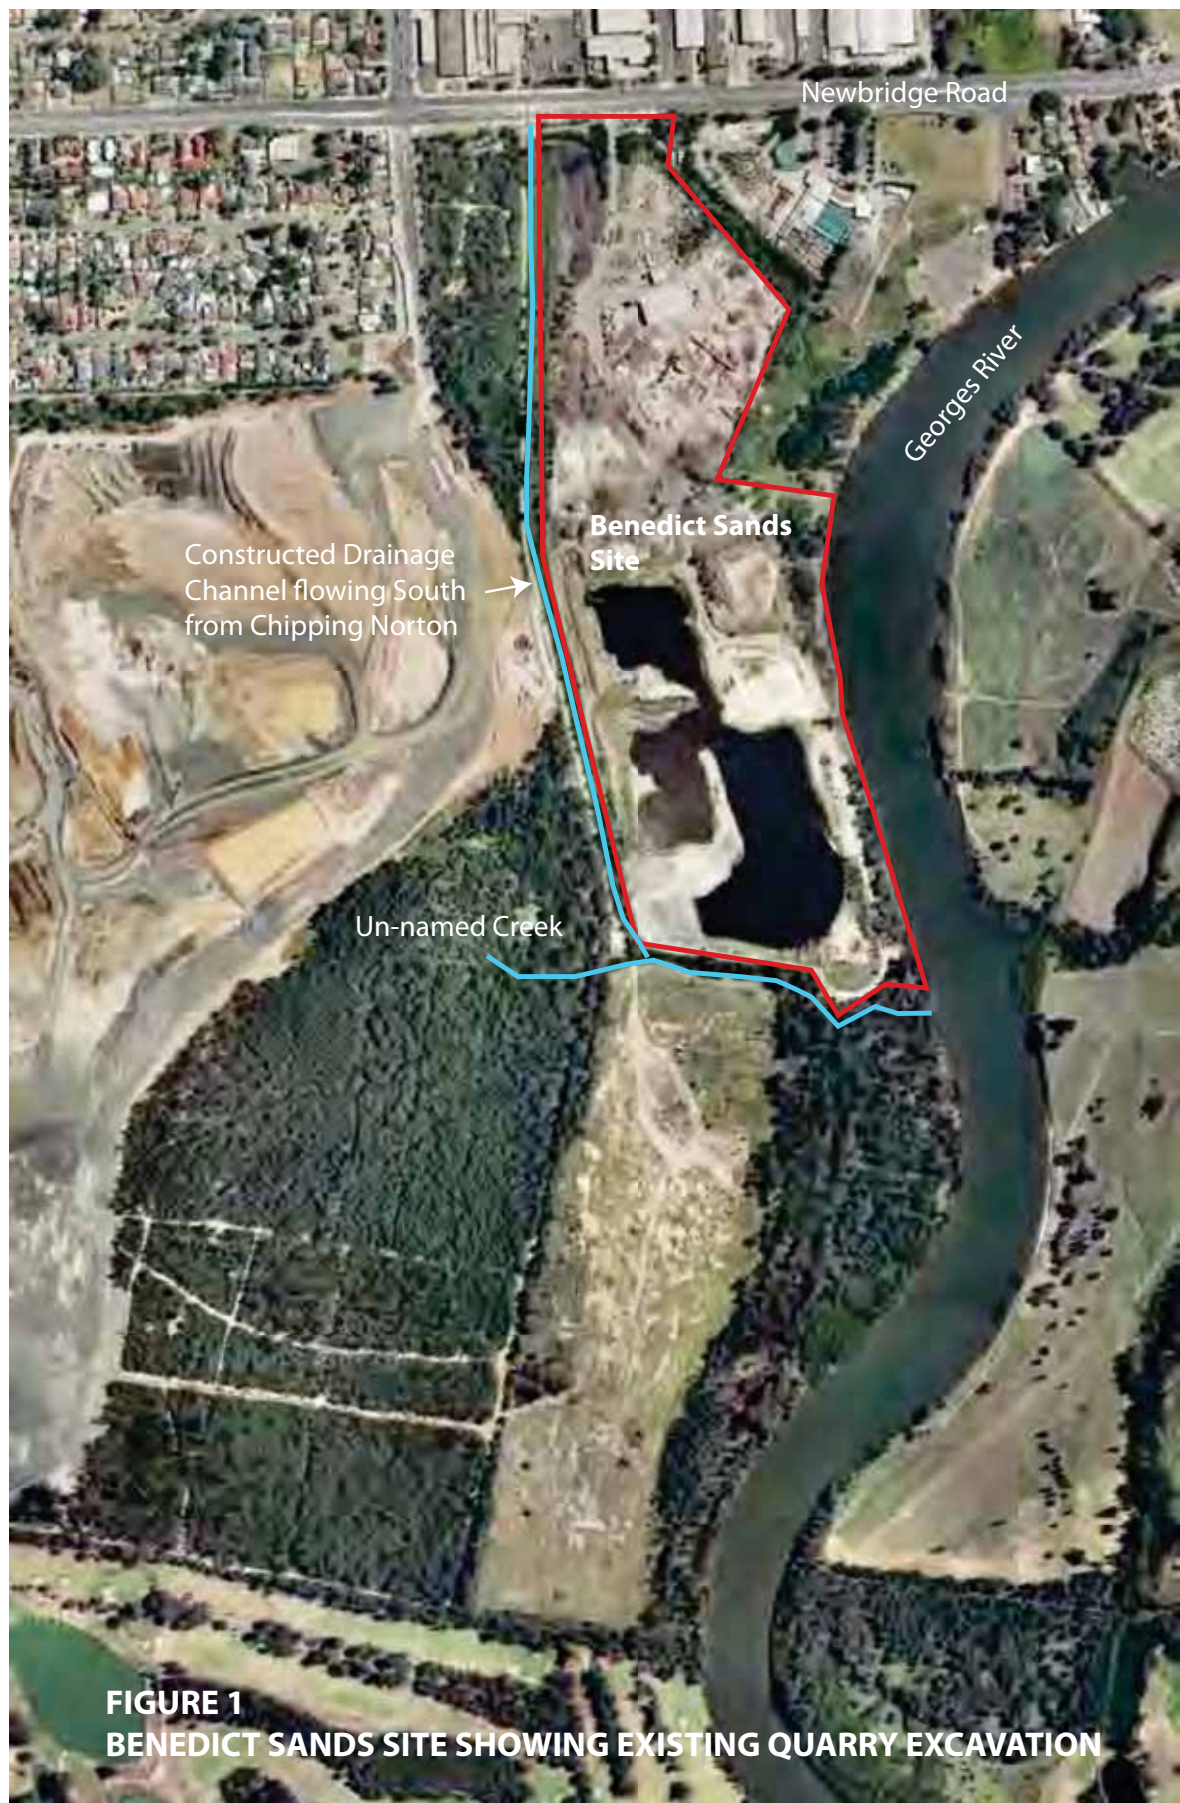
01 Site Plan - Ground Level
1: 2000

Figure 2 provides the Micheal Fountain Architects Site Plan for the marina and adjacent housing development proposed for the Benedict Site. Comparison of the current state of the existing site in Figure 1 with the proposal in Figure 2 indicates that the formation of the proposed marina basin and the hardstand areas for the marina infrastructure will require considerable earthmoving activities, all wholly contained within the existing disturbed site. Construction of the outer part of the entrance channel and Georges River foreshore rock protection will occur in the riparian zone of the Georges River.

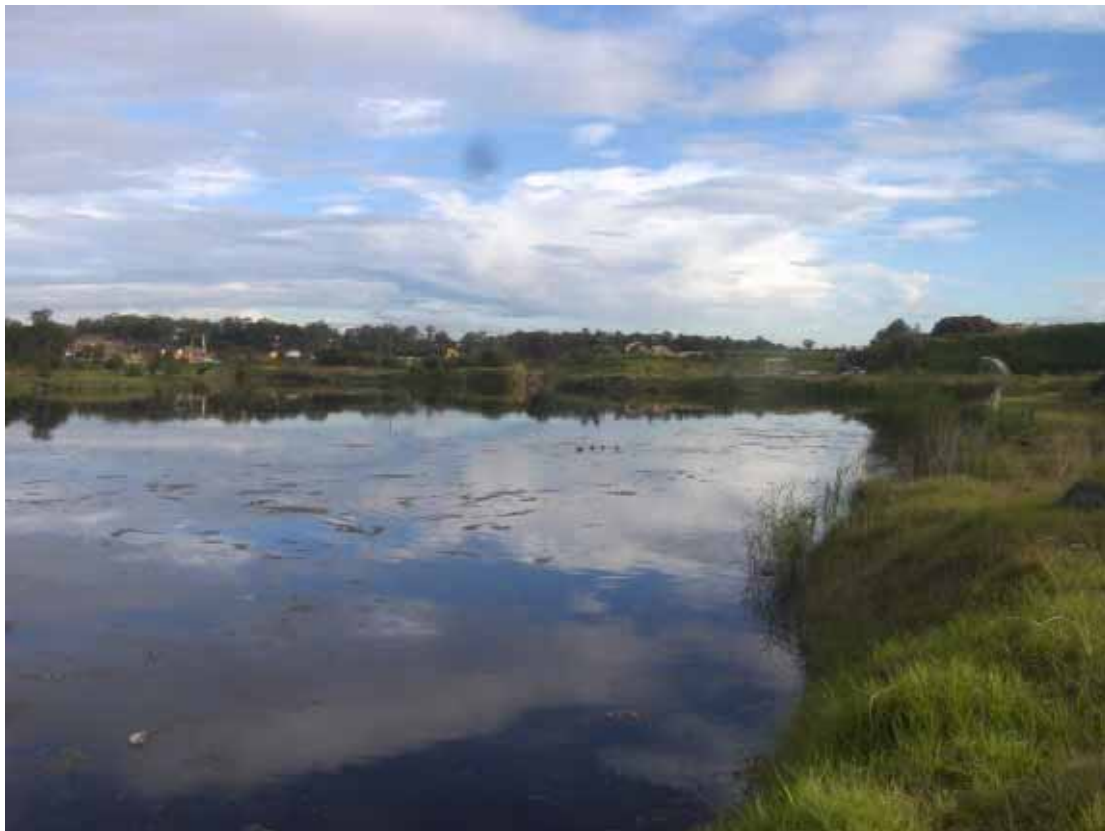
Figure 5 View of Deep Pool looking north from Dredge showing flocculants and algae floating on surface (Photo 27 April 2007).

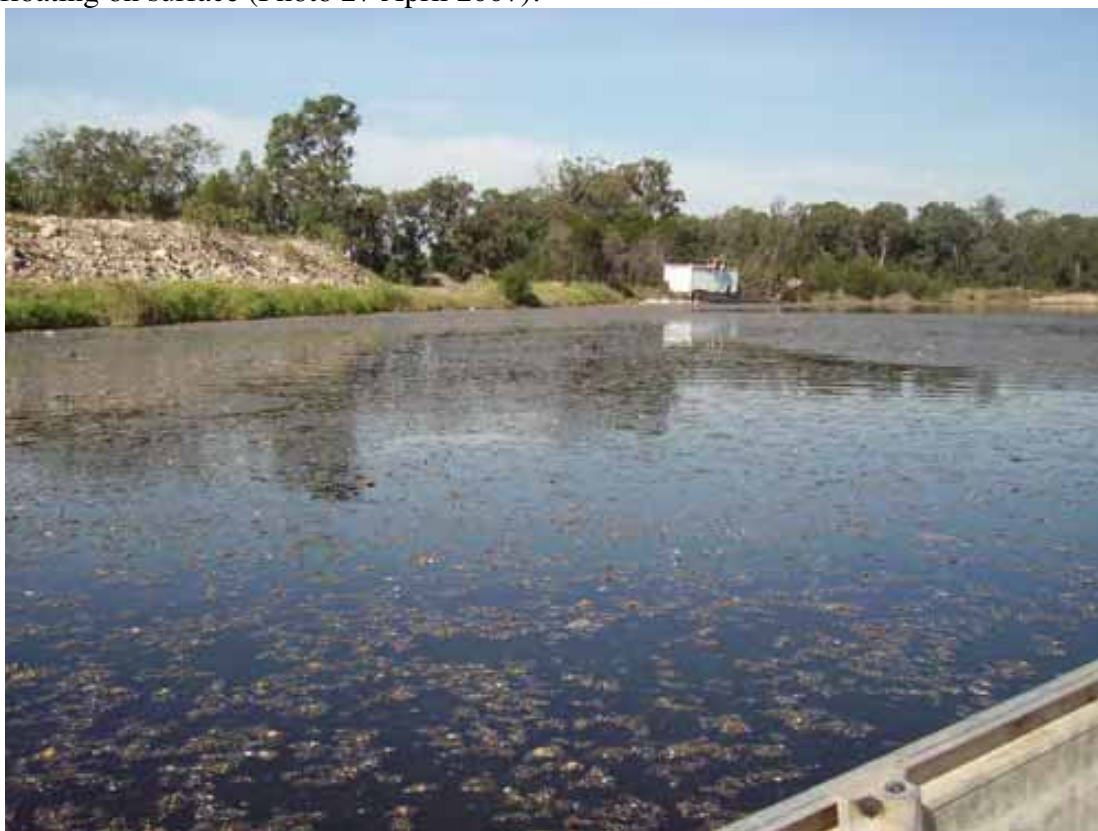
Figure 6 Same view of Deep Pool, looking south from Site 7 towards dredge and showing denser floating flocculants plus algae on pool surface (Photo 28 May 2007).

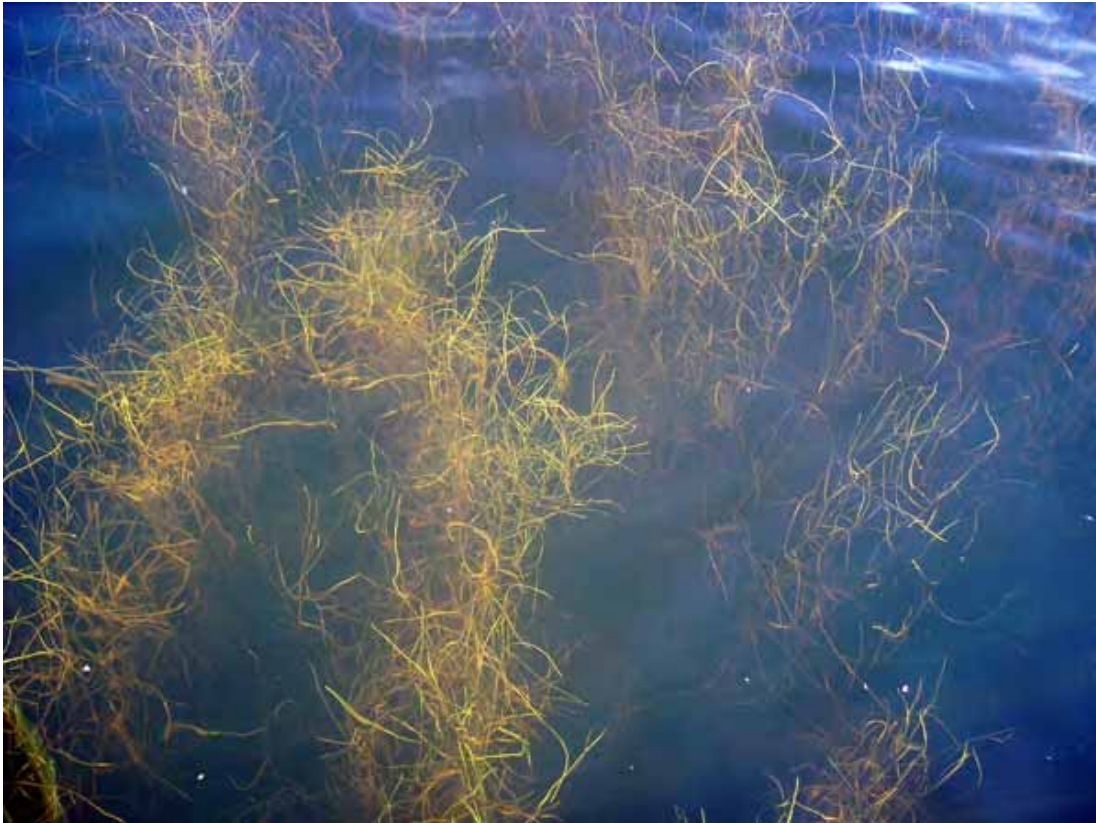
Figure 7 *Ruppia sp.* growing in Ruppia Pool (Photo May 2007).

The *Ruppia* pool is so called as it supports a vigorous growth of a brackish water submerged plant *Ruppia sp.*, growing to between 1.5 and 2 m height (see Figure 7). The pond has gently sloping sides with 1 m depths around the edges and an open basin to about 2 m depth. Much of the riparian edge supports swathes of *Phragmites*. There were schools of small fish observed amongst the reeds, generally Mosquito Fish, an introduced pest species generally known from freshwaters but also found in brackish water ponds.

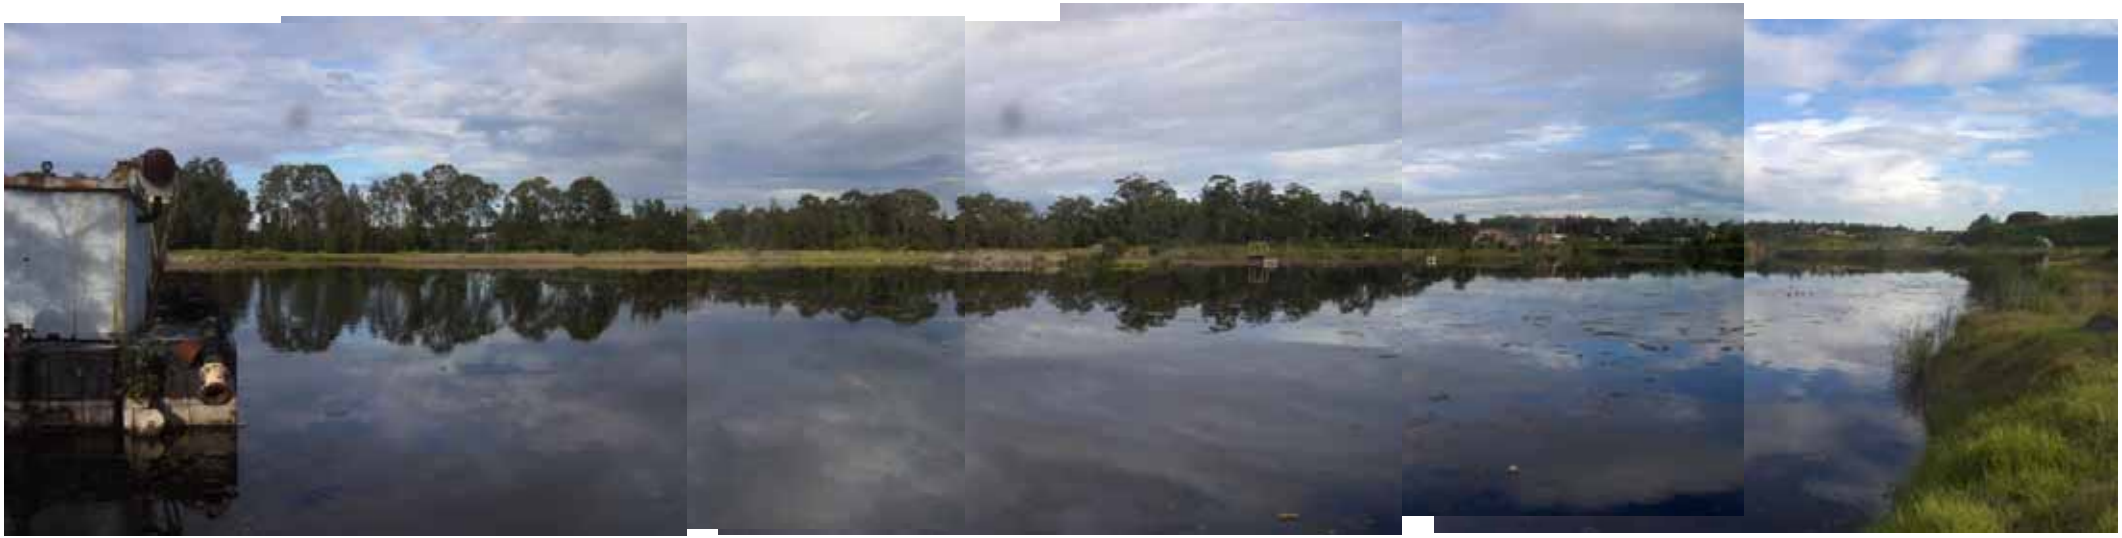
Figure 8 Panorama view of Deep Pool from the bank just north of the Dredge, looking north (along right edge) and south (along edge of dredge). Most of the pool edges are steep. Figure 10 (below) shows the remainder of the deep pond to the south-west (obscured by the dredge).

The three quarry pond habitats comprise the benthic sediment habitat of each of the ponds, the pond water bodies and the pond riparian edges. Figures 8 and 9 provide panoramic views across the Deep Pool and the Shallow Pool, and Figures 10 to 14 provide various views of the quarry pool aquatic habitats (discussed below).

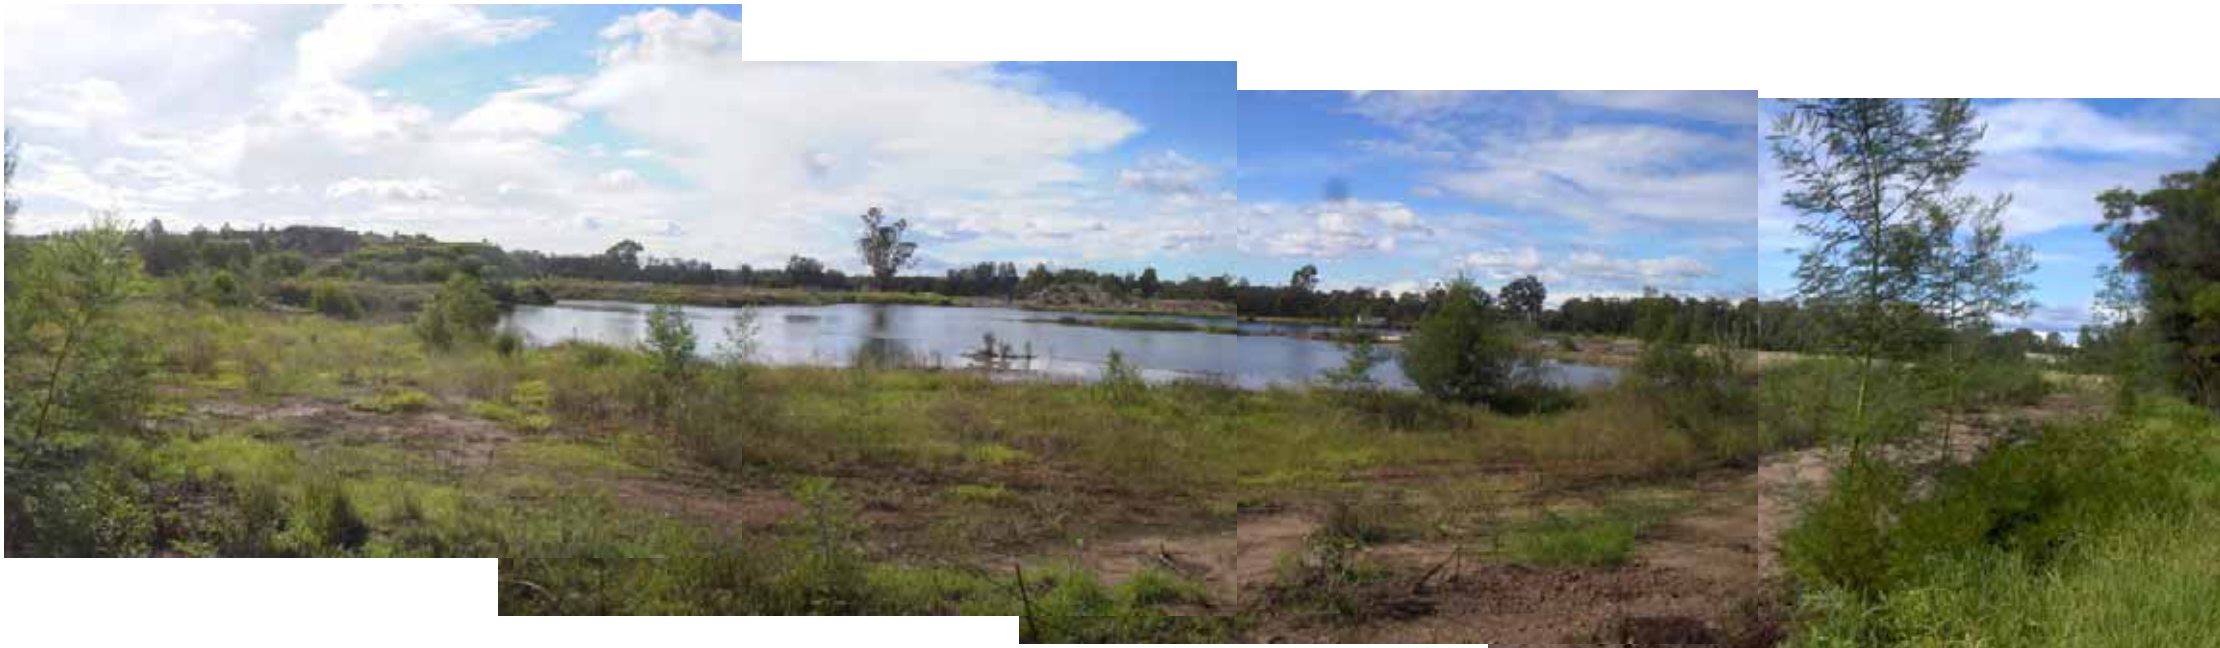
Figure 9 Panorama view of Shallow Pool in foreground and Deep Pool in background from the west looking south (along right edge) and north (along left edge). The return wash -water drain can be seen in the left hand corner of the Shallow Pool with the floating boom located off-shore from the discharge.

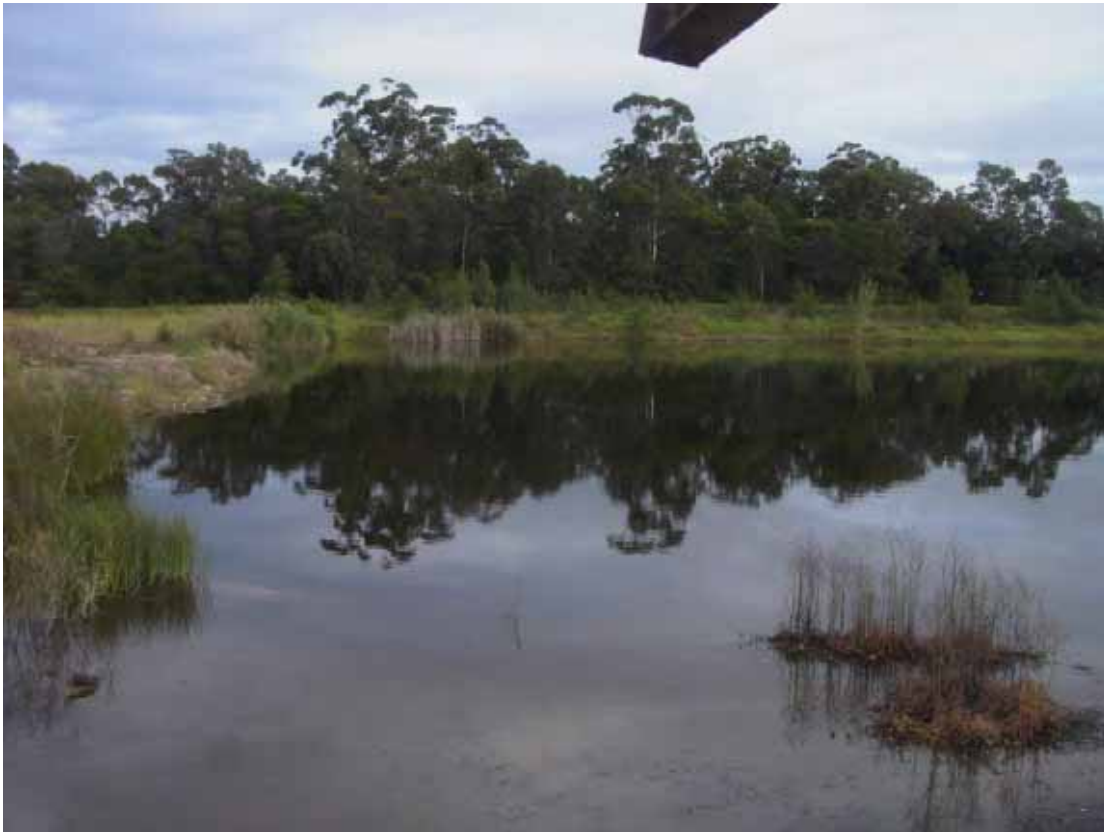
Figure 10 South-west corner of Deep Pool looking west from Dredge, and showing various emergent and bank plants.

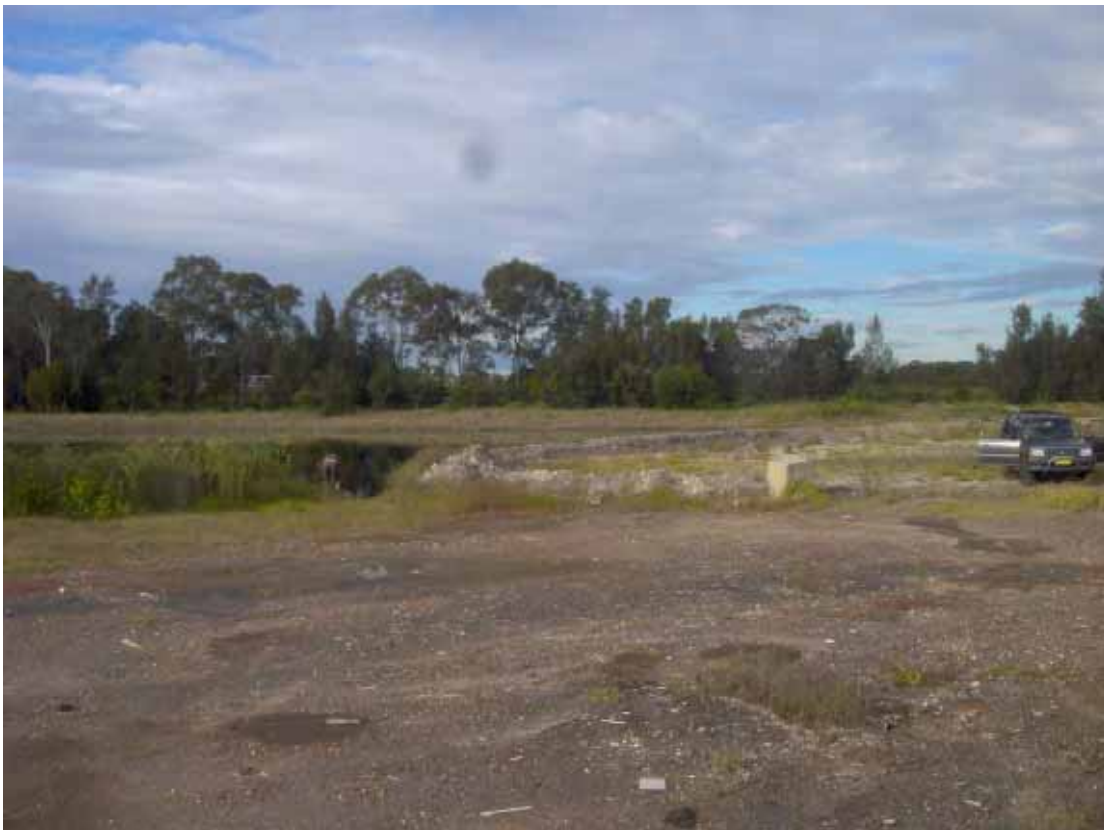
Figure 11 Sand spit on west side of Deep pool looking south-west.

The Deep pool is separated from the Shallow Pool by a constructed sand spit (see plan view in Figure 3 and various ground views in Figures 11, 13 and 14). The upper half of the sand spit comprises loose coarse sand and supports scattered terrestrial weed species (see Figure 11). The outer portion of the sand spit is much lower to the water and consequently it would be inundated from time to time. As a consequence the lower sand spit supports small and isolated clumps of saltmarsh species (Figures 13 and 14). Plants observed included several species of *Atriplex*, some *Sarcocornia*, Austral Seabligh and Club Rush. These plants are commonly found on the edges of brackish water ponds and the intermittency of the inundation was evident in that there were also areas of dead saltmarsh plants observed.

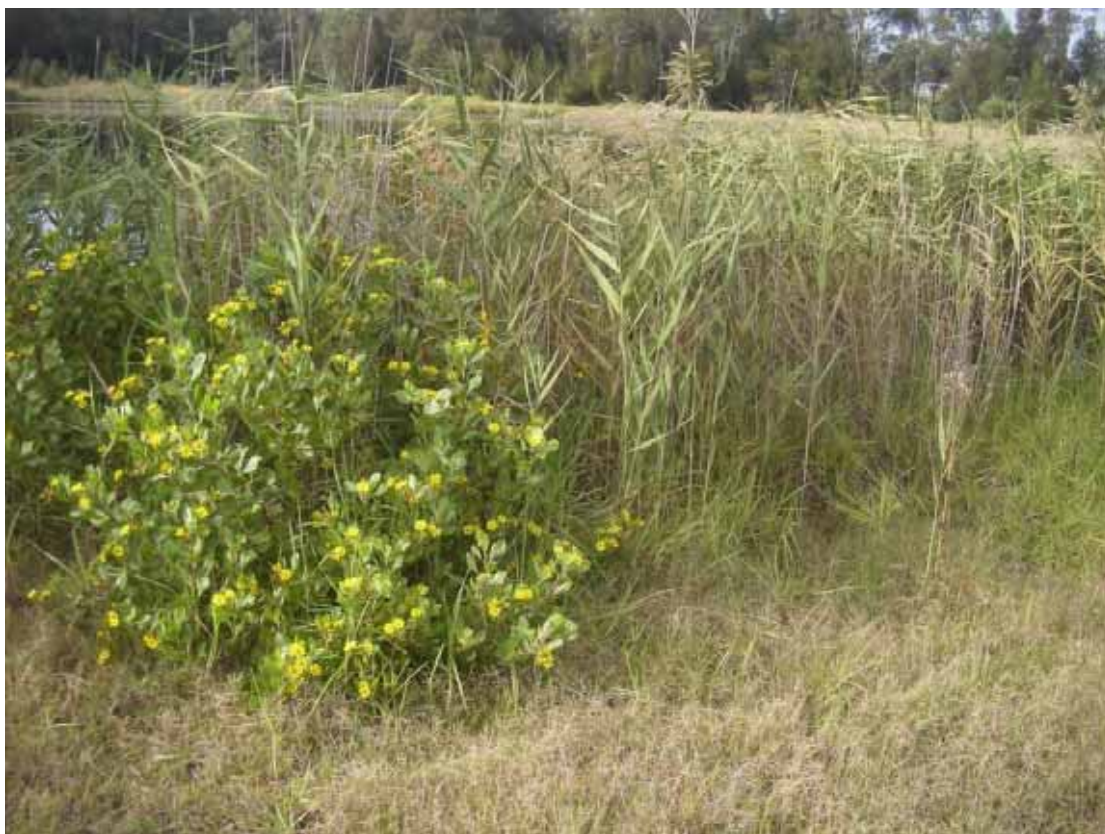
Figure 12 Bittou Bush and *Phragmites australis* growing on Deep Pool bank.

Other than *Phragmites*, there are scattered saltmarsh plants amongst the riparian grasses, mainly New Zealand Spinach. There are also isolated stands of Bittou Bush (see Figure 12).

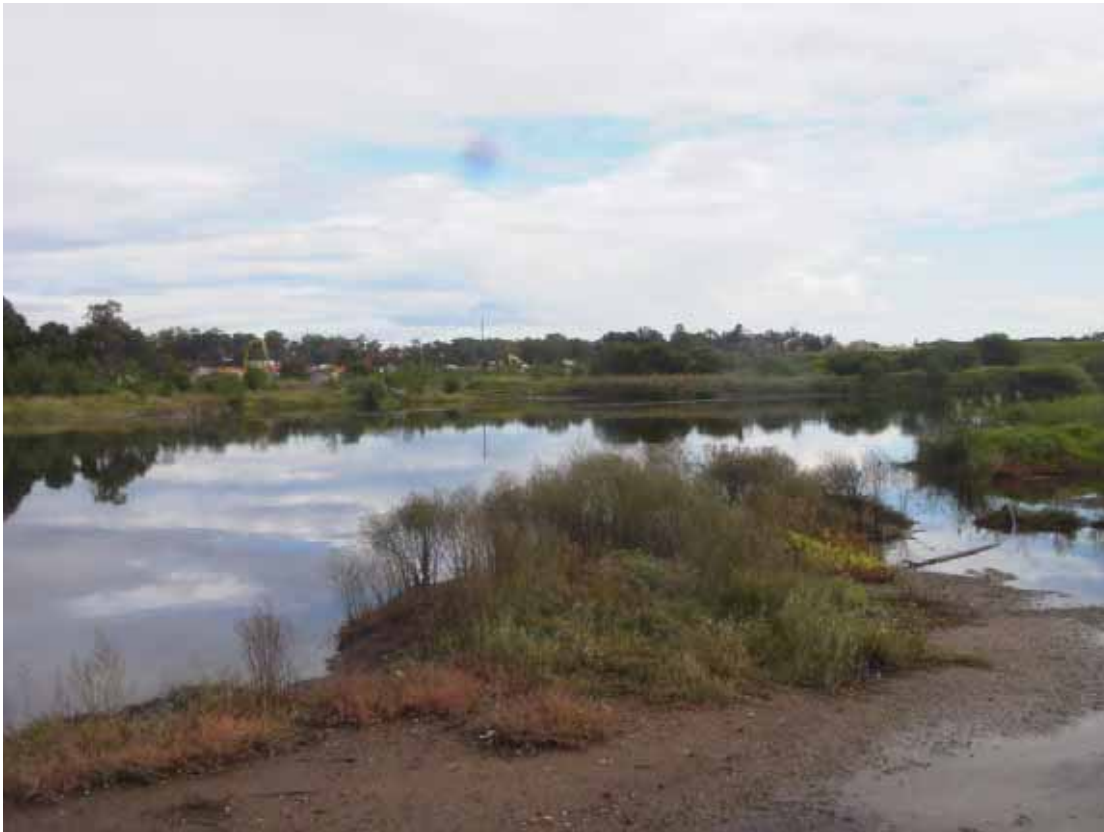
Figure 13 View of Shallow pond looking north-west from sand spit with quarry wash water runoff in background (behind floating boom). Sand spit supports a variety of saltmarsh species.

The shallow pool (Figure 13) has depths generally less than 1 m. it has a hard sandy bottom with no observable epibenthic fauna, and there were no burrows of benthic organisms observed. It is concluded that the brackish nature of the waters probably preclude many estuarine benthic species. However, a large adult Dusky Flathead was observed in this pond, indicating that the waters are sufficiently brackish to support an adult flathead and that there must be some benthic fauna for the flathead to feed upon.

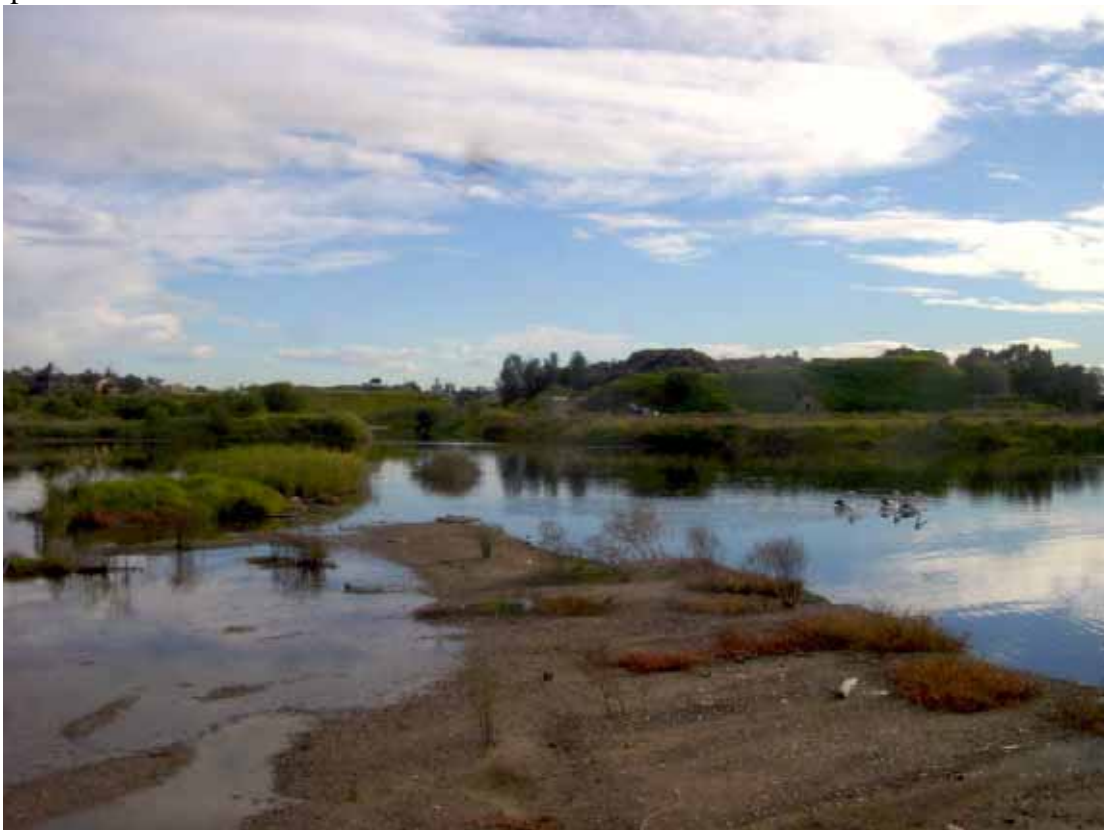
Figure 14 Sand spit on east side of Shallow pool looking towards *Ruppia* Pond.

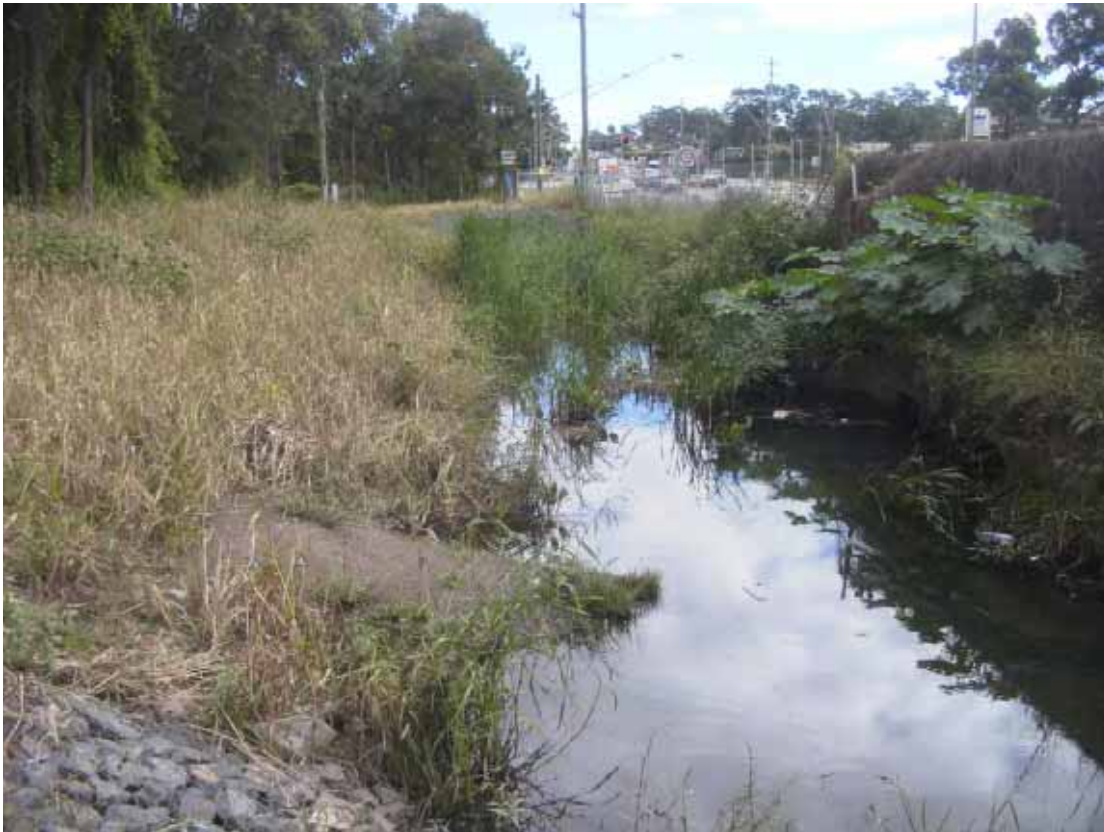
Figure 15 Chipping Norton Stormwater drain at Milperra Road (looking west).

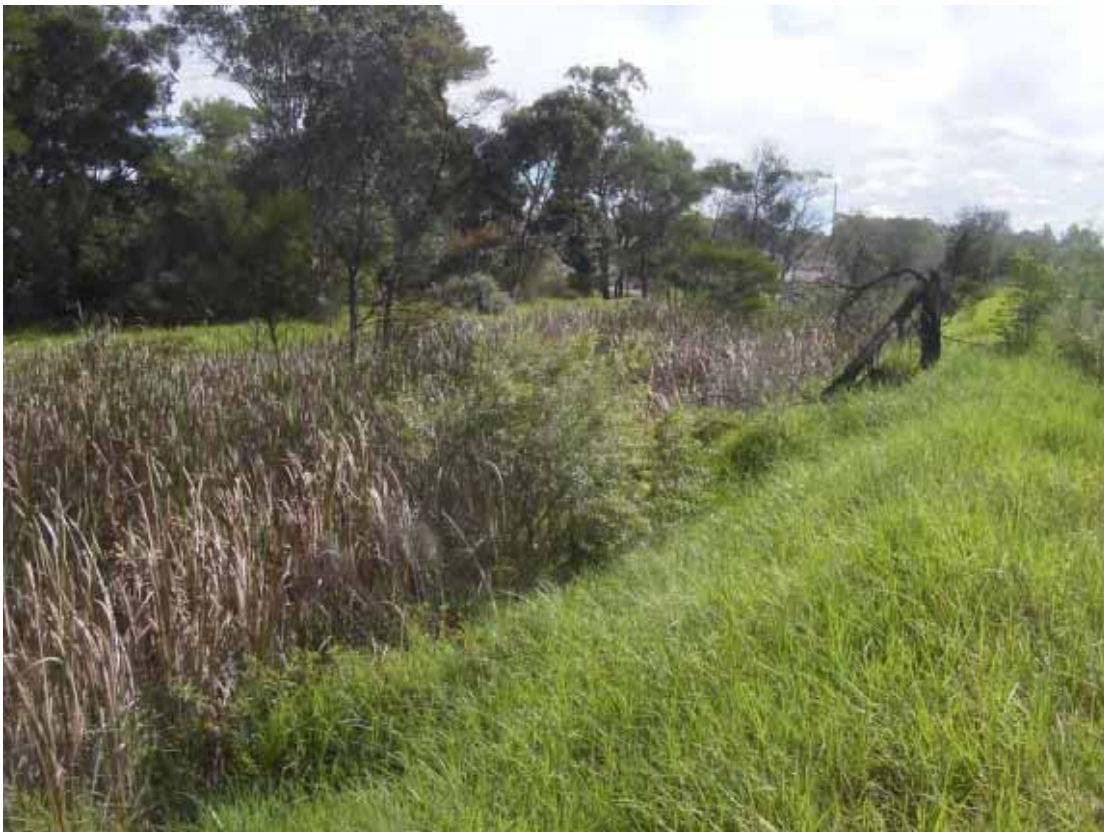
Figure 16 Stormwater drain adjacent Study Site (looking upstream – north) from levee bank. Drain is filled with Cumbungi.

The stormwater drain that runs along the western boundary of the site is separated from the site by a levee running from Milperra Road to the confluence with the un-named southern creek (Figures 1 and 3, and see also Sections 13 to 15 on the survey plan in Appendix A). This is a freshwater system draining stormwater from the Chipping Norton industrial area to the north of Milperra Road. Figures 15 to 17 show parts of the stormwater drain from the culvert pool below Milperra Road to just above the confluence with the un-named southern creek. The upper culvert pool did not appear to support any fish and the shallows lower down the drain supported Mosquito Fish. Much of the drain is filled with Cumbungi and Alligator Weed, a noxious aquatic weed.

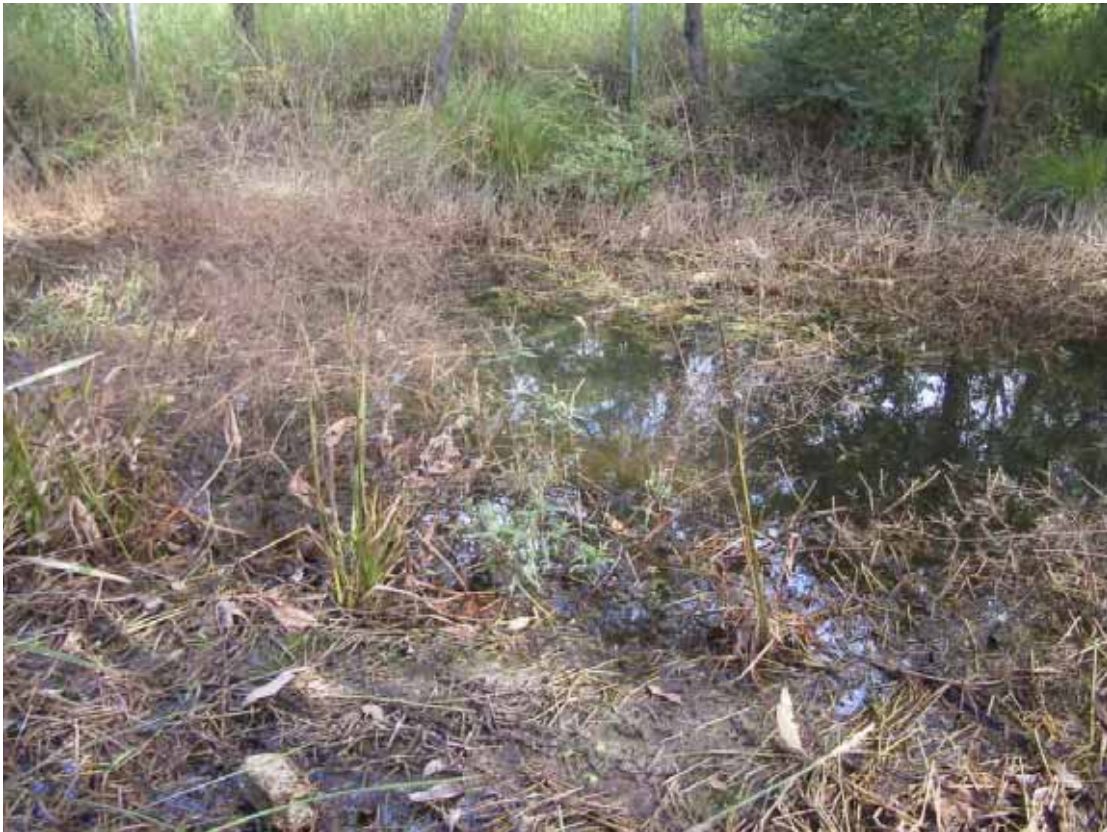
Figure 17 Stormwater Drain upstream of Un-named Creek confluence. Drain supports Alligator weed and Frogs Mouth.

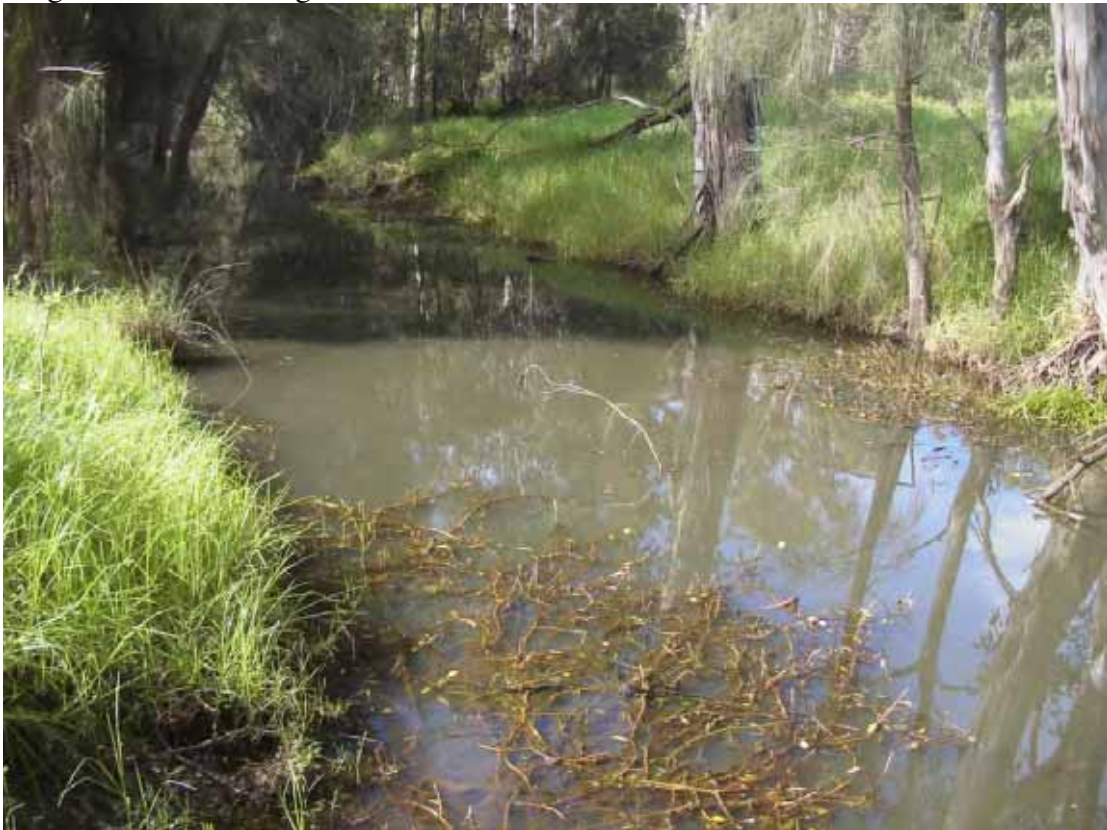
Figure 18 Un-named Creek just downstream of Stormwater Drain confluence (looking east). Alligator Weed is main emergent aquatic plant.

The unnamed creek has a more or less intact native riparian cover along the creek from the confluence with the stormwater drain to its confluence with Georges River. The creek is freshwater for most of its length then becomes brackish and estuarine as it approaches the Georges River (Figures 18 to 21). The upper pools have grassy banks and patches of Duck weed, Alligator Weed and *Persicaria* and there were Mosquito Fish observed, as well as an Eastern Long-Necked Turtle (Figure 19). Another noxious aquatic weed *Ludwigia* is also

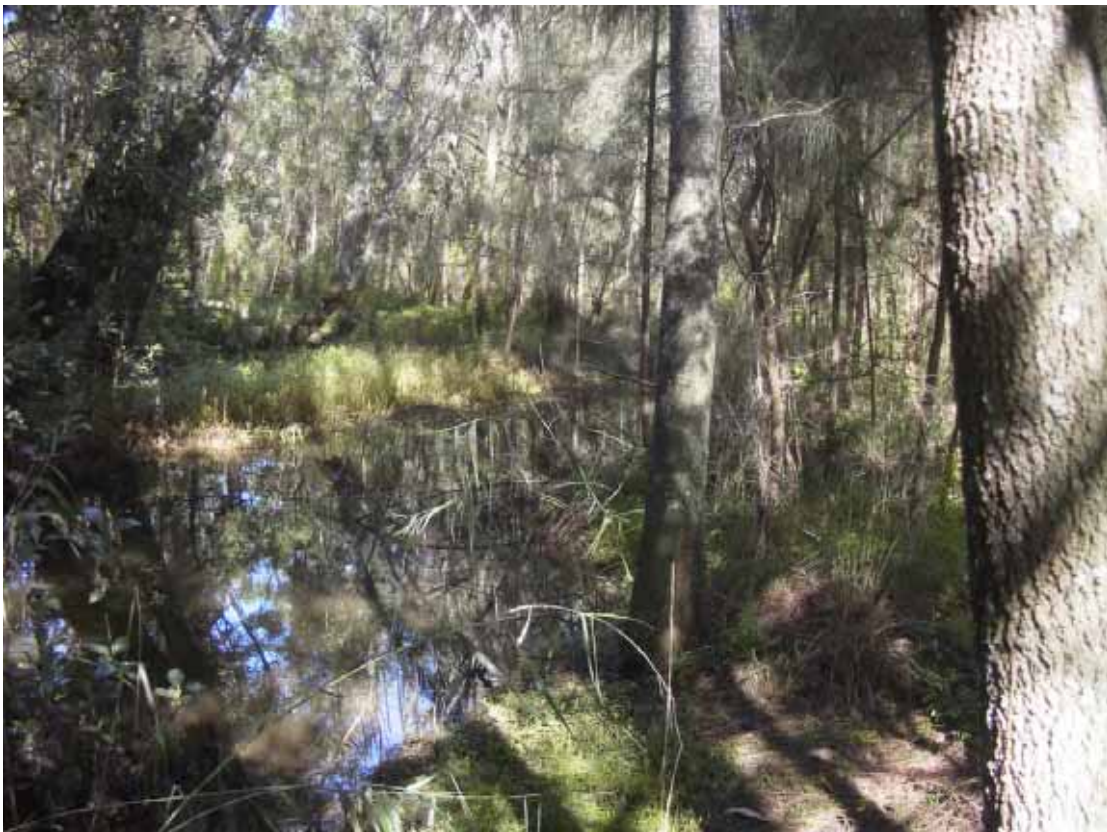
Figure 20. Un-named Creek just upstream of Georges River confluence (looking west). Grey Mangrove on right, *Phragmites* along north bank and Alligator weed in background.

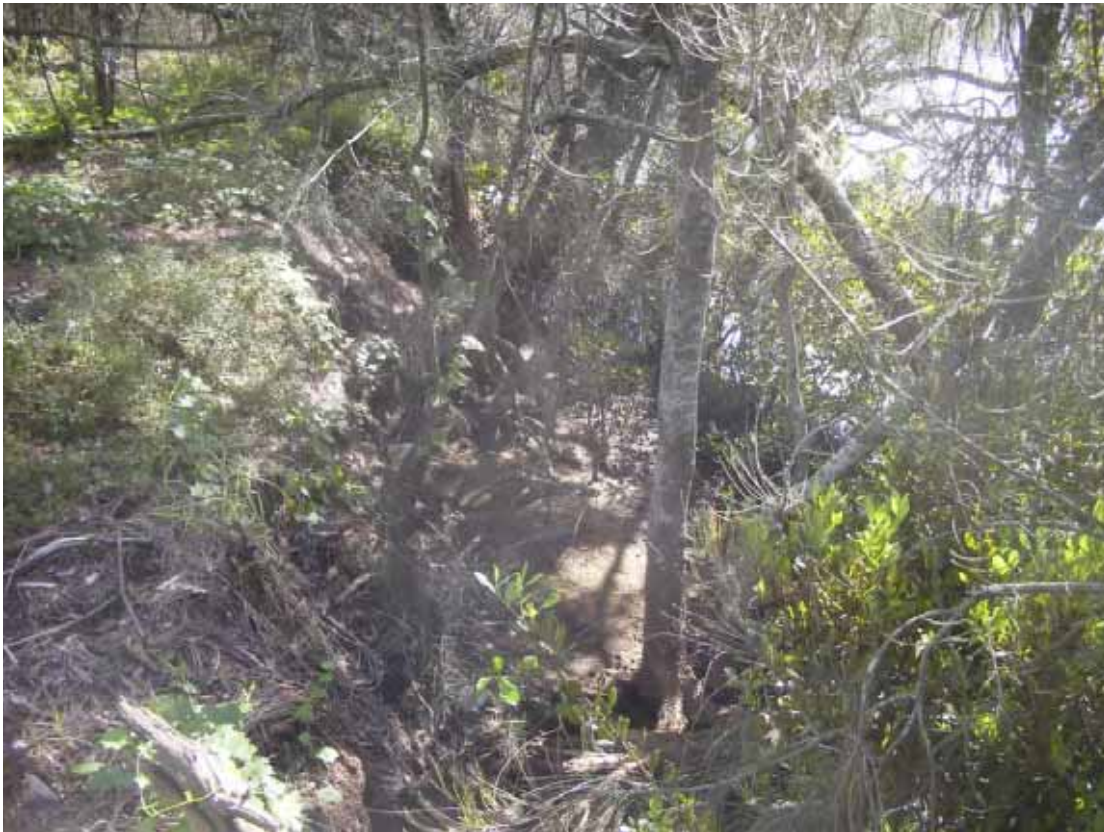
Figure 21. Georges River bank at the Un-named Creek confluence (site south-east boundary) looking north. Grey and River mangroves with She-oaks on bank.

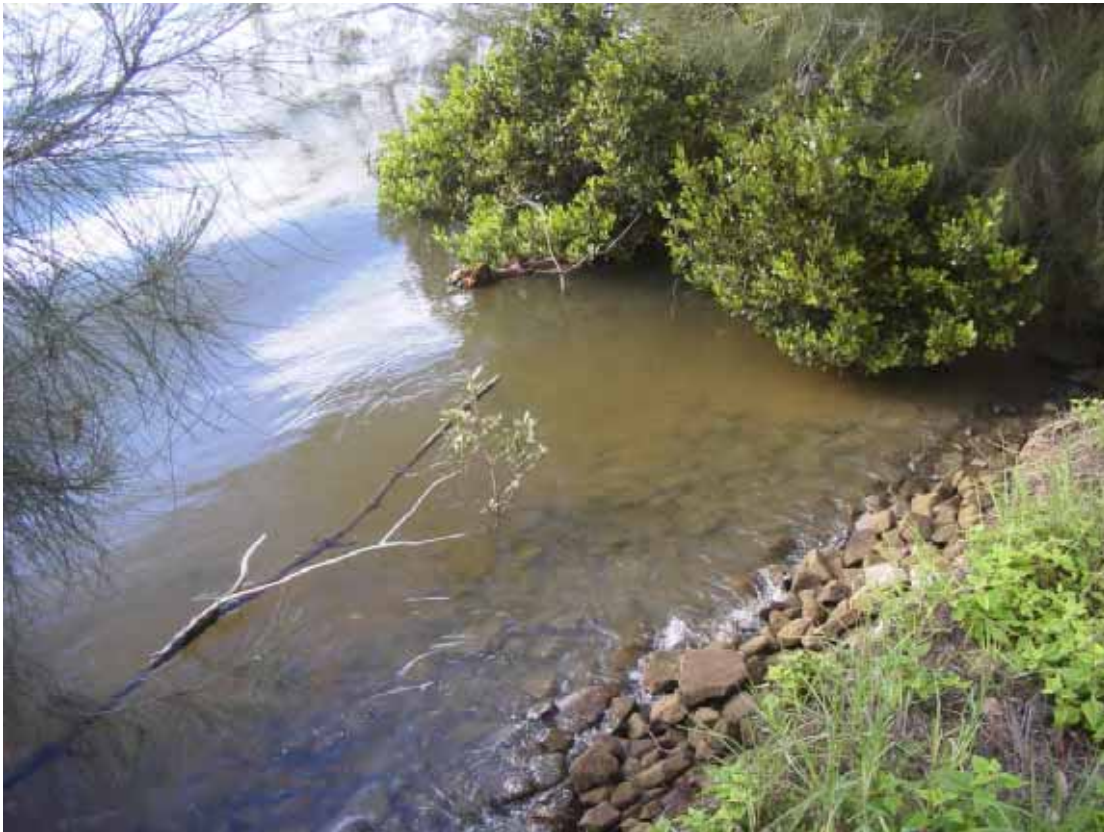
Figure 22 Georges River bank at north end of mangrove stand upstream of un-named creek confluence (looking south). Note engineered rubble bank treatment.

- There is an engineered treatment along the bank immediately upstream of the mangrove stand at the property southern boundary (the Creek confluence mangrove stand) see Figures 22 to 26. This treatment has failed in several places with slumping of the rocks and exposure of the underlying silt cloth plus active bank erosion behind the treatment resulting in terrestrial trees (mainly She-oaks) falling into the river (Figure 24 and 25).

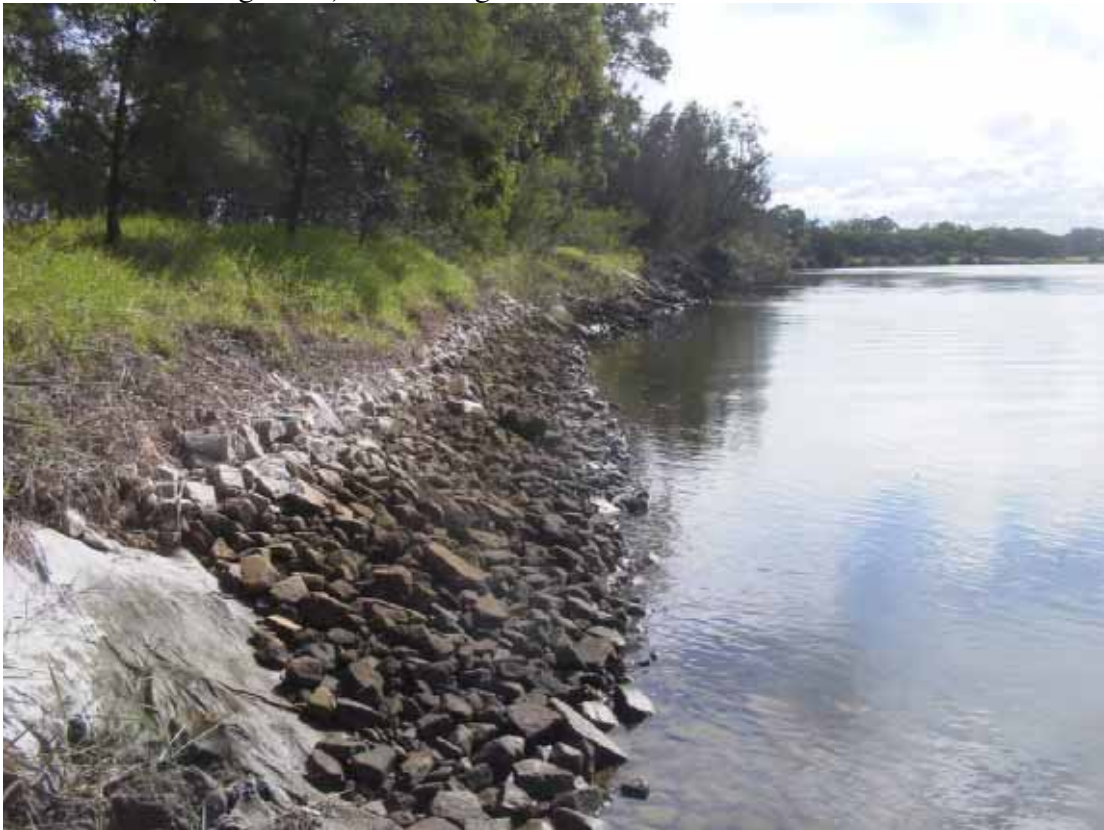
Figure 23 Engineered Rock Rubble embankment looking north of mangrove band with failed and slumped bank in foreground.

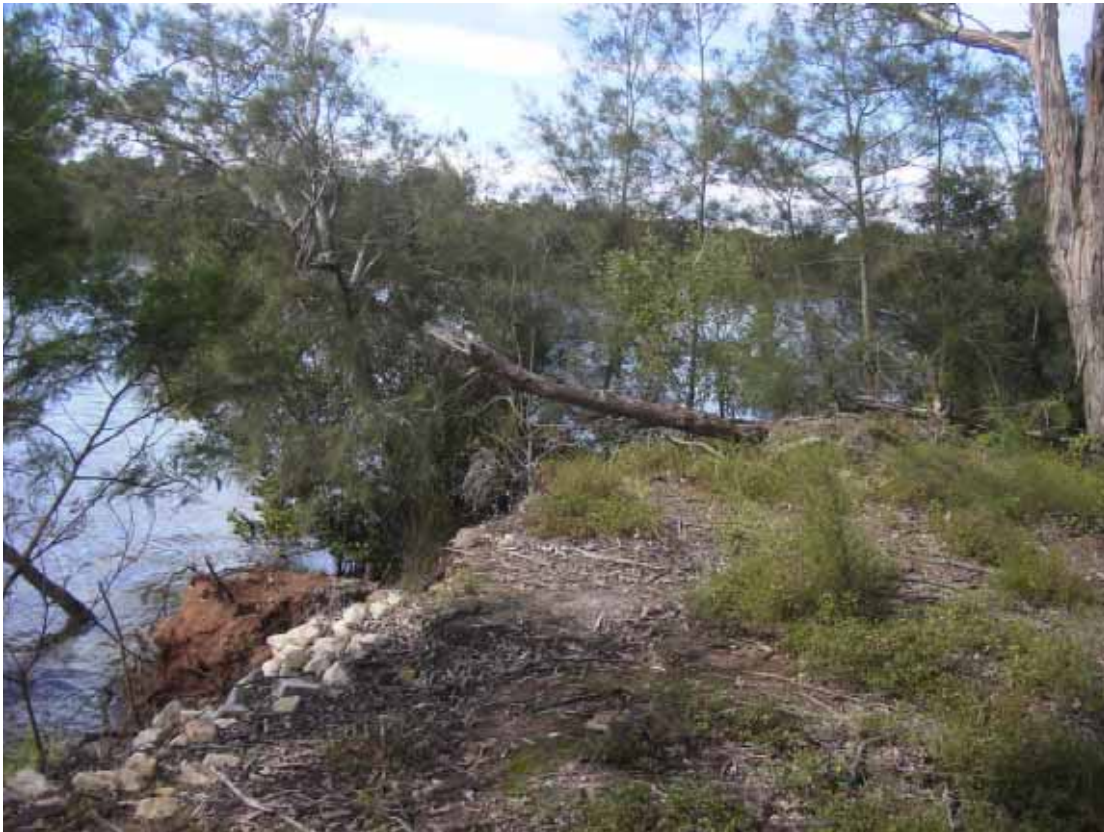
Figure 24 showing bank erosion and toppled she-oaks (looking south from Figure 23).
