GEORGES RIVER MARINA, MOOREBANK

AQUATIC ECOLOGY ASPECTS & ENVIRONMENTAL ASSESSMENT OF MARINA CONCEPT DESIGN

**REPORT PREPARED FOR
BENEDICT INDUSTRIES PTY LTD**

**MARINE POLLUTION RESEARCH PTY LTD
MARCH 2010**

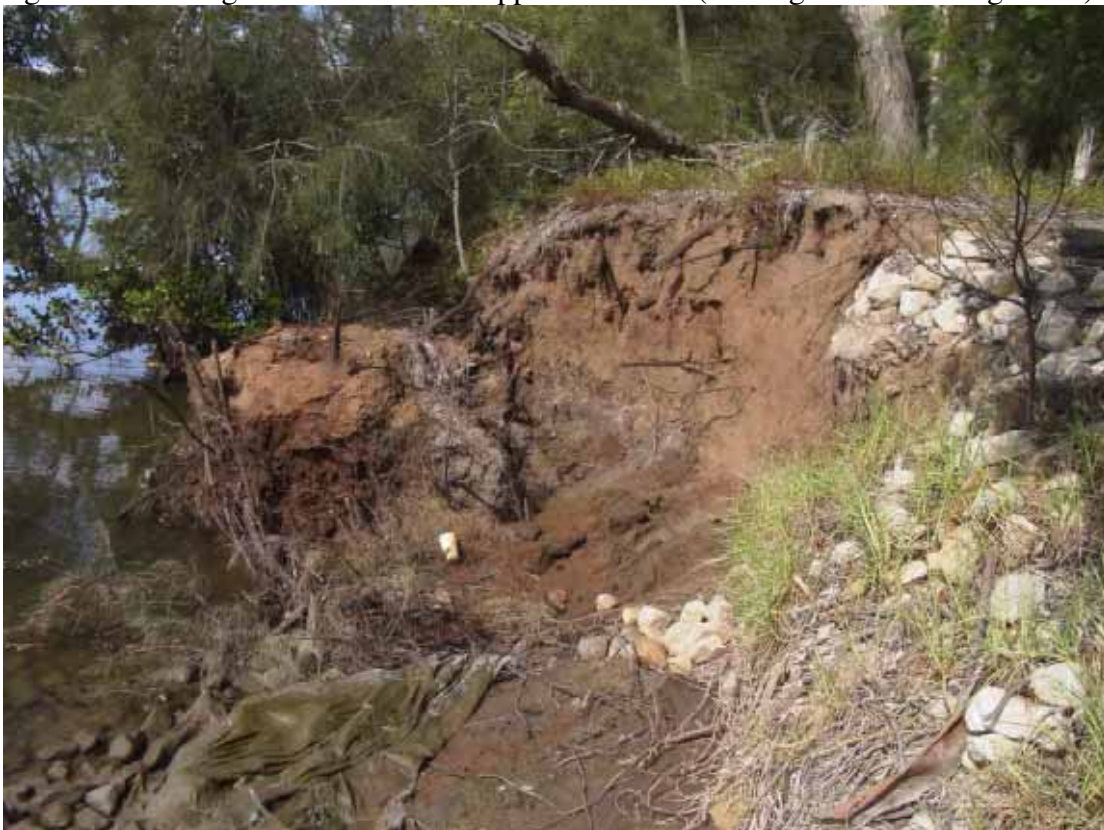
Figure 25. Detail of active bank erosion including exposure of silt-cloth plus slumped rubble fill treatment (looking south from Figure 23).

- There is an engineered treatment along the bank immediately upstream of the mangrove stand at the property southern boundary (the Creek confluence mangrove stand) see Figures 22 to 26. This treatment has failed in several places with slumping of the rocks and exposure of the underlying silt cloth plus active bank erosion behind the treatment resulting in terrestrial trees (mainly She-oaks) falling into the river (Figure 24 and 25).

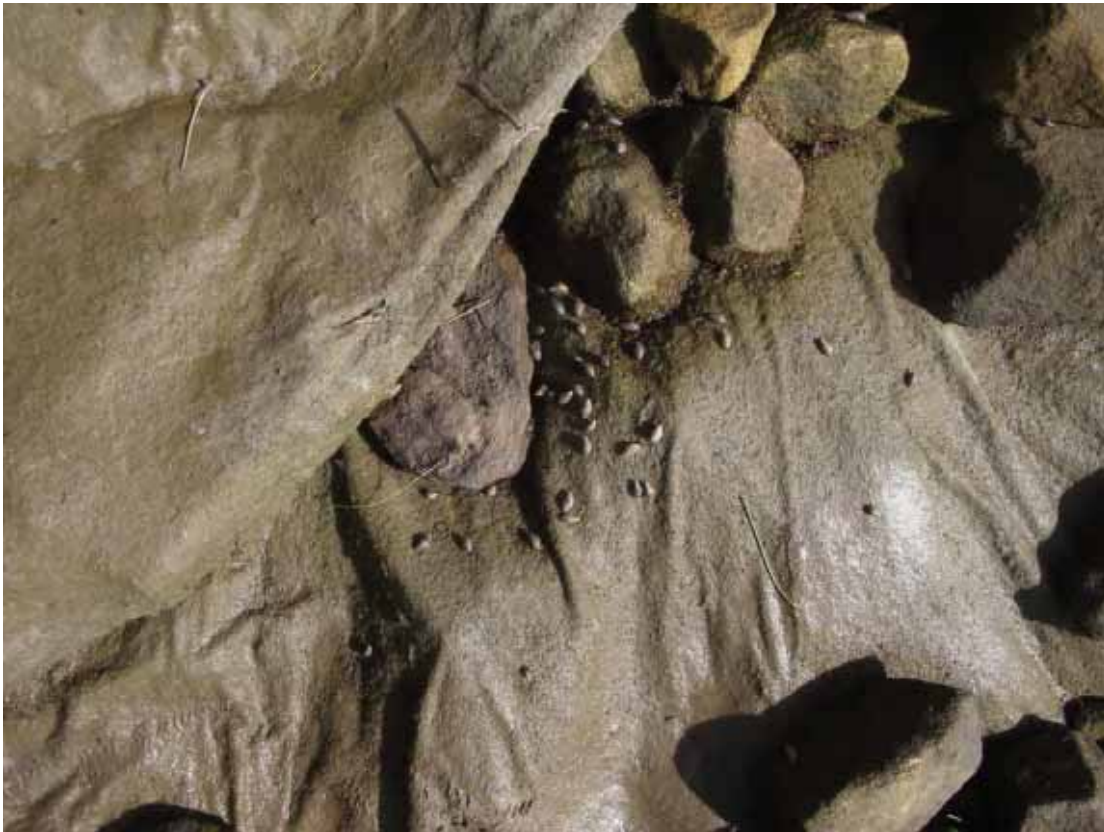
Figure 26. Littorinid snails grazing silt/algae matrix on exposed silt cloth.

- Where the silt cloth is exposed in the intertidal it has been covered in a silt/algae matrix that provides food for grazing molluscs (Figure 26).
- Upstream of the rubble and siltcloth bank treatment there is a section where the bank is protected by larger piece of masonry, mainly concrete slab pieces (Figures 23 and 27). There are also dead trees amongst this rubble indicating earlier active bank erosion.

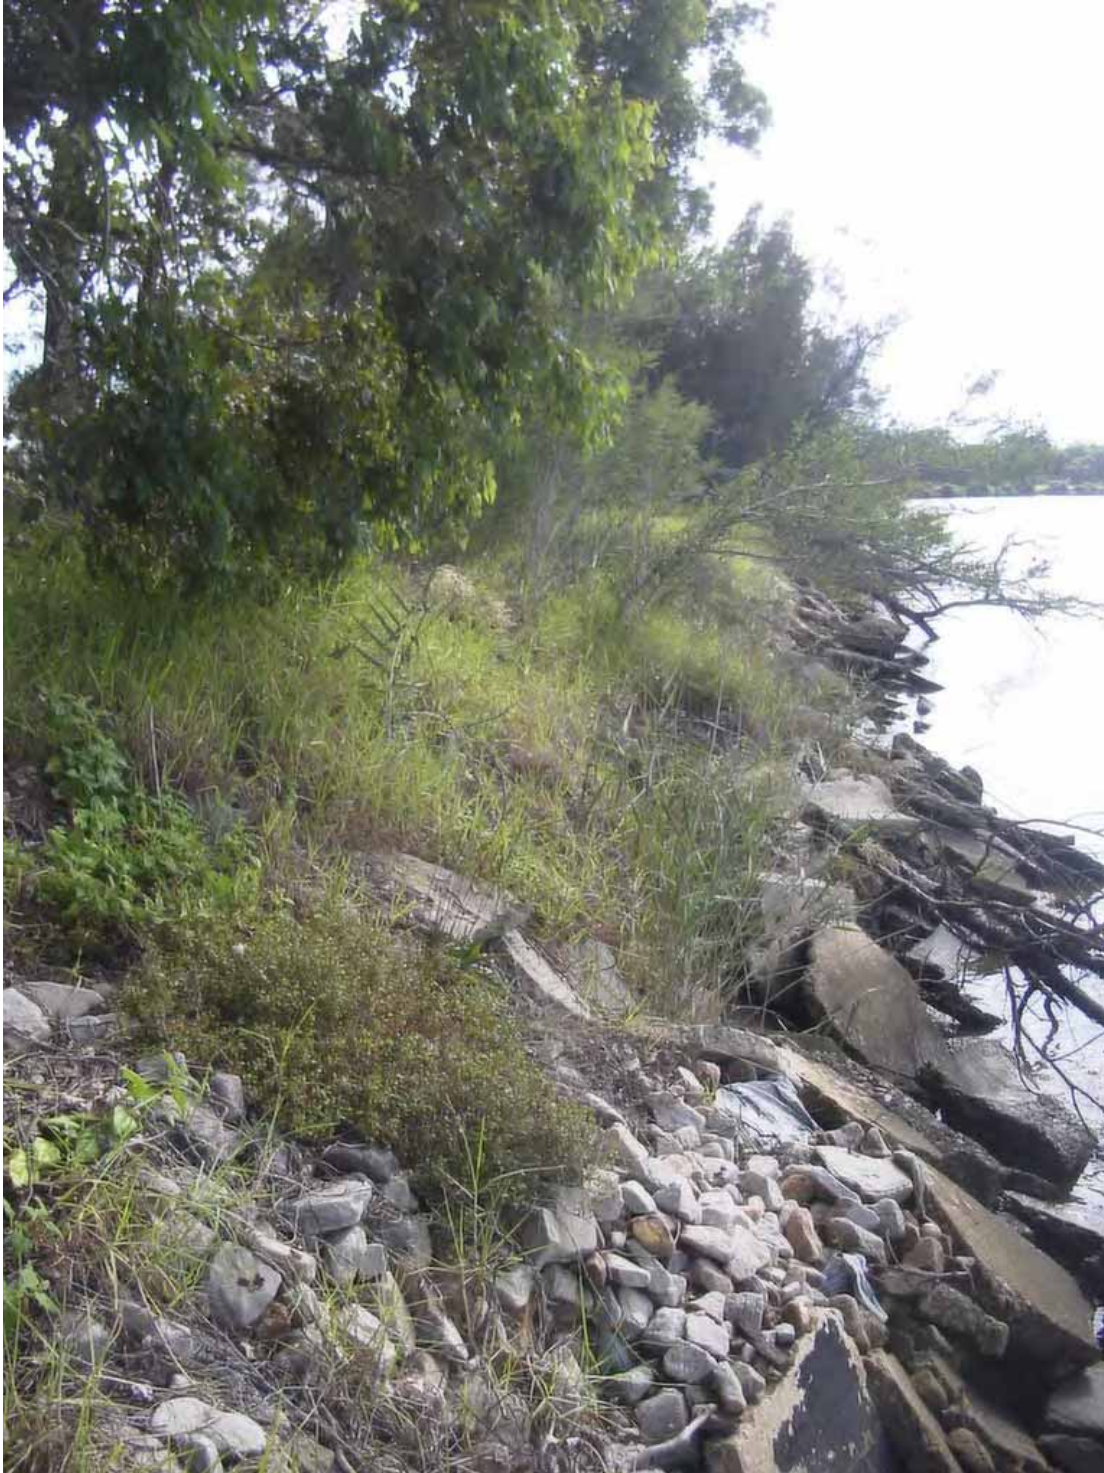
Figure 27. Next upstream bank treatment from engineered rock rubble treatment (Figure 23). This treatment continues up to the site boundary (see following photos).

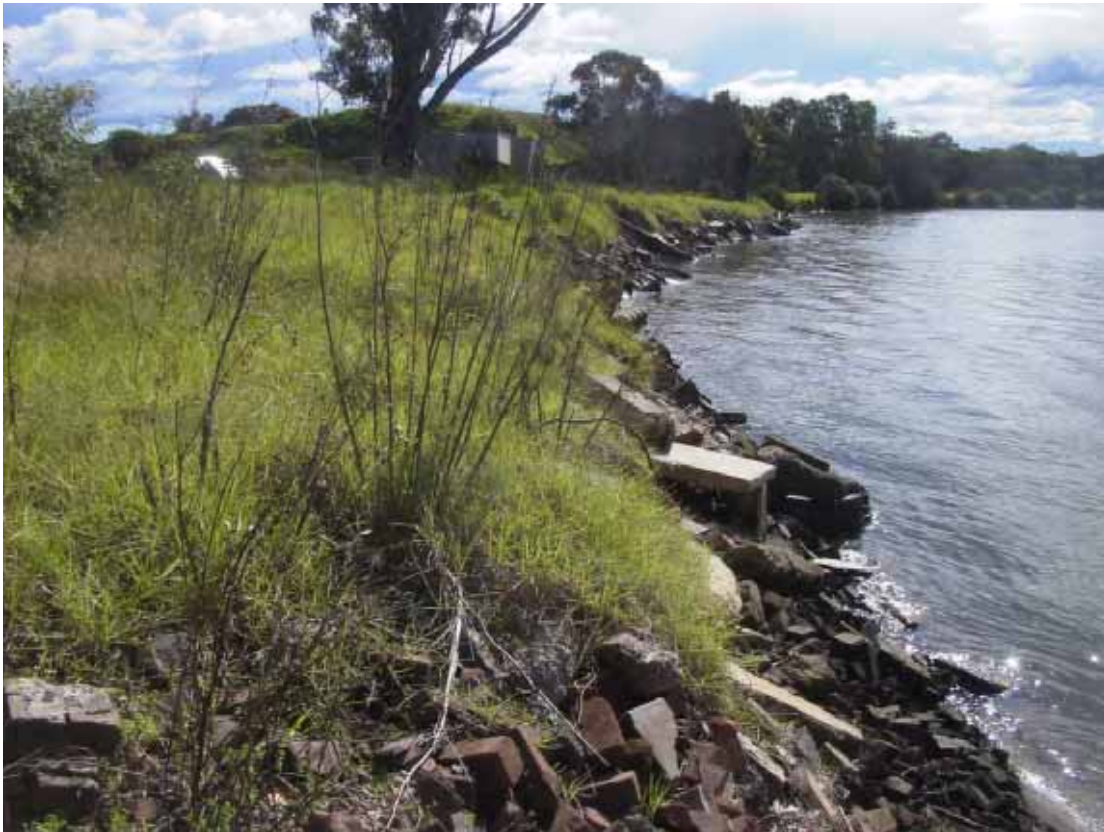
Figure 28 Continuation of bank treatment looking upstream from Figure 27. Note individual mangroves in background (see Figure 74 below).

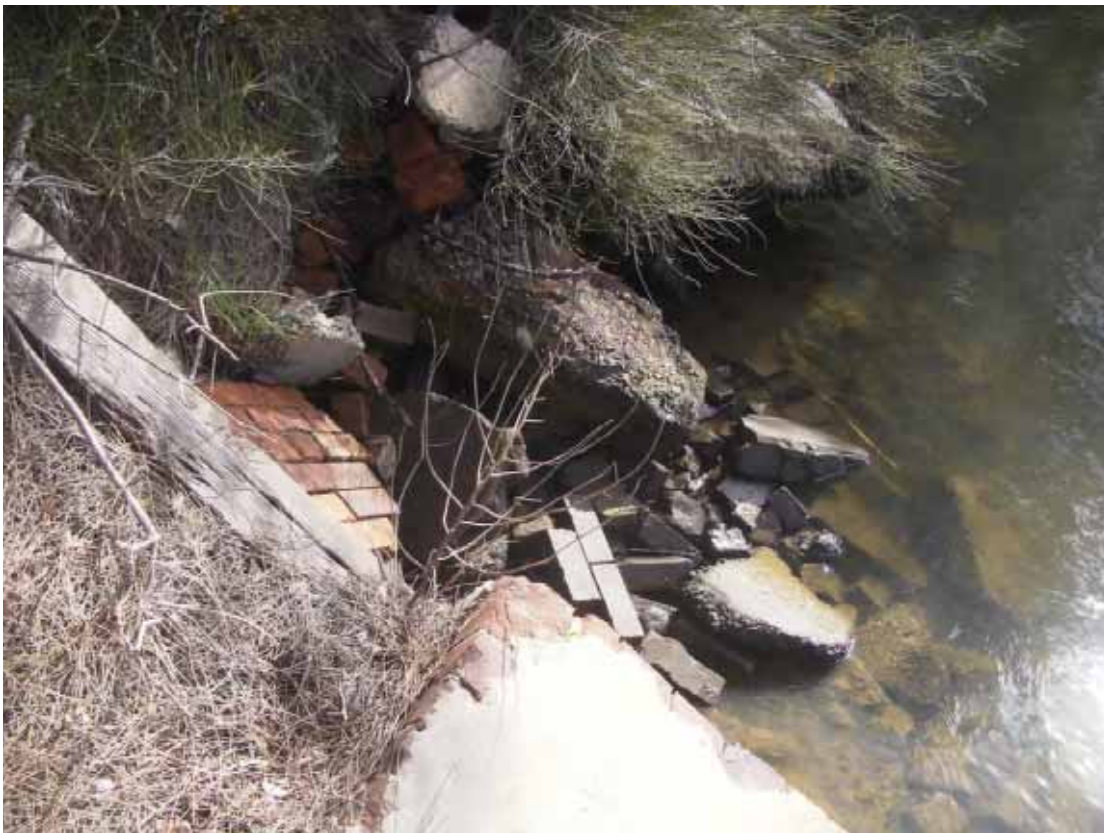
Figure 29. Diversity of masonry and road base fill material.

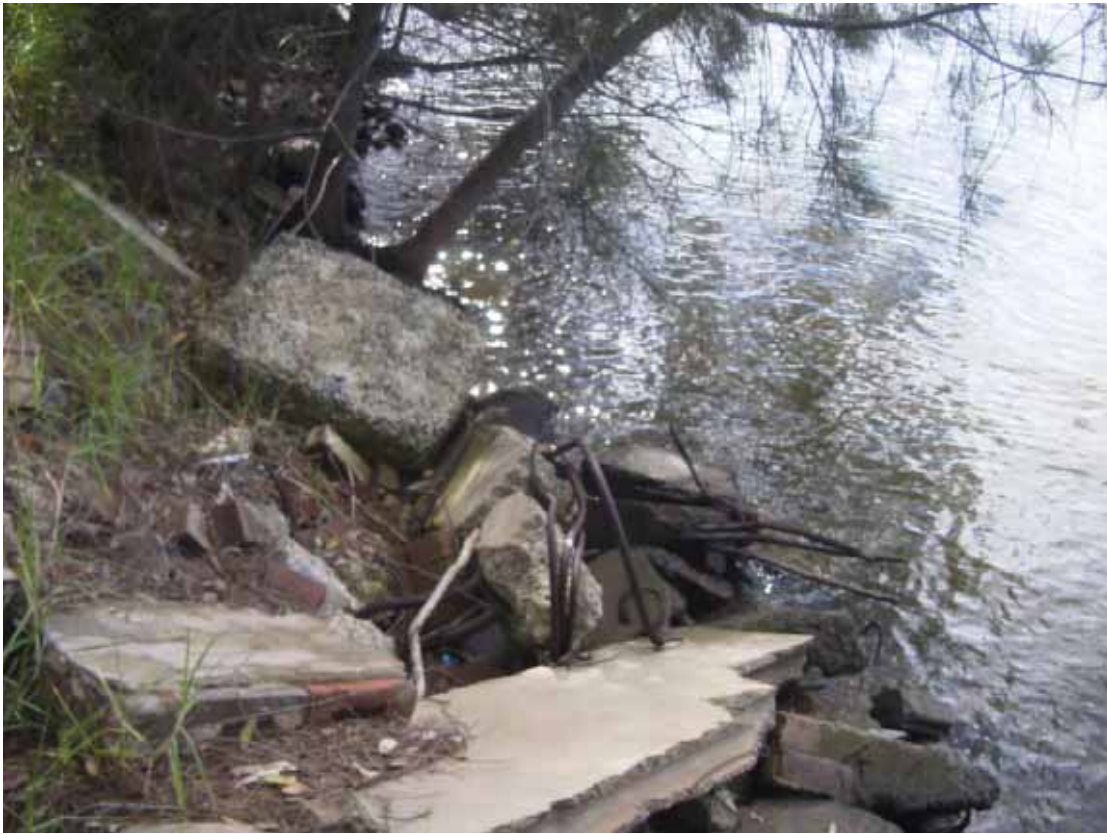
Figure 30. Masonry and concrete fill material.

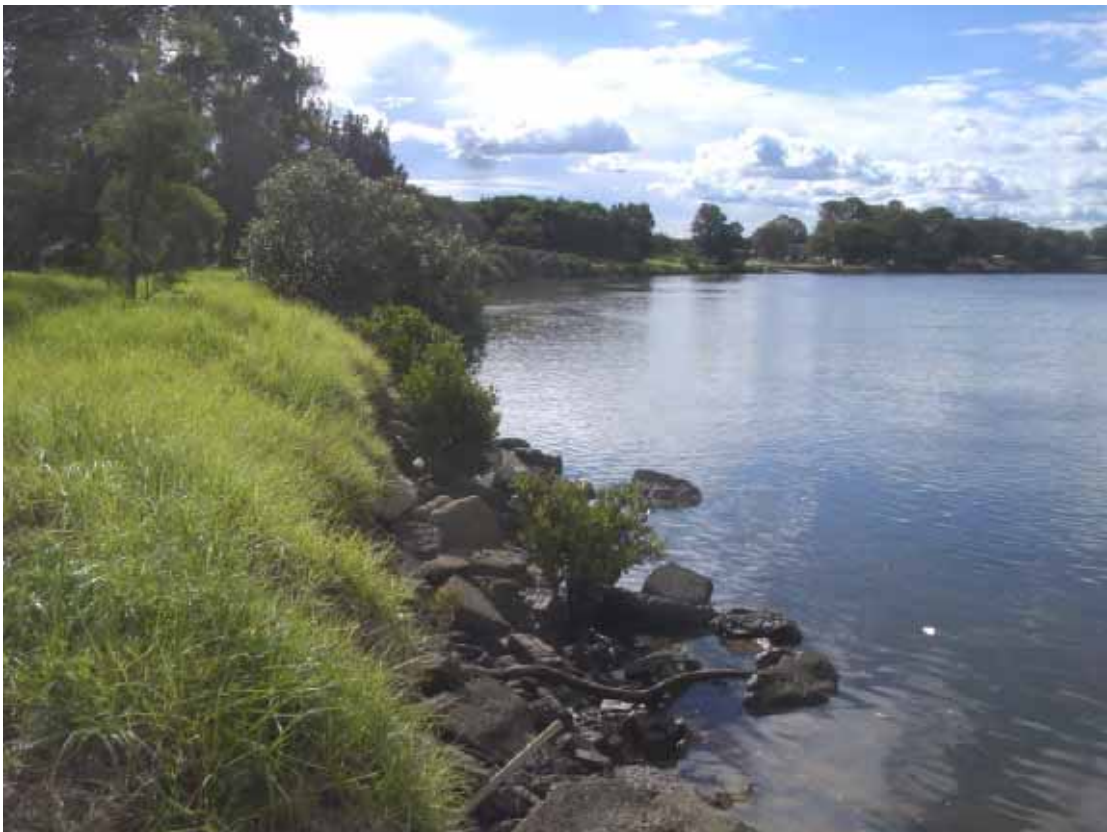
Figure 31. River mangroves growing between masonry rubble (looking upstream). See Figures 33 and 34 for remaining views beyond the she-oak.

- The mixed masonry bank treatment continues to (and beyond) the northern boundary. This fill has been in place for many years and there are mangroves that have colonised the fill (Figures 31 and 33).

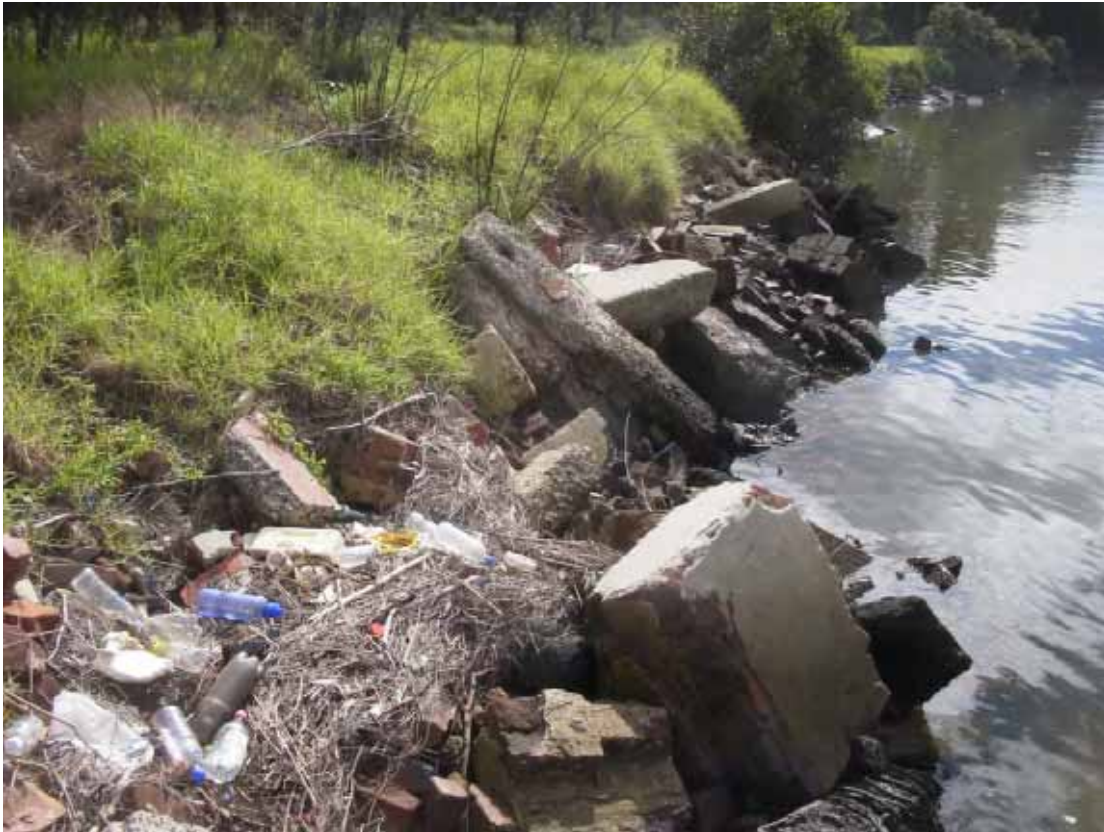
Figure 32. Trapped floating rubbish amongst masonry rubble.

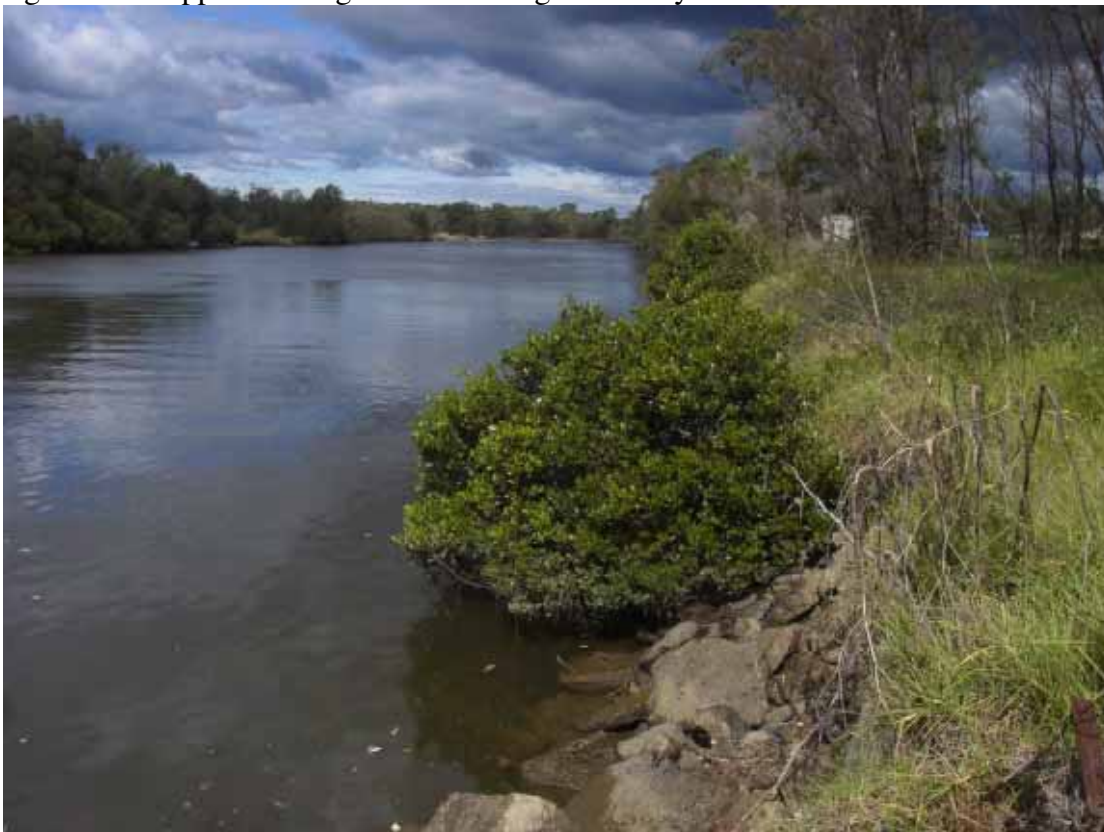
Figure 33. Bank treatment around individual Grey mangroves at north-east end of study site looking downstream (i.e., back south towards Figure 31).

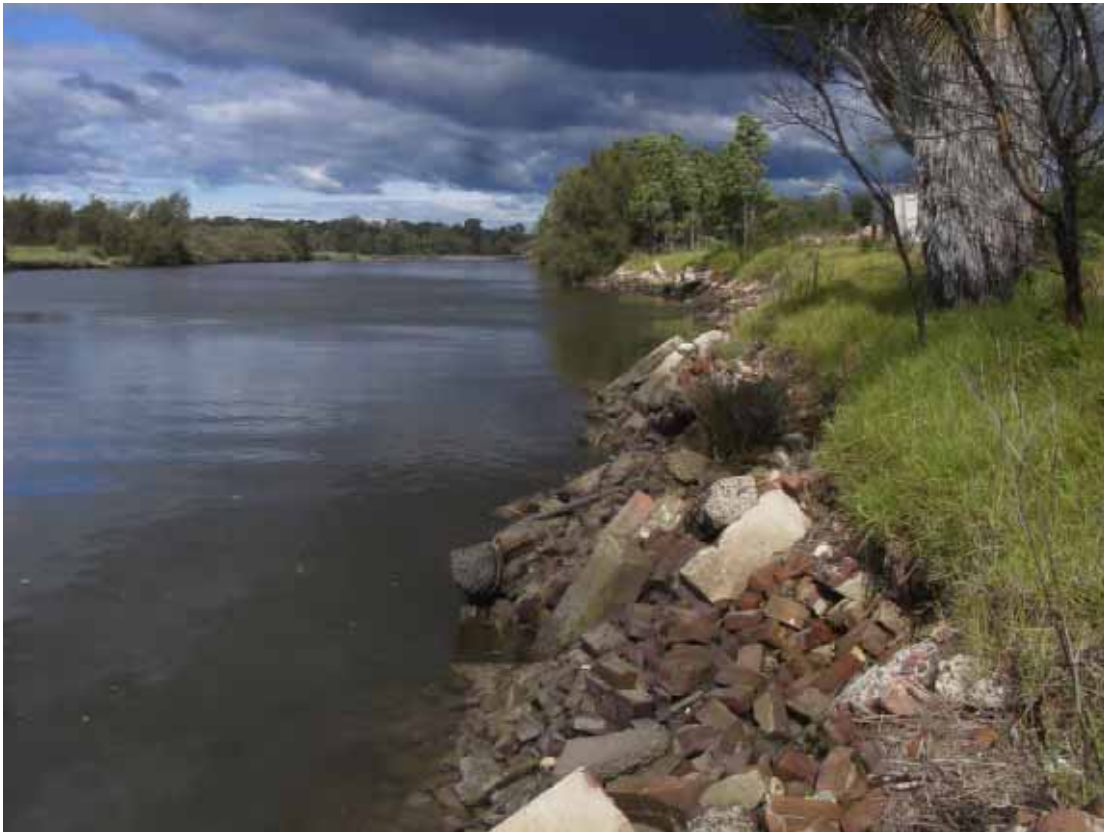
Figure 34. Bank treatment south of mangrove in Figure 33, looking downstream. Note pump-house on bank in middle distance.

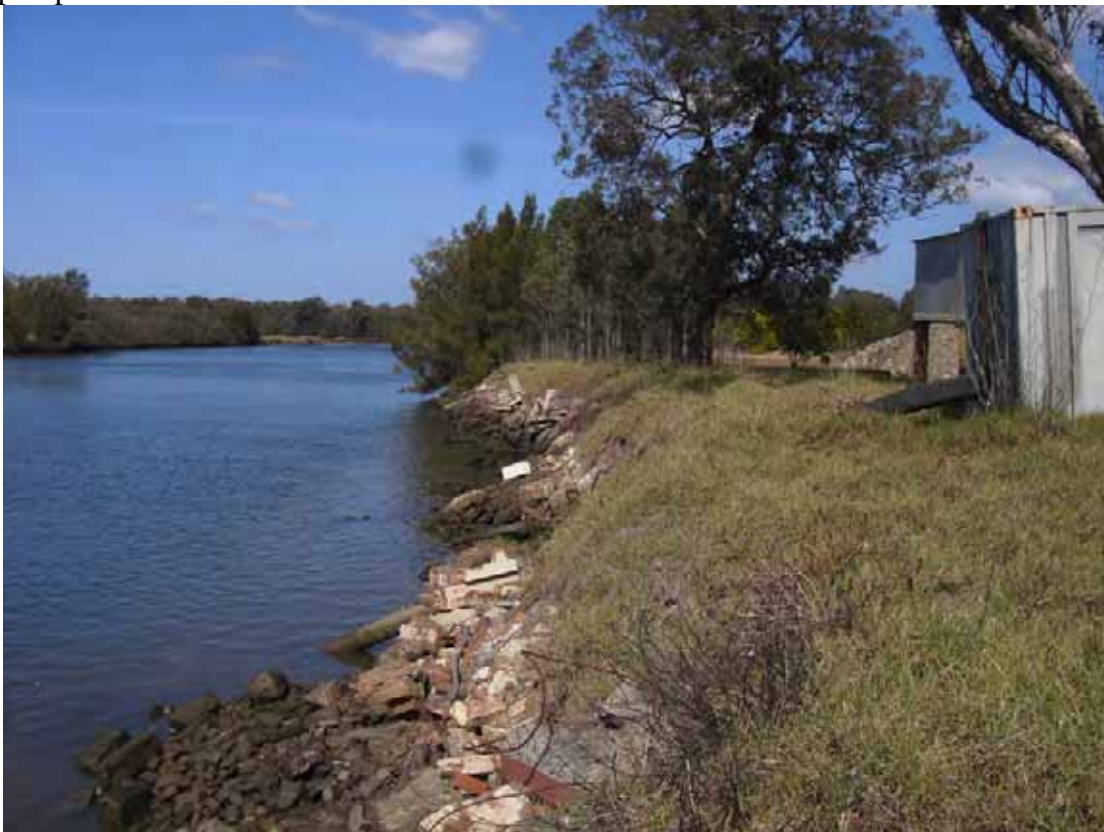
Figure 35 Pump House and Inlet pipe for pumping ‘make up’ river water to Quarry (August 2004 photo).
