Report on  
Geotechnical Investigation

Proposed Sports and Health Centre of Excellence  
Goldsmith Avenue, Macarthur Heights  
Campbelltown, NSW

Prepared for  
Campbelltown City Council

Project 34255.25  
February 2018

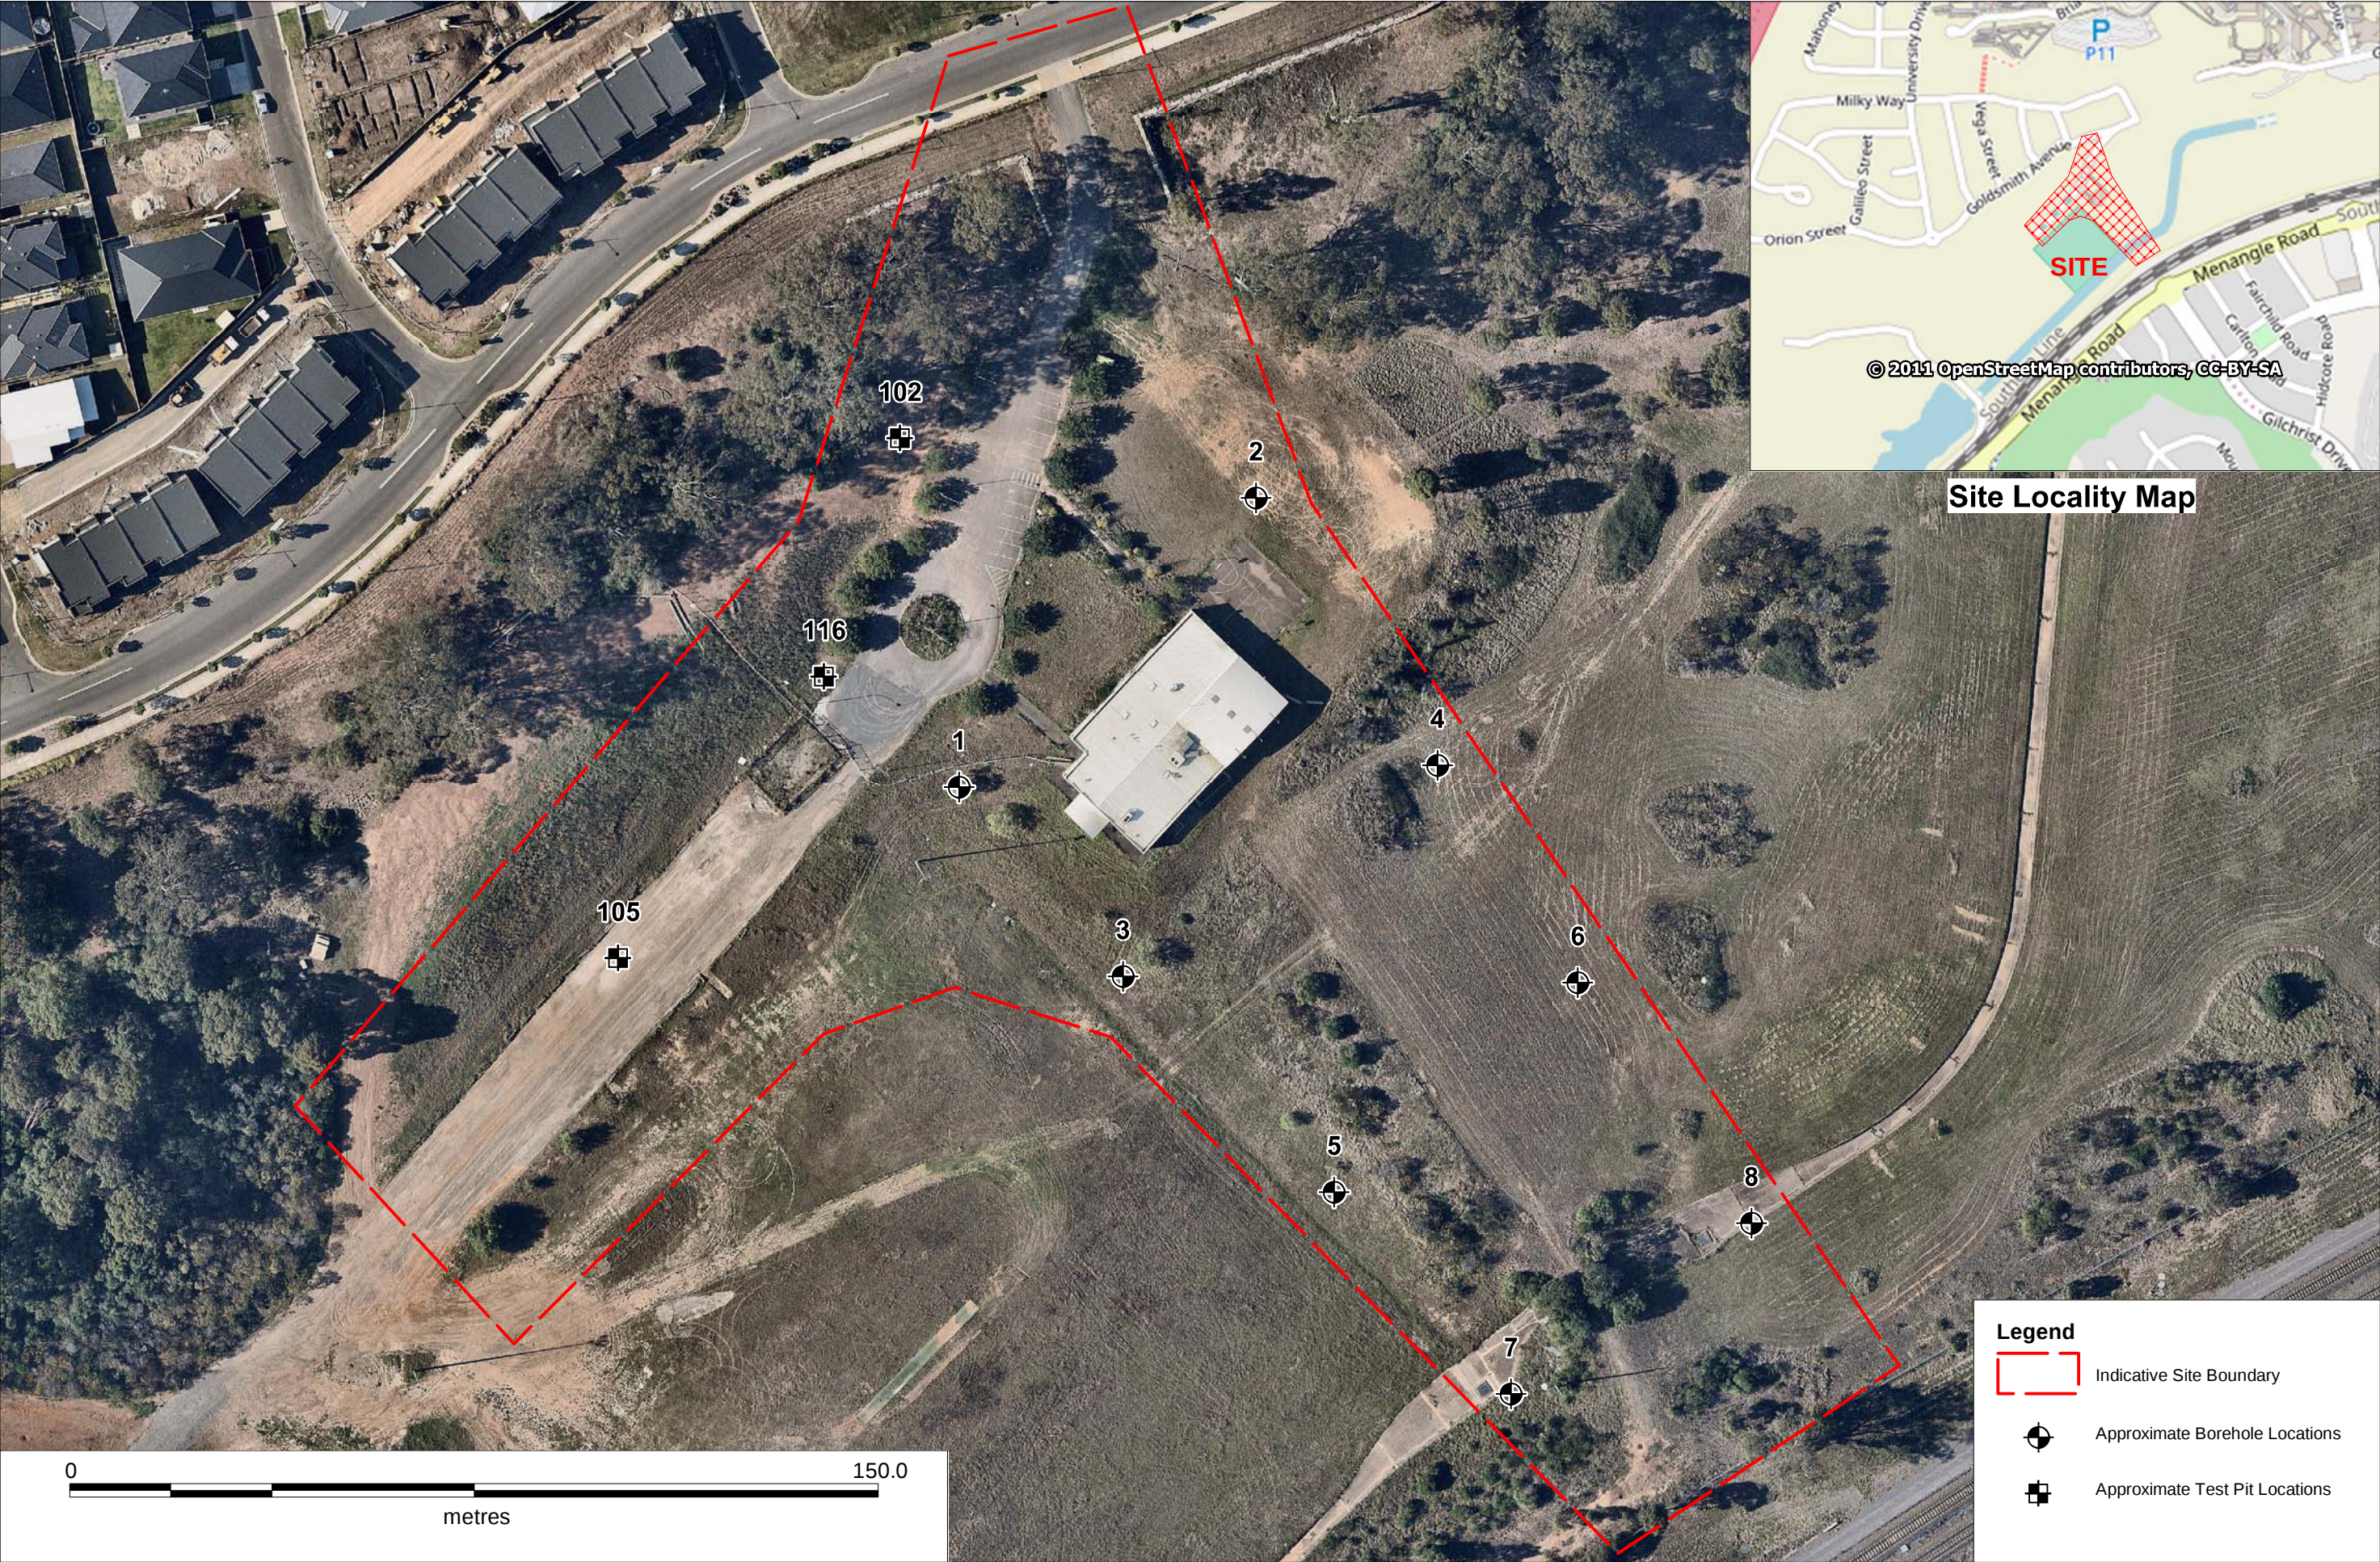
About This Report  
Drawing 1

The locations of the field tests are shown on Drawing 1 in Appendix A. The borehole locations were nominated by Client. The test pit locations were nominated by DP and all were located on site prior to the investigation using a differential GPS unit for which an accuracy of  $\pm 20$  mm is typical. The surface levels to Australian Height Datum (AHD) and coordinates to Map Grid of Australia (MGA) were obtained using the differential GPS unit.

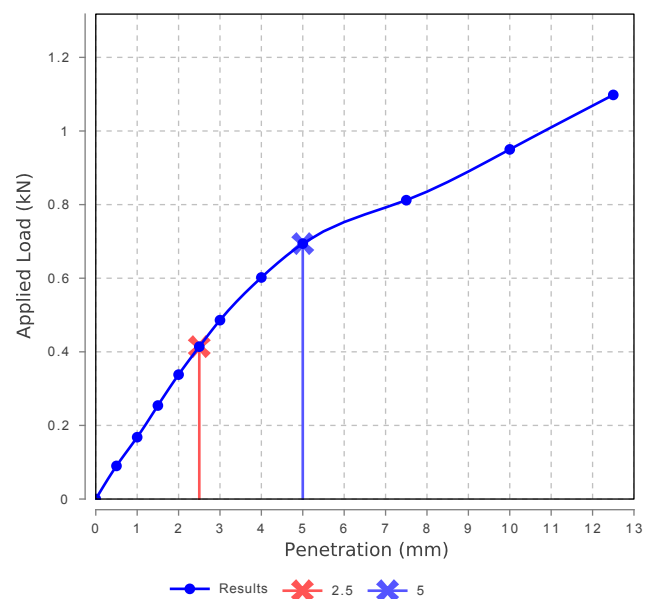
California Bearing Ratio

| Pit No. | Depth (m) | W <sub>F</sub> (%) | OMC (%) | MDD (t/m <sup>3</sup> ) | CBR (%) | Swell (%) | Material |
|---|---|---|---|---|---|---|---|
| 116 | 0.5 – 0.7 | 14.3 | 19.5 | 1.73 | 3.5 | 1.0 | Silty Clay |

**Report Number:** 34255.25-1  
**Issue Number:** 1  
**Date Issued:** 30/01/2018  
**Client:** Campbelltown City Council  
 PO Box 57, Campbelltown NSW 2560  
**Contact:** Ares Liu  
**Project Number:** 34255.25  
**Project Name:** Proposed Sports and Health Centre of Excellence, Geotechnic  
**Project Location:** Macarthur Heights, Campbelltown  
**Work Request:** 278  
**Sample Number:** 18-278G  
**Date Sampled:** 19/01/2018  
**Sampling Method:** Sampled by Engineering Department  
**Sample Location:** Macarthur Heights, Campbelltown (0.5 - 0.7m)  
**Lot No:** 116  
**Material:** CLAY - Silty clay
