Bush Fire Hazard Assessment Report

For Proposed; Sports & Health Centre (Commercial)

Goldsmith Ave Campbelltown NSW 2560

9th March 2018

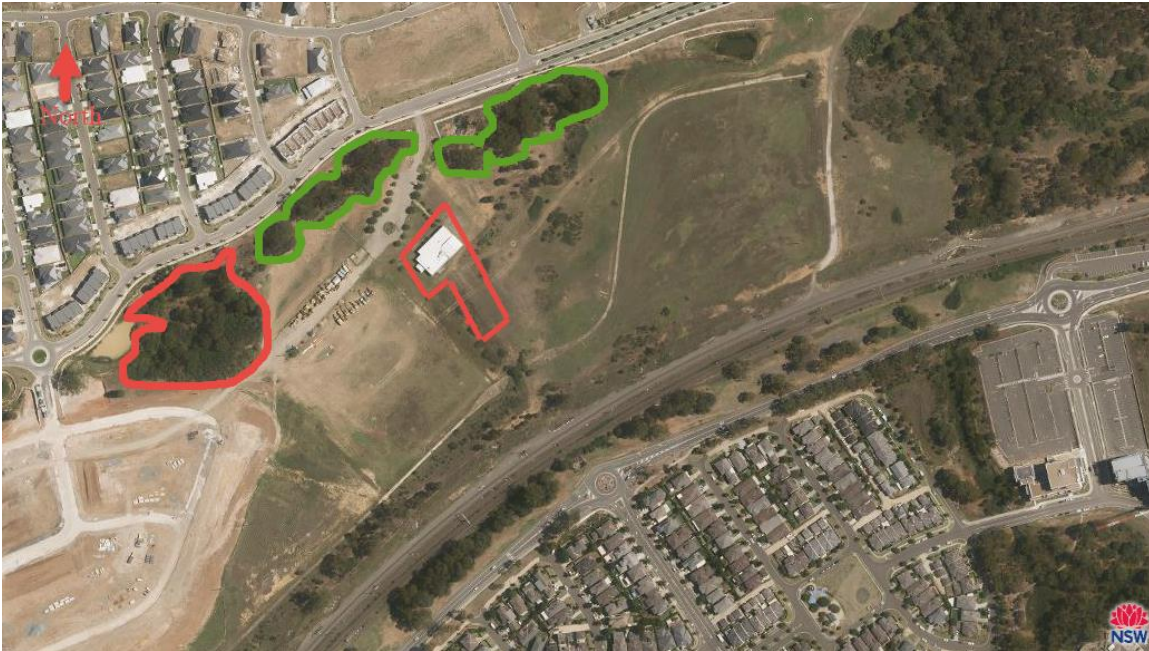
Image 1: Aerial View of the allotment. Note the Red Lines indicate the approx. extremities of the proposed new structure facades in each aspect. The vegetation in the identified within the red-line is the nearest Category 2 Bushfire Hazard Vegetation (Forest) whilst the areas identified within the green-line is vegetation that has been deemed a non-hazard to the proposal and is therefore not part of this assessment (NSW Government 2018)

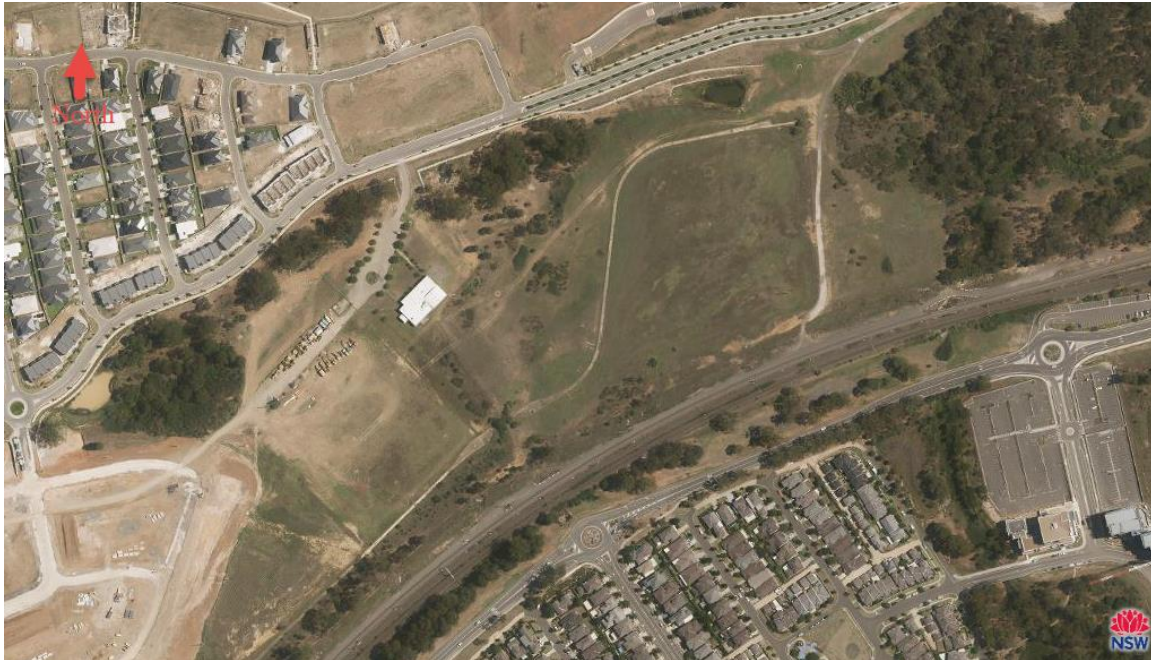
Image 2: - Site Aerial showing the existing structure that will be demolished (NSW Government 2018)

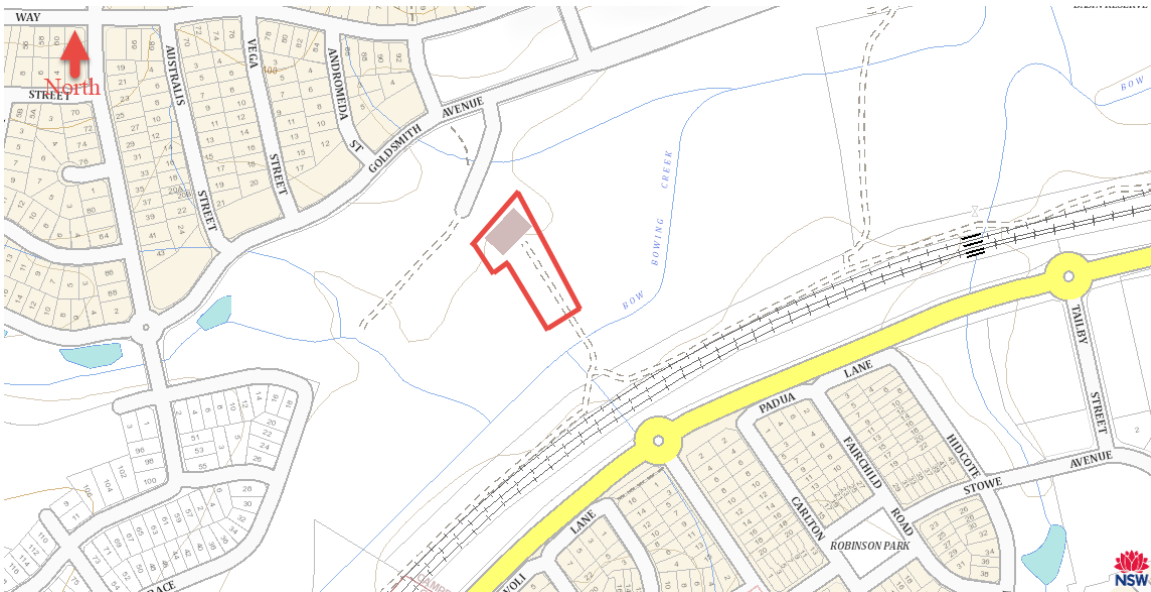
Figure 2: - Street Location of Property also indicating the approx. building footprint of the proposal (NSW Government 2018)

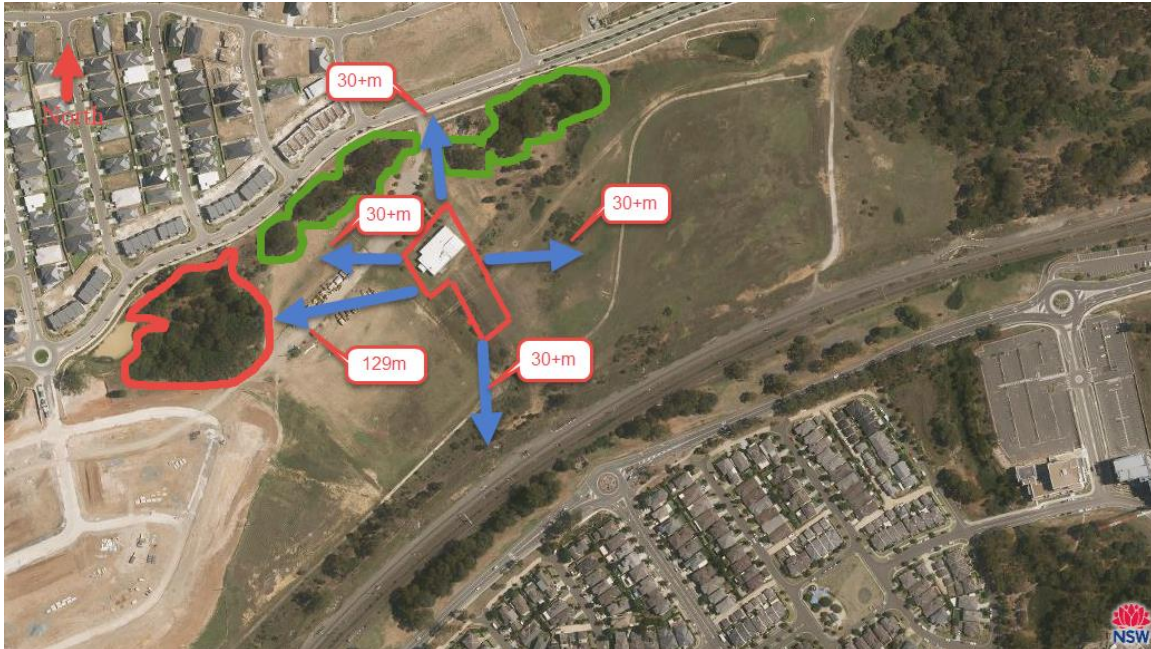
Image 3 – Indicates the areas of Remnant Scrub (Green) and Forest Classified Vegetation (Red) at 129m from the proposal. Both areas are not considered as being a threat to the proposal due the Remnant Scrub being deemed as a non-hazard and the Forest Classified Vegetation being more than 30m from the proposal (NSW Government 2018)

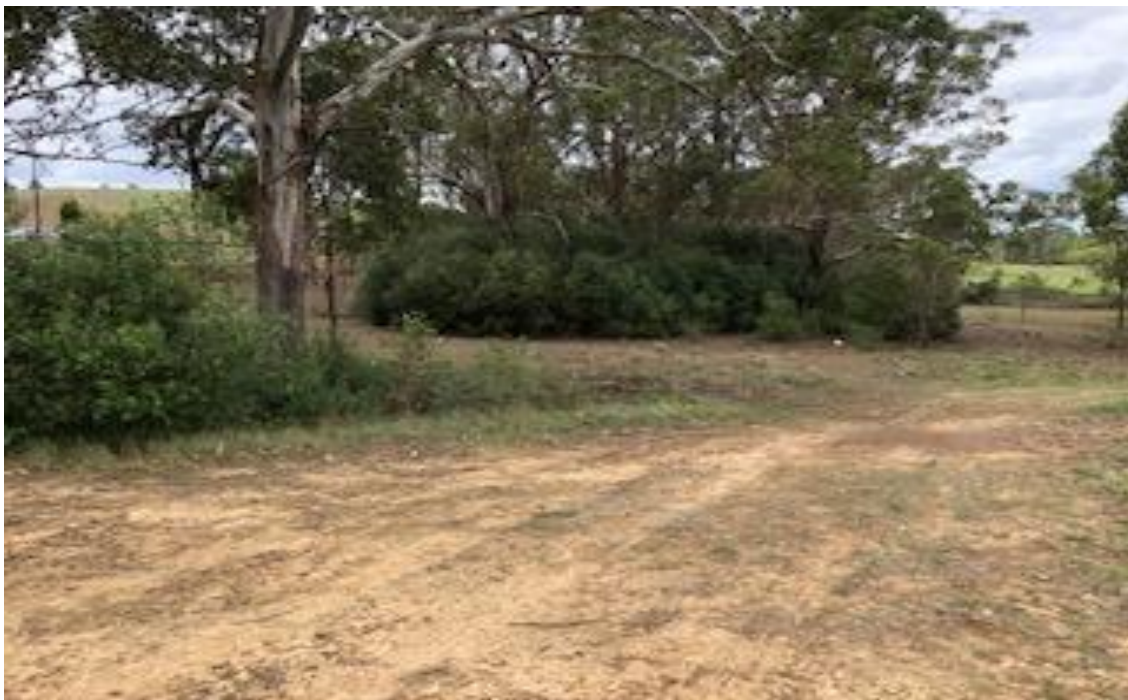
Photo 1 – Indicates the vegetation that is considered as Remnant Scrub and not being deemed as a hazard to the proposal (Steve Brooks 2018).

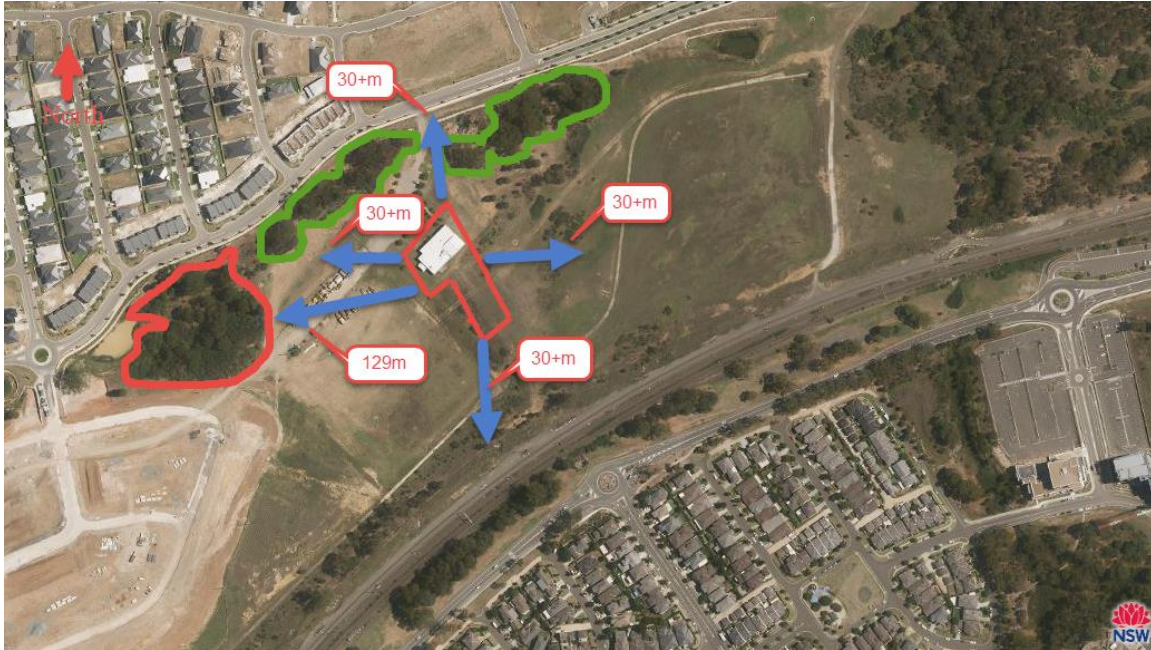
Image 4: - Indicates the distances to what can be Classified as Category 2 Bushfire Hazard Vegetation - Forest (identified within the red-lined area) which is more than 30m (129m) West from the proposal. Note the vegetation in the Green area has been deemed as a non- hazard to the proposal and is therefore not part of this assessment (NSW Government 2018)

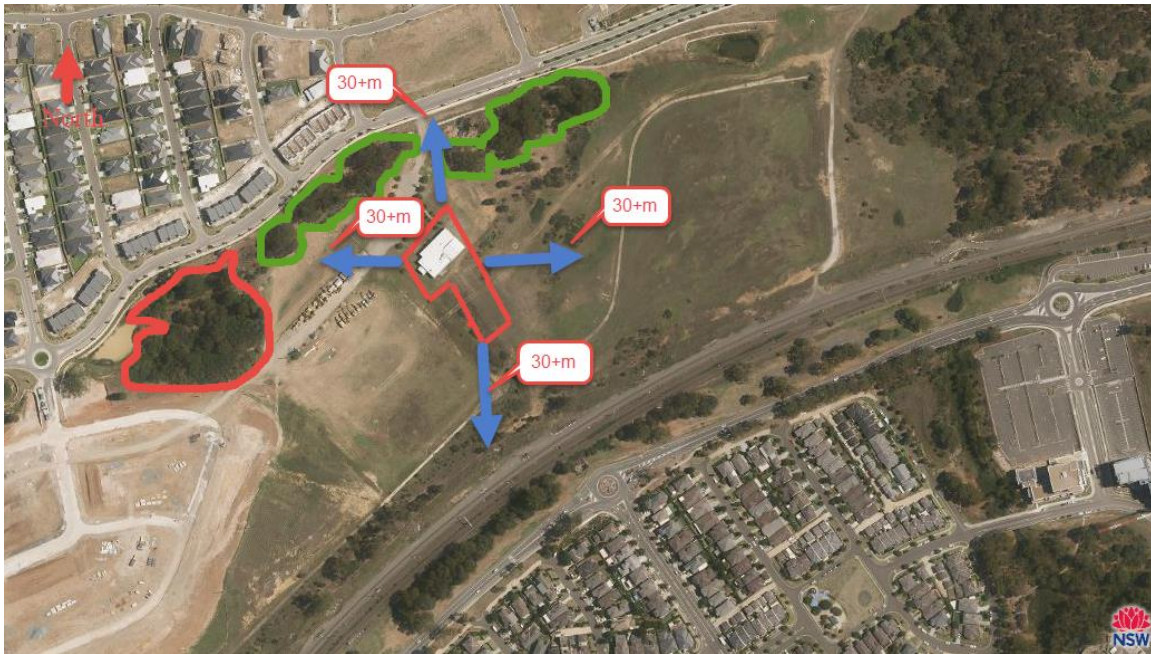
Image 5: - Indicates the proposed new Sports and Health Centre in proximity to the Category 2 Bushfire Hazard Vegetation in the red-line area to the West of the proposal. Note the vegetation in the Green area has been deemed as a non-hazard to the proposal and is therefore not part of this assessment (NSW Government 2018).

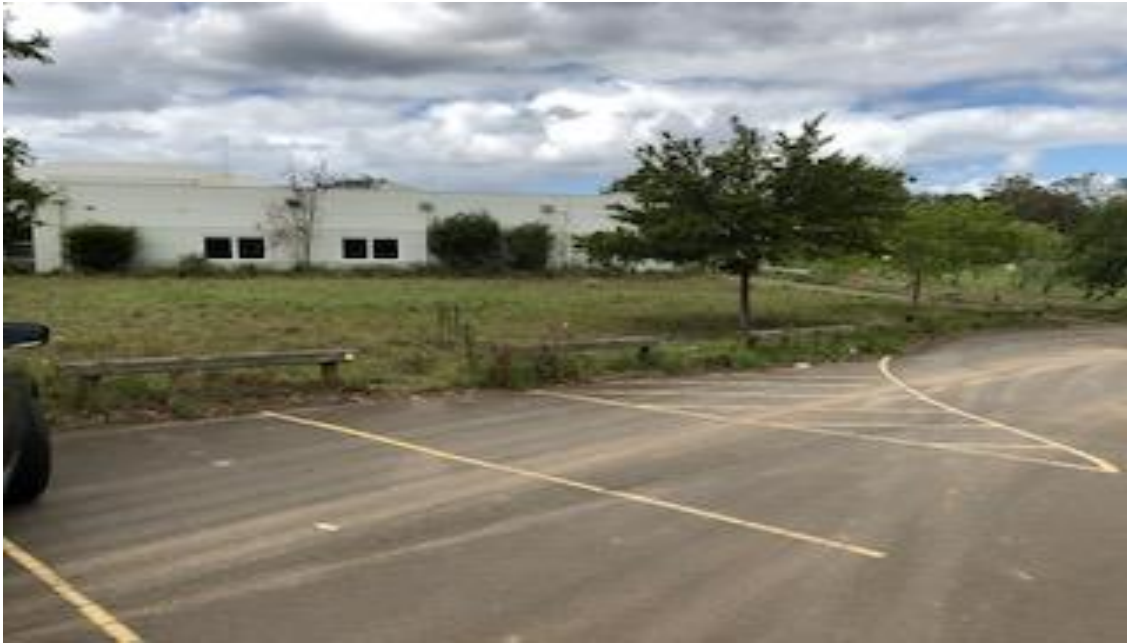
Photo 2 -Indicates the current structure and the location of the proposed new structure (Steve Brooks 2018)

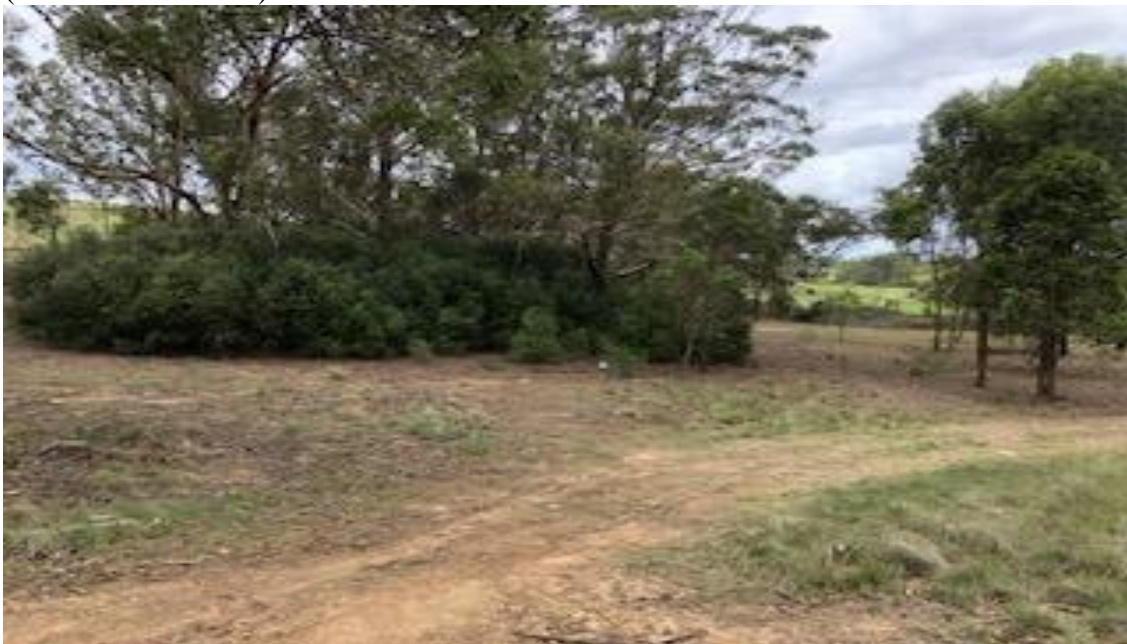
Photo 3 – Indicates an area of Non-Hazard Vegetation to the North of the proposal (Steve Brooks 2018)

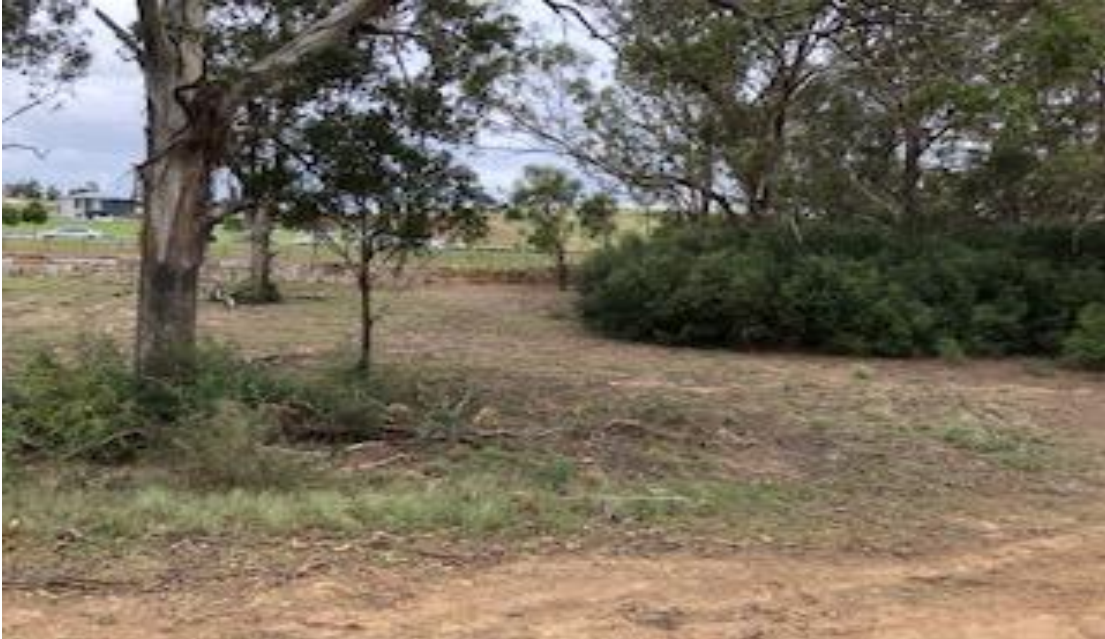
Photo 4 – Indicates an area Non-Hazard Vegetation North-West of the proposal(Steve Brooks 2018)

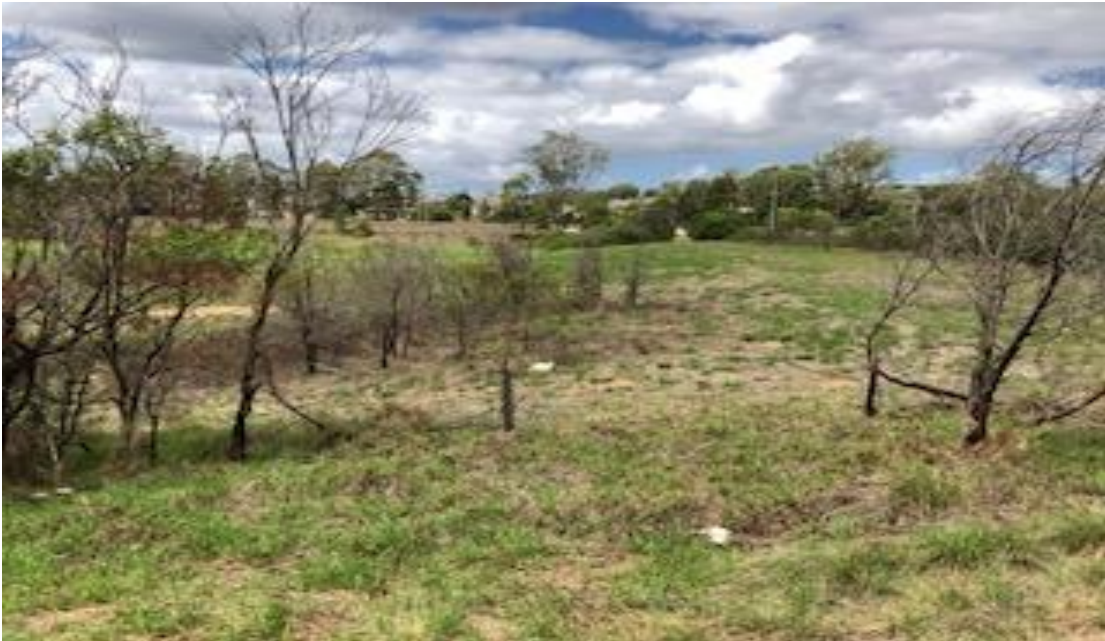
Photo 5 – Indicates an area of Non-Hazard Vegetation (Steve Brooks 2018)

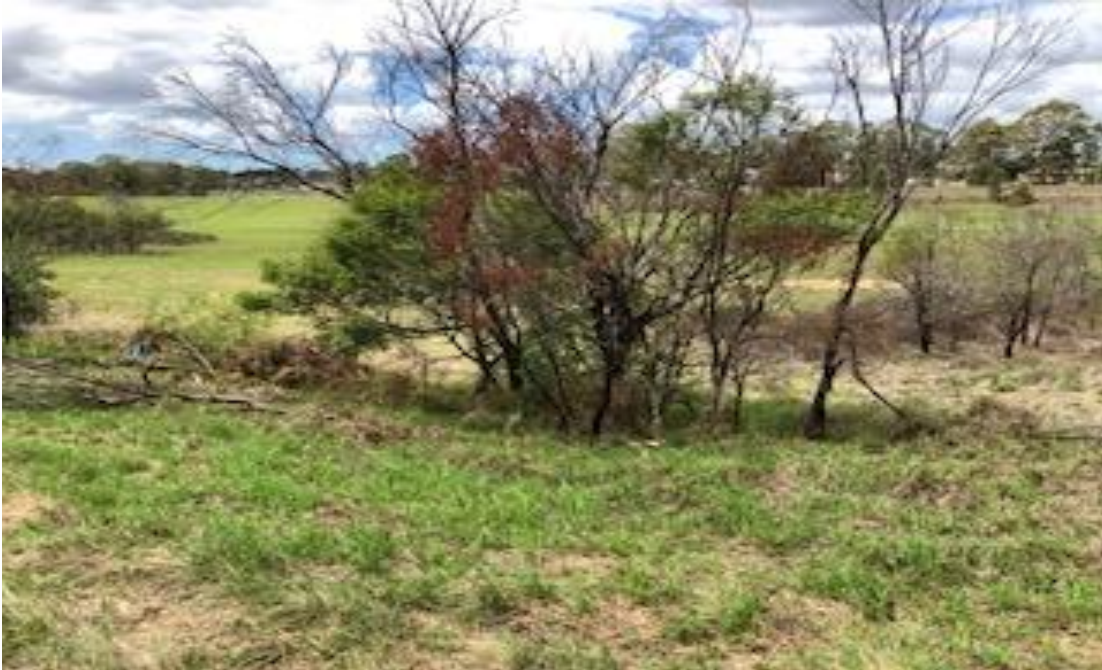
Photo 6 – Indicates the view South from the existing structure and Non-Hazard Vegetation (Steve Brooks 2018)

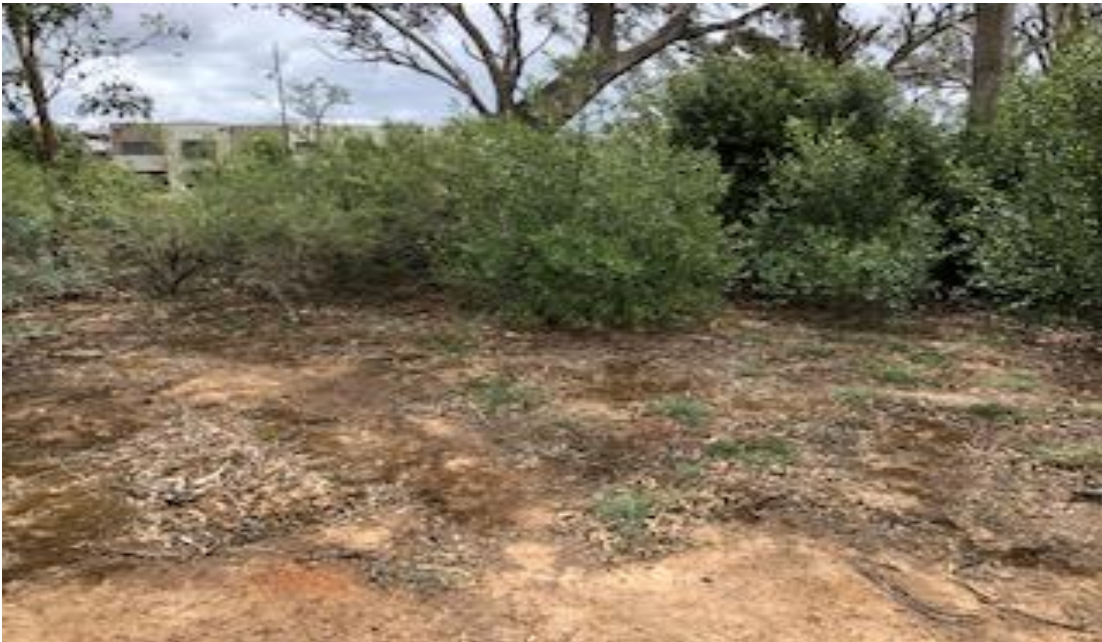
Photo 7 - Indicates a small area of Non-Hazard Vegetation North-West of the proposal (Steve Brooks 2018)

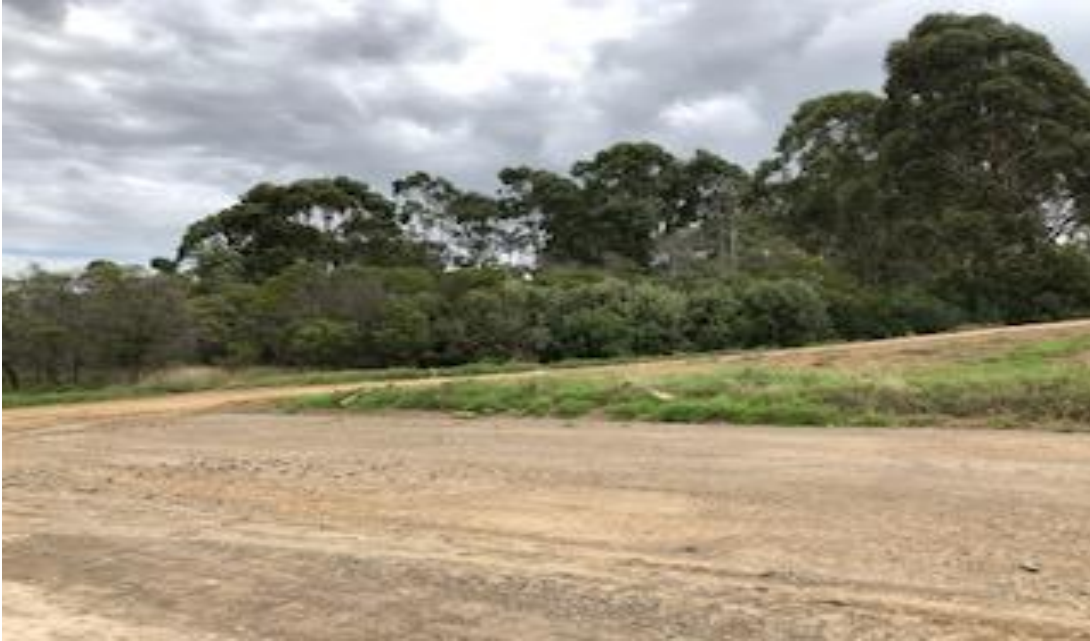
Photo 8 – Indicates the area of Forest Classified Vegetation (Category 2) approx. 129m West of the proposal (Steve Brooks 2018)
