Report on
Salinity Assessment and Management Plan

Proposed Sports and Health Centre of Excellence
Goldsmith Avenue, Campbelltown

Prepared for
Campbelltown City Council

Project 34255.27
February 2018

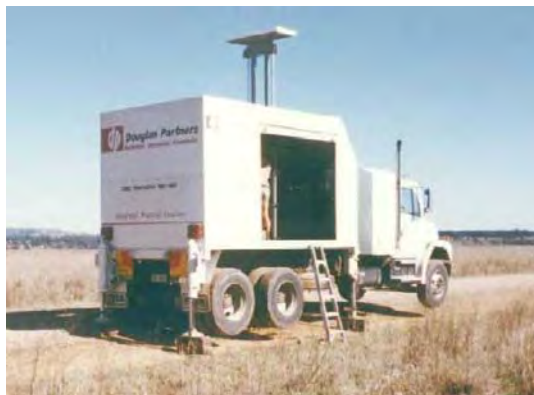
Figure 2: Purpose built CPT rig

The cone is thrust into the ground at a steady rate of about 20 mm/sec, usually using the hydraulic rams of a purpose built CPT rig, or a drilling rig. The testing is carried out in accordance with the Australian Standard AS1289 Test 6.5.1.
