Report on
Preliminary Site Investigation

Proposed Sports and Health Centre of Excellence
Goldsmith Avenue, Macarthur Heights,
Campbelltown, NSW

Prepared for
Campbelltown City Council

Project 34255.26
February 2018

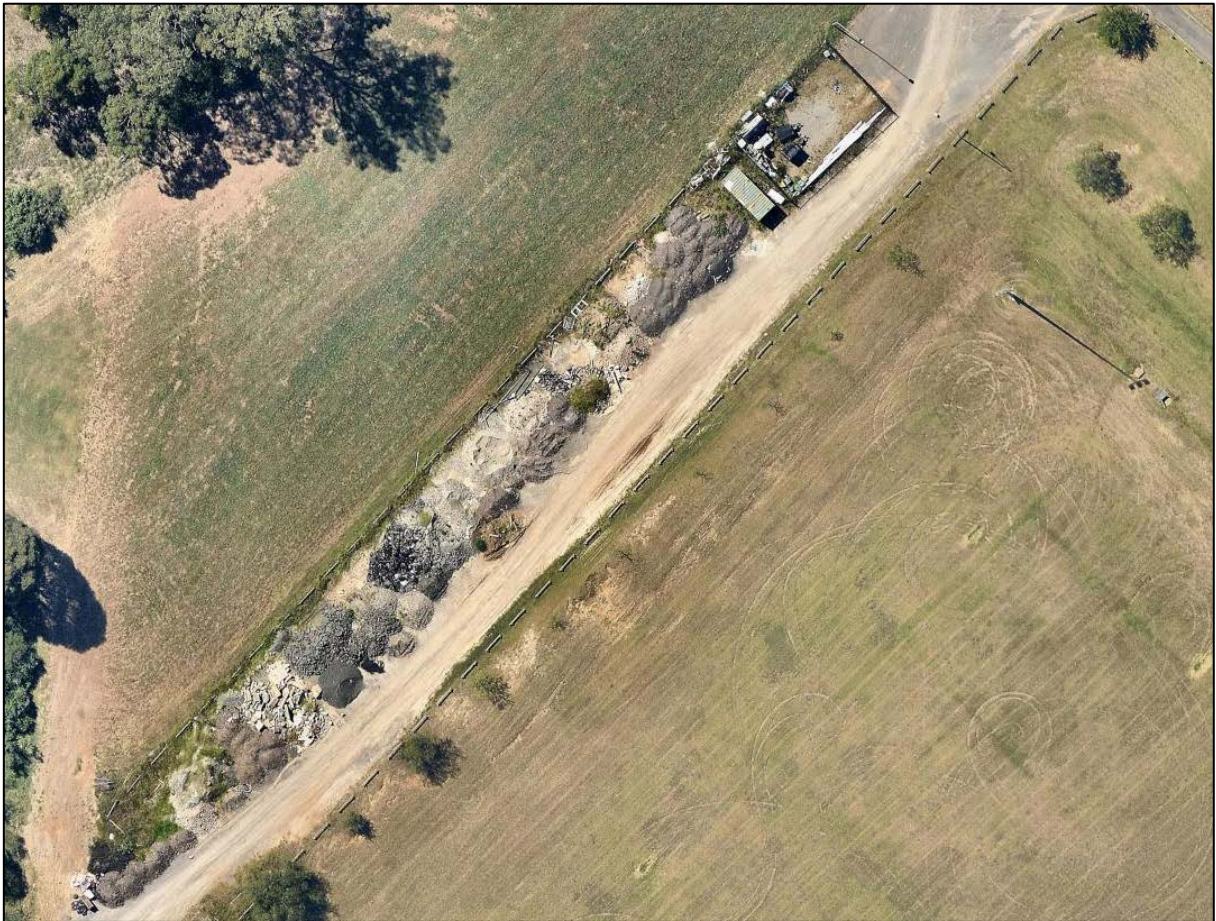
Figure 1: Storage of soil stockpiles, machinery and materials in the south western portion of the site, as observed in Nearmap aerial photograph dated 25 February 2016.

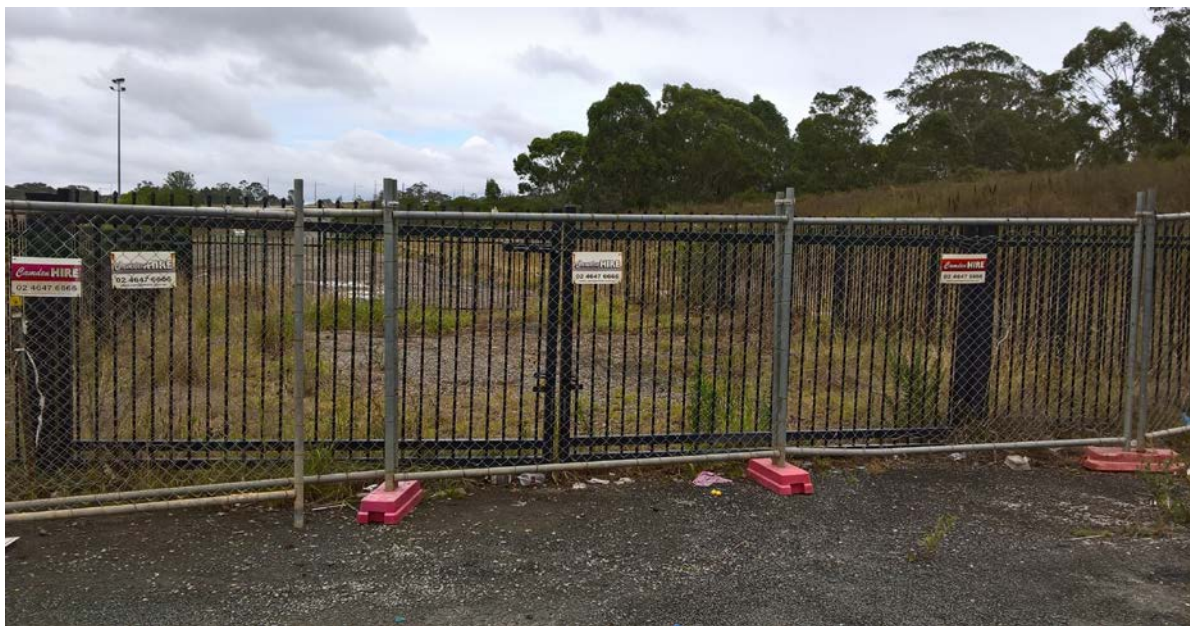
Photograph 1 - Heras-type fencing located at the site in nearground. Fenced storage compound visible immediately behind.
View due south west

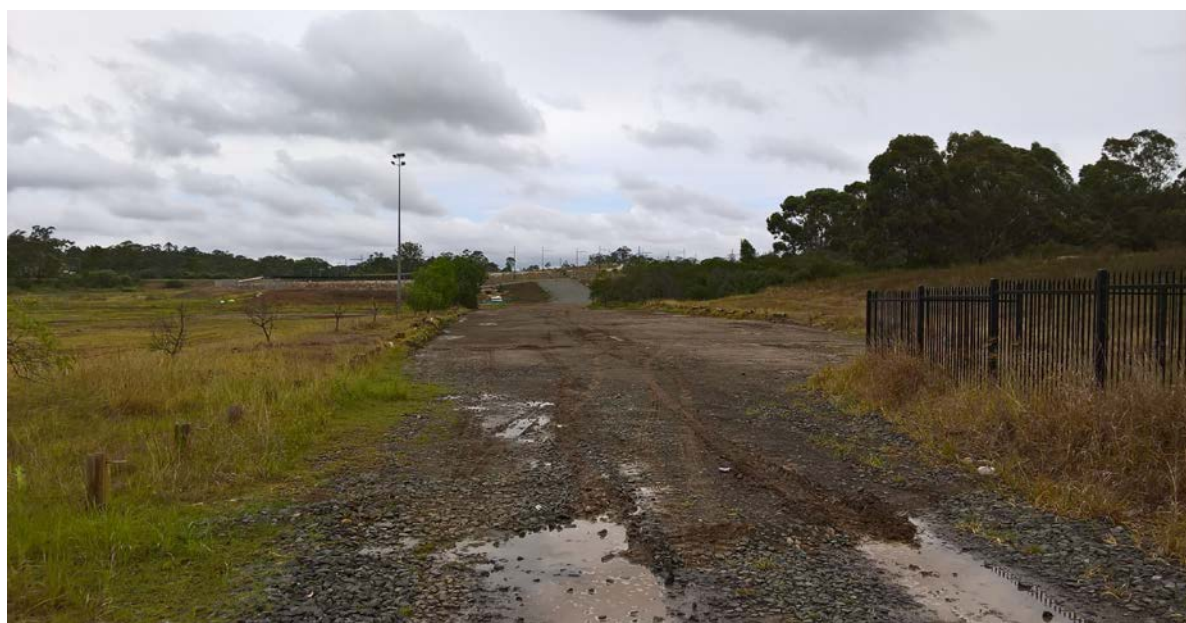
- The access road running from Goldsmith Avenue to the front (north side) of the sports centre was covered with asphalt in poor repair in places. Further south west the road was unpaved (Photograph 2). The boundary of this road were marked with occasional timber fenced bollards;

Photograph 2 - Unpaved access road. View due south west

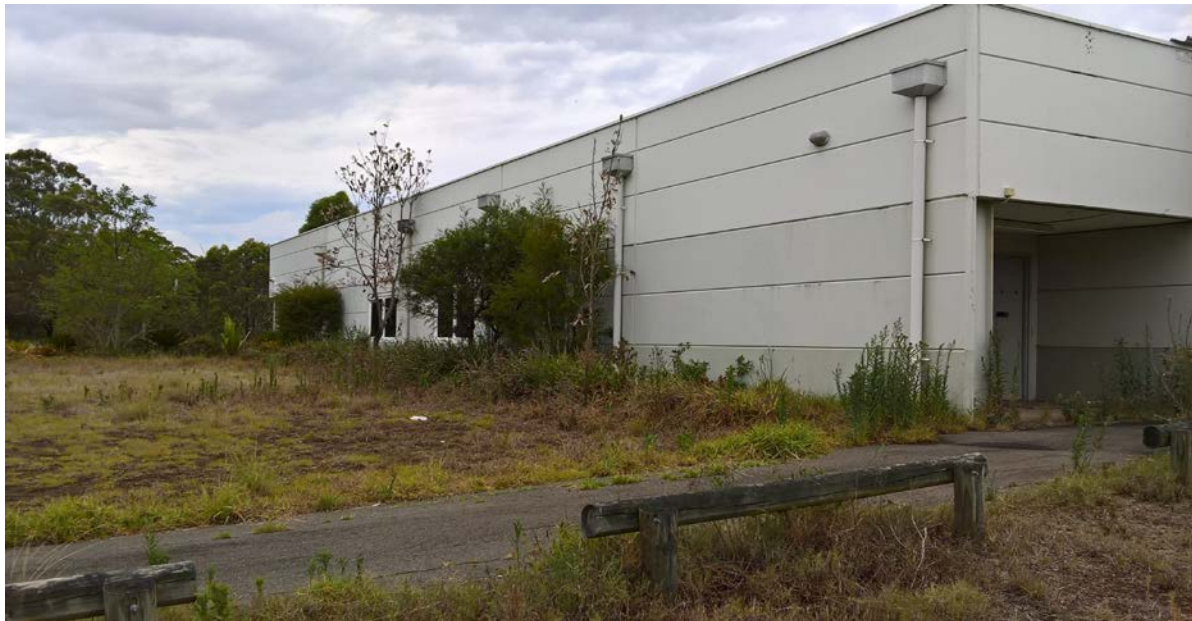
- The former sports centre was in generally good condition (Photograph 3) – the windows and the basic structure remained intact and some gym equipment was still present inside the building;

Photograph 3 - Former sports centre

A hazardous building materials survey should be conducted prior to demolition of the former sports centre. Demolition of structures containing hazardous building materials should be carried out by a licenced asbestos removal contractor. After removal of the former sports centre, an inspection of the footprint should be conducted and targeted soil sampling and analysis to confirm the contamination status of the footprint.

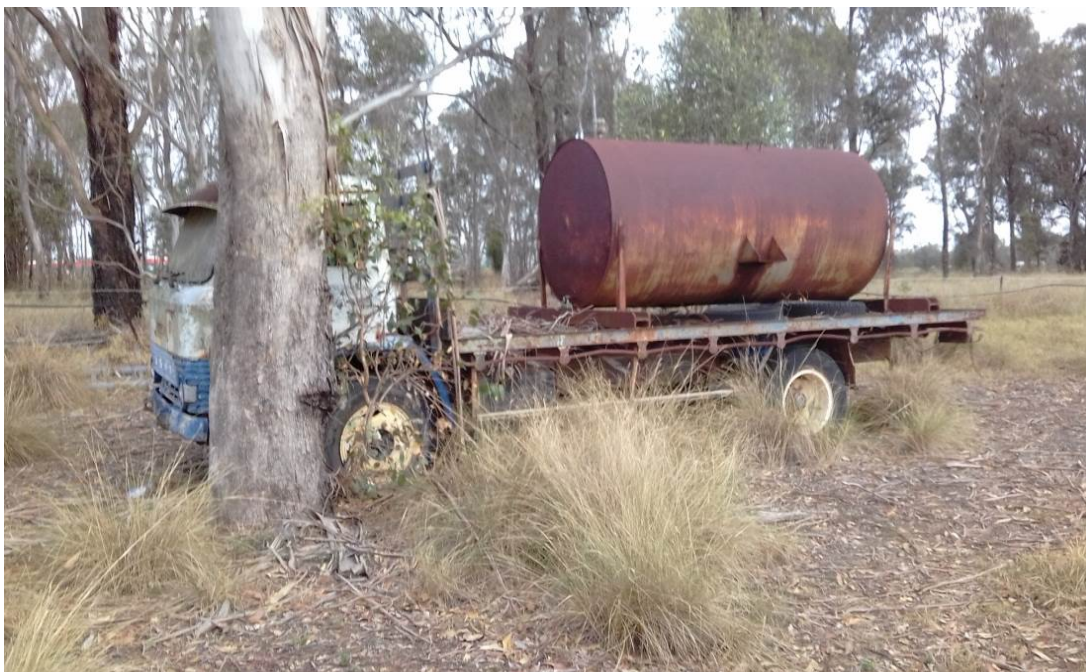
Photograph 4 - Dilapidated suspected water cart on property 1402

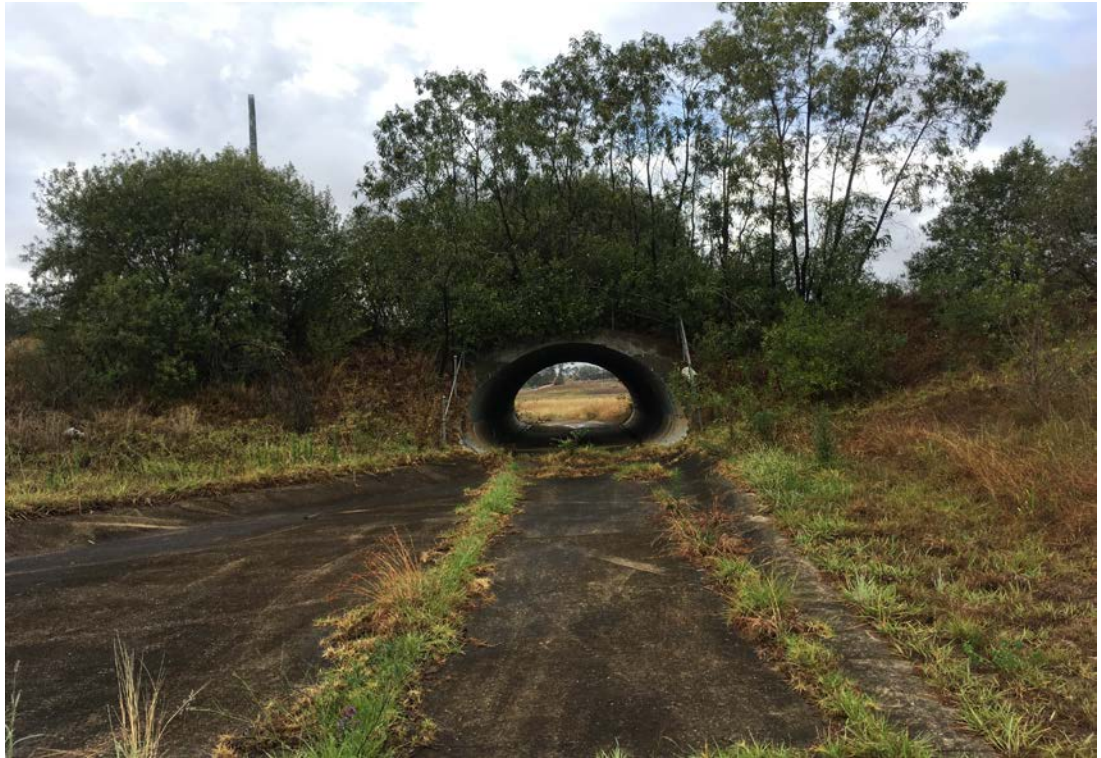
Photograph 5 - tunnel through embankment. Bow Bowing Creek is located below the concrete surface

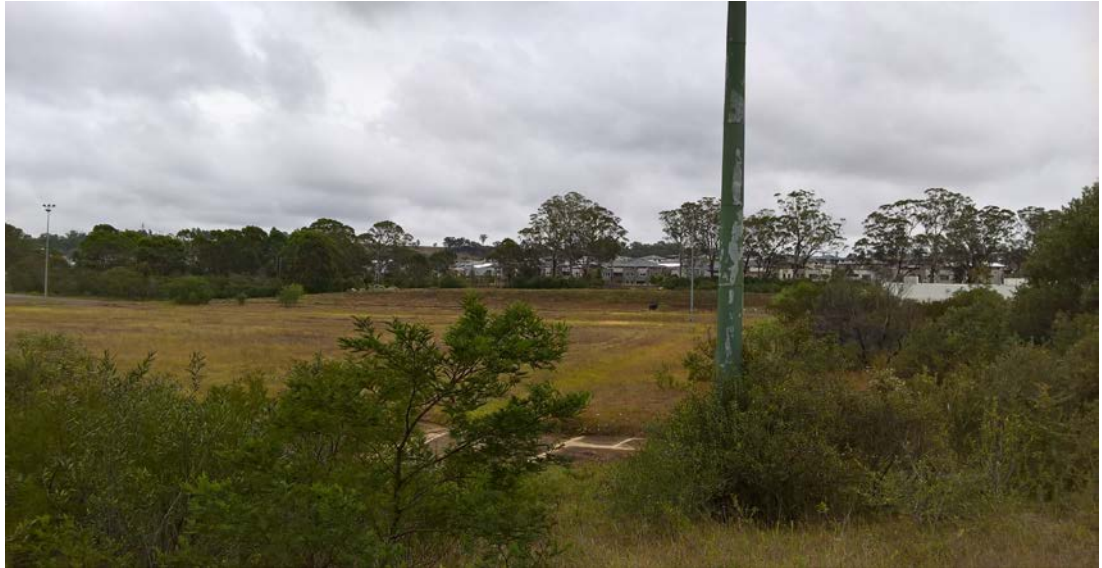
Photograph 6 - Chimney / flue stack visible on embankment. Bow Bowing Creek is visible in the tree break

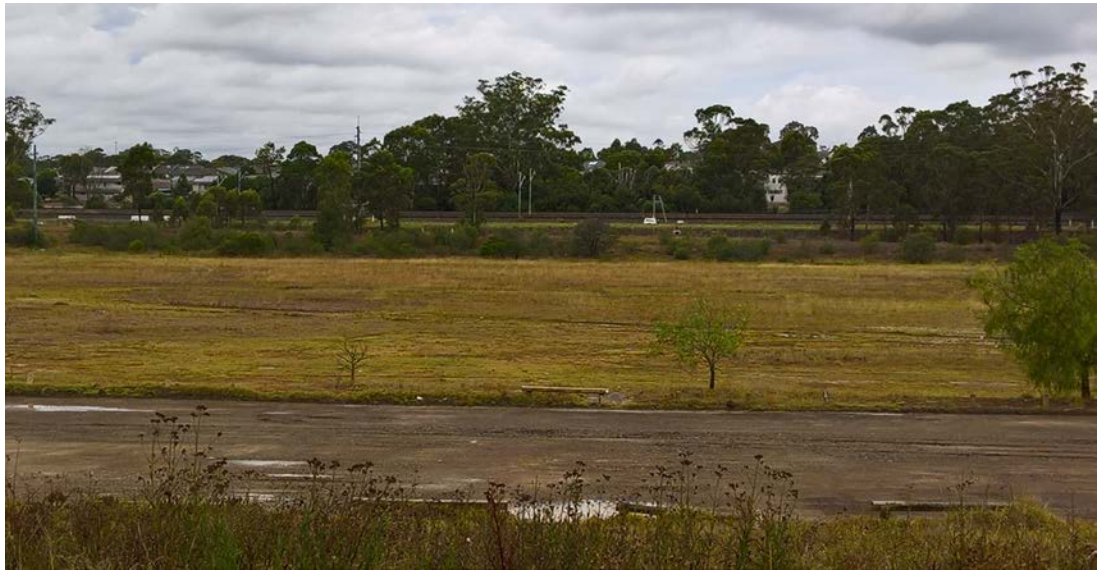
- With the exception of localised littering, the site appeared to be in general good condition with no potential visual / olfactory indicators of contamination visible (general site photographs – Photographs 7 and 8).

Photograph 7 - General site conditions

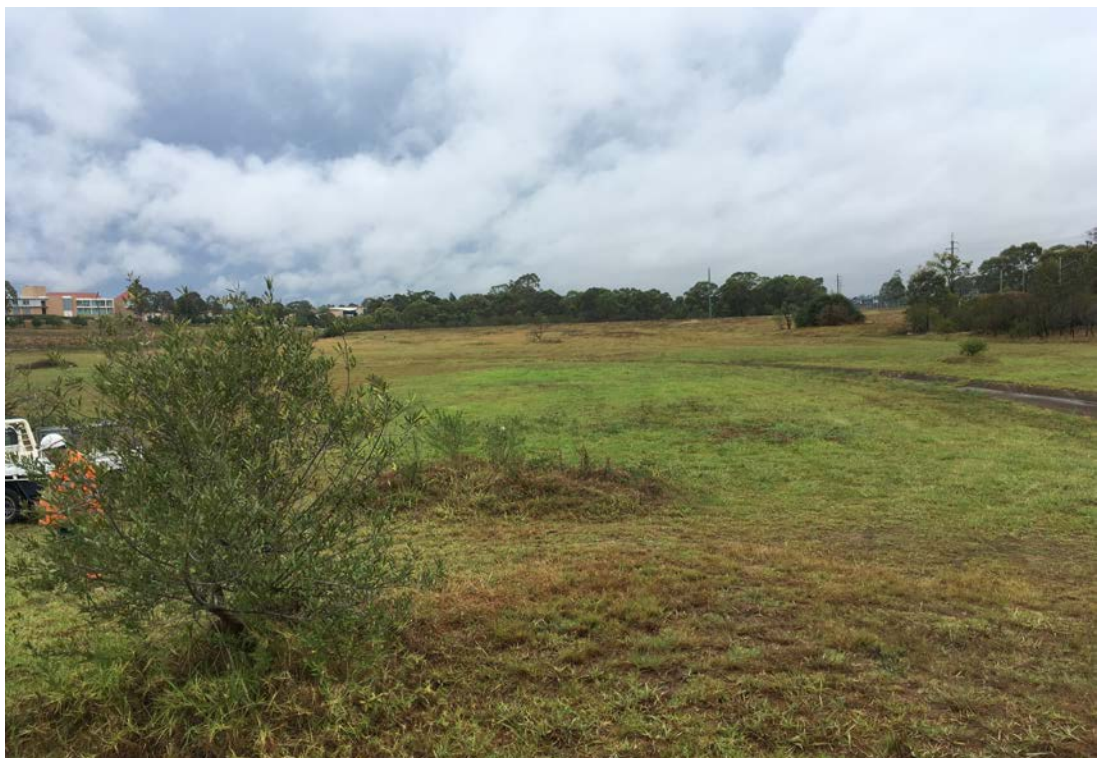
Photograph 8 - General site conditions
