### Visual Impact Photomontages and Methodology Report

Waterbrook Bowral

Waterbrook Bowral - Visual Impact Photomontage Report Date issued: 22/03/2019

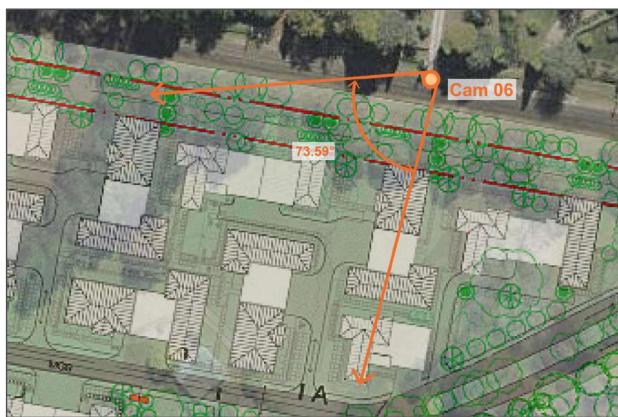
Location map of camera position

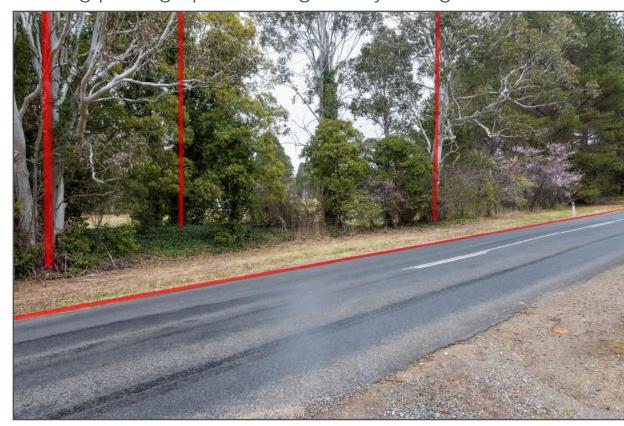
Existing photograph showing surveyed alignment elements

Each camera position in the report includes a wire frame overlay showing the surveyed elements used for the purposes of 3D camera alignment.

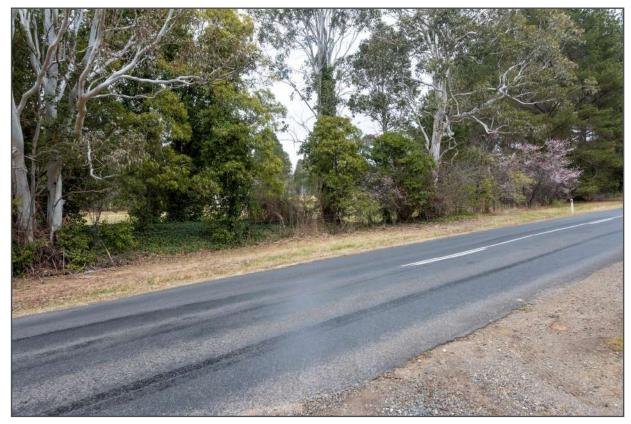
Existing photograph

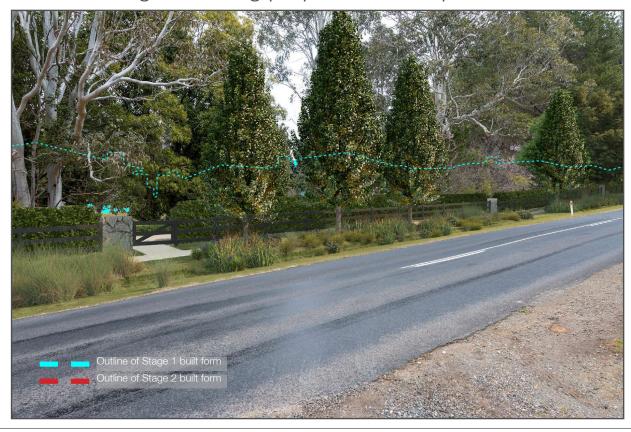
Photomontage including proposed development

Date of photography: 03/09/2018
Focal length of camera lens: 24mm

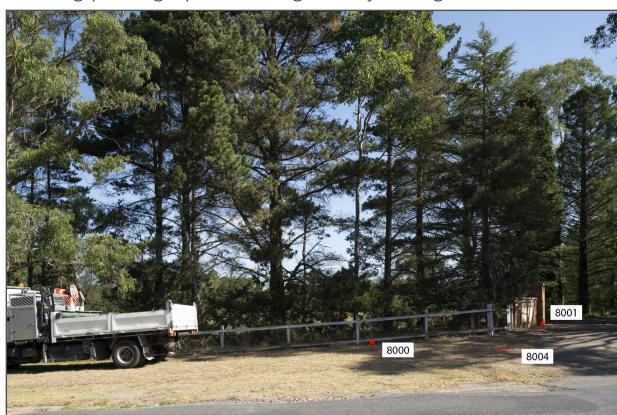
Existing photograph showing surveyed alignment elements

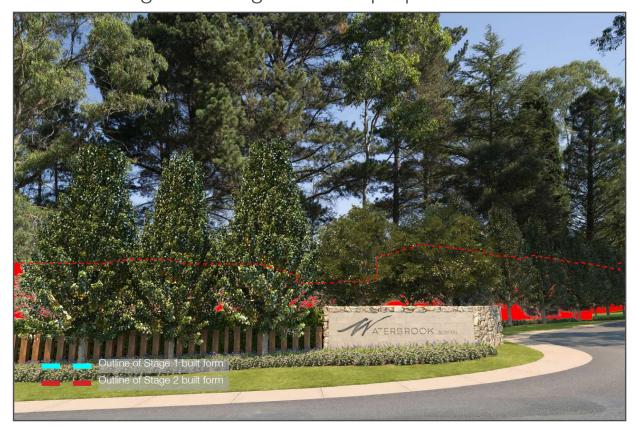
Photomontage including outline of proposed built form

This visual impact assessment presents photomontages with proposed built form massing and semi-mature landscaping for the purposes of evaluating the visual impact of the development post-construction. Where this is hidden behind landscaping or vegetation, the proposed built form has been indicated by an outline. Stage 1 built form is shown as a dotted blue line and Stage 2 built form is shown as a dotted red line.

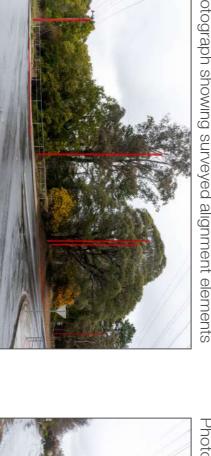
# Camera Position C13 - Overview - View Corridor

Existing photograph showing surveyed alignment elements

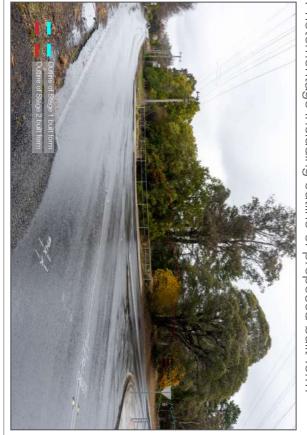
Photomontage including outline of proposed built form

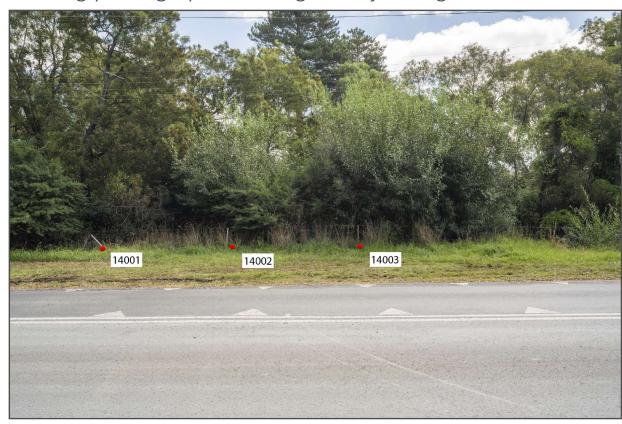
Existing photograph showing surveyed alignment elements

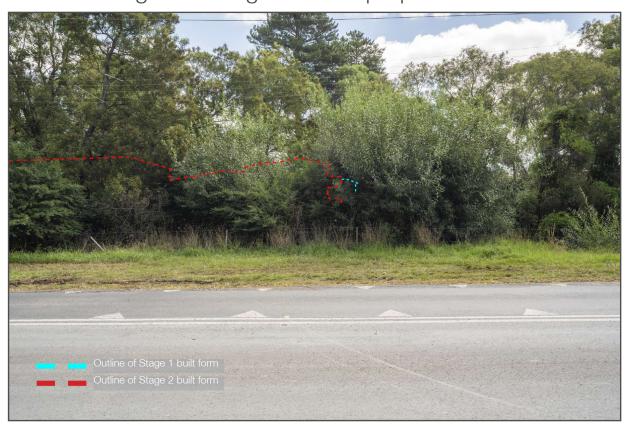
Photomontage including outline of proposed built form

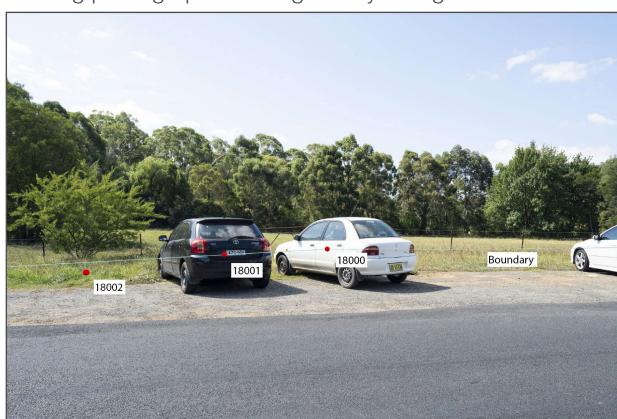
Existing photograph showing surveyed alignment elements

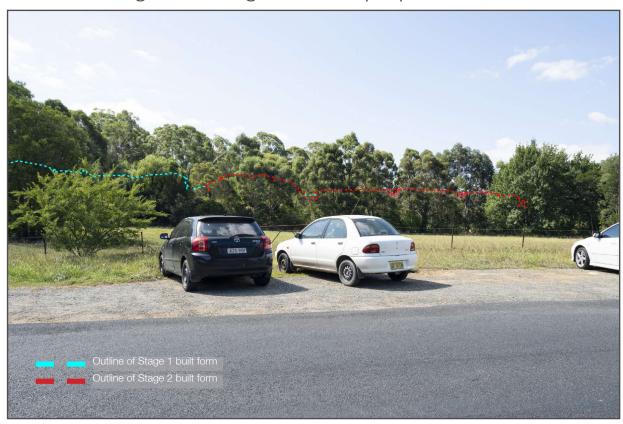
Photomontage including outline of proposed built form

Date of photography: 25/02/2019 Focal length of camera lens: 24mm
