# DETAILED SITE INVESTIGATION

2-18 CENTENNIAL ROAD, BOWRAL NSW

19 MARCH 2019

## 10025626

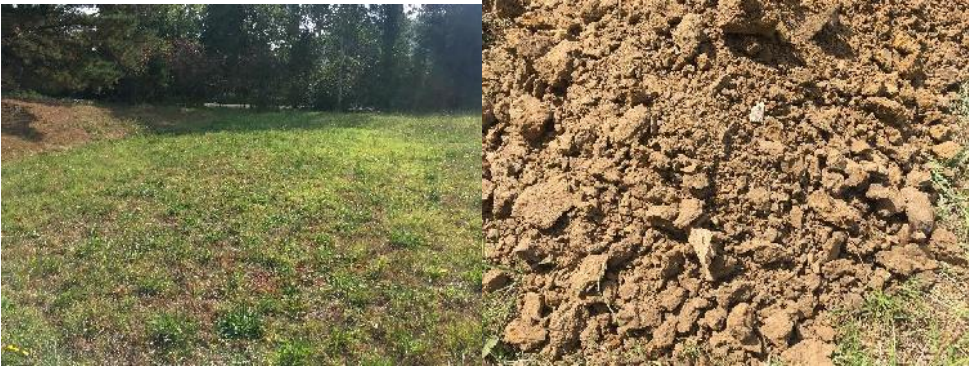
| Photo No. | Date | | | |
|---|---|---|--|--|
| <b>Description:</b><br><br><b>TP204 – Fill depth 0.4m</b><br><br>Located on northern playing field (NPF)<br><br><b>Fill material:</b> Clayey Silty GRAVEL, brown / grey, moderately consolidated, shale and sandstone cobbles to 150mm.<br><br>Anthropogenic Material Observed:<br>Plastic, glass and tile | | | | |

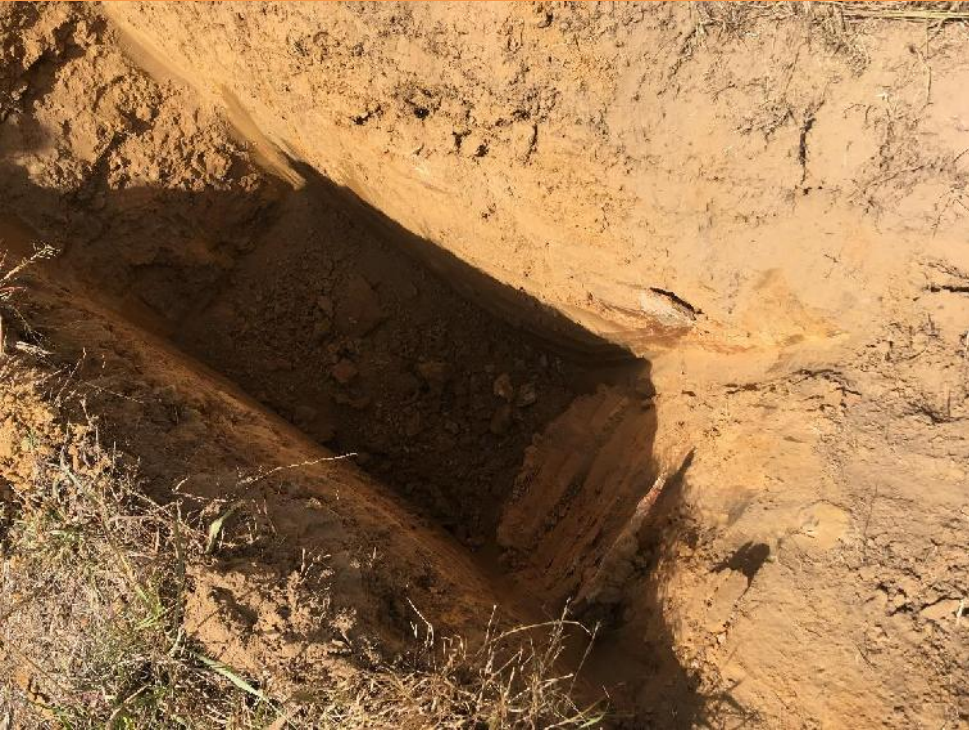
| Photo No. | Date | | | |
|---|---|---|--|--|
| <b>Description:</b><br><br><b>TP205 – Fill depth 0.3m</b><br><br>Located on northern playing field (NPF)<br><br><b>Clayey SILT</b> - brown / grey, roots.<br>and<br><b>Gravelly Clayey SILT</b> - brown, orange / red streaking, moderately consolidated, roots. | | | | |

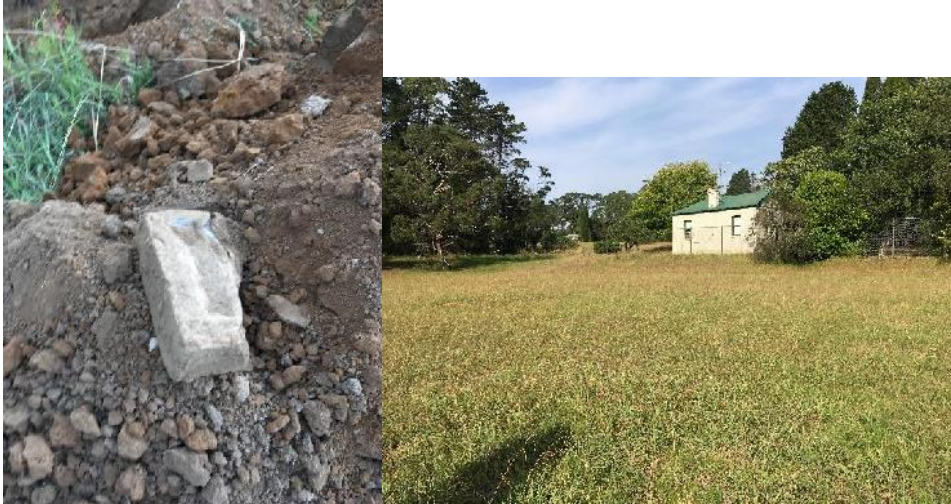
| Photo No. | Date | | | |
|---|---|---|--|--|
| <b>Description:</b><br><br><b>TP207</b> – Fill depth 1.5m<br><br>Located on northern playing field (NPF)<br><br><b>Fill Material</b> - Clayey SILT, brown / grey and Clayey Silty GRAVEL, brown, loose, angular gravel.<br><br>Anthropogenic Material<br>Observed: Brick, sandstone, plastic PACM (see Photo 4.) | | | | |

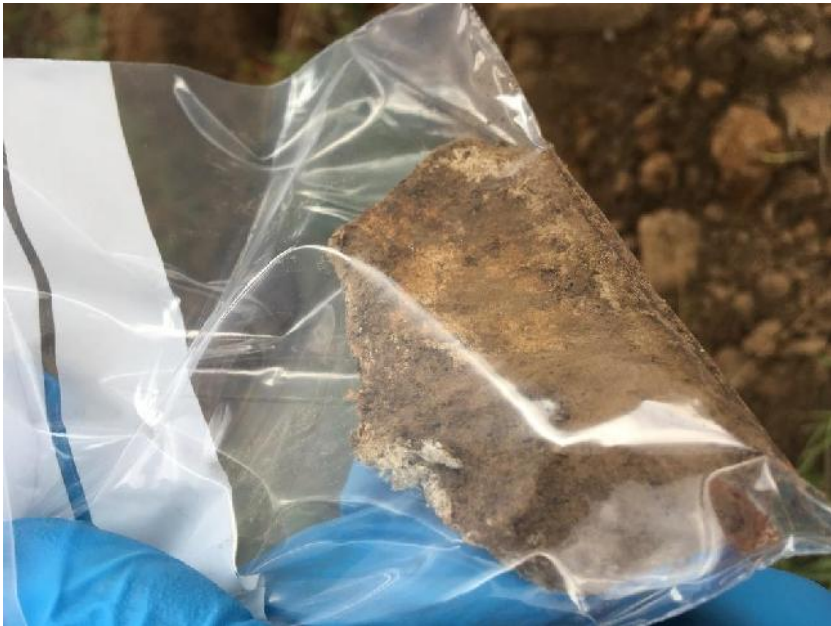
| Photo No. | Date | | | |
|---|---|---|--|--|
| 4. | 5/3/19 | | | |

| Photo No. | Date | | | |
|---|---|---|--|--|
| <b>Description:</b><br><br><b>TP207</b> – PACM at 0.5m<br><br>Located on northern playing field (NPF) | | | | |

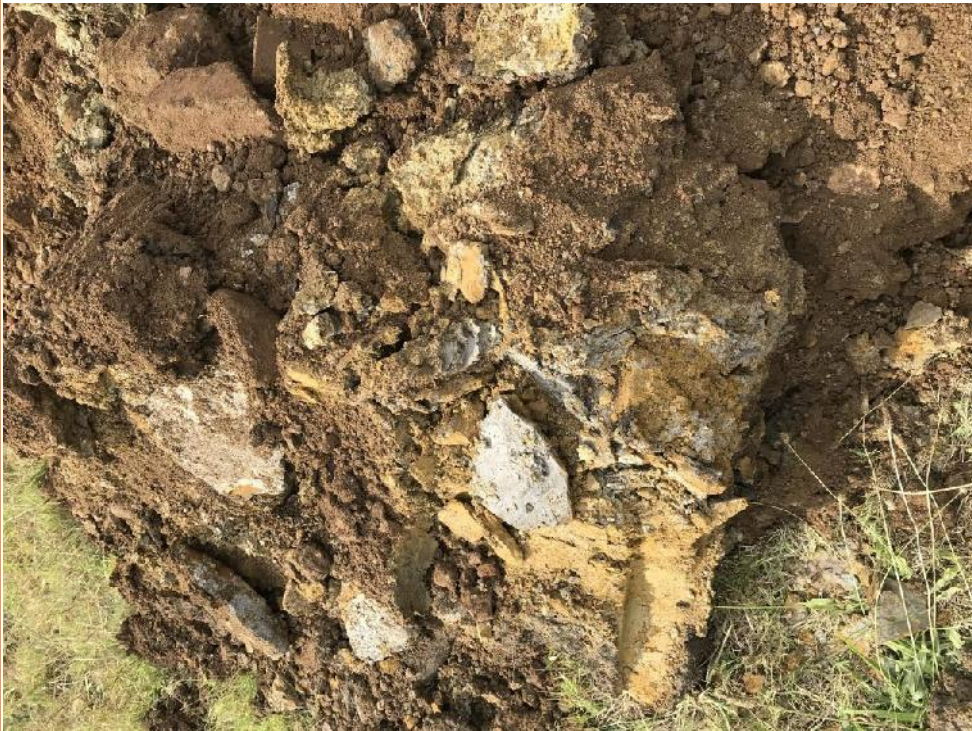
- The former location infilled dam within the NPF was observed during intrusive works (TP208) and the sample of fill at 1.5m above the former dam base was noted to have PAH concentrations above detection limits, however below adopted SAC.

| Photo No. | Date | |
|---|---|---|
| <b>Description:</b><br><br><b>TP208</b> –Reworked material to 2.7m<br><br>Located on northern playing field (NPF)<br><br><b>Reworked material:</b><br><b>Silty Sandy GRAVEL</b> - brown, shale boulders to 500mm and <b>Silty CLAY</b> - blue / grey to grey, orange / yellow streaking, medium plasticity, minor sand. | | |

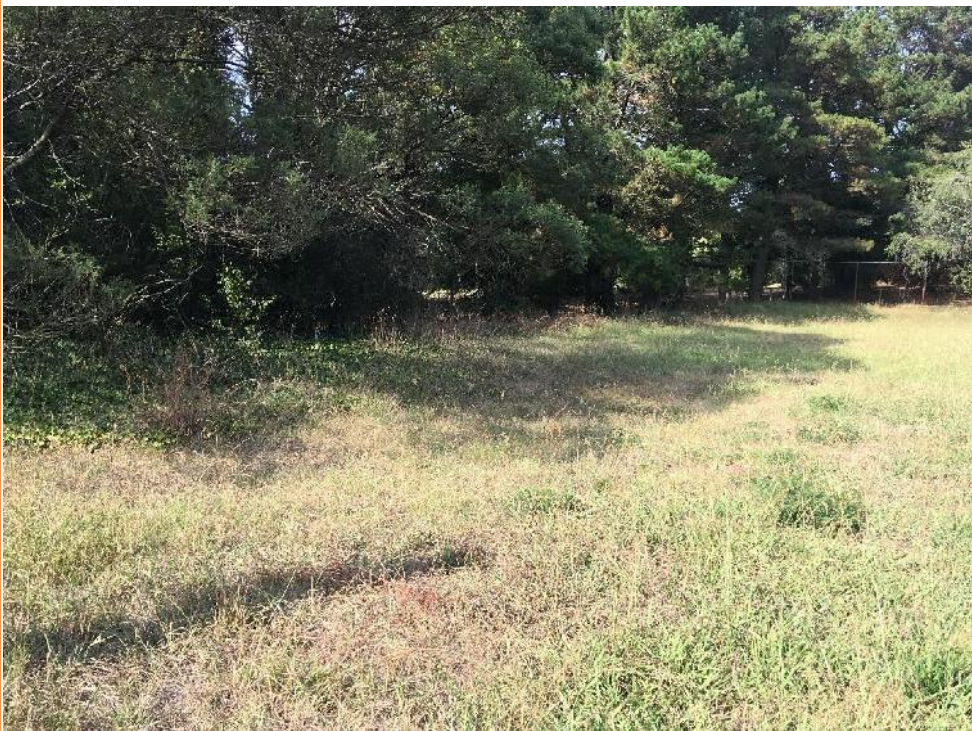
| Photo No. | Date | |
|---|---|---|
| <b>Description:</b><br><br><b>TP209</b> – Fill depth 0.4m<br><br>Located on northern playing field (NPF)<br><br><b>FILL</b> - Silty Sandy GRAVEL, brown, loose, angular gravel, roots. - Foreign clumps of residual clay throughout<br><br>Reworked depth: 0.4 – 1.5m<br><br><b>Crushed SHALE</b> - brown, extremely weak, structure apparent. | | |

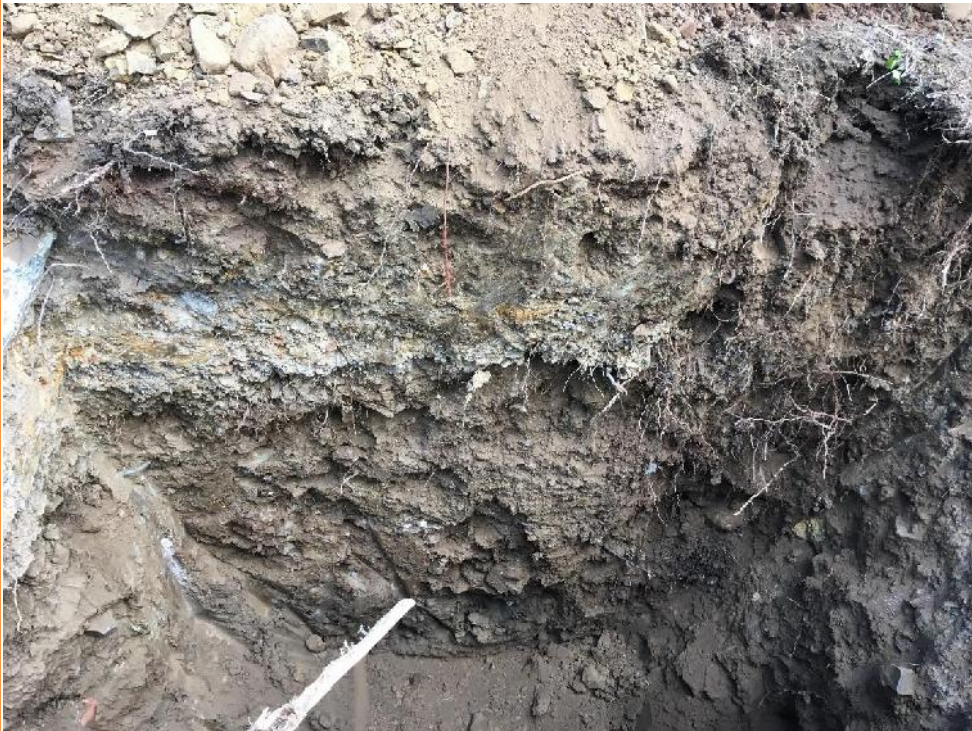
| Photo No. | Date | |
|---|---|---|
| <b>Description:</b><br><br><b>TP210 – Fill depth 4.0m</b><br><br>Located on northern playing field (NPF) – Berm<br><br><b>FILL</b> - Silty Sandy GRAVEL, brown, foreign rounded cobbles >150mm, trace clay.<br>Clay lens 0.4-0.6m.<br><br><b>FILL</b> - Crushed SHALE, grey, red / orange streaking, large foreign cobbles.<br><br>Anthropogenic material including bricks <5%. Concrete slab at 1.5m.<br><br>PACM at 0m (surface) and 2.5m. | | |

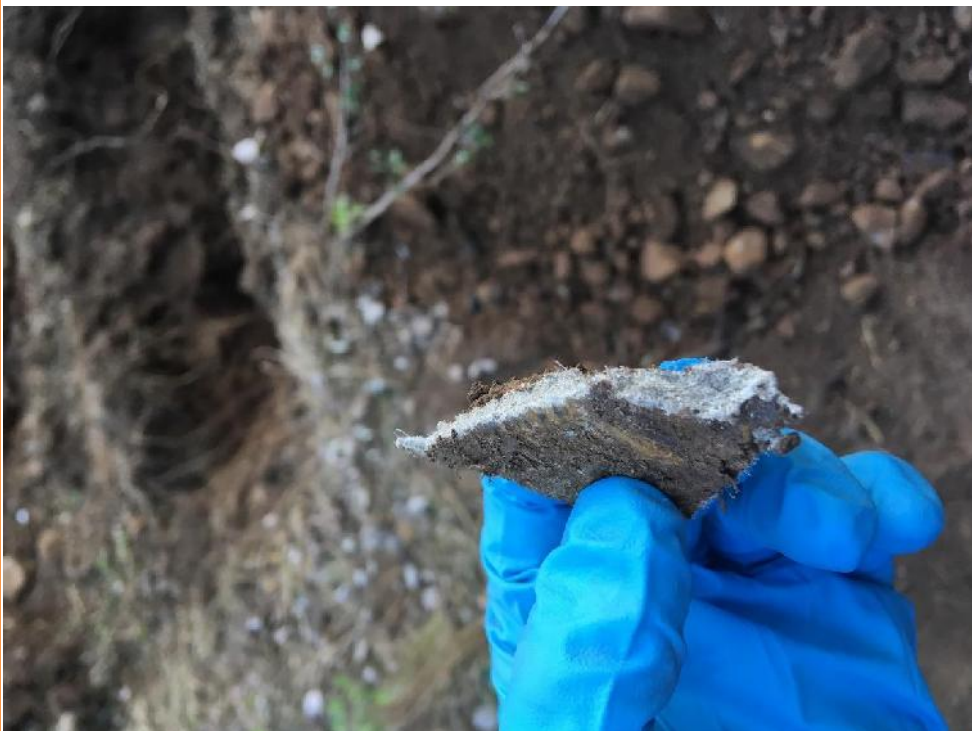
| Photo No. | Date | |
|---|---|---|
| 8. | 6/3/19 | |

| Photo No. | Date | |
|---|---|---|
| <b>Description:</b><br><br><b>TP210 – PACM at surface (0m)</b><br><br>Located on northern playing field (NPF) - Berm | | |

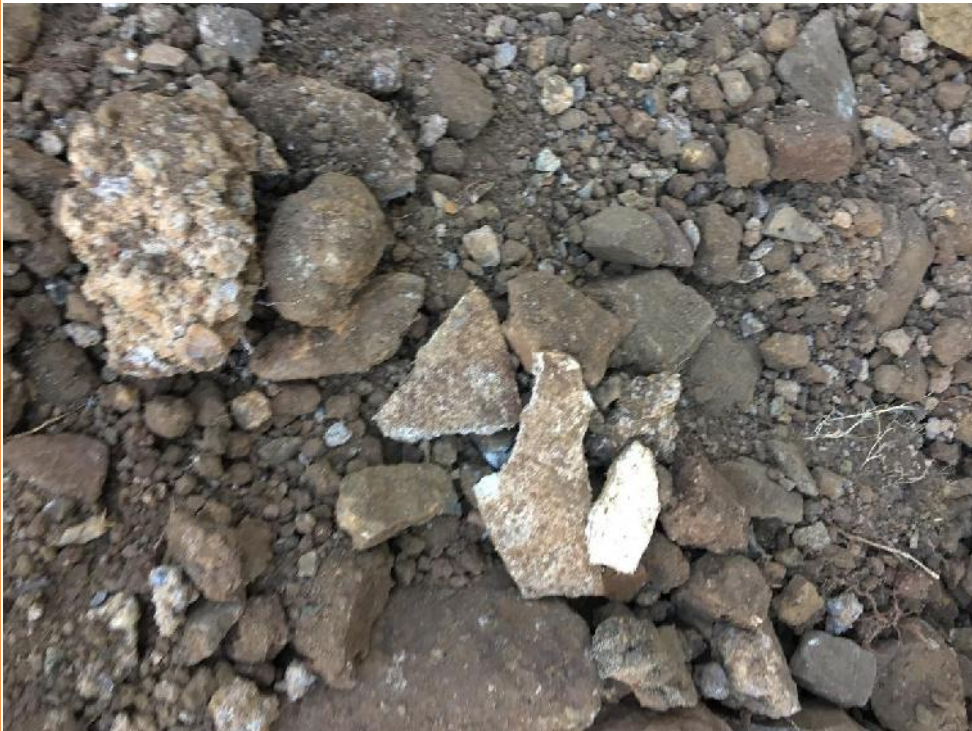
| Photo No. | Date | |
|---|---|---|
| 9. | 6/3/19 | |

| Photo No. | Date | |
|---|---|---|
| <b>Description:</b><br><br><b>TP210</b> – PACM at surface (2.5m)<br><br>Located on northern playing field (NPF) - Berm | | |

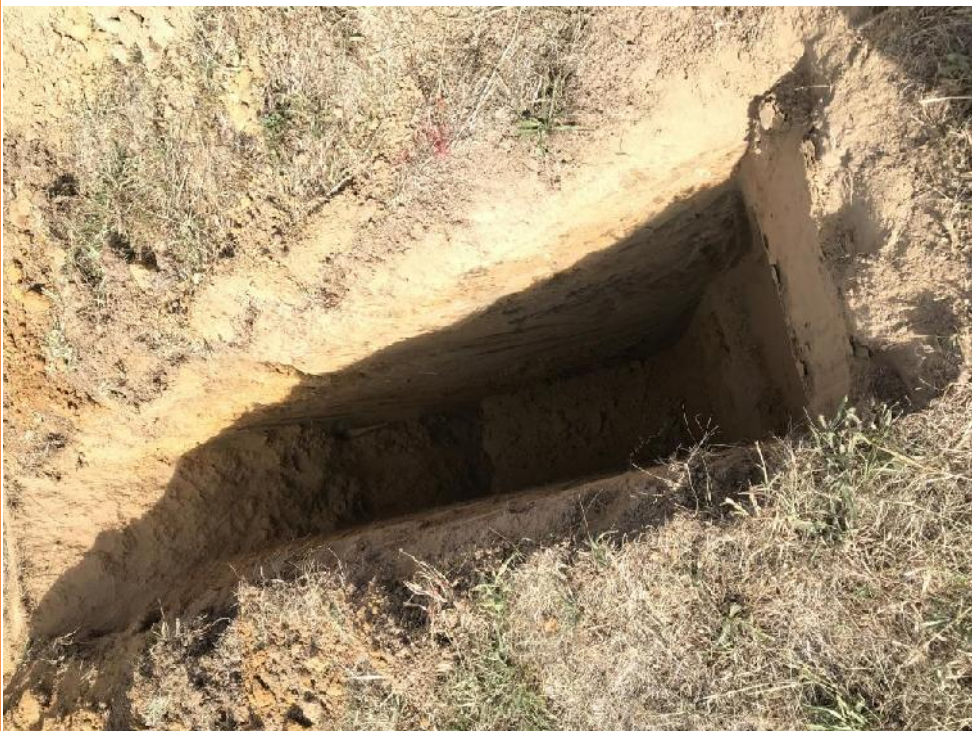
| Photo No. | Date | |
|---|---|---|
| <b>Description:</b><br><br><b>TP214</b> – Reworked material depth: 2.4m<br><br>Located on Main Oval (MO)<br><br><b>Clayey SILT</b> - brown, roots.<br><br><b>Gravelly Clayey SILT</b> - brown / orange, shale gravels. | | |

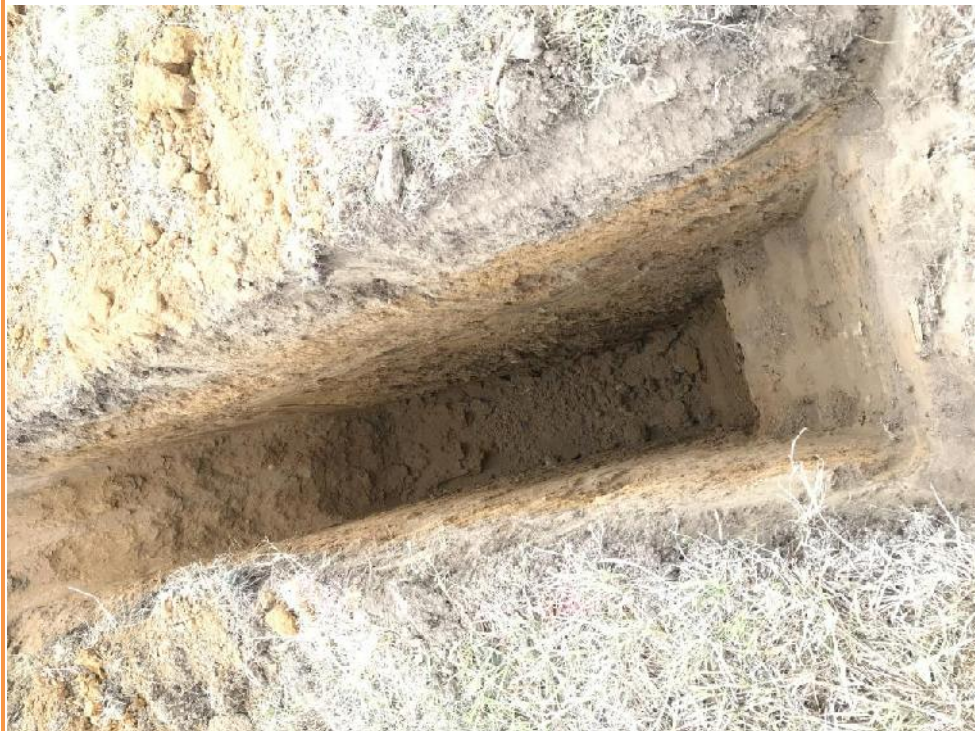
| Photo No. | Date | |
|---|---|---|
| <b>Description:</b><br><br><b>TP215</b> – Reworked material depth 2.2m<br><br>Located on Main Oval (MO)<br><br><b>Clayey SILT</b> - brown, clumpy, roots.<br><br><b>Clayey SILT</b> - brown / orange, red streaking, minor shale gravel, roots. | | |

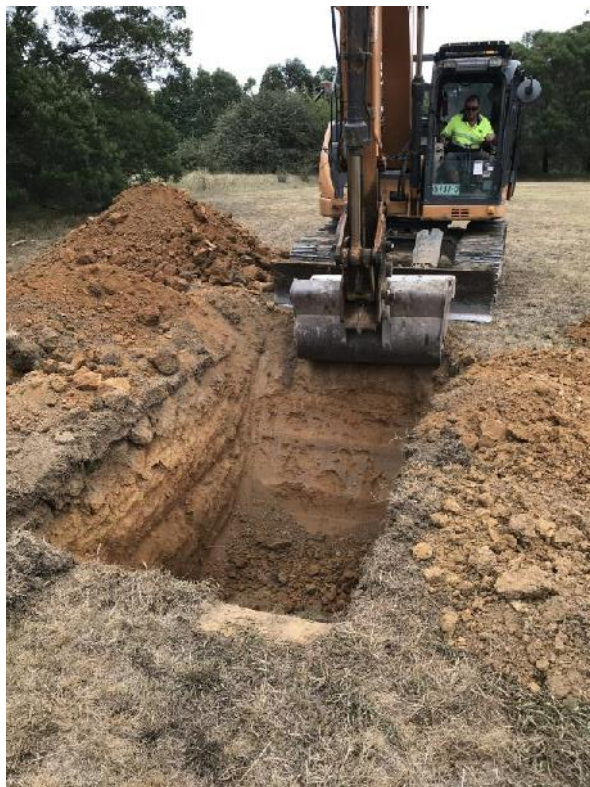
| Photo No. | Date | |
|---|---|---|
| <b>Description:</b><br><br><b>TP216</b> – Reworked material depth: 3.2m<br><br>Located on Main Oval (MO)<br><br><b>Clayey SILT</b> - grey / brown, low consolidation, clumpy.<br><br><b>Silty Clayey GRAVEL</b> - orange / brown, low consolidation, rounded shale boulders to 300mm. Compacted reworked natural material, homogenous. | | |

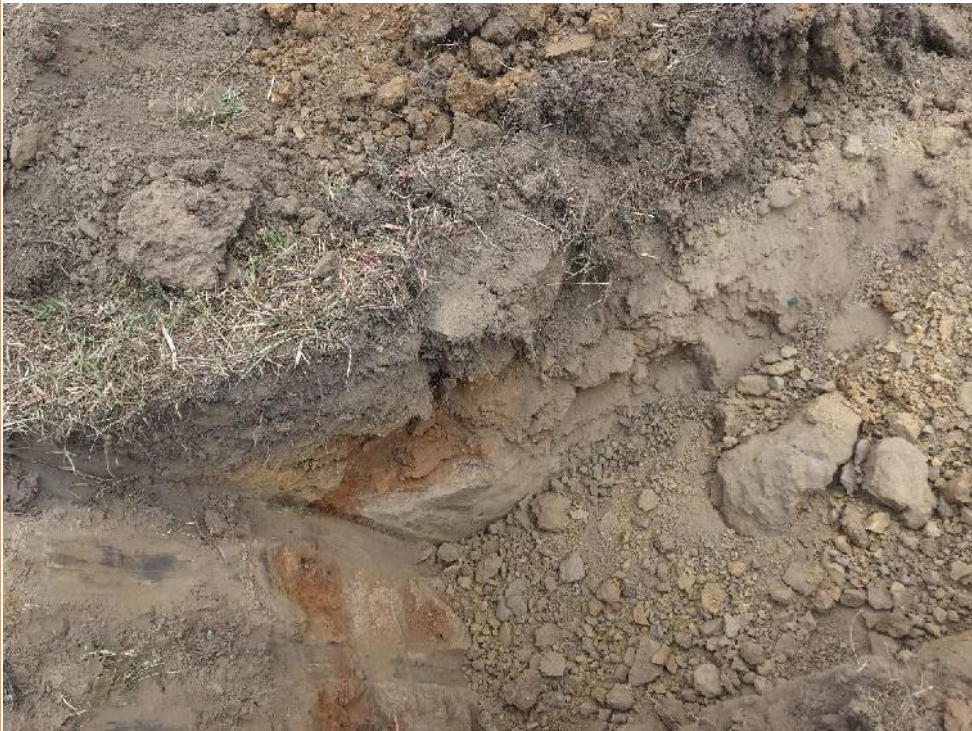
| Photo No. | Date | |
|---|---|---|
| 13. | 6/3/19 | |

| Photo No. | Date | |
|---|---|---|
| <b>Description:</b><br><b>TP217</b> – Fill depth 0.2m<br>Located on Main Oval (MO)<br><b>FILL</b> - Clayey SILT, light brown, low consolidation, clumpy, roots.<br>Glass, plastic. | | |

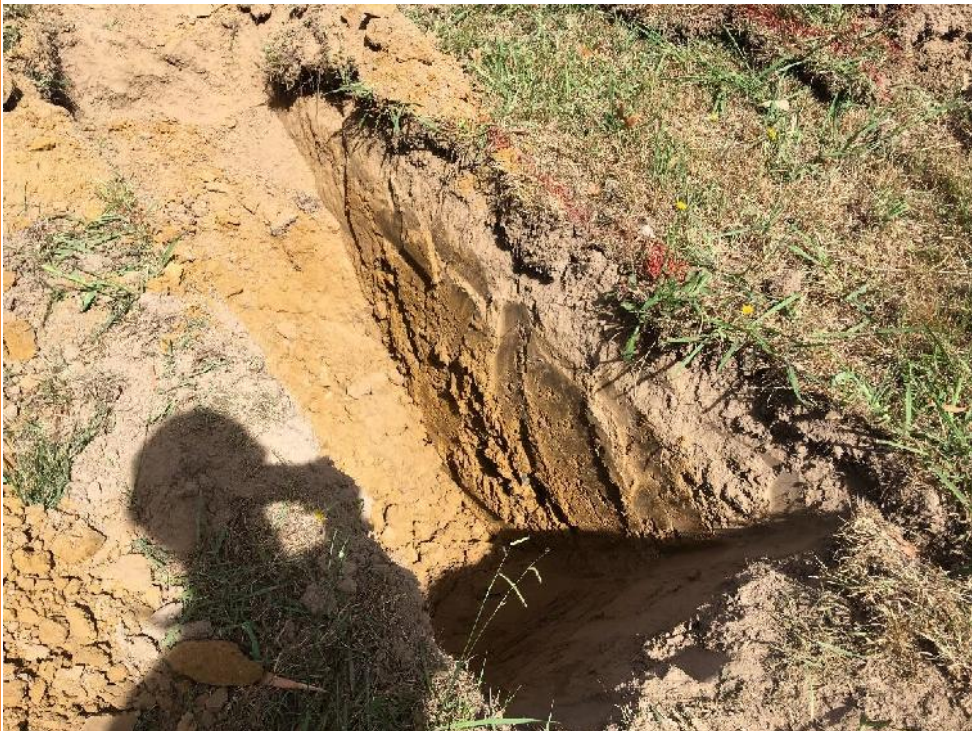
| Photo No. | Date | |
|---|---|---|
| 14. | 6/3/19 | |

| Photo No. | Date | |
|---|---|---|
| <b>Description:</b><br><b>TP218</b> – Fill depth 0.3m<br>Located on Main Oval (MO)<br><b>FILL</b> - Clayey SILT, grey / brown, clumpy, roots. | | |

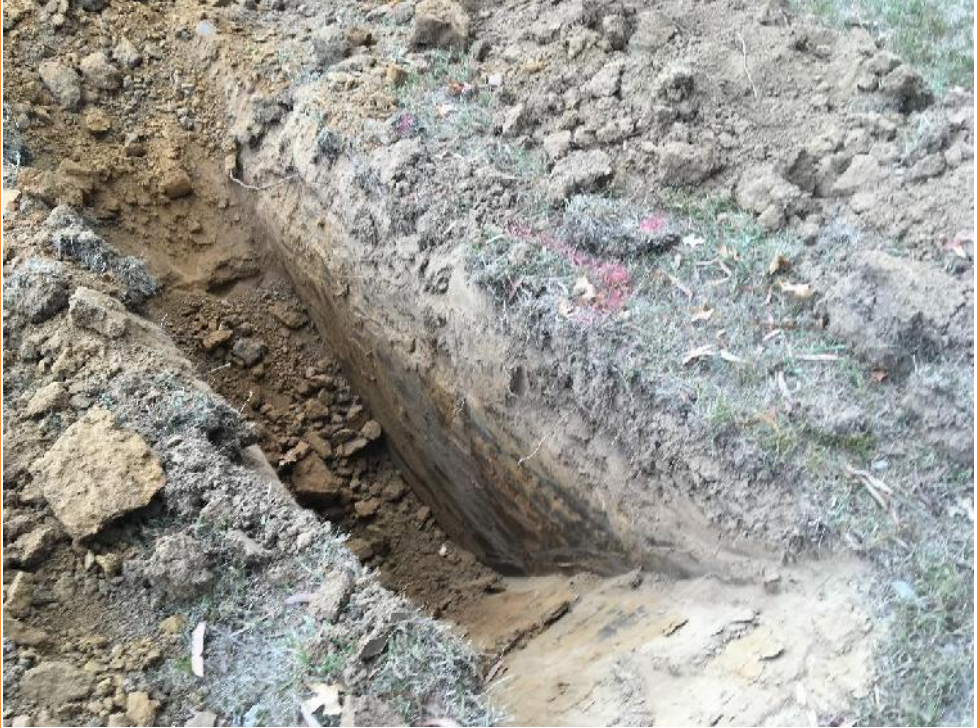
| Photo No. | Date | |
|---|---|---|
| <b>Description:</b><br><b>TP219</b> – Fill depth 0.3m<br>Located near Amenities Block<br><br><b>FILL</b> - Clayey SILT, light brown, clumpy, minor sand / gravel, roots.<br><br>PACM at 0.1m.<br>Bottlecap, coin, roots. | | |

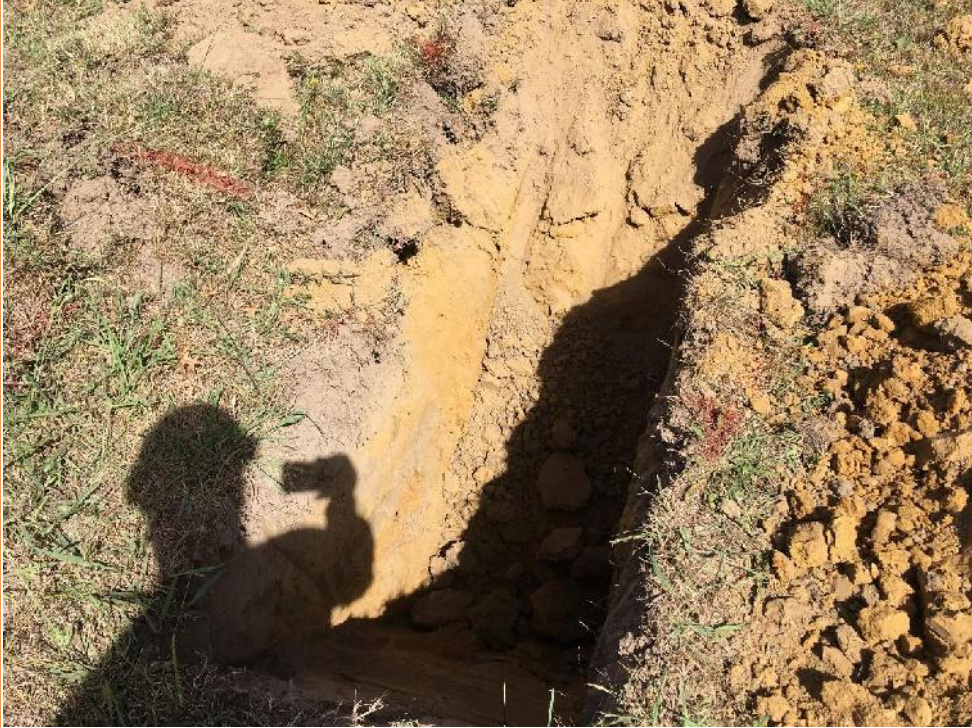
| Photo No. | Date | |
|---|---|---|
| 17. | 6/3/19 | |

| Photo No. | Date | |
|---|---|---|
| <b>Description:</b><br><b>TP220</b> – Fill depth 0.15m<br>Located near Amenities Block<br><b>FILL</b> - Clayey SILT, grey / brown, low plasticity, moderate consolidation, roots. | | |

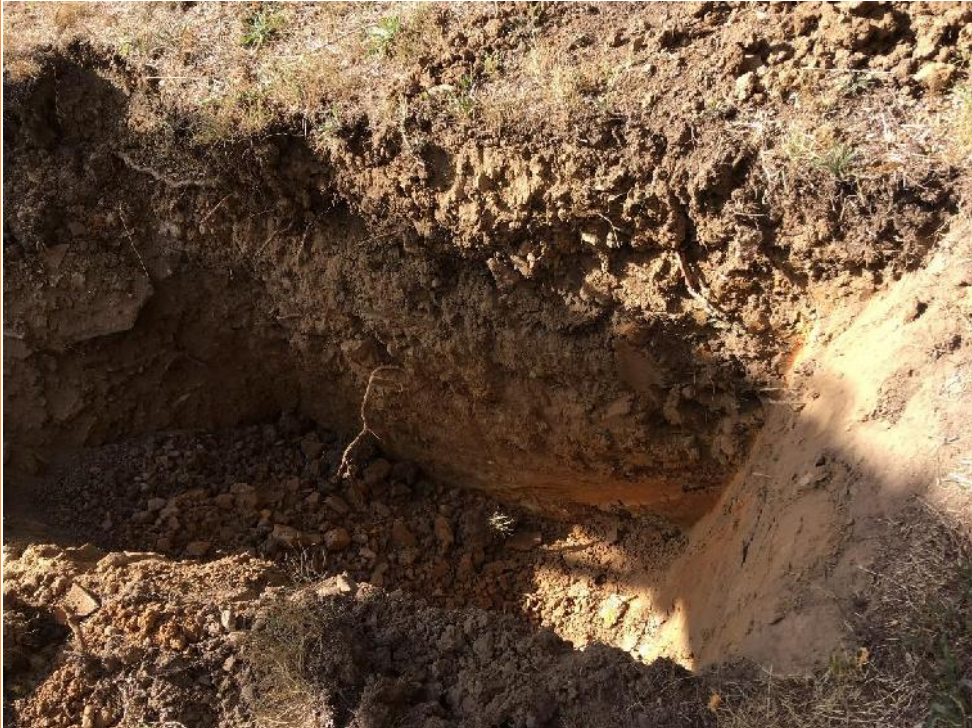
| Photo No. | Date | |
|---|---|---|
| <b>Description:</b><br><b>TP224</b> – Fill depth 0.6m<br>Located Near tennis court<br><b>FILL</b> - Silty Sandy GRAVEL, brown, angular gravel (foreign and coal).<br>Concrete slab & terracotta pipe encountered close to surface. | | |

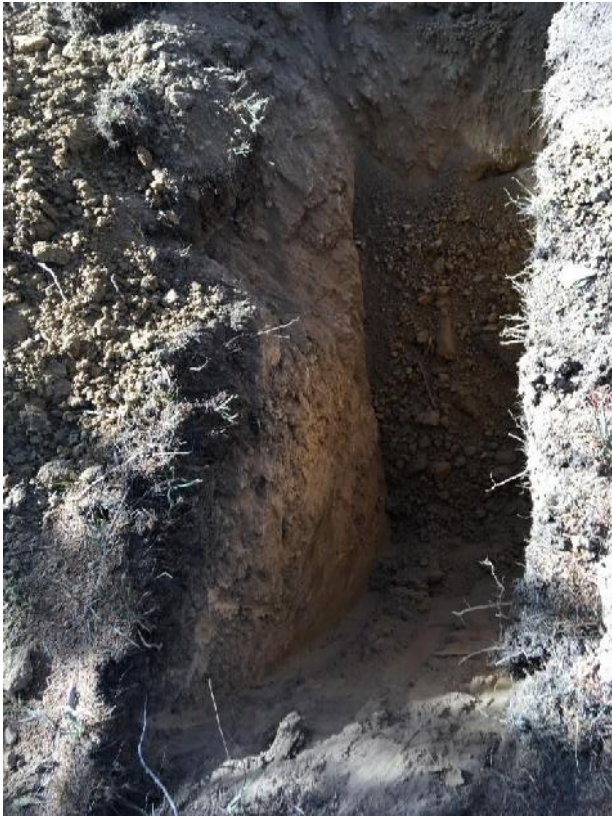
| Photo No. | Date | | | |
|---|---|---|--|--|
| 19. | 6/3/19 | | | |

| Photo No. | Date | | | |
|---|---|---|--|--|
| <b>Description:</b><br><br>TP225 – Fill depth 0.5m<br><br><b>FILL</b> - Silty GRAVEL, brown, low consolidation, angular shale gravel to 100mm, roots. | | | | |

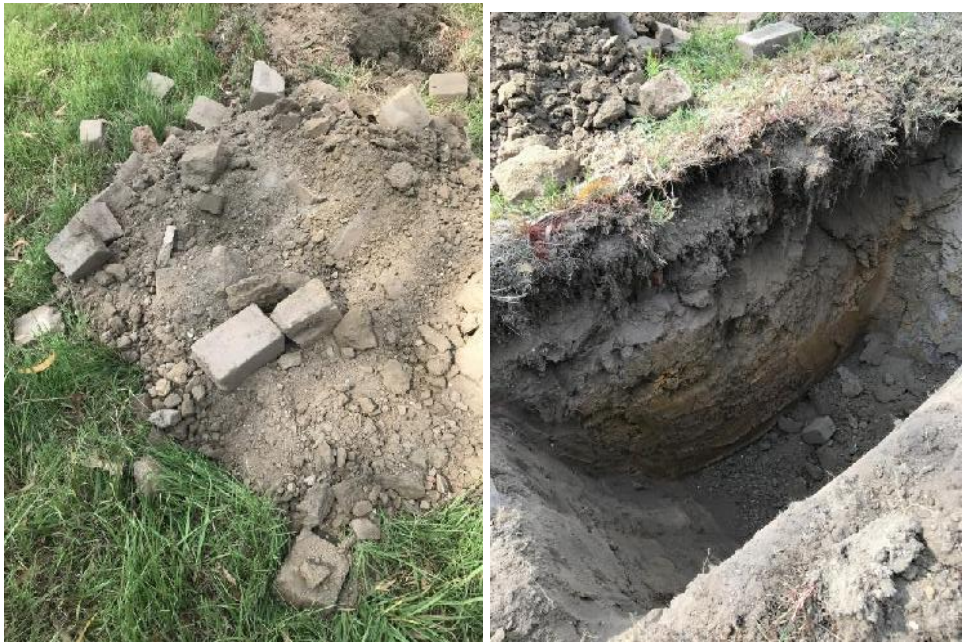
| Photo No. | Date | | | |
|---|---|---|--|--|
| 20. | 6/3/19 | | | |

| Photo No. | Date | | | |
|---|---|---|--|--|
| <b>Description:</b><br><br>TP227 – Fill depth 0.4m<br><br>Located near western boundary<br><br><b>FILL</b> - Sandy Silty GRAVEL, brown, loose.<br><br>Red bricks present. | | | | |

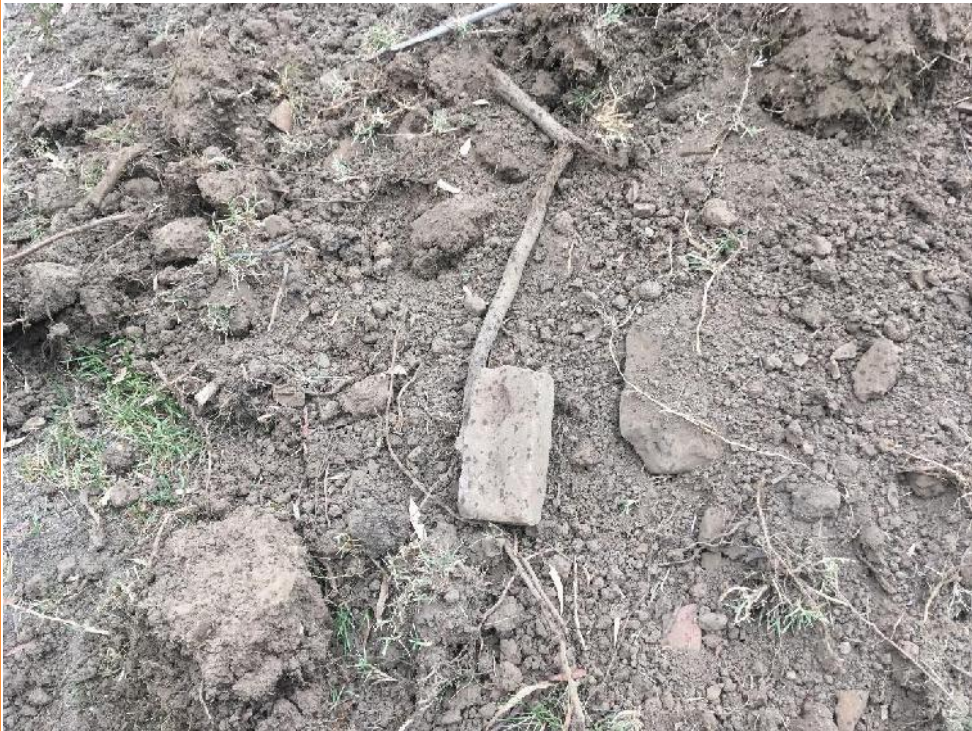
- A vegetated fill mound was observed south-west of the Amenities Building and was observed to contain both ACM (TP246) and detections of PAHs below adopted SAC. It is noted that this location is outside the staged development footprint including the cut and fill areas.

| Photo No. | Date | |
|---|---|---|
| <b>Description:</b><br><br><b>TP246</b> – Fill depth 0.2m<br><br>Mound near timber/tree/wood stockpile. Raised approximately 0.1 – 0.2 m.<br><br><b>FILL</b> - Clayey SILT, brown, loose, roots.<br><br>terracotta pipe.<br><br>PACM at 0.1m | | |

- Completion of activities under a Construction Environmental Management Plan (CEMP) and an Asbestos Management Plan (AMP). The CEMP should include an unexpected finds protocol in the event that additional fill material, waste etc. is identified during construction/civil activities, which Arcadis considers likely. This recommendation is reiterated from the PSI;
