## **Queanbeyan East Public School**

### **Proposed New Learning Centre**

Report on  
Preliminary Geotechnical Investigation

Proposed Additional Classrooms  
10 Yass Road, Queanbeyan

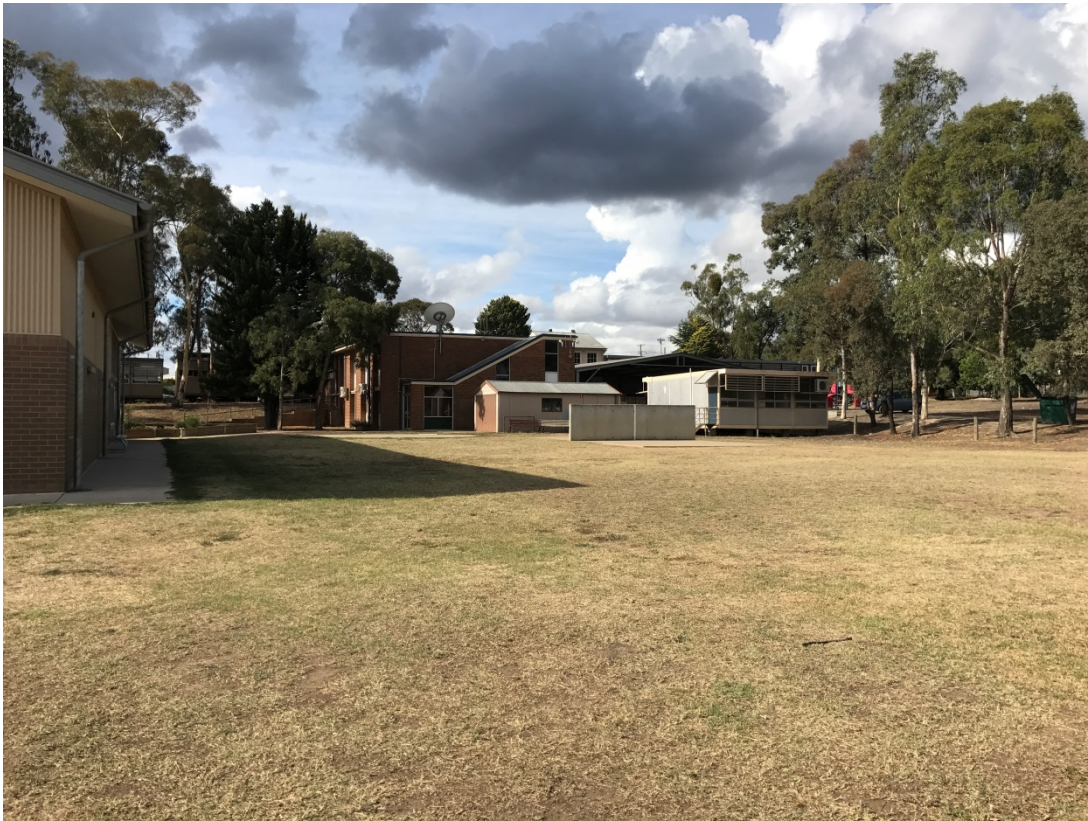
Figure 1 shows the general conditions of the northern portion looking from the centre of the site.

**Figure 1: View of northern part of site.**

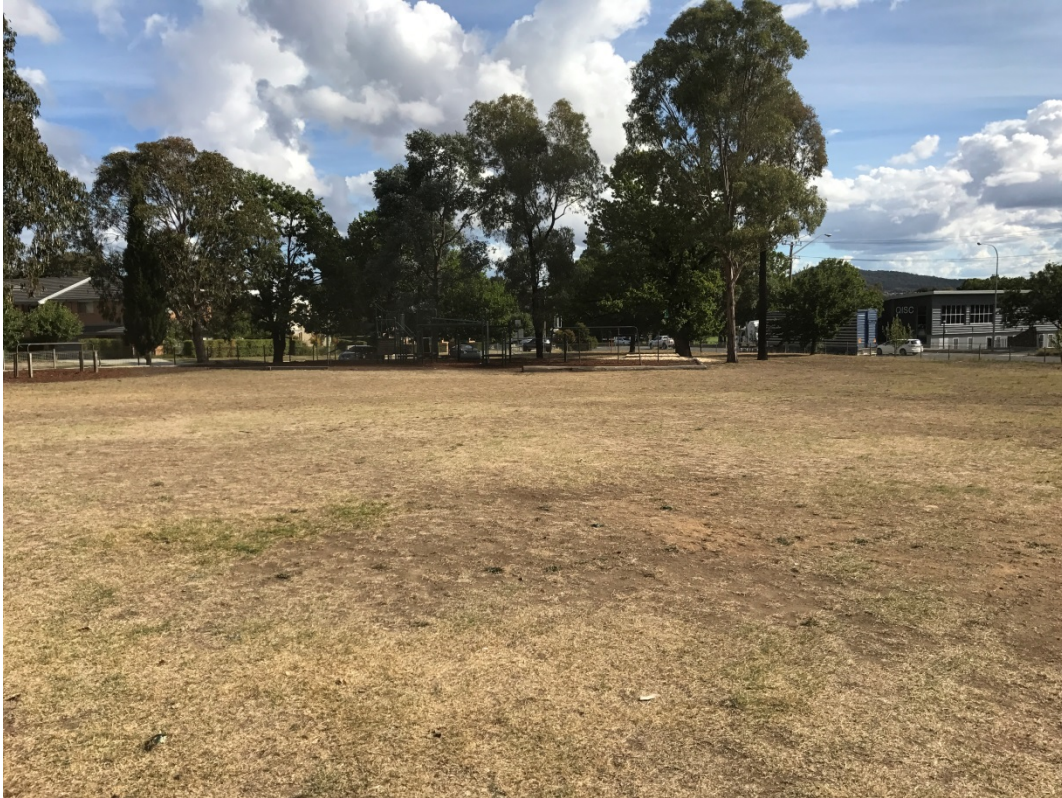
Figure 2 shows the general conditions of the southern portion looking from the centre of the site.

**Figure 2: View of southern part of site.**

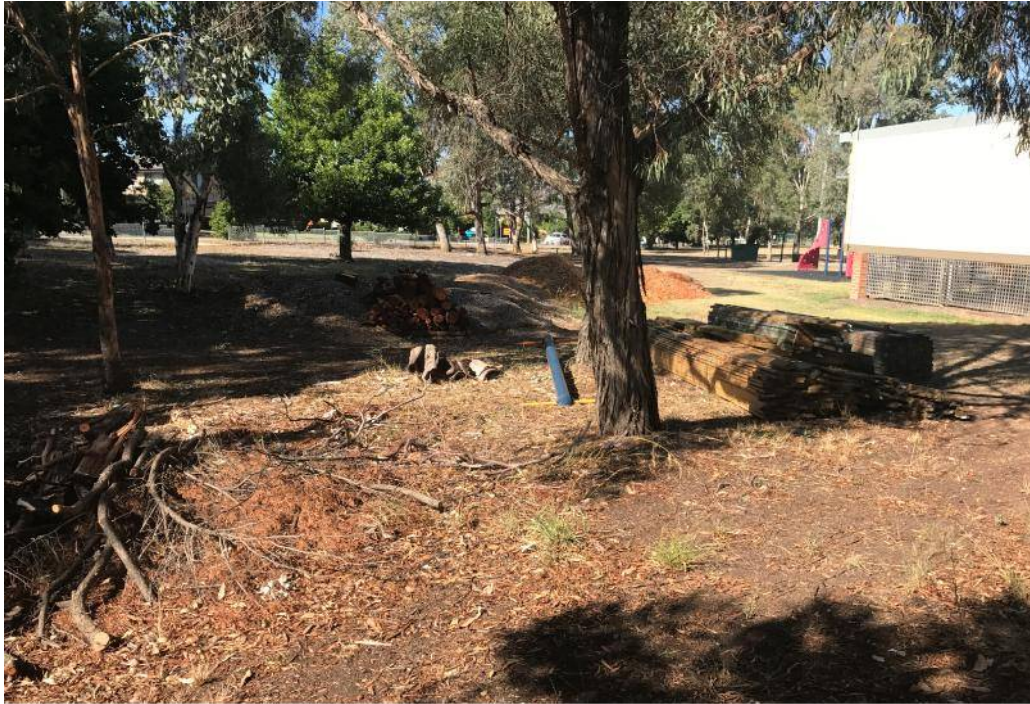
Photo 1 – Stockpiles and building material located in the north east corner of the site.

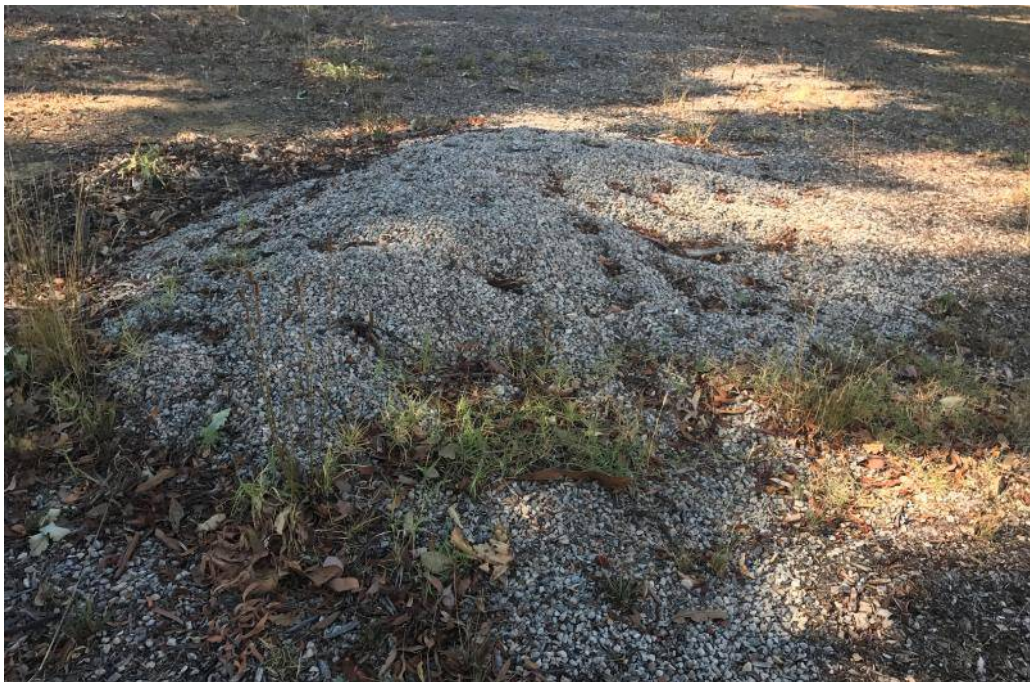
Photo 2 – Stockpile of gravel.

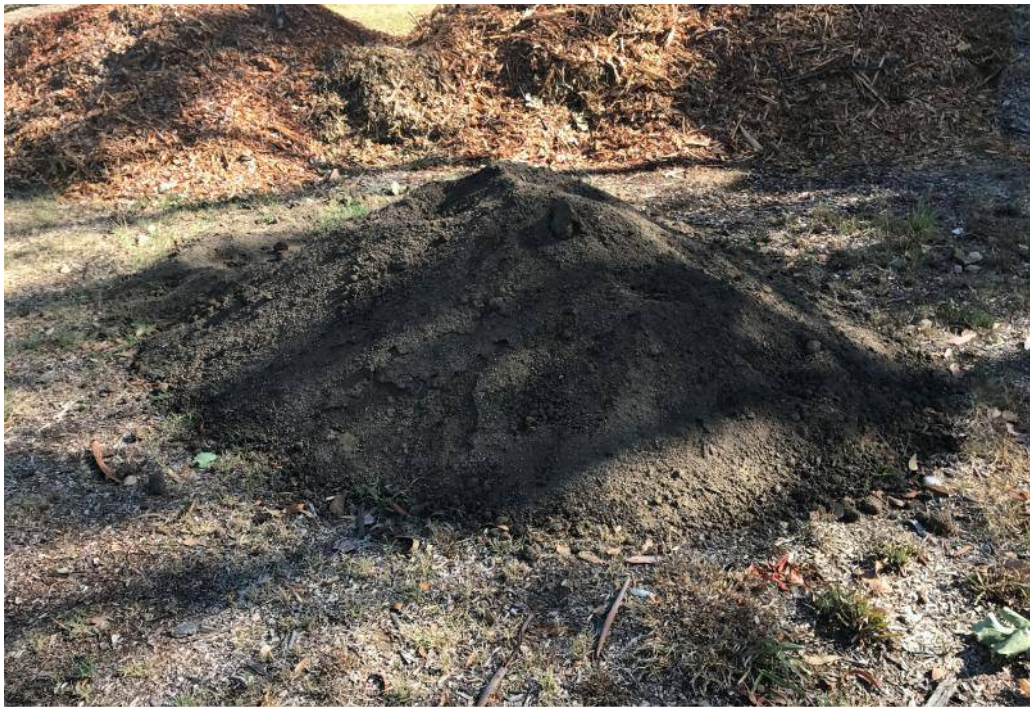
Photo 3 – Stockpile of topsoil

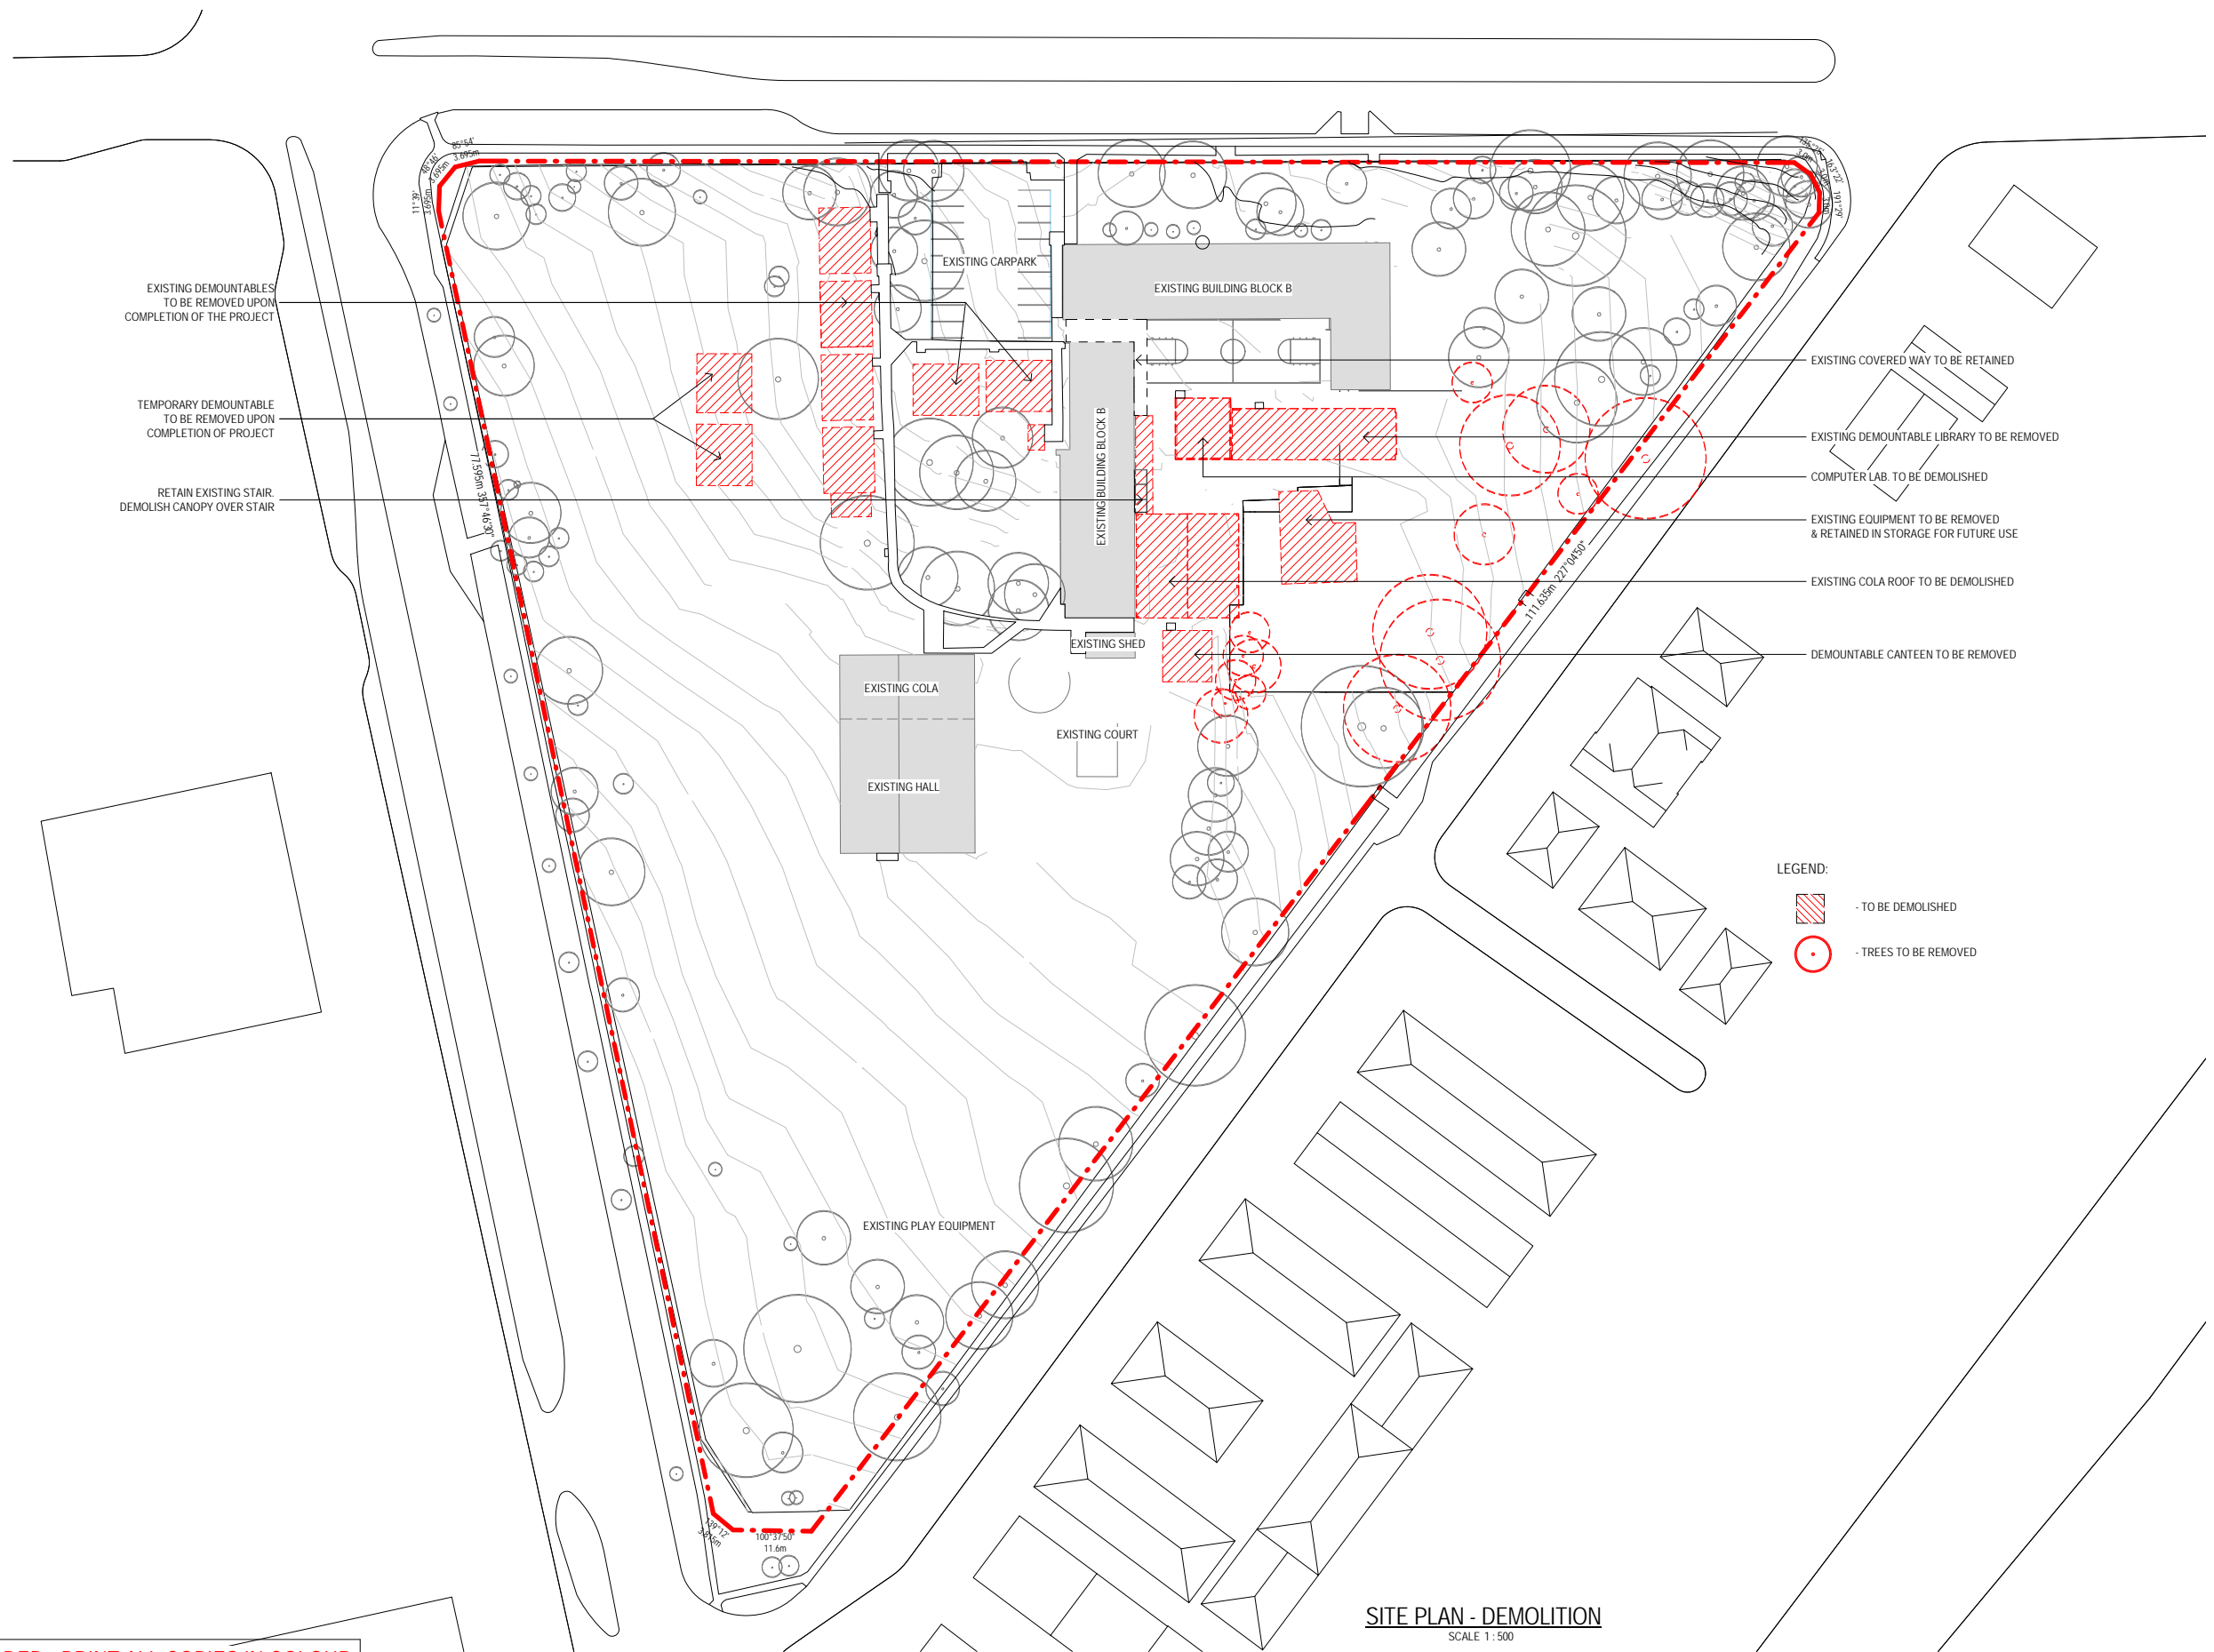
Original Size **A1** Drawing No: **23-16004 - QEPS - DA-AR-0200** Rev: **B**

SITE PLAN - DEMOLITION  
SCALE 1:500
