Moore Trees  
Arboricultural Services

# Arboricultural Development Assessment Report

*Anglicare, St Lukes*  
*4 Lindsay Evans Place, Dapto NSW 2530*  
ILU PROJECT  
April 2019  
*FINAL (Updated 16<sup>th</sup> July 2019)*

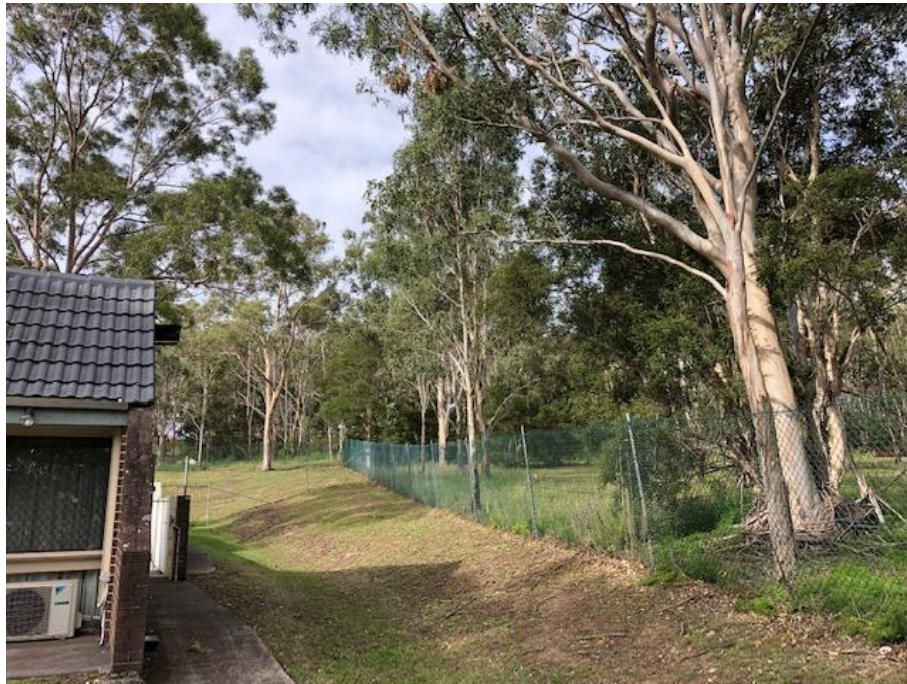
**Plate 1:** Trees to the south of the site. P. Vezgoff.

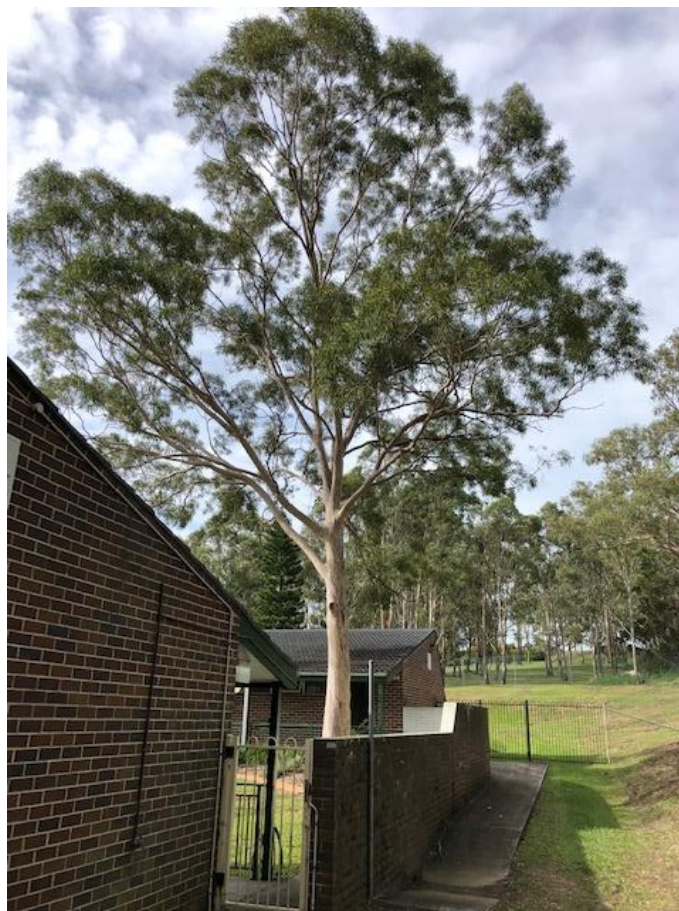
**Plate 2:** Tree 111. P. Vezgoff.

- 3.7** Two (2) trees within the site located between buildings are large mature specimens in good health and condition. These trees are numbered as 111 and 168 (Plates 2 and 3). Another tree near Tree 168 has recently been removed as evidenced by the ground out stump.

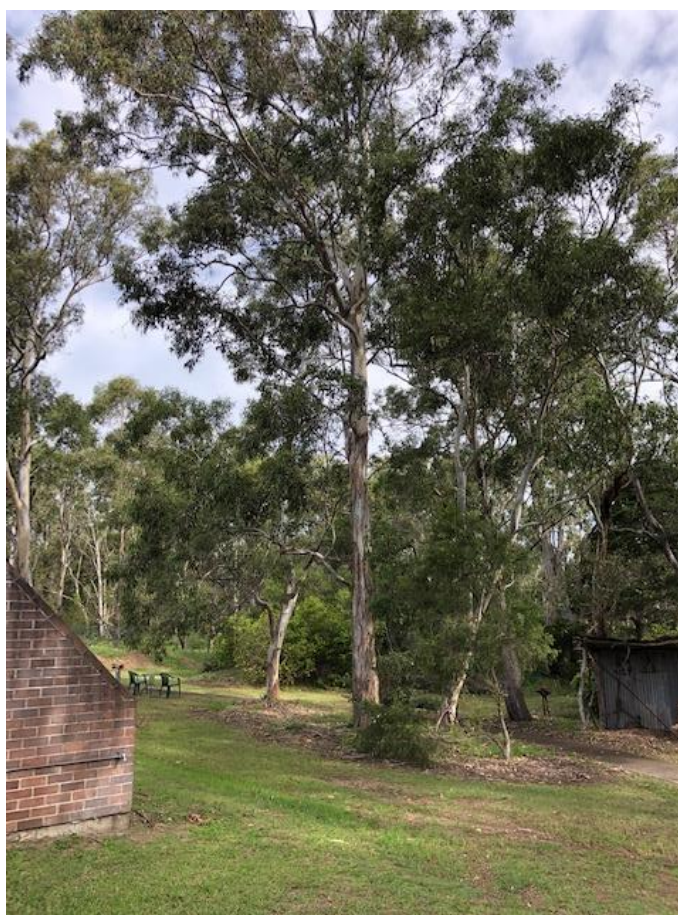
**Plate 8:** Trees 151-153. P. Vezgoff.

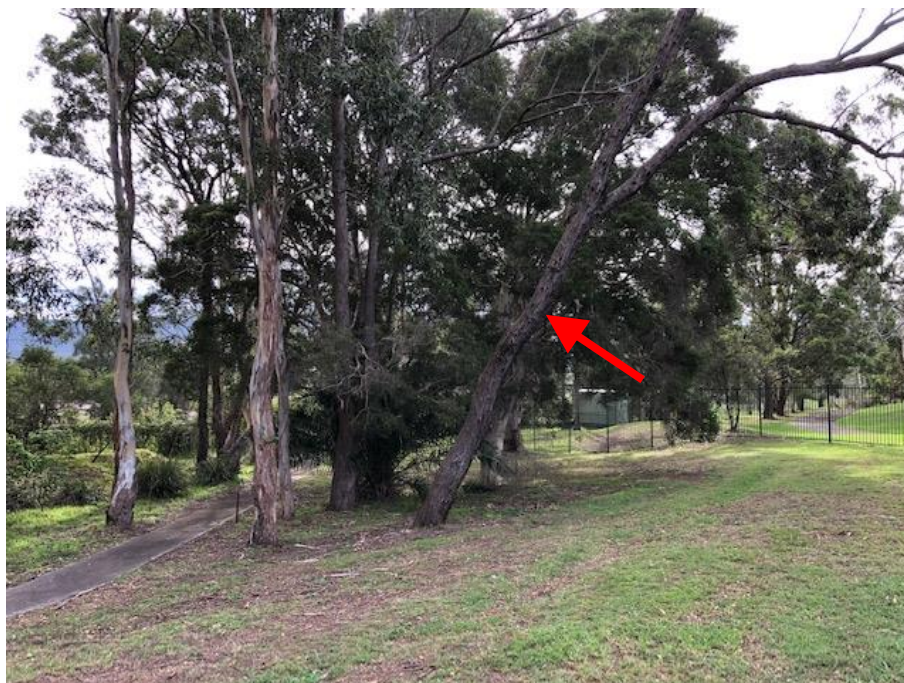
**Plate 9:** Trees 162, 163, 164, 166, 167 and 345. Tree 166 (red arrow) has recently failed. P. Vezgoff.

- 4.2** Trees numbered as 50, 61, 158-161, 166, 288, 289, 294, 304, 306, 308, 309, 310, 315, 335, 347 348, 409 and 410 are required to be removed so to comply with the bush fire management recommendations for the APZ area to the south of the site. These removals form part of an approved Development Application being DA 2008/1470 and which provides for a 40m APZ. These numbers related to the site tree tags affixed to the main stems. All other trees should be possible to retain.

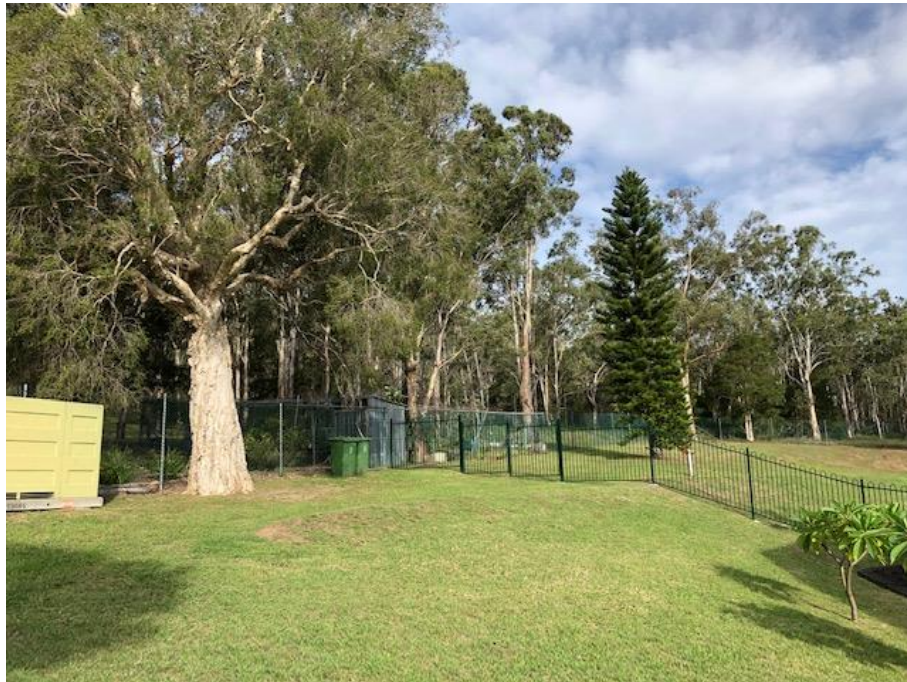
- 3.5** The site trees are mostly native specimens being Forest red gum (*Eucalyptus tereticornis*), *Melaleuca styphelioides*, White stringy bark (*Eucalyptus globoidia*), Swamp mahogany (*Eucalyptus robusta*), Lemon-scented gum tree (*Corymbia citriodora*). Only one (1) exotic specimen was noted being Tree 171 (Plate 10) a small semi mature Cook Island Pine (*Araucaria columnaris*).

**Plate 10:** Trees 172, 173 and 171. P. Vezgoff.

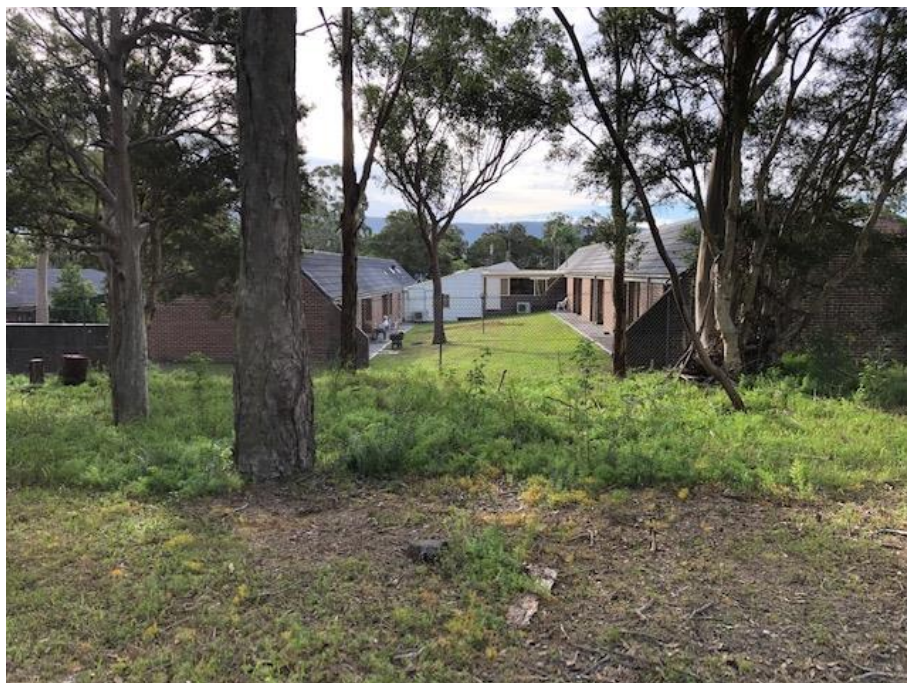
- 3.8** A short access way or path is proposed within the tree group between Trees 297 and 305 (Plate 11). These trees are in mixed condition but generally in good health with the exception of Tree 300 that is a small dead tree.

**Plate 11:** Image showing adequate space between trees 297-305 for the path construction. P. Vezgoff.

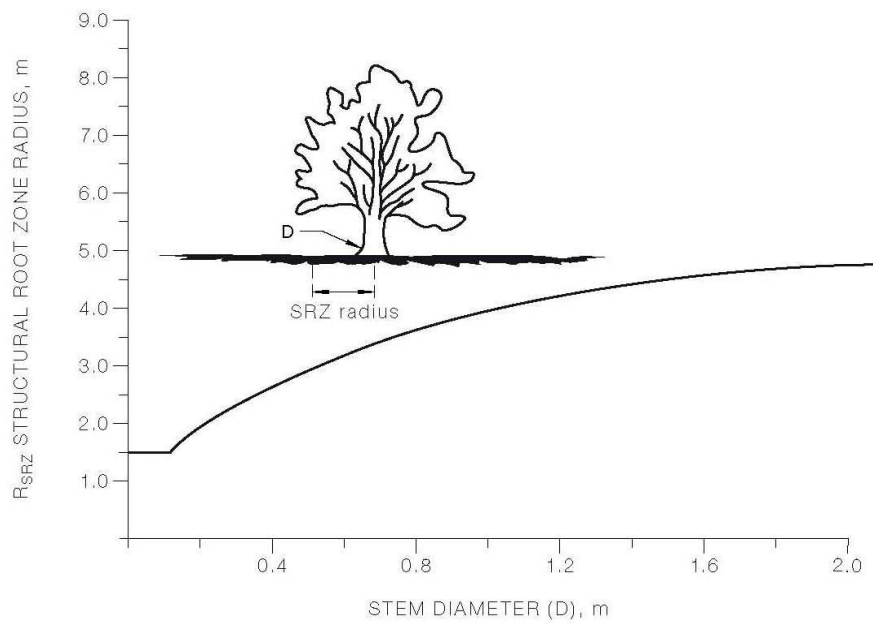
**FIGURE 1 - STRUCTURAL ROOT ZONE**

NOTE: The SRZ for trees with trunk diameters less than 0.15m will be 1.5m (see Figure 1).

The curve can be expressed by the following formula:  
 $R_{SRZ} = (D \times 50)^{0.42} \times 0.64$

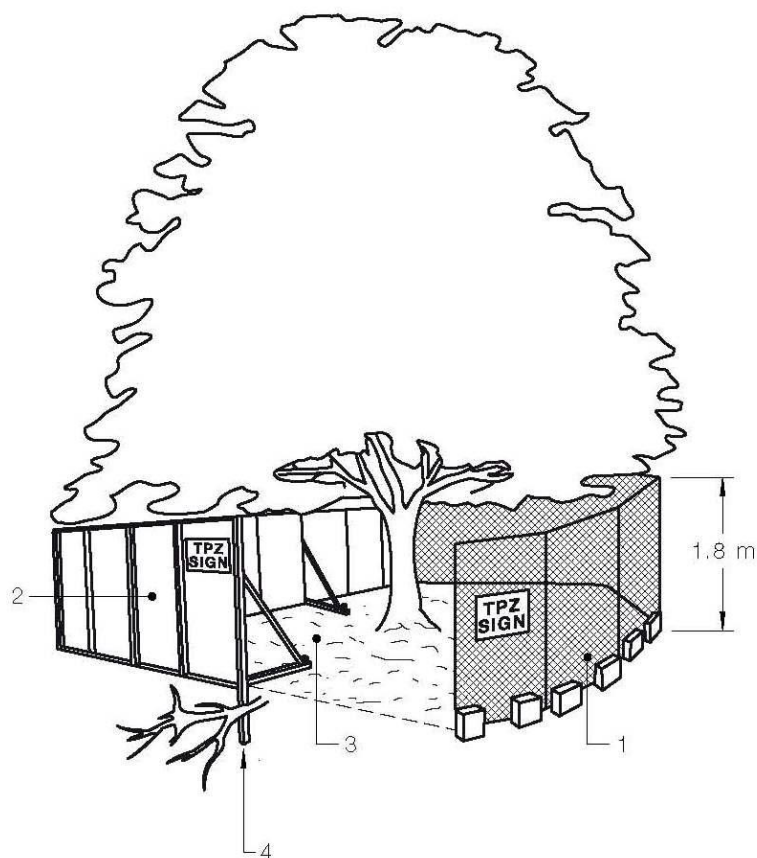
- 1 Chain wire mesh panels with shade cloth (if required) attached, held in place with concrete feet.
- 2 Alternative plywood or wooden paling fence panels. This fencing material also prevents building materials or soil entering the TPZ.
- 3 Mulch installation across surface of TPZ (at the discretion of the project arborist). No excavation, construction activity, grade changes, surface treatment or storage of materials of any kind is permitted within the TPZ.
- 4 Bracing is permissible within the TPZ. Installation of supports should avoid damaging roots.
