PRELIMINARY SITE INVESTIGATION

Goulburn Aquatic Centre A portion of Lot 1 DP 117890 Goulburn NSW 2580

October 2017

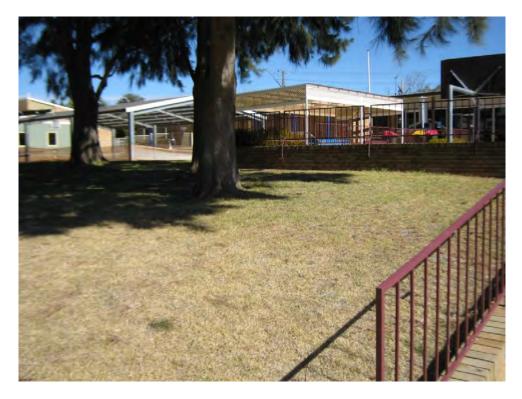
Photograph 2: AEC 1 - Area of potential fill material south of the outdoor pool. View to the west.

Due to the potential for imported fill material on the site Robson recommend a soil assessment be undertaken of the fill material and a Construction Environmental Management Plan (CEMP) with an unexpected finds protocol (UFP) to be prepared for the site prior to redevelopment works.

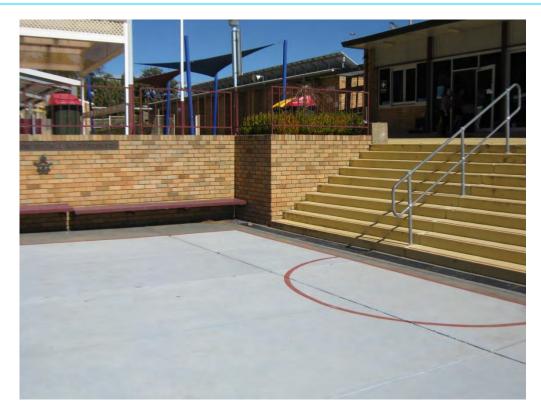
Photograph 3: AEC 1 - Area of potential fill material south of the outdoor pool. General waste/recycling bins in background were observed across the whole site. View to the southwest.

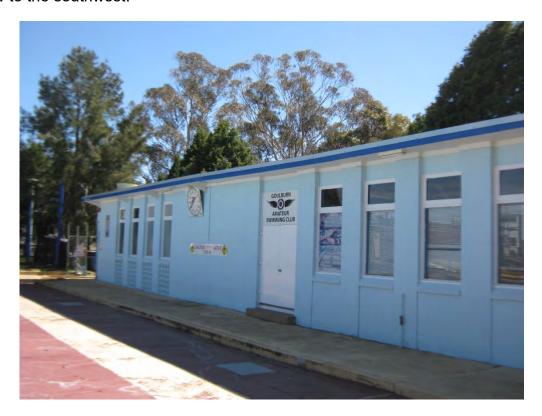
Photograph 4: General view of the outdoor pool plant room/clubhouse that contains a chemical storage area (AEC 2). View to the northwest.

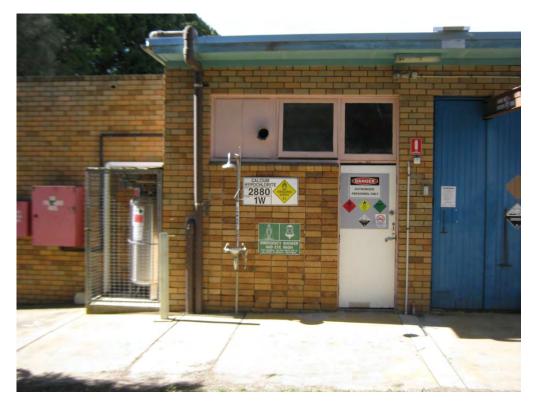
Photograph 5: General view of the outdoor pool plant room/clubhouse that contains a chemical storage area (AEC 2). View to the east.

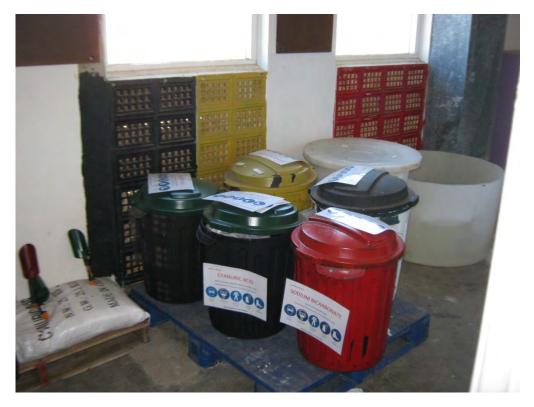
Large amounts of chemicals used for pool cleaning and chlorination were observed in the outdoor pool plant room. Two (2) brick bunding areas, one (1) approximately 2 m x 2 m and one (1) approximately 3 m x 3 m were observed in the outdoor pool plant room and were in good condition. Minor amounts of chemicals have been stored in the indoor pool plant room. The plant rooms were constructed with brick and concrete, and were observed to be old but in fair condition. Minor spillage was observed on the concrete.

Photograph 6: AEC 2 – Large quantity of chemicals stored in the outdoor pool plant room.

Therefore further assessment of this AEC is not required at this time however, should the buildings containing the storage areas be demolished and/or significantly redeveloped, Robson recommends that an assessment of the soil directly beneath the footprint of the buildings for COPC including acids/pH (in addition to the COPC associated with fill material) be undertaken.

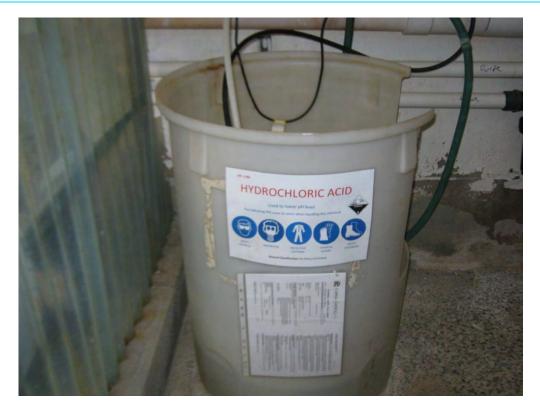
Photograph 7: AEC 2 – Large quantity of chemicals stored in the outdoor pool plant room.

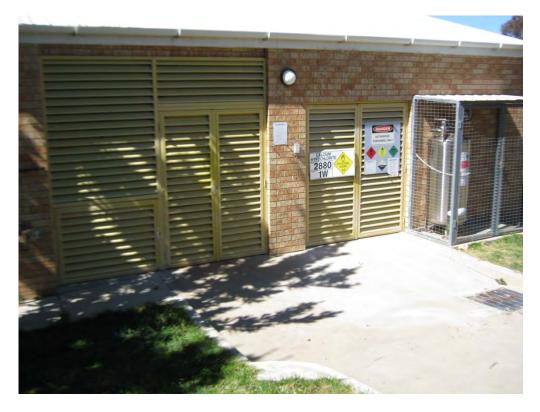
Photograph 8: General view of the indoor pool plant room that contains a chemical storage area (AEC 2). View to the east.

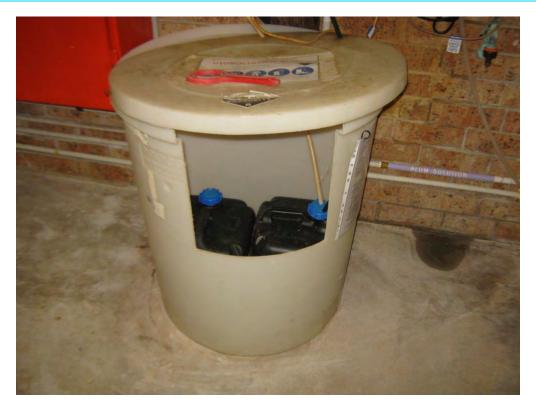
Photograph 9: AEC 2 – Small quantity of chemicals stored in the indoor pool plant room.

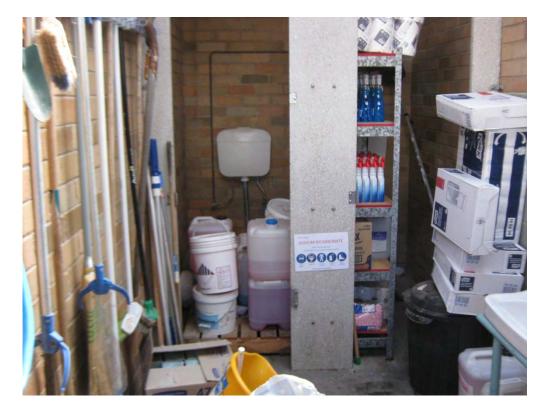
Photograph 10: Small quantities of household/toilet cleaning chemical storage in women's change room.
