Phase 1 Contamination Assessment

130 Princes Highway, Ulladulla, NSW

Date: 20 December 2017

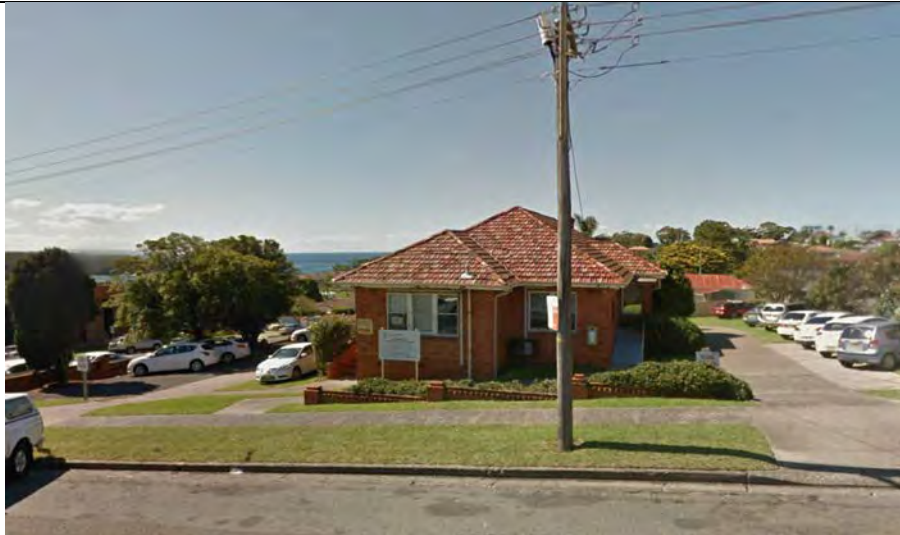
Photo 1 Looking east west from Princes Highway facing (Ref: Google Earth Pro)

- The site is used as Community Health Centre providing facility for services of various medical practitioners.
- The site has a medical facility and administration building fronting the Princes Highway (Photo 1 and 4).
- A part buried twin garage is present in the north-eastern side of the building (Photo 2).
- A brick retaining wall is observed along the northern property boundary and site terrain is elevated with respect to surrounding offsite areas (Photo 3).
- The building comprised old brickwork on all walls. Some flaking paint and fibre cement (suspected ACM) material on the underside of roof areas (Photo 5).
- Evidence of weed spraying was observed around the perimeter of the main building as dieback of grass was noted around edges (Photo 4).
- No apparent evidence of chemical storage, underground fuel tanks, staining, odours or significant vegetation die back was observed.

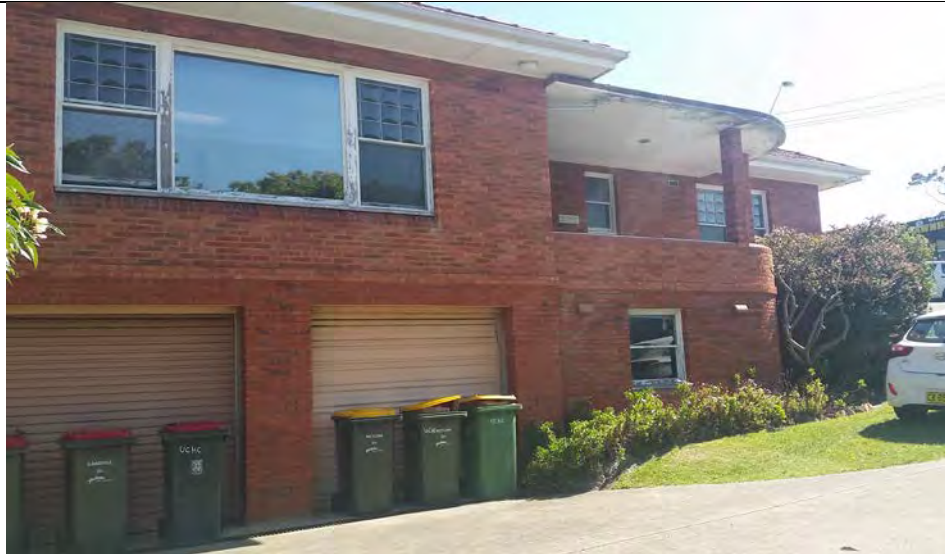
Photo 2 Looking south on norther side of building

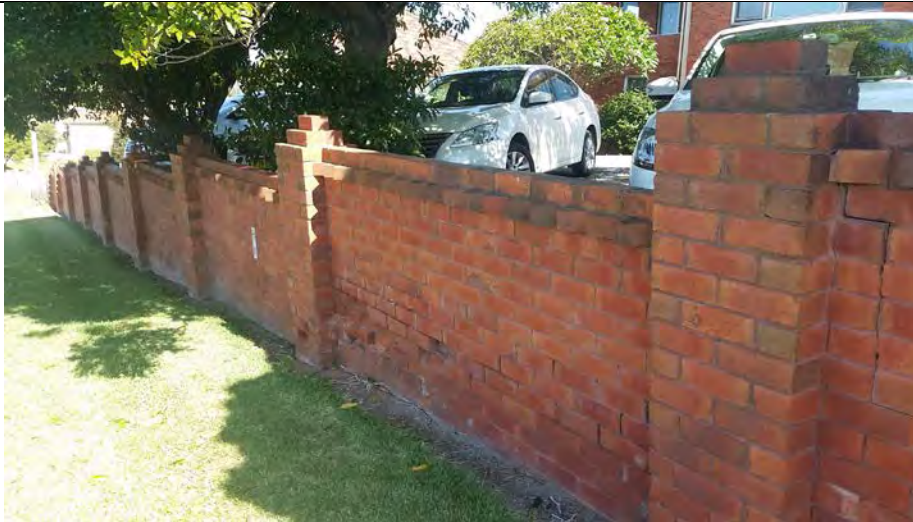
Photo 3 Retaining wall on northern site boundary

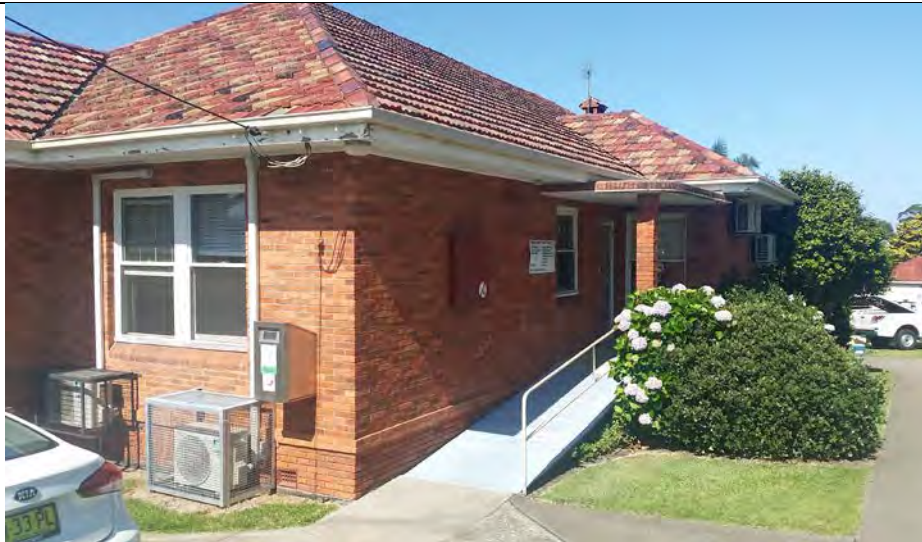
Photo 4 Facing north-east showing building and southern driveway

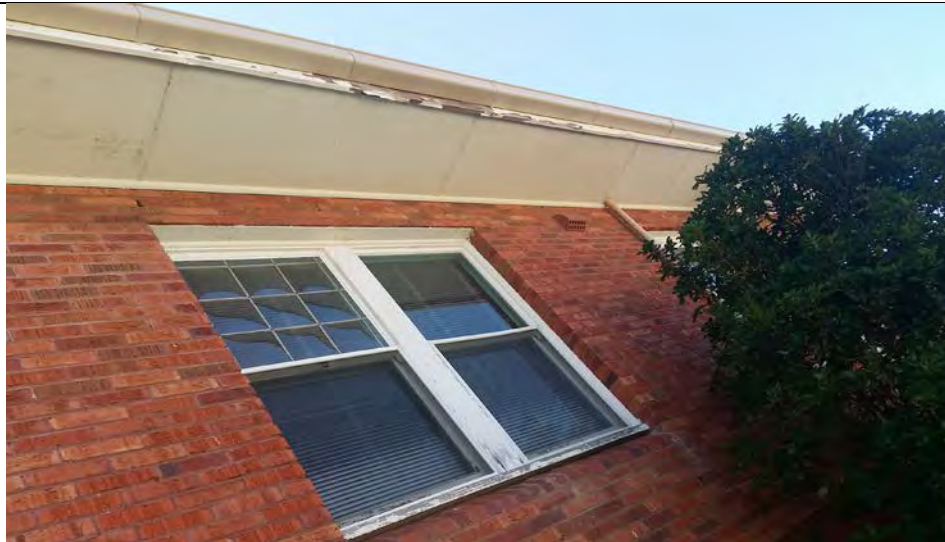
ISLHD provided SMEC with a copy of a hazardous materials survey report (Clearsafe, 2015). The report indicated the presence of some lead paint and non-friable asbestos within the building and PCB was suspected in light capacitors. Some loose (non-friable) debris was noted in the internal subfloor space.

Photo 5 Building eaves with flaking paint

We recommend that all site structures be appropriately demolished in accordance with all relevant guidance with respect to removal and clearance of hazardous building materials. A pre-demolition intrusive hazardous materials survey may also be required. This may also include tracing and chasing out any subsurface conduits that are made of hazardous materials (e.g. ACM piping). Completion of this prior to any bulk earthworks (along with a clearance) is recommended to avoid incidental damage and/or mixing of hazardous materials with site soils.

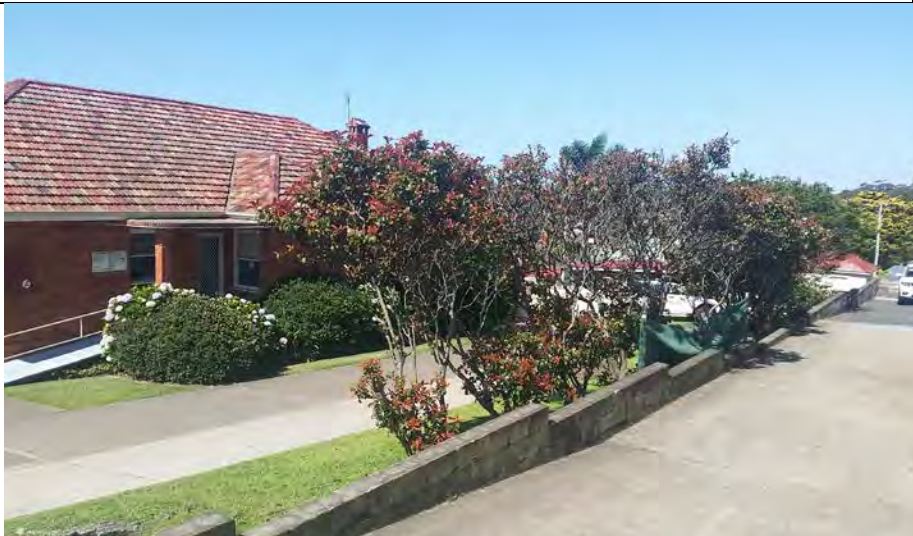
Photo 6 Site looking north-east from adjacent commercial premises driveway

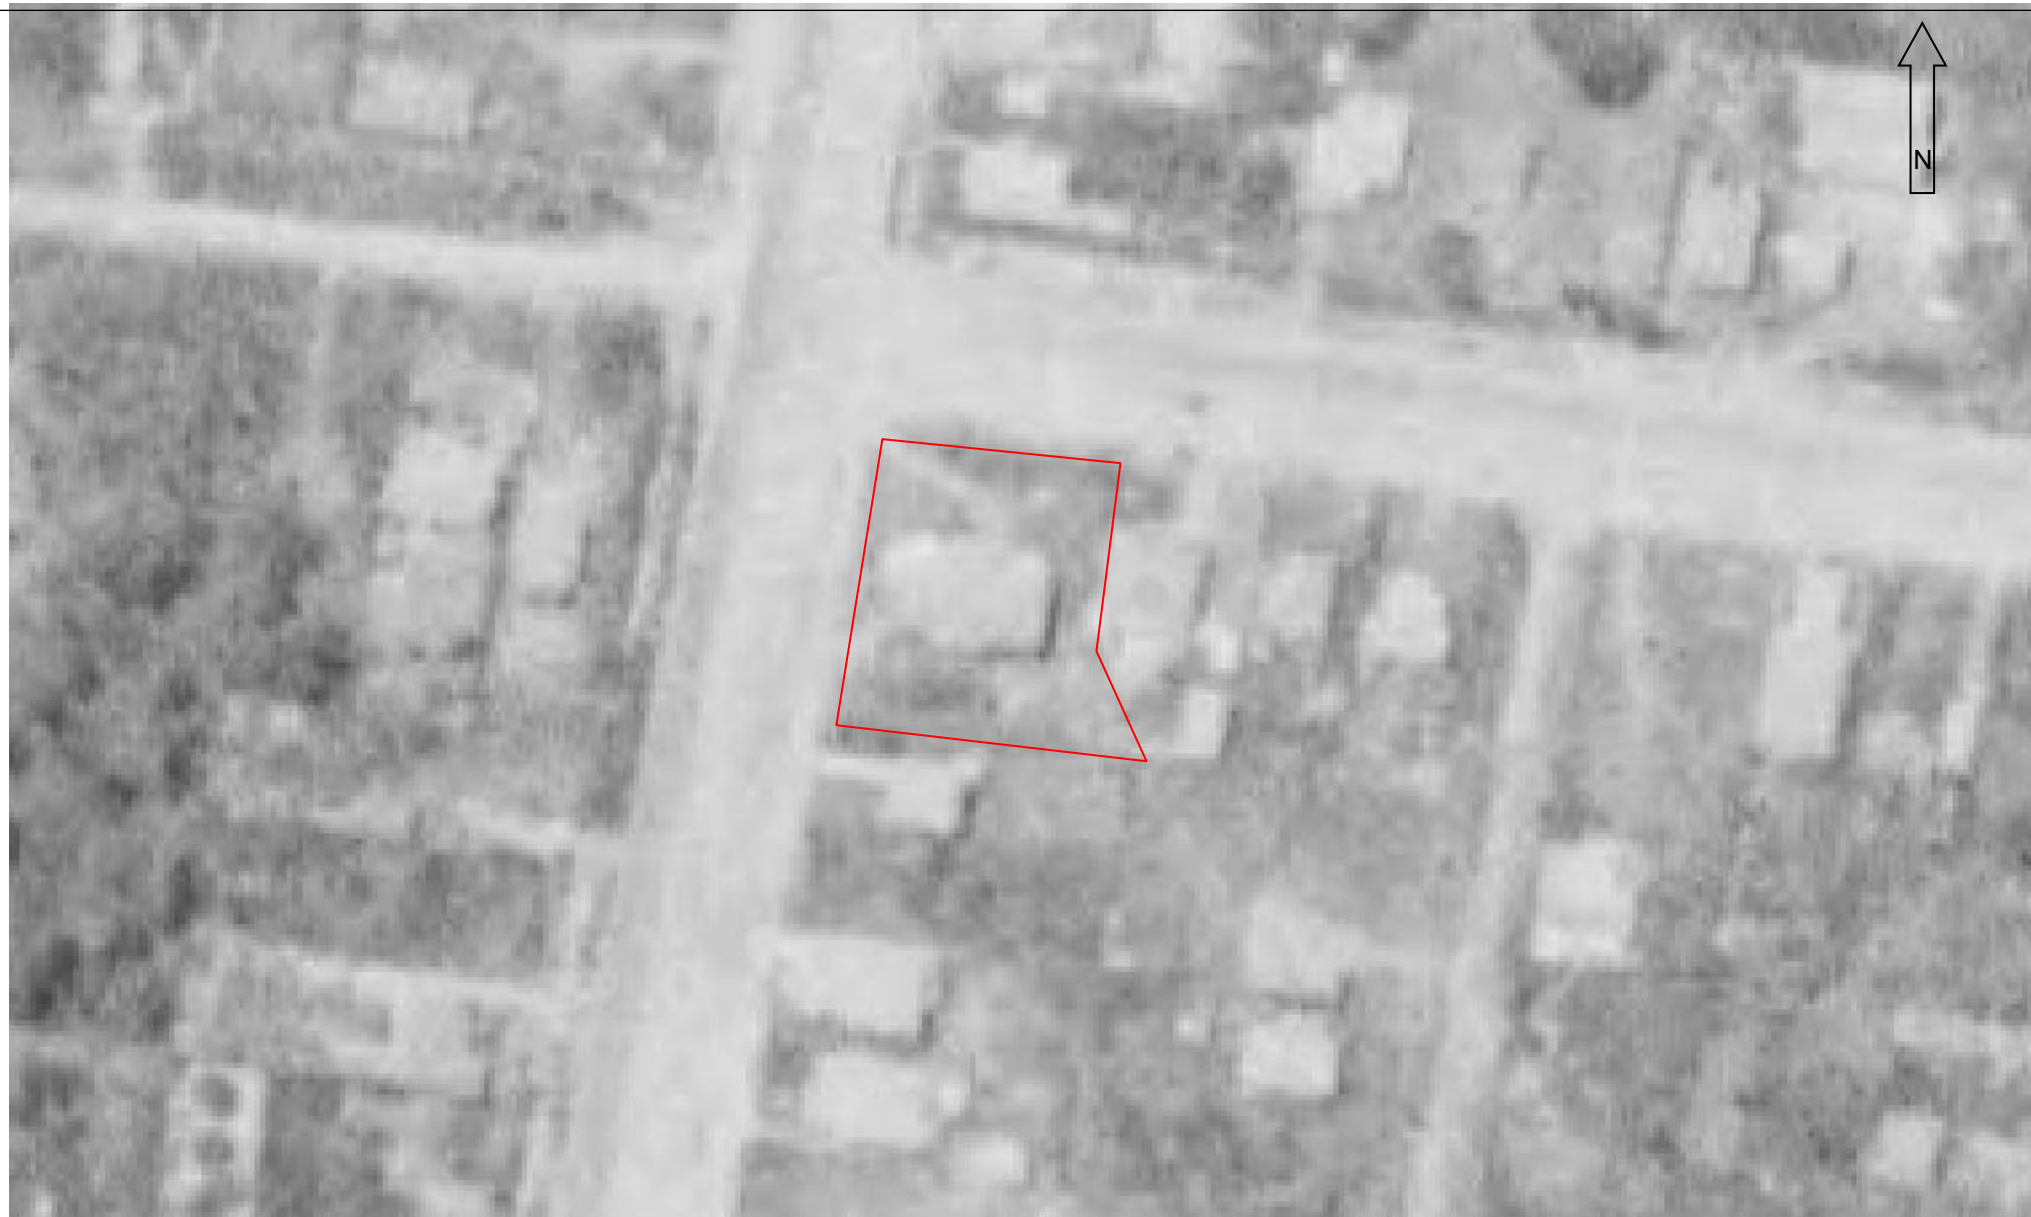
Figure No: 2A

Historic aerial photos reviewed during this study are presented in **Figure 2A (1949)**, **Figure 2B (1967)**, and **Figure 2C (1987)**, **Figure 2D (2004)** **Appendix A**. Site features and surrounding site conditions are summarised in Table 3.1

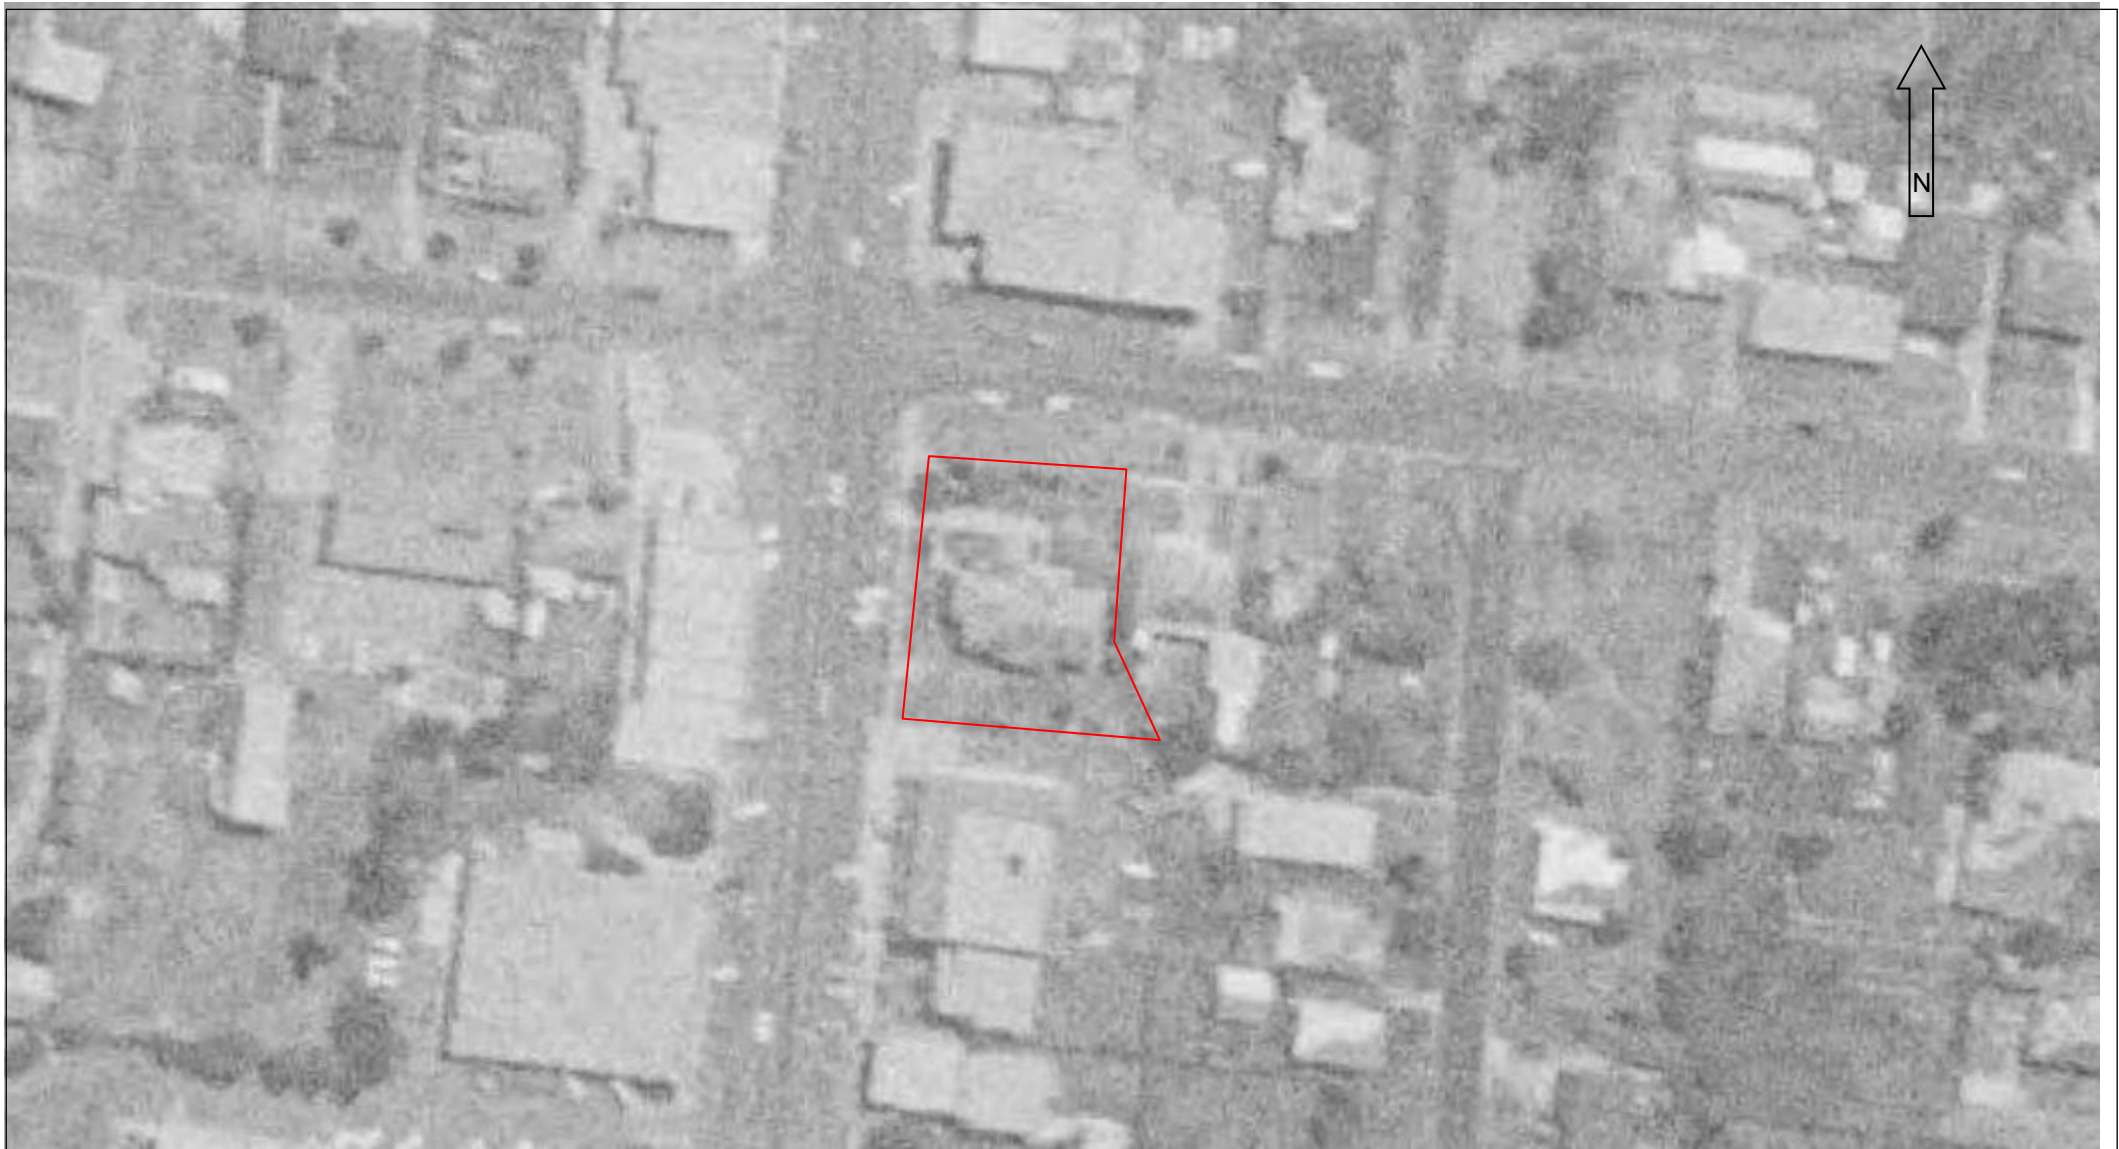
Member of the Surbana Jurong Group SMEC AUSTRALIA PTY LTD A.C.N. 065 475 149	Historical aerial photograph 1987
	Approved	MF			Project No.: 30012196
	Date	20/12/17			Figure No: 2C
	Scale	As shown

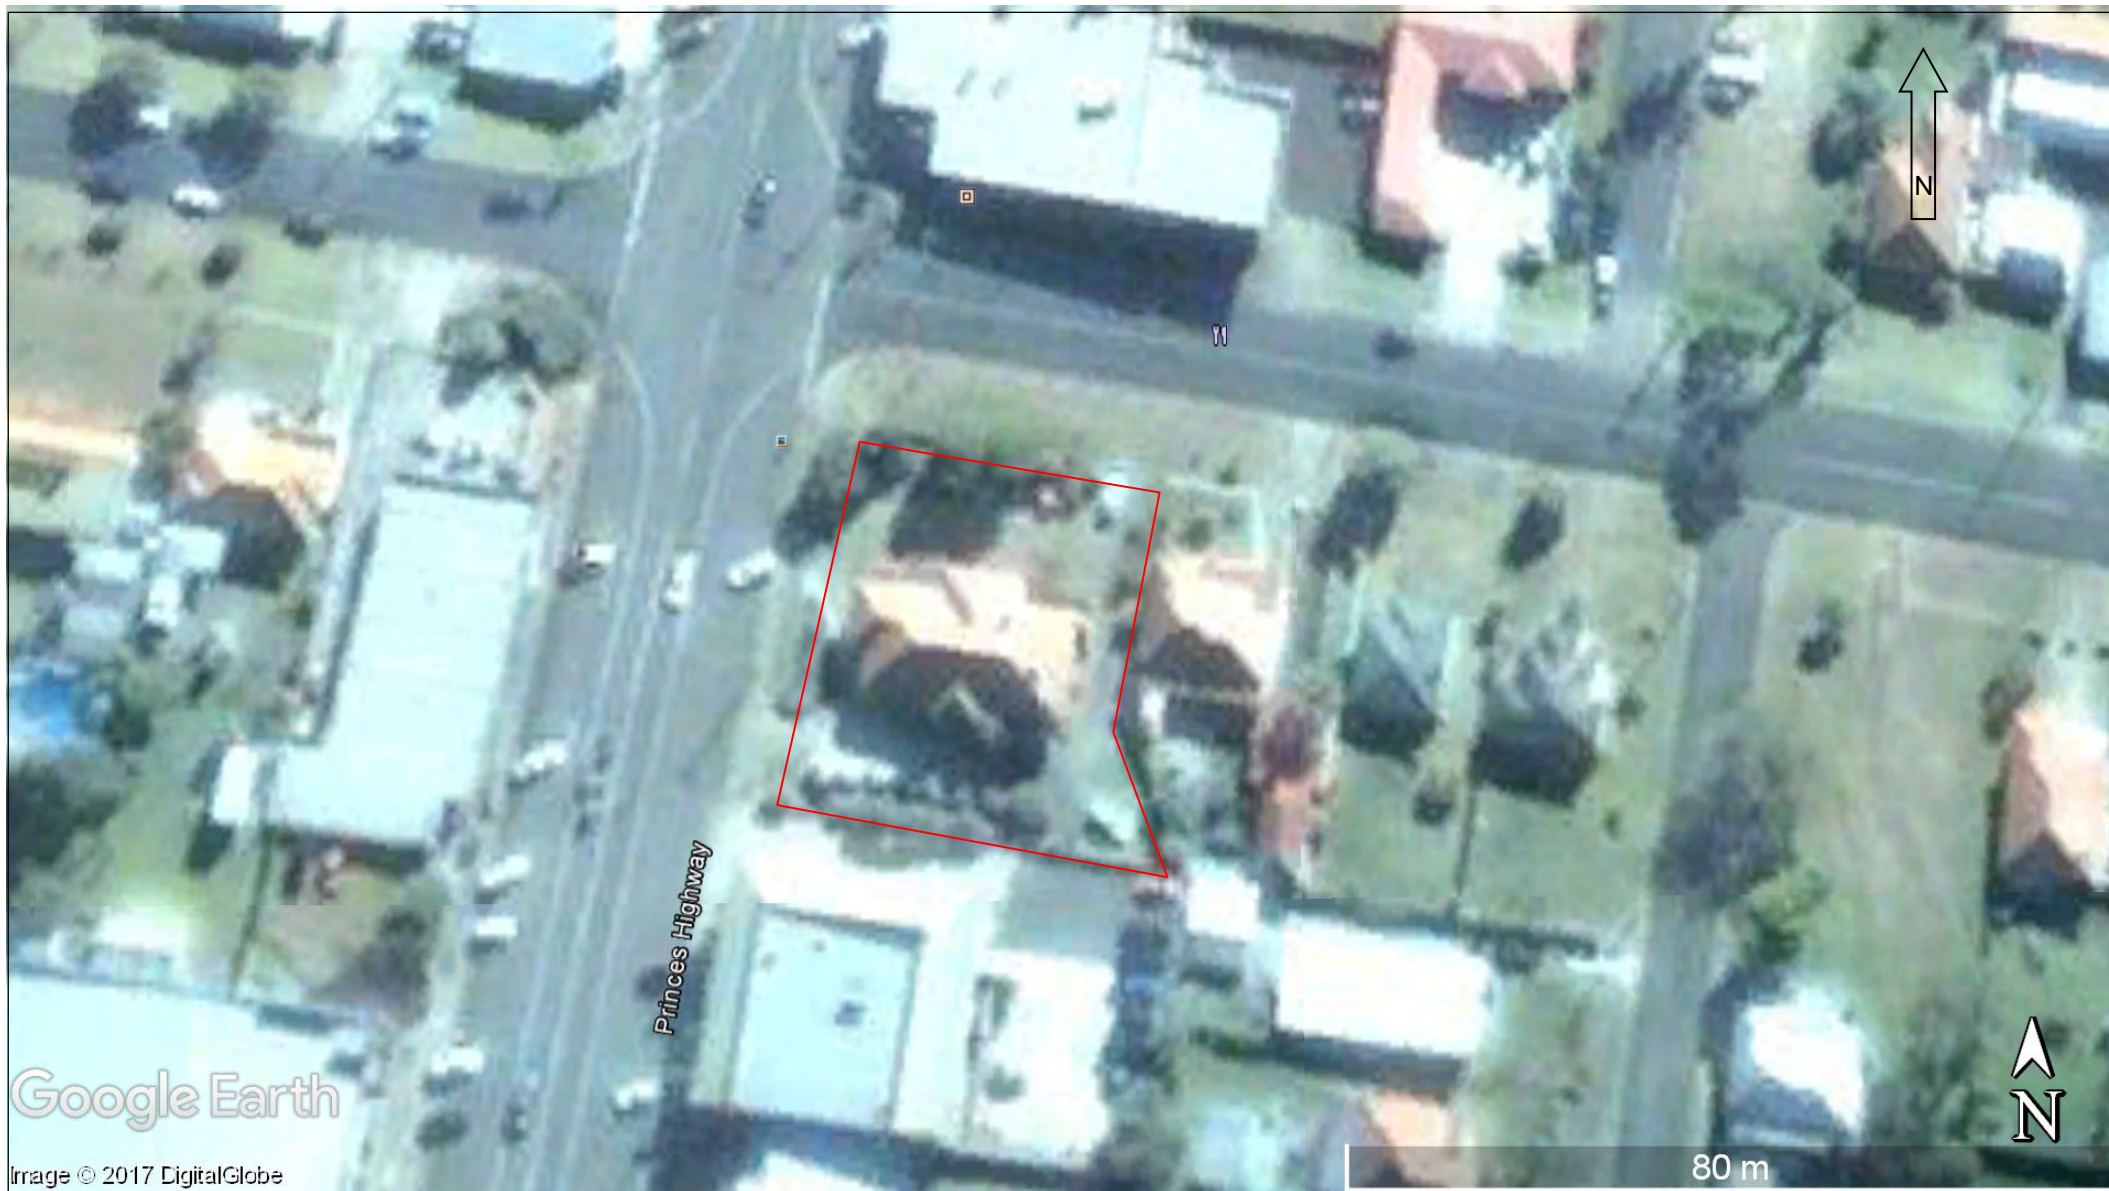
Member of the Surbana Jurong Group SMEC AUSTRALIA PTY LTD A.C.N. 065 475 149	Historical aerial photograph 2004
	Approved	MF			Project No.: 30012196
	Date	20/12/17			Figure No: 2D
	Scale	As shown
