Report on
Preliminary Site Investigation for Contamination

Pre-Purchase Due Diligence
49 Beach Road, Batemans Bay

Prepared for
Aspen Group

Project 89333.00
September 2017

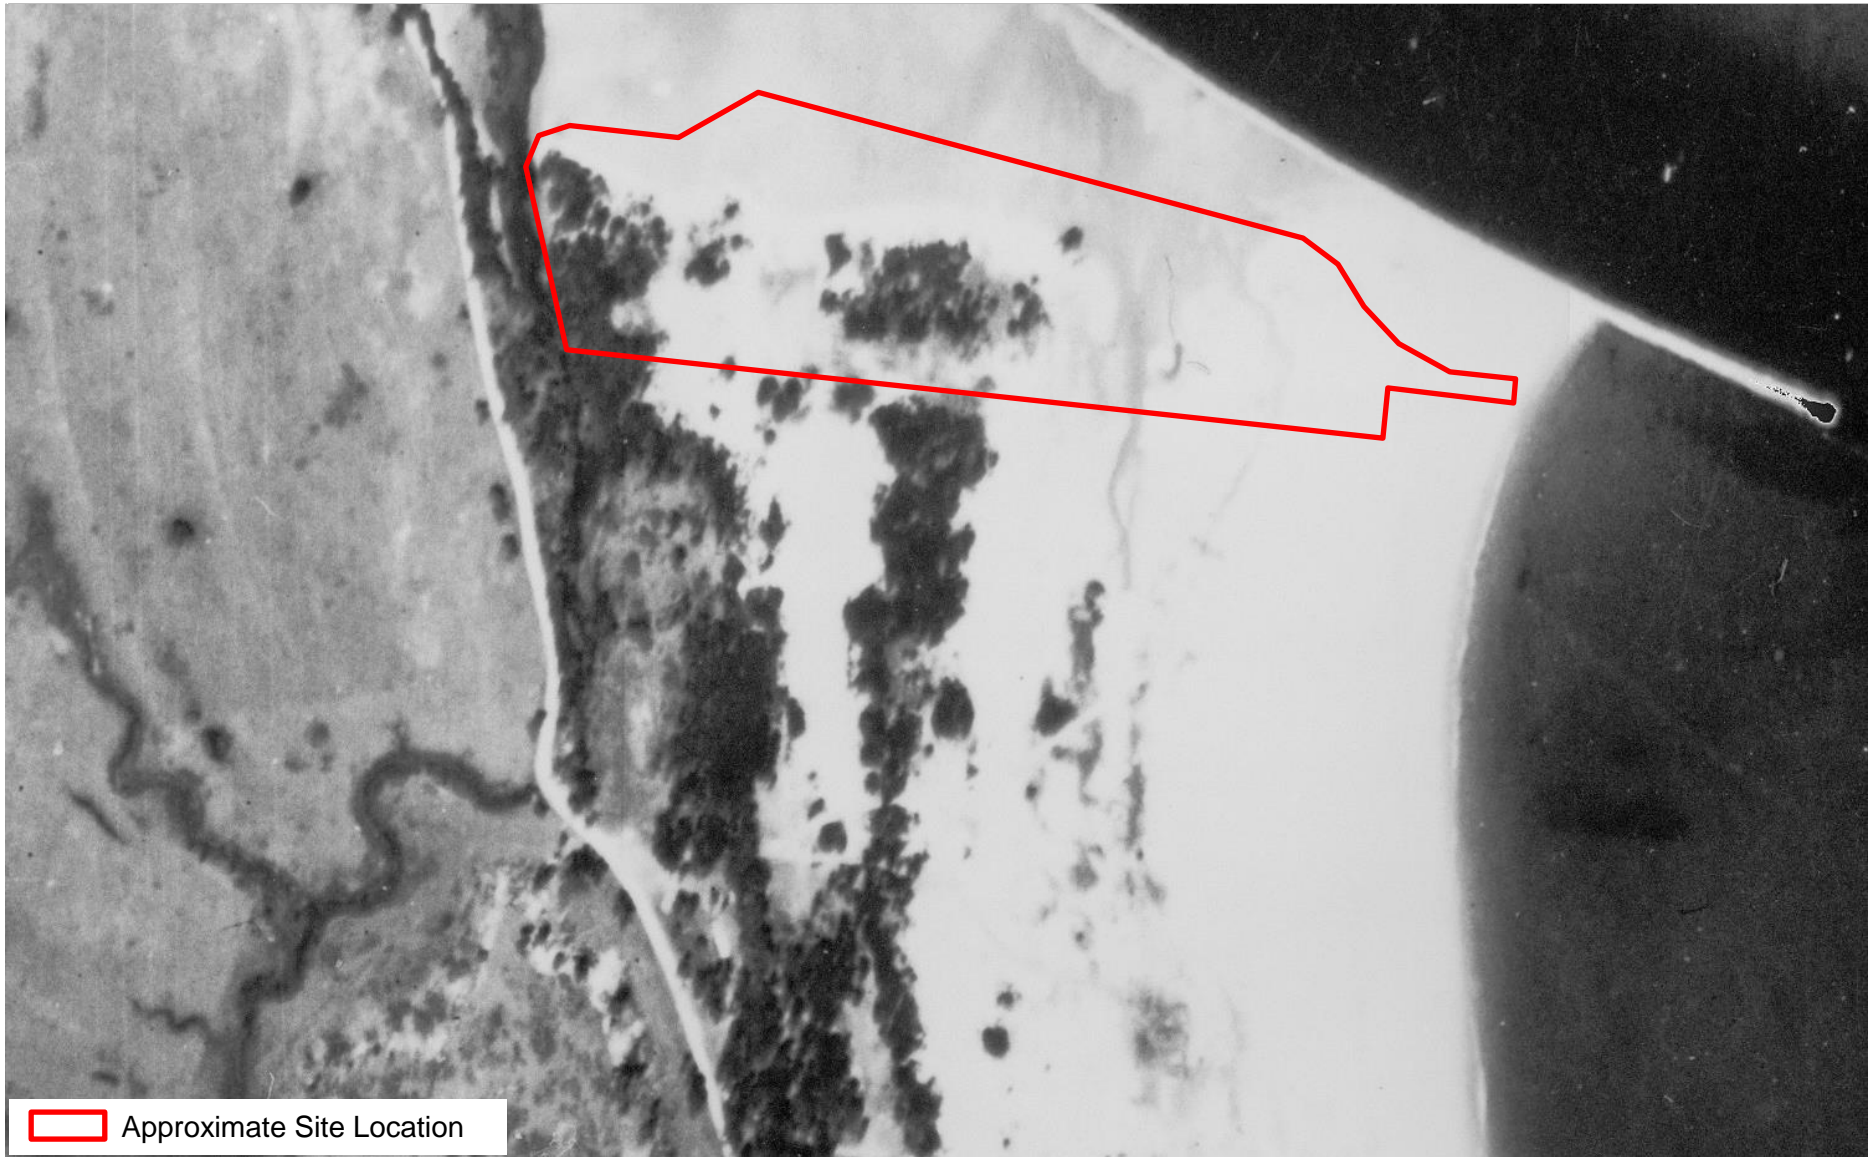
Douglas Partners <i>Geotechnics Environment Groundwater</i>	Project No. 89333.00	Historical Aerial Photograph - 1949	Drawing No. 1
	Date: 6 Sep 2017	Contamination and Geotechnical Investigation Client: Aspen Group	Revision 0

Approximate Site Location

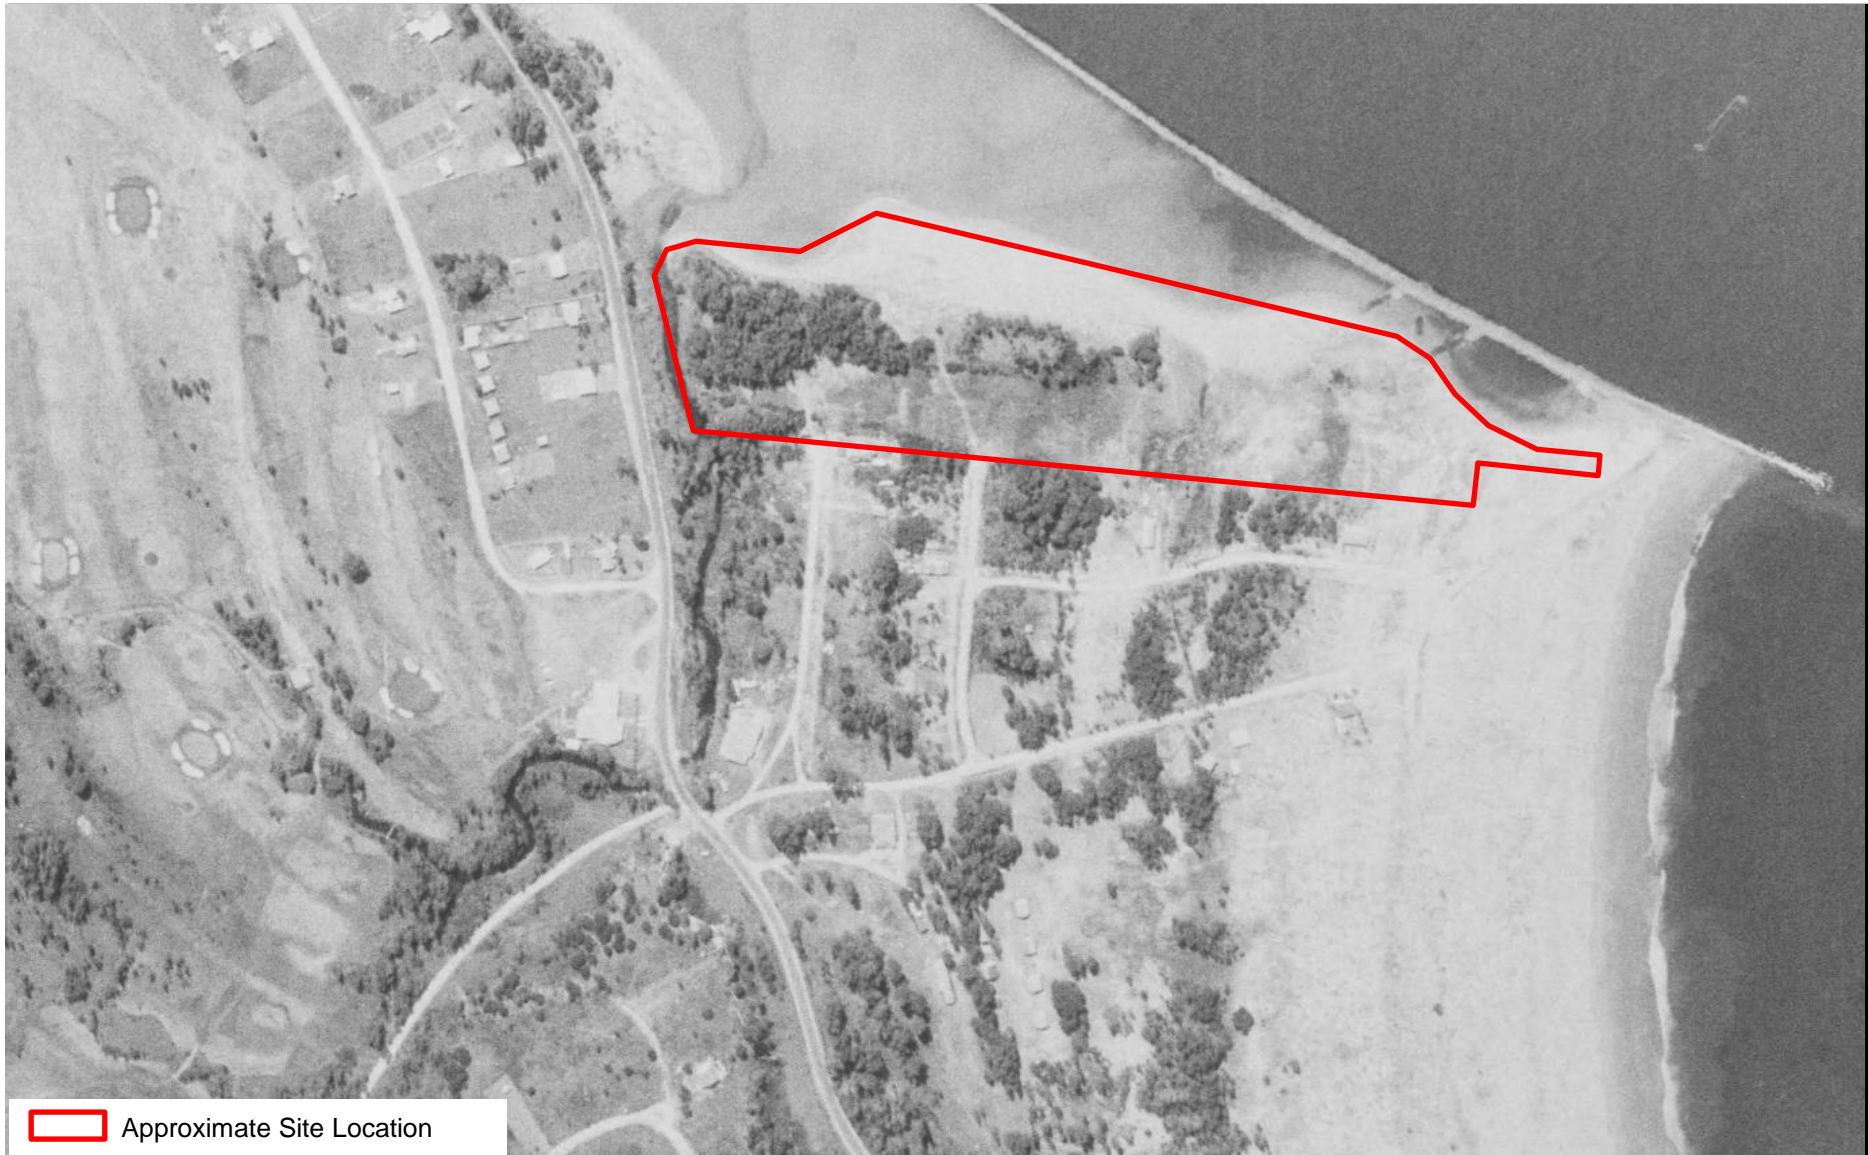
Douglas Partners Geotechnics Environment Groundwater	Project No. 89333.00	Historical Aerial Photograph - 1964	Drawing No. 2
	Date: 6 Sep 2017	Contamination and Geotechnical Investigation Client: Aspen Group	Revision 0

Approximate Site Location

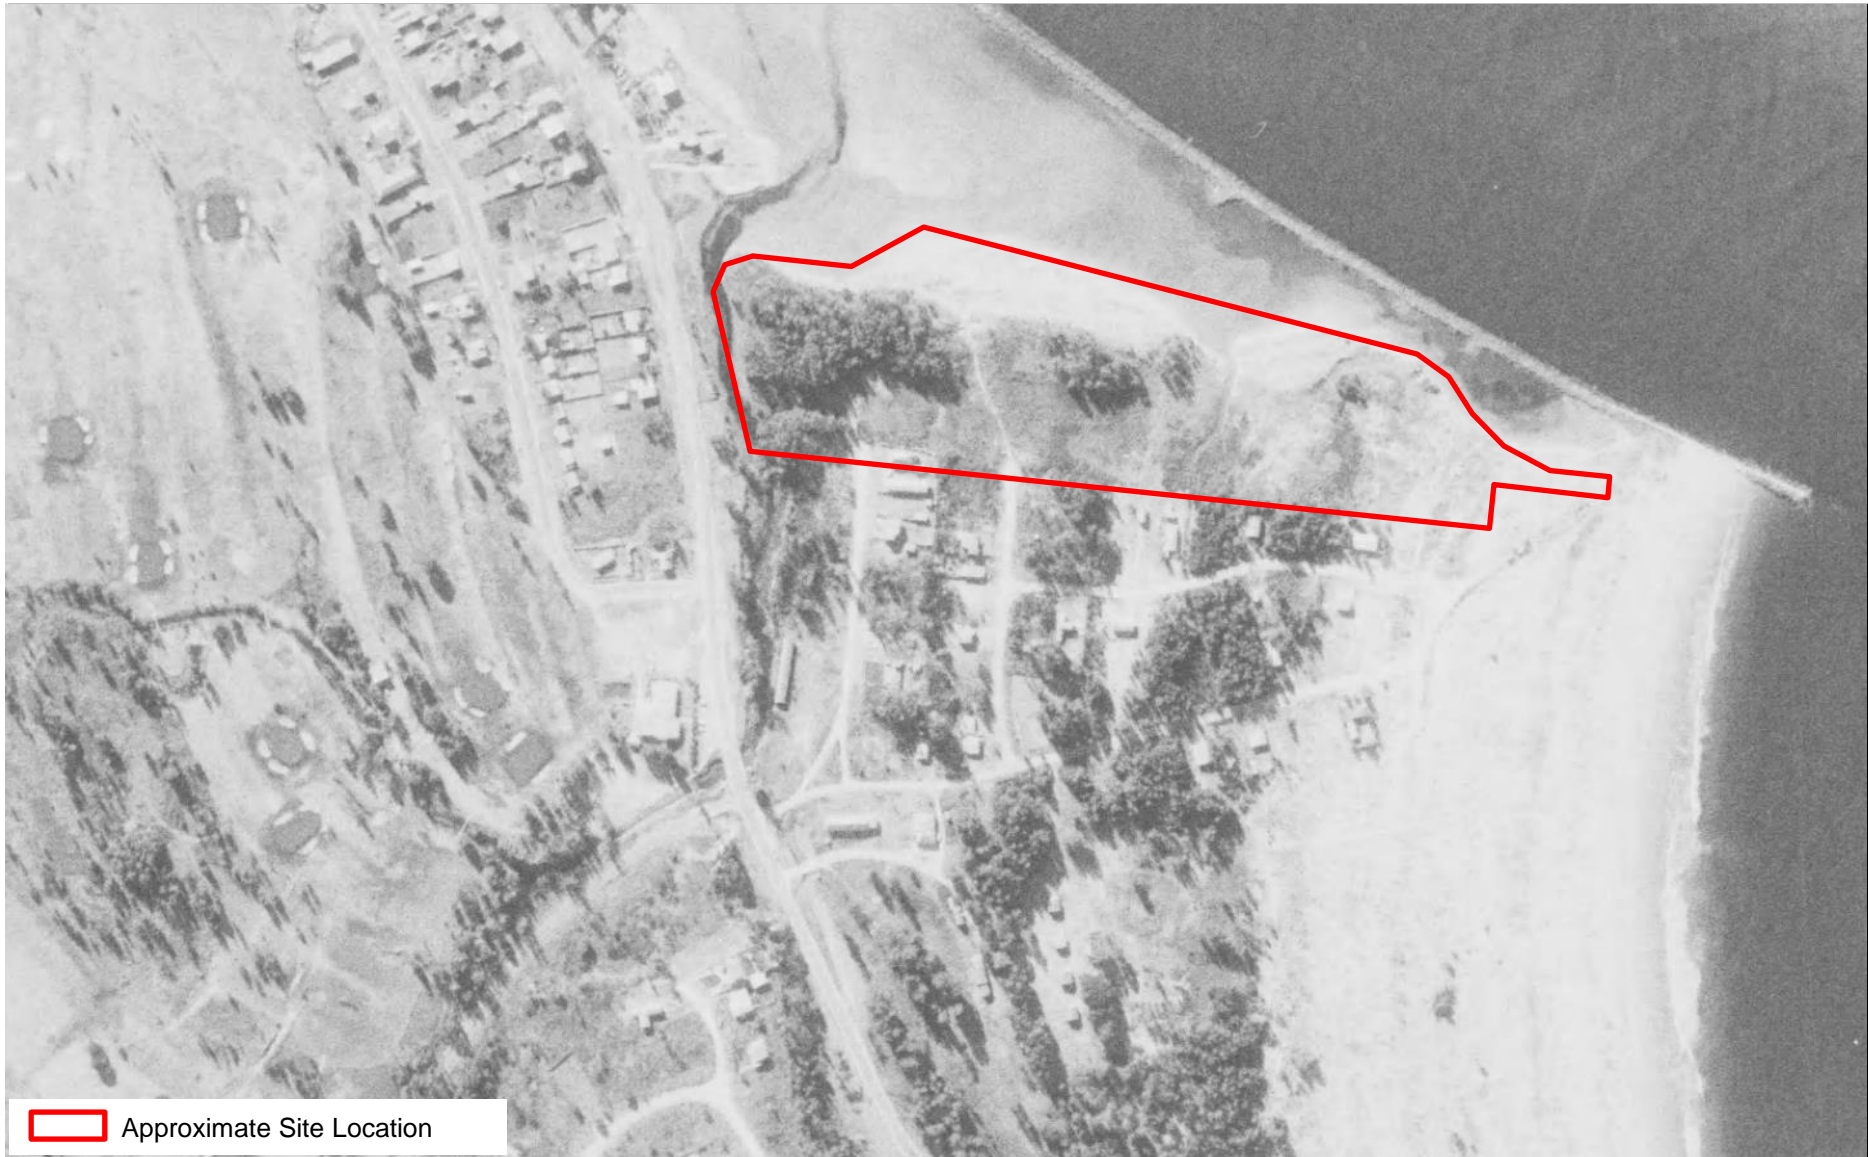
Douglas Partners <i>Geotechnics Environment Groundwater</i>	Project No. 89333.00	Historical Aerial Photograph - 1969	Drawing No. 3
	Date: 6 Sep 2017	Contamination and Geotechnical Investigation Client: Aspen Group	Revision 0

Approximate Site Location

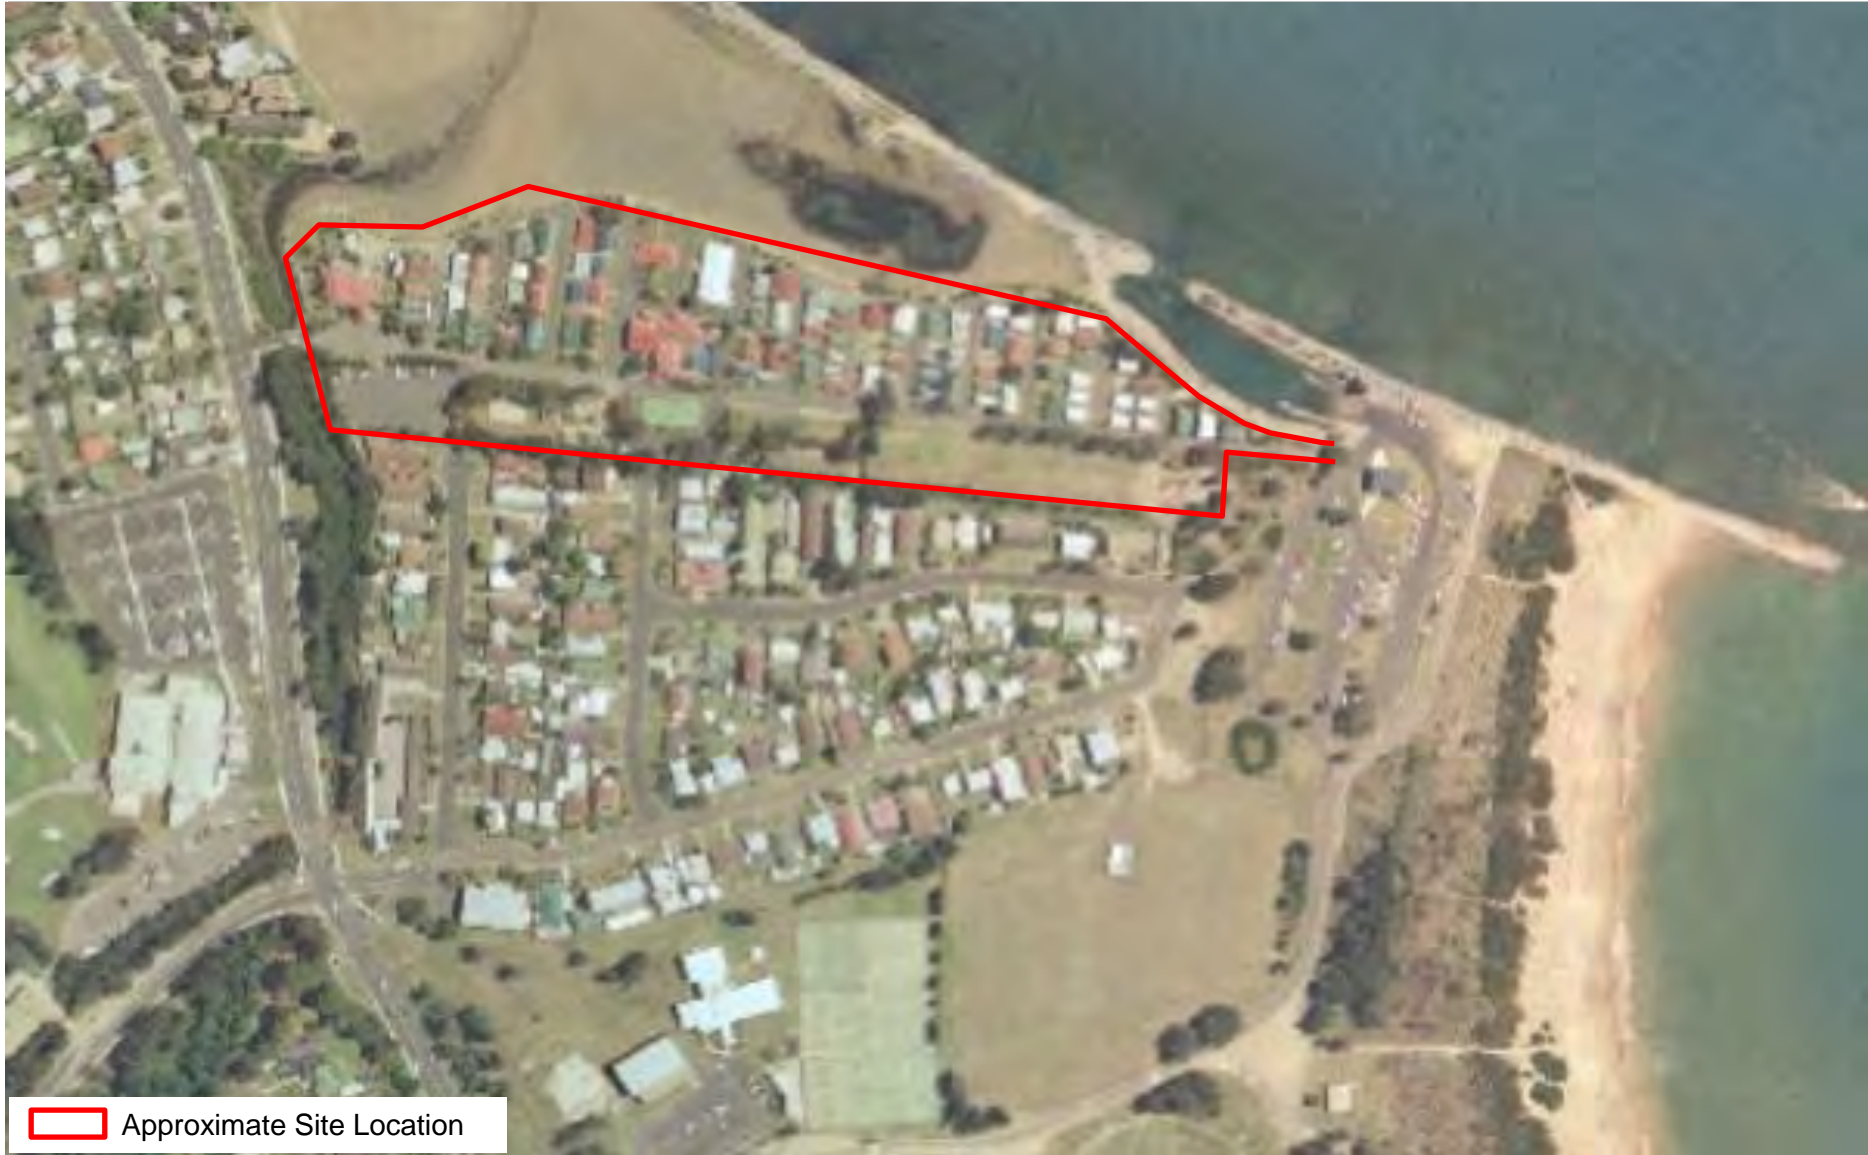
Douglas Partners <i>Geotechnics Environment Groundwater</i>	Project No. 89333.00	Historical Aerial Photograph - 2006	Drawing No. 6
	Date: 6 Sep 2017	Contamination and Geotechnical Investigation Client: Aspen Group	Revision 0

Approximate Site Location

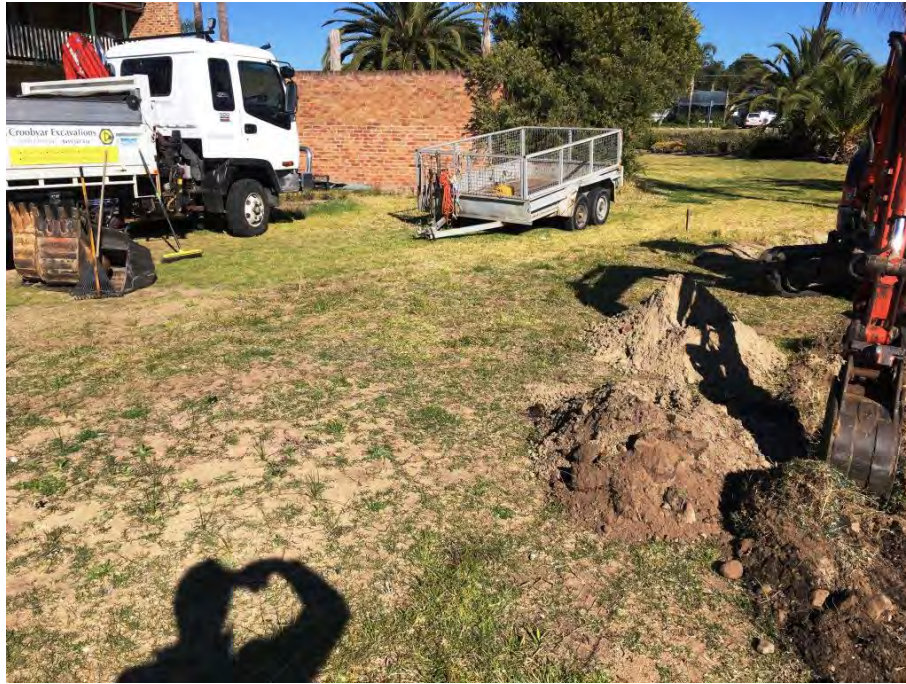
Photo 1 – View of northern portion of the site and minor brick structure.

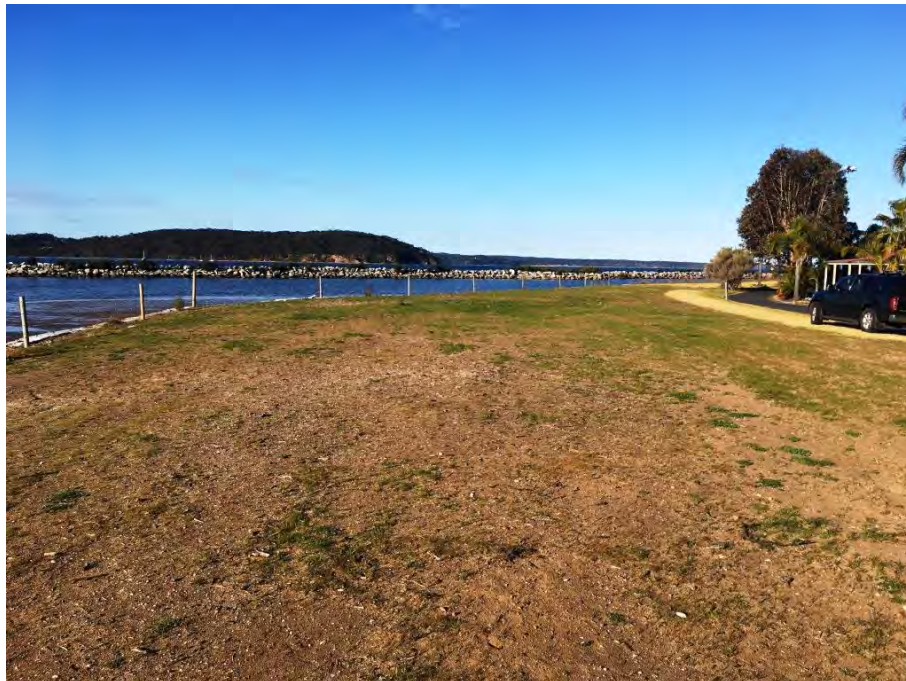
At the time of the investigation, Area A was lightly grassed. The retaining wall along the northern boundary of Area A was leaning downslope, towards the tidal flats below. Concrete blocks had been placed against the wall in a few places to buttress it. In other places a gap was observed between the concrete block wall and the dredged filling behind the wall. Likewise, Area B was lightly grassed with rows of trees along much of the boundary and around site improvements. Site improvements in Area B comprised asphalt car parking and access ways in the western and central areas, a playground, volley ball and tennis courts, and maintenance sheds in the central-western area. The eastern part of Area B comprised a grassed field.

Photo 2 – View of northern portion of site and retaining wall.

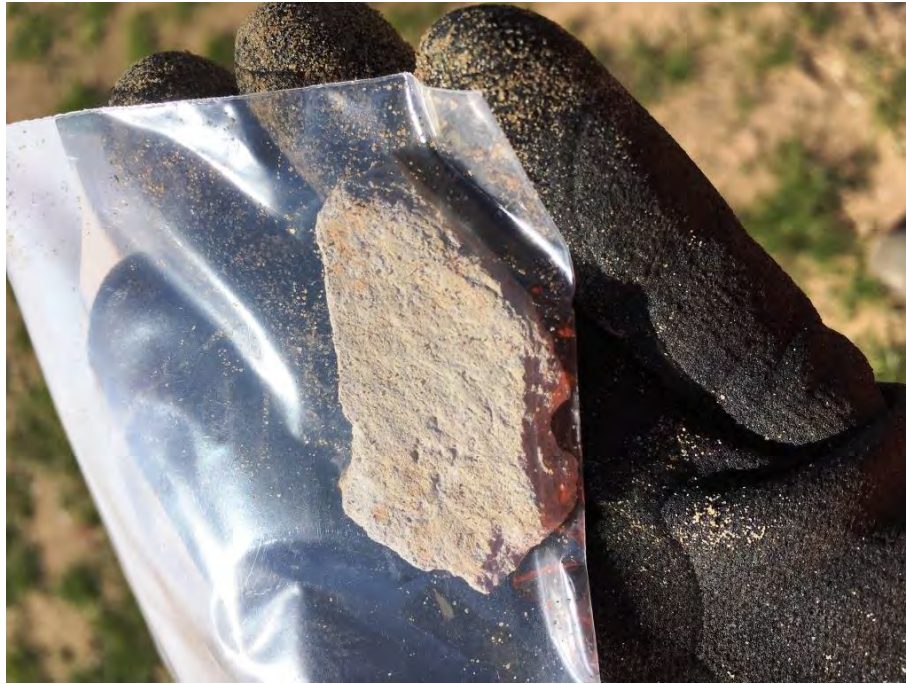
Anthropogenic materials (brick, concrete, plastic) were encountered in Pit 1, Pit 3 and Pit 5. A fragment of fibrous cement was observed on the surface of the site near Pit 1 and was collected for laboratory analysis for the presence or absence of asbestos.

Photo 3 – View of fibrous cement fragment found near Pit 1.

It is recommended that a detailed site investigation for asbestos (in accordance with NEPC, 2013) be undertaken in areas of elevated risk to assess the potential for asbestos contamination to exist at the site. The detailed site investigation would target areas of the site where anthropogenic materials were observed in the subsurface filling, and will include a sampling grid for asbestos across the remainder of the site in line with the recommendations of NEPC (2013).

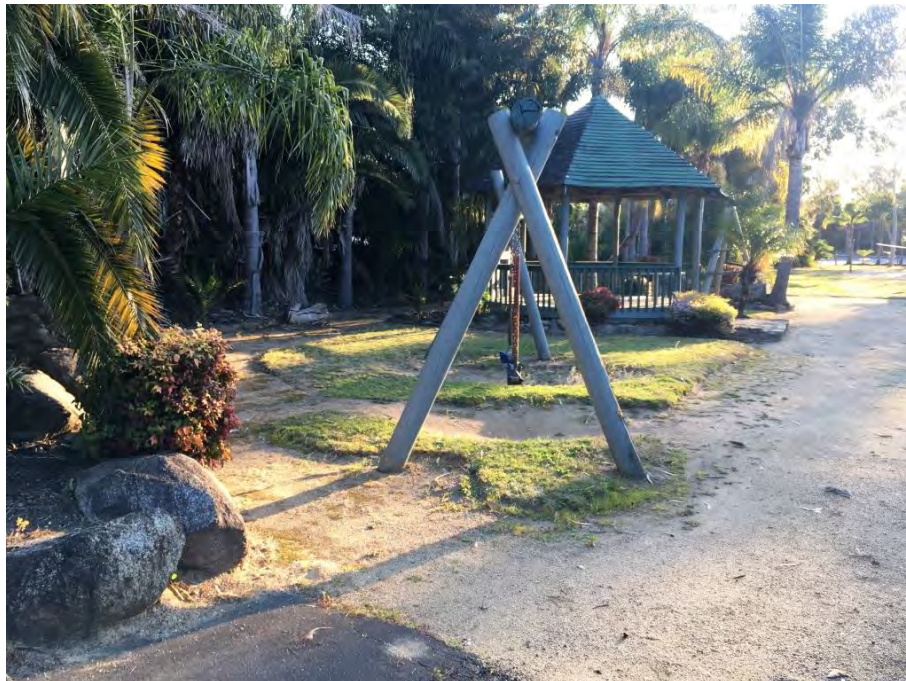
Photo 4 – View of shelter and playground equipment in southern portion of site.

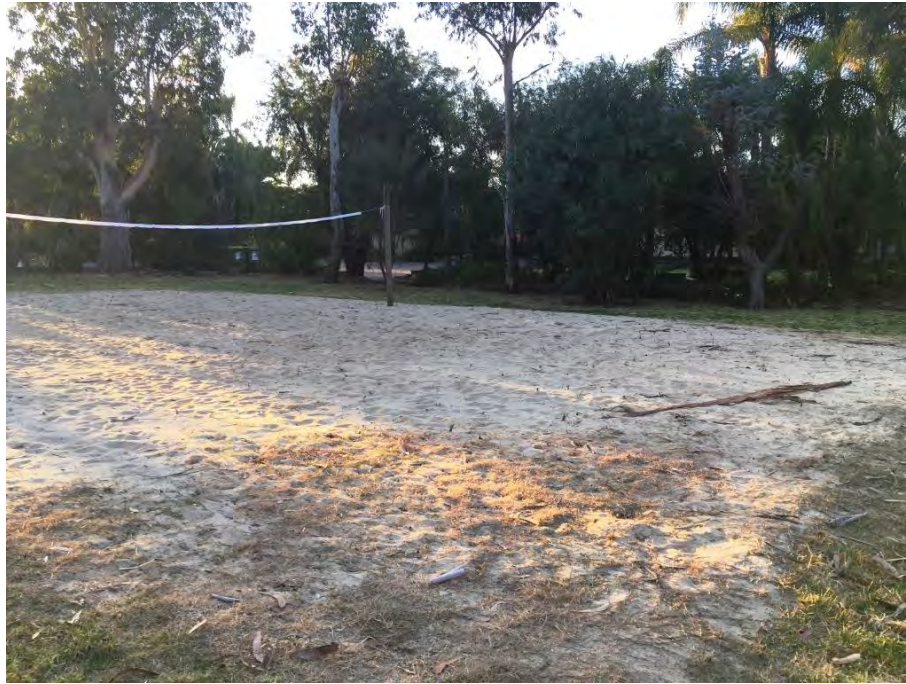
Photo 5 – View of volley ball court in southern portion of the site.

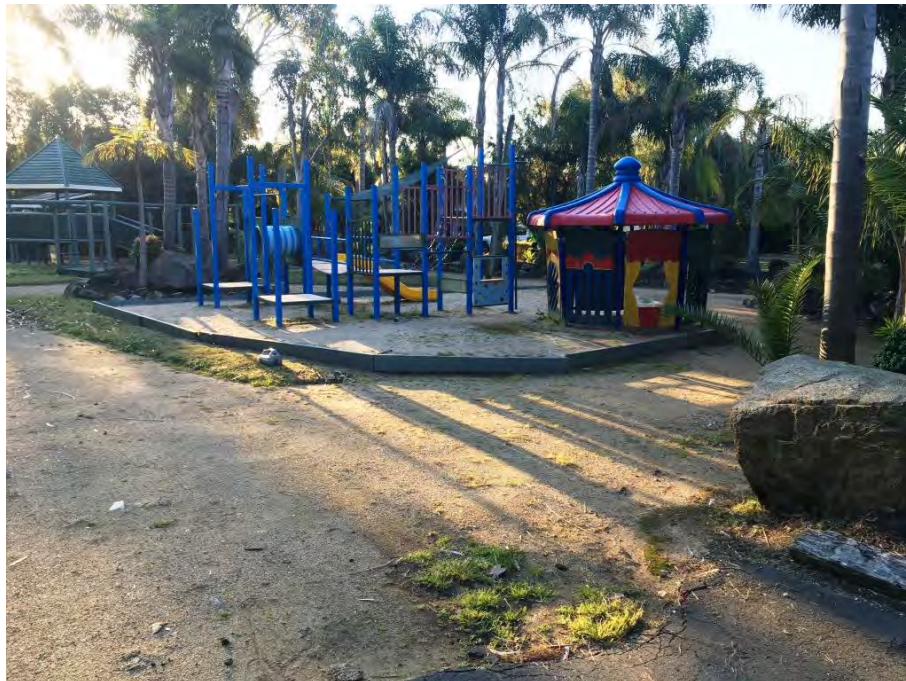
Photo 6 – View of playground in southern portion of the site.

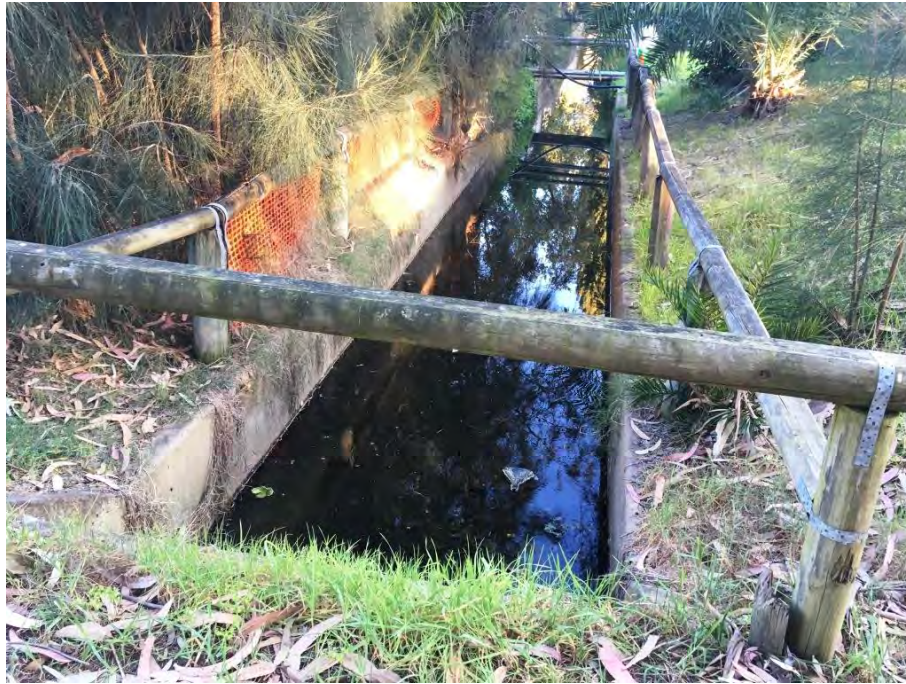
Photo 7 – View of concrete drain in central portion of the site.

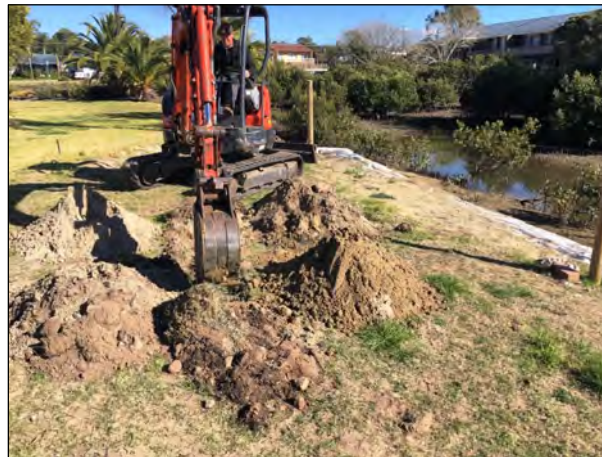
1.2	SAND - dark grey, slightly silty, fine-grained sand with some organic material, damp to wet (ESTUARINE)		D E	1.5		PID : 0.0 ppm					
		- becoming wet below 1.8m		D E	2.0		PID : 0.0 ppm

2.0	SAND - grey, brown and beige, fine to medium-grained sand with abundant shells, damp (ESTUARINE)		D E	2.0		PID : 0.0 ppm					
	2.1	Pit discontinued at 2.1m (Collapse of pit precluded further excavation)

View looking at spoil from Pit 1 excavation.

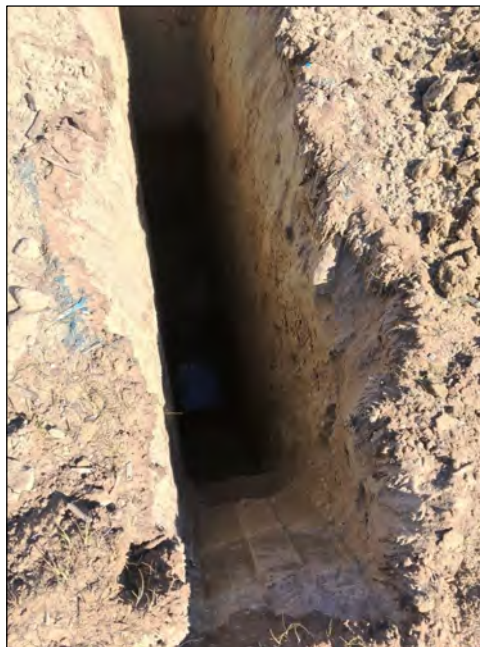
RL	Depth (m)	Description of Strata	Graphic Log	Sampling & In Situ Testing				Water	Dynamic Penetrometer Test (blows per 150mm)			
				Type	Depth	Sample	Results & Comments		5	10	15	20
	0.1	FILLING - grey, slightly silty, fine-grained sand with some shells, traces of rootlets, humid (TOPSOIL)		D E	0.1		PID : 0.2 ppm					
		FILLING - grey, fine to medium-grained sand with some shells, humid		D E	0.5		PID : 0.4 ppm					
	1			D E	1.0		PID : 0.0 ppm	1				
	1.8			D E	1.5		PID : 0.1 ppm					
	2	SILTY SAND - dark grey, silty, fine-grained sand with organic material and shells, moist (ESTUARINE)		D E	2.0		PID : 0.1 ppm	2				
	2.4	SAND - brown and beige, fine to medium-grained sand with some shells, wet (ESTUARINE)										
	2.5	Pit discontinued at 2.5m (Limit of Investigation)

View looking at Pit 2 excavation.

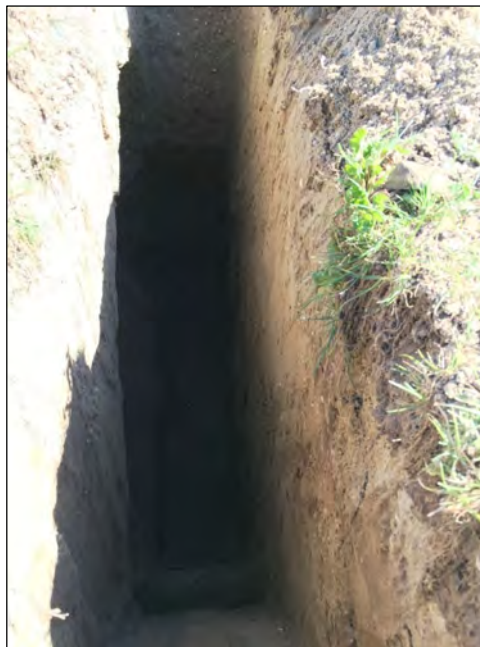
D E	2.0		PID : 0.2 ppm	2	
	2.3	- becoming brown and beige below 2.2 m Pit discontinued at 2.3m (Collapse of pit precluded further excavation)

View looking at Pit 3 excavation. Note collapse of the left wall.

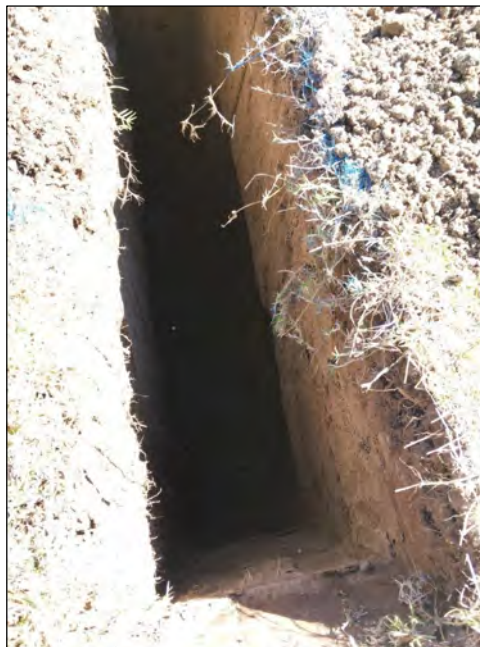
RL	Depth (m)	Description of Strata	Graphic Log	Sampling & In Situ Testing				Water	Dynamic Penetrometer Test (blows per 150mm)
				Type	Depth	Sample	Results & Comments		
	0.3	FILLING - grey and brown, slightly silty, fine to medium-grained sand with some rootlets, humid (TOPSOIL)		D E	0.1		PID : 0.1 ppm		
		FILLING - grey and light brown, fine to medium-grained sand with some shells, damp		D E	0.5		PID : 0.2 ppm		
	1			D E	1.0		PID : 0.3 ppm		
				D E	1.5		PID : 0.0 ppm		
	1.9	- becoming moist below 1.7 m							
	2	SAND - dark grey, slightly silty, fine to medium-grained sand with some shells, wet (ESTUARINE)		D E	2.0		PID : 0.1 ppm		
	2.2	Pit discontinued at 2.2m (Collapse of pit precluded further excavation)

View looking at Pit 4 excavation. Note collapse (undercutting) of right wall.

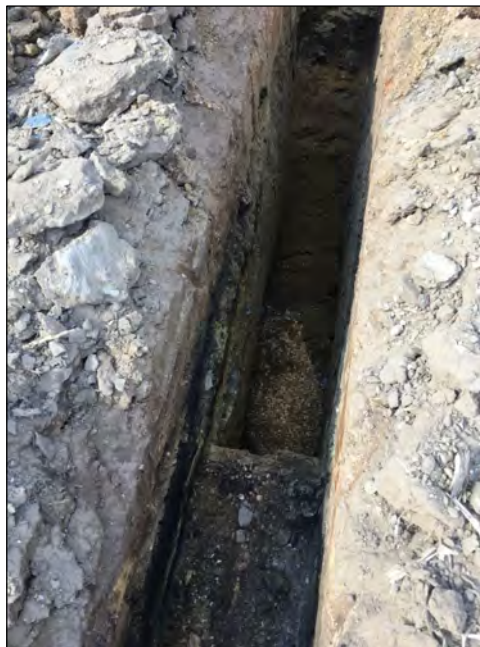
1.1	- concrete rubble at 0.7 m		D E	1.0		PID : 0.3 ppm					
		SAND - loose to medium dense, brown and beige, fine to medium-grained sand with shells (20% w/w), damp (LITTORAL)		D E	1.5		PID : 0.2 ppm

2.0	- becoming wet below 2.0 m		D E	2.0		PID : 0.2 ppm					
	2.4	Pit discontinued at 2.4m (Collapse of pit precluded further excavation)

View looking at Pit 5 excavation.

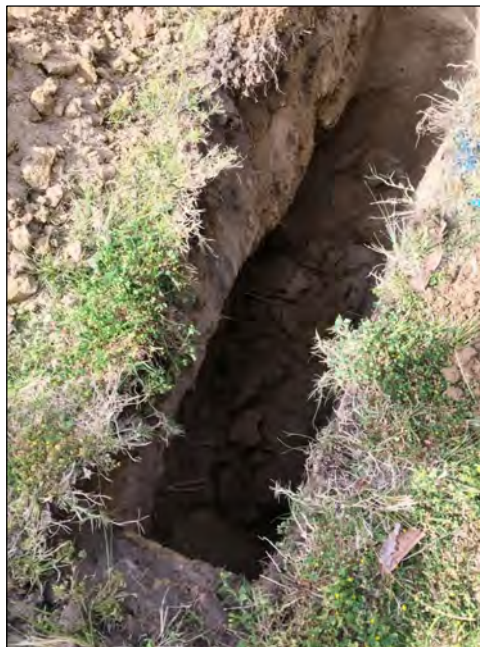
2			D E	2.0		PID : 0.1 ppm		
	2.1	Pit discontinued at 2.1m (Collapse of pit precluded further excavation)

View looking at Pit 6 excavation. Note left wall collapse.

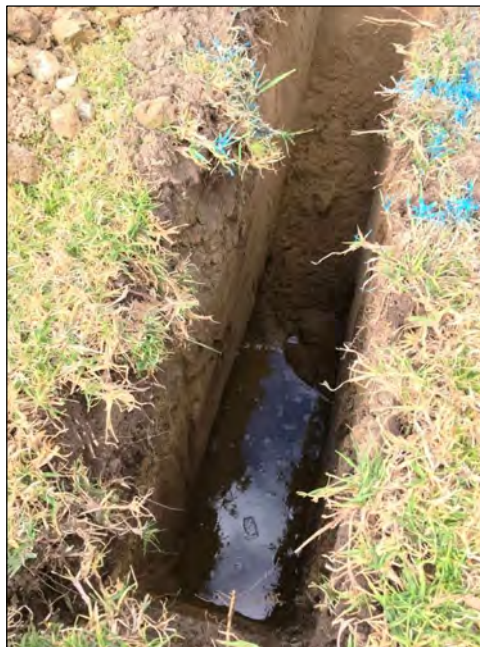
RL	Depth (m)	Description of Strata	Graphic Log	Sampling & In Situ Testing				Water	Dynamic Penetrometer Test (blows per 150mm)
				Type	Depth	Sample	Results & Comments		
	0.4	FILLING - brown, silty clay with some gravel and cobbles, damp		D E	0.1		PID : 0.1 ppm		
		SAND - medium dense to dense, light brown, fine to medium-grained sand with some shells, damp (LITTORAL)		D E	0.5		PID : 0.2 ppm		
	1	- becoming wet below 1.0 m		D E	1.0		PID : 0.2 ppm	▼ 1	
	1.6	Pit discontinued at 1.6m (Collapse of pit precluded further excavation)		D E	1.5		PID : 0.0 ppm

View looking at Pit 7 excavation.

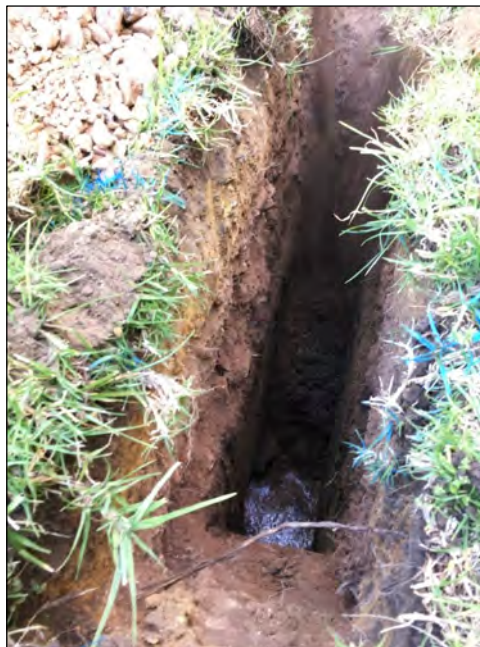
D E	2.0		PID : 0.0 ppm	2				
	2.2	Pit discontinued at 2.2m (Collapse of pit precluded further excavation)

View looking at Pit 8 excavation.

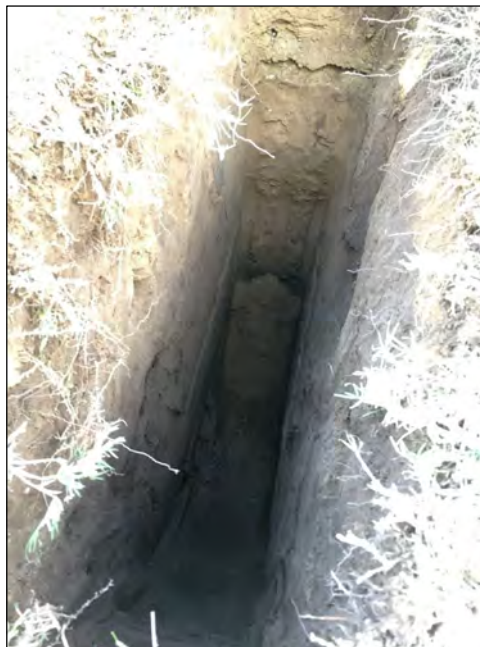
RL	Depth (m)	Description of Strata	Graphic Log	Sampling & In Situ Testing				Water	Dynamic Penetrometer Test (blows per 150mm)			
				Type	Depth	Sample	Results & Comments		5	10	15	20
	0.3	FILLING - brown and grey, silty, fine to medium-grained sand with abundant rootlets, damp (TOPSOIL)		D E	0.1		PID : 0.1 ppm					
		SAND - medium dense, brown, fine to medium-grained sand with some silt, damp (POSSIBLE FILLING)		D E	0.5		PID : 0.0 ppm					
	1			D E	1.0		PID : 0.0 ppm					
				D E	1.5		PID : 0.0 ppm					
	1.9	- becoming wet below 1.8m										
	2	SAND - brown, fine to medium sand with some shells, wet (LITTORAL)		D E	2.0		PID : 0.1 ppm					
	2.2	Pit discontinued at 2.2m (Collapse of pit precluded further excavation)

View looking at Pit 9 excavation.

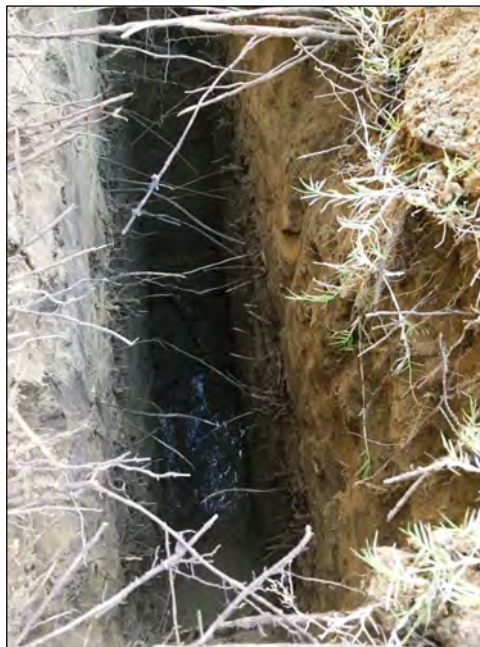
RL	Depth (m)	Description of Strata	Graphic Log	Sampling & In Situ Testing				Water	Dynamic Penetrometer Test (blows per 150mm)
				Type	Depth	Sample	Results & Comments		
	0.4	FILLING - brown, slightly silty, fine-grained sand with traces gravel and rootlets, damp (TOPSOIL)		D E	0.1		PID : 0.0 ppm		
		SAND - medium dense to dense, brown, fine to medium-grained sand with some shells, damp (LITTORAL)		D E	0.5		PID : 0.1 ppm		
	1	- becoming medium dense below 0.9m		D E	1.0		PID : 0.1 ppm		
				D E	1.5		PID : 0.1 ppm		
	2	- becoming dark brown and wet below 2.0 m		D E	2.0		PID : 0.0 ppm		
	2.2	Pit discontinued at 2.2m (Collapse of pit precluded further excavation)

View looking at Pit 10 excavation.
