# Detailed Site Investigation

7 Luxford Road, Mount Druitt NSW

E23648.E02\_Rev0 3 September 2019

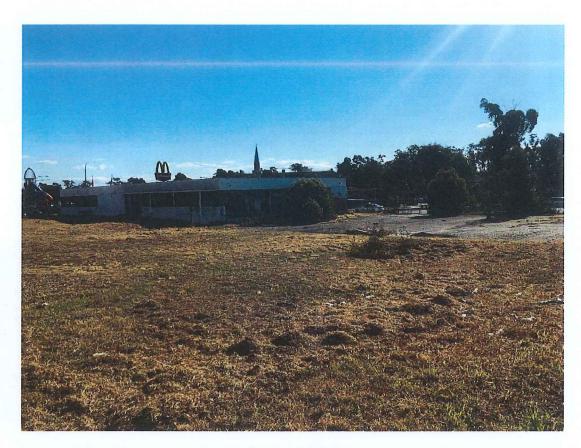
Photograph 1: Site overview, facing north-west (01/08/19).

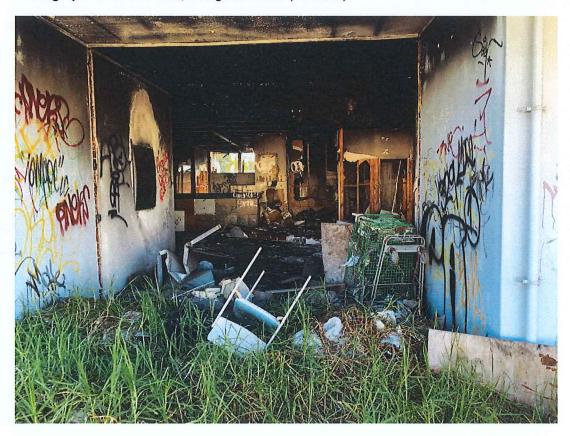
At the commencement of site works on 1 August 2019 it was noted that the existing building appeared to have been extensively damaged by fire and vandalised. Vegetation across the site appeared overgrown but generally in good condition.

Photograph 2: Vandalised building, with scattered rubbish (01/08/19).

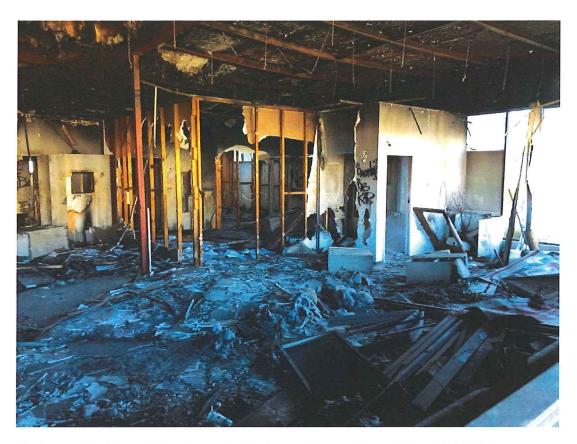
Although the PFAS decision tree has not identified a significant risk of PFAS contamination at the site, it was noted during a site walkover that the existing building on site had been fire damaged. As such, PFAS was added as a contaminant of concern to groundwater to screen for any potential impacts from fire-fighting activities that have been undertaken on the site.

Photograph 3: Signs of fire damage inside the building - ceiling and floor (01/08/19).

Based on visual evidence obtained during site works, there is a potential for hazardous materials to be present within the existing building on site. As such, the following tasks are also recommended for the site:

- The completion of a Hazardous Materials Survey of existing structures prior to any demolition works required by the development;
- Completion of a clearance inspection following the demolition of site structures and removal of demolition debris.

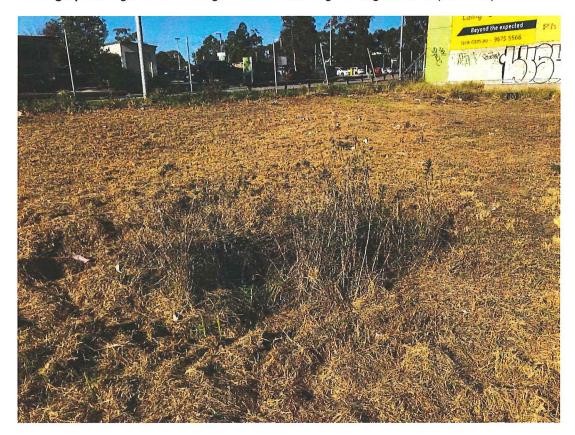
Photograph 4: Circular depression indication of potential salinity (01/08/19).
