## Vegetation Management Plan

Lot 5 DP 222736  
14-30 Violet St., Katoomba

February 2018  
(REF: A16026V)

## **Vegetation Management Plan** (Katoomba Christian Convention)

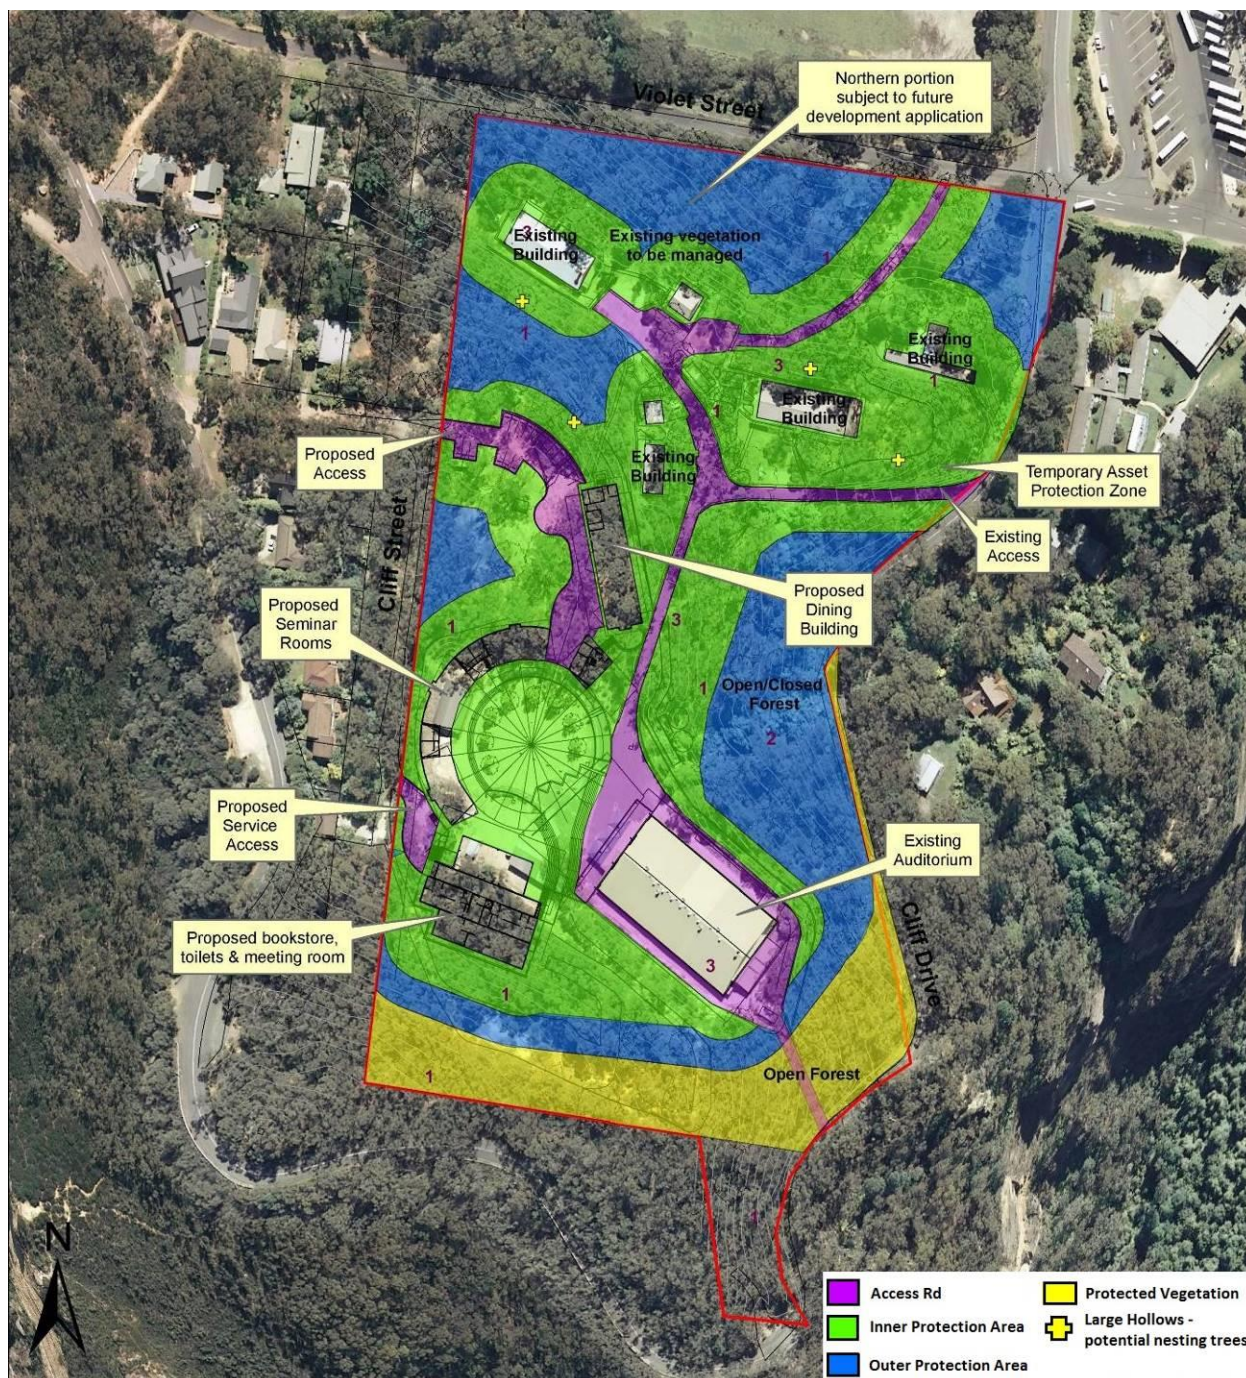
Figure 2 – Vegetation works as approved under the previous development application

Proposed works under the previous DA included extensions to administration buildings and additional dining and seminar rooms. Vegetation works as approved under the previous development application are shown in Figure 2.

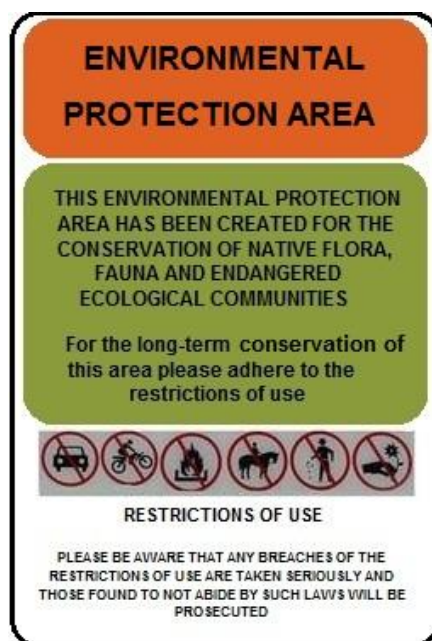
Figure 6 – Environmental protection area Signage

Three (3) signs will be erected to raise community awareness in regards to the role of the protected area. Locations of signs are shown in Schedule 1 Vegetation Management Works. An example of signage is given in Figure 6.
