**ANN WALSH BUILDING**

**WEST STREET, LEWISHAM, NSW**

**REVISED HERITAGE IMPACT STATEMENT**

Date: Revised 15<sup>th</sup> June 2020

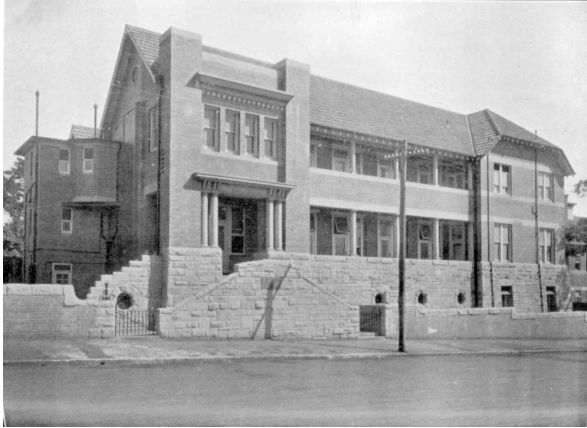
Figure 2.1 The West Street frontage of the outpatients' department as completed in 1917

*The new building has a frontage to West Street and is being erected on land adjoining the private hospital. The new outdoor patients' department will have a pleasant outlook, for it will overlook Petersham Park. The portion now being erected will comprise a two-storey brick building, built upon stone foundations and rooked with tiles. It will contain a large entrance hall leading to extensive waiting rooms, dispensary, reception, examination and operating rooms, all fitted in the most up-to-date manner necessary for the speedy and successful treatment of all classes of outpatients. The lower floor of the northern wing will be arranged for pathological work, and will contain up-to-date X-ray rooms, drug stores, etc. Indeed, when this building is completed, the hospital will be in possession of a very fine outdoor patients' department, fitted and furnished throughout with all the latest in medical and surgical requirements to carry on such work successfully. The system of ventilation to be employed and the general lay-out of the building will provide for a maximum of sunlight and air, while electricity will be installed for artificial light and for cooking purposes.*

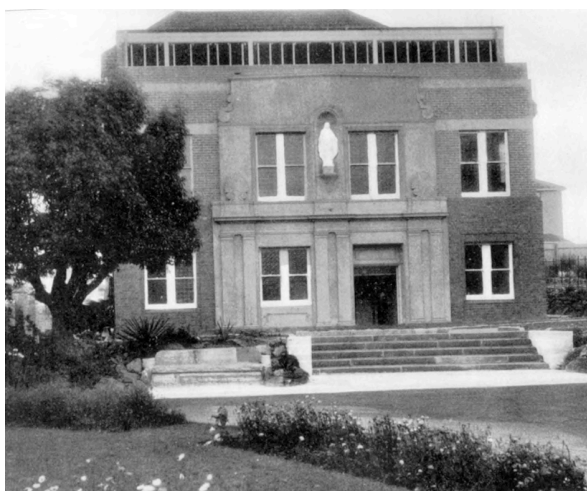
Figure 2.3 The northern frontage of the outpatients' department as altered

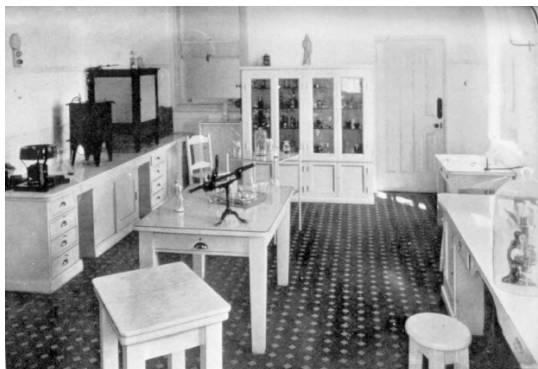
Figure 2.6 The fittings and decoration of one of the specialist rooms as built

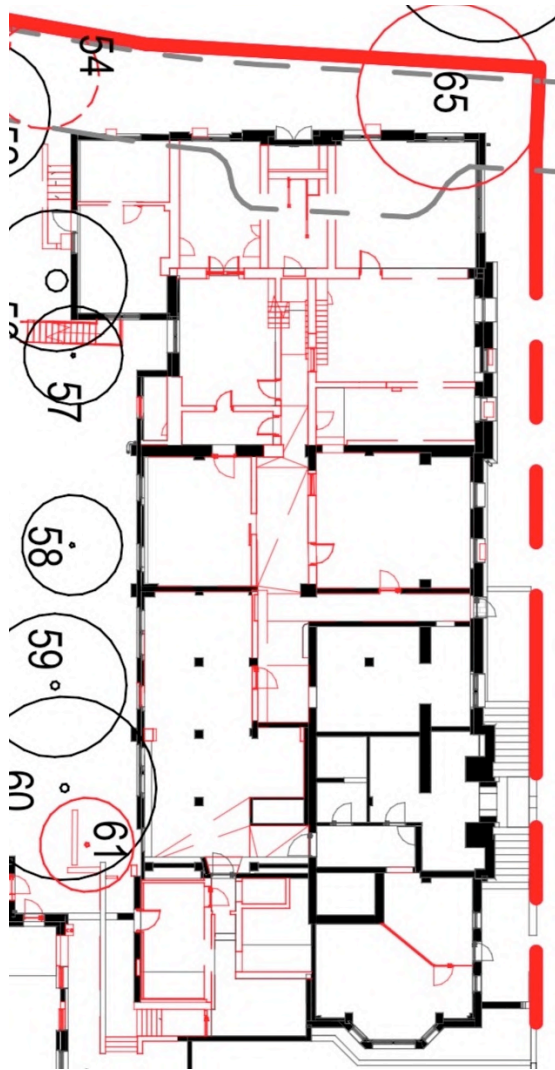
Figure 8.5.2 Lower Ground Floor Demolition Plan

AREA	ITEM	COMMENT/IMPACT
G01-G06	Demolition of north section	Deleted. The north wing will be retained
G03-G03	Demolition	The annexe will be retained
G06-G11	Demolition of internal walls	The area is of moderate significance and has no features of note
G12	Removal of ramp and excavation	The area is of little significance and the excavation will allow for adaptive reuse by increasing head heights
G13	Demolition of hall wall	The area is of little significance and has no features of note
G14/G15	Demolition of walls and excavation	The area is of little significance and the excavation will allow for adaptive reuse by increasing head heights
G21-G23	Demolition of walls	The area is part of the later alteration and is a service area with no features of note and poorly planned
G24	Removal of screen	The screen is a later alteration but is not of high quality

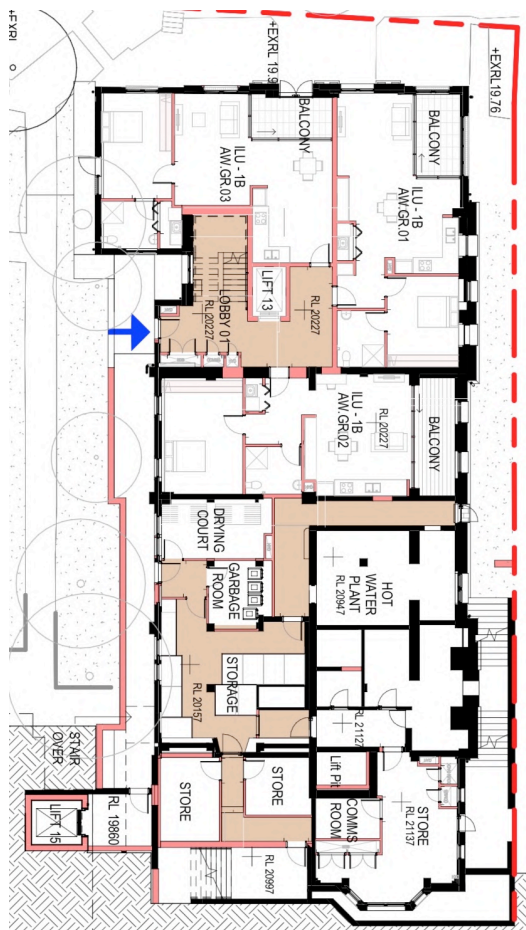
Figure 8.5.5 Lower Ground Floor Plan as Proposed

The lower ground floor will be converted to accommodation and service areas. A ramp will be provided to the west in the lightwell to link with a new lift in the former Novitiate.

AREA	ITEM	COMMENT/IMPACT
G05-G08	Reconfiguration	The 1930s addition will be retained and reconfigured internally
		The area was noted as being of Moderate to Little significance and only the stair removal will have some impact thought this is a later element with no features of note
G01	New balcony	The balcony is inset from the entry door that will be retained and set in the open position
G06	New balcony	The balcony is inset and the existing windows will be retained
Other	Reconfiguration	Neutral. The lower ground floor is an area of relatively low significance and the works will not impact on fabric and spaces of high significance
G21	New link to the Novitiate	Minor. The link is single storey and will allow disabled access between the buildings. It is discretely placed away from public view

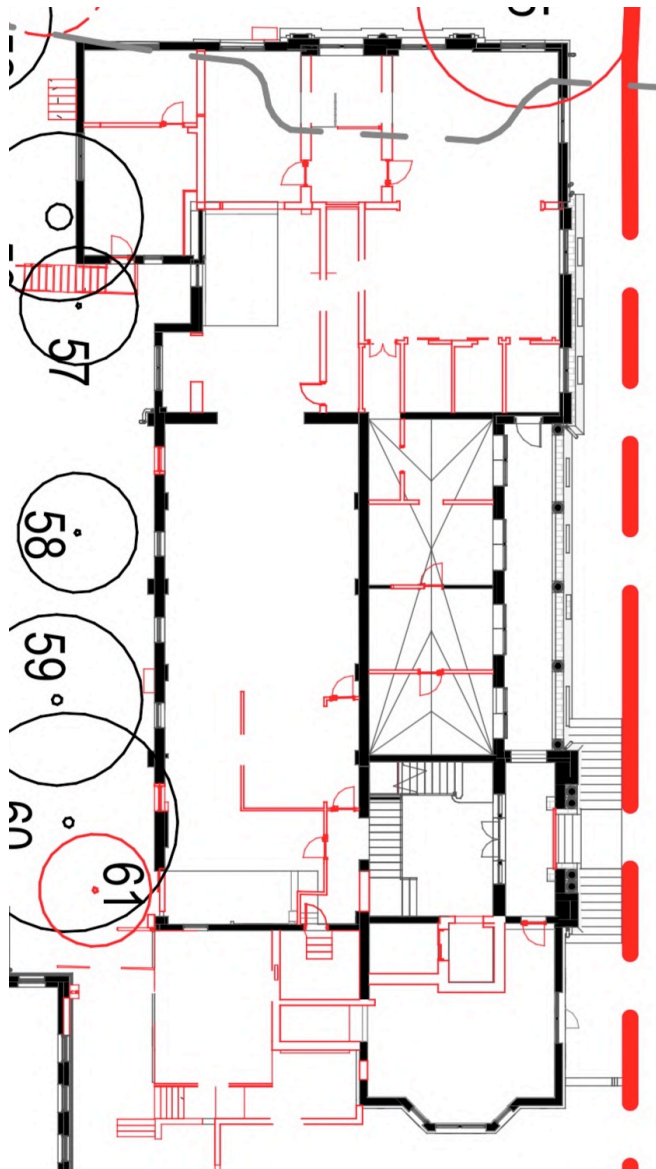
Figure 8.5.7 Ground Floor Demolition Plan

AREA	ITEM	COMMENT/IMPACT
F1-F4	Demolition of north section	The north wing will be retained
F18-F19	Demolition	The annexe will be retained
F3-F5	Reconstruction of the external facade	The work will return the building its original detail
	Demolition of walls	See below
F6	Demolition of walls and ceiling	Positive. The walls and ceiling are modern, intrusive elements
F8-F11	Demolition of walls	The works will allow for adaptive reuse
F13-F14	Demolition of walls	The walls are later alterations of little significance
F17	Removal of roller door	Positive. The removal will reopen the former main entrance porch
F15	Demolition of walls	The walls are to a service area that is poorly planned and accessed

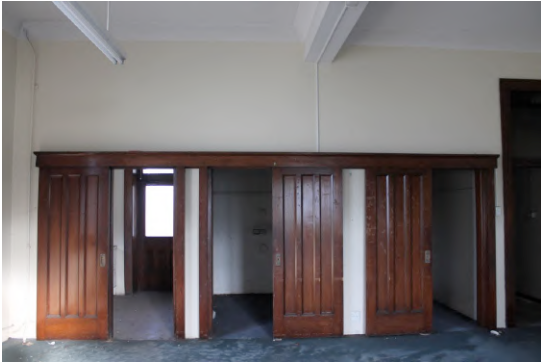
Figure 8.5.8                  Sliding doors to the first floor treatment rooms (Room F4)

The rooms are part of the original layout though the main consulting room has been extended into the northern addition. The rooms contain small, cellular treatment rooms that have bespoke, timber sliding doors in the manner that is common throughout the Ground Floor. The hall has been blocked though it retains original joinery.

The current layout does not lend itself to adaptive reuse and it is proposed that all of the internal walls will be removed. The works will include a new stair and lift. The north elevation will be rebuilt to its original detail.

F3-F4	Recommendation	<i>Joinery be salvaged for reuse in other areas or for fixing to walls in the common area</i>
-------	----------------	---

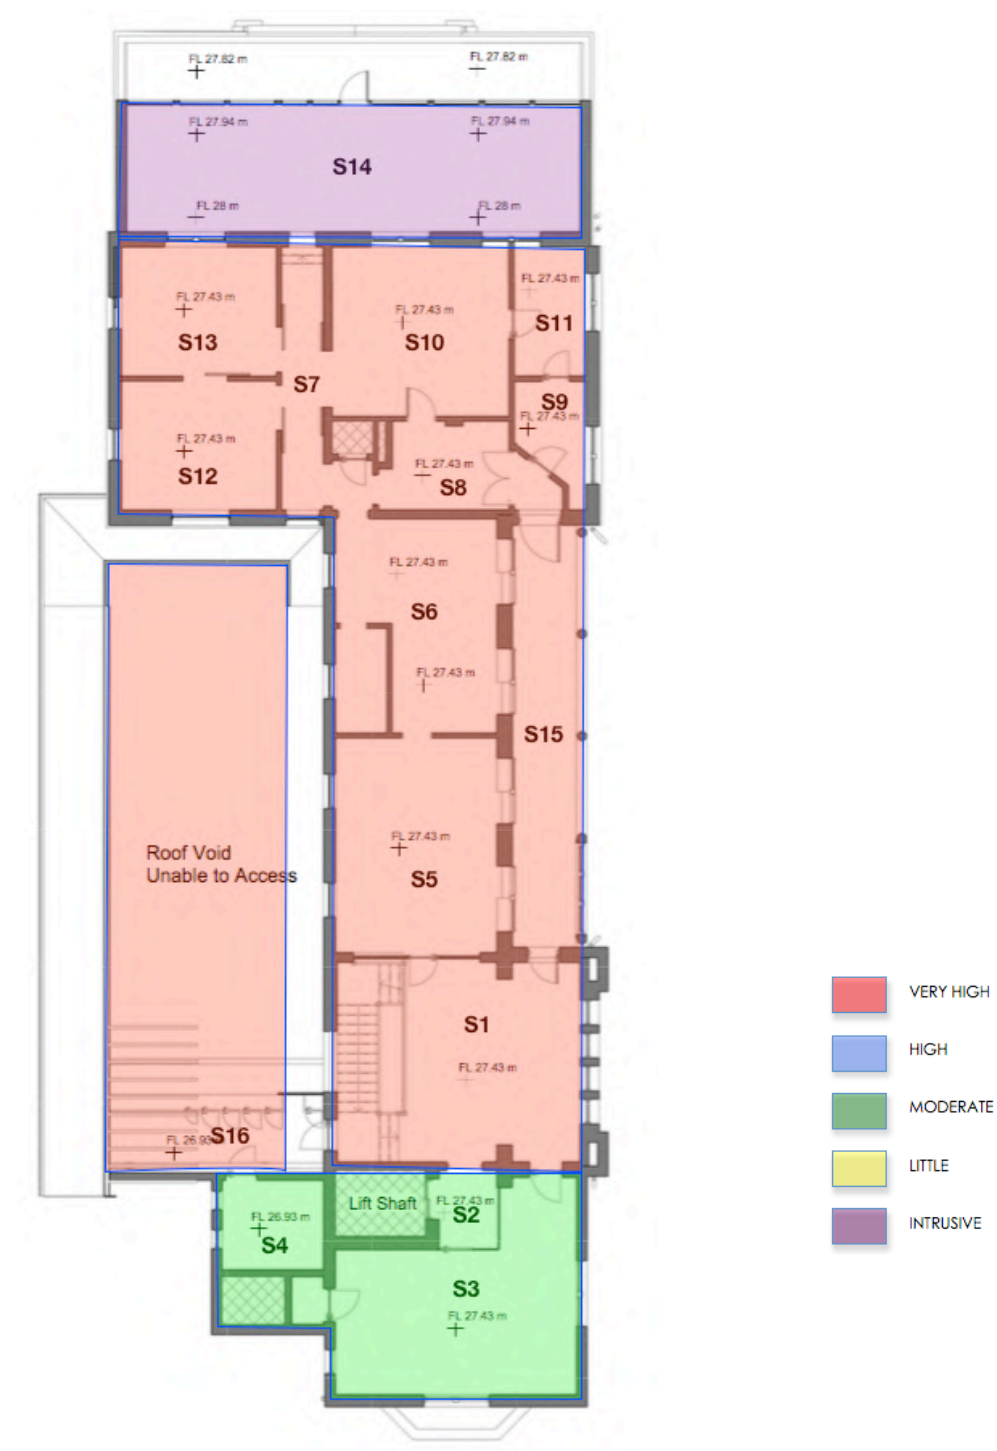
Figure 8.5.10 Gradings of Significance- Ann Walsh Internal Spaces - First Floor

The first floor contained larger consulting room largely to the same detail as the first floor.

ROOM	USE	ITEM	RANKING	TREATMENT
S1	STAIR LANDING	Polished timber floor	H	R
		Chamfered, polished timber skirting	M	R
		Polished, part glazed, timber doors	H	R
		Stained glass window	VH	R
S2	LIFT LOBBY	Polished timber floor	M	R
S3	OFFICE	Polished, part glazed, timber door	M	S
S4	LAVATORY	Two panel, painted timber doors	M	D
		Polished timber door and fanlight	H	S
S5	CONSULTING ROOM	Timber or tiled floor (under carpet)	H	D
		Polished, chamfered timber skirting	M	R or S
		Polished timber door frame and architrave	M	R or S
		Polished timber door and fanlight and side window	VH	R

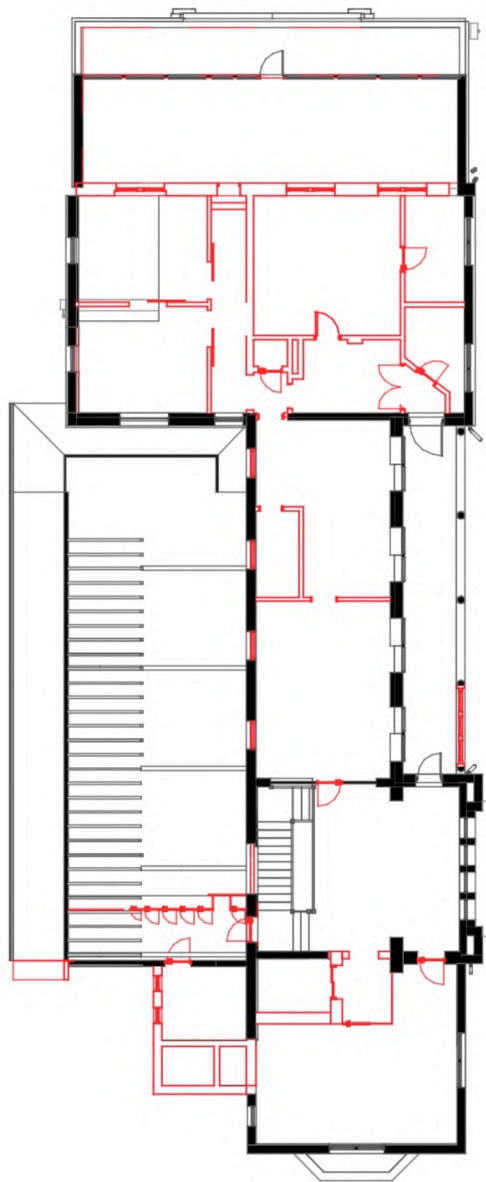
Figure 8.5.11 First Floor Demolition Plan

AREA	ITEM	COMMENT/IMPACT
S1	Demolition of infill walls	These are later intrusive elements
S3	Demolition of lift lobby	This is a later intrusive element
S4	Demolition	This is a later intrusive element
S5-S6	Demolition of walls	Thus area has less of the intricate detail of the first floor and the external door cases will be retained
S8-S13	Demolition of walls	The impact will be as per the works to the same area below (see comments above)
S14	Demolition of walls	The roof top addition is intrusive
	Demolition of external wall	The wall is original but has been altered and is now internal
S16	Demolition of walls	The area is a secondary store area above the later modern ceiling

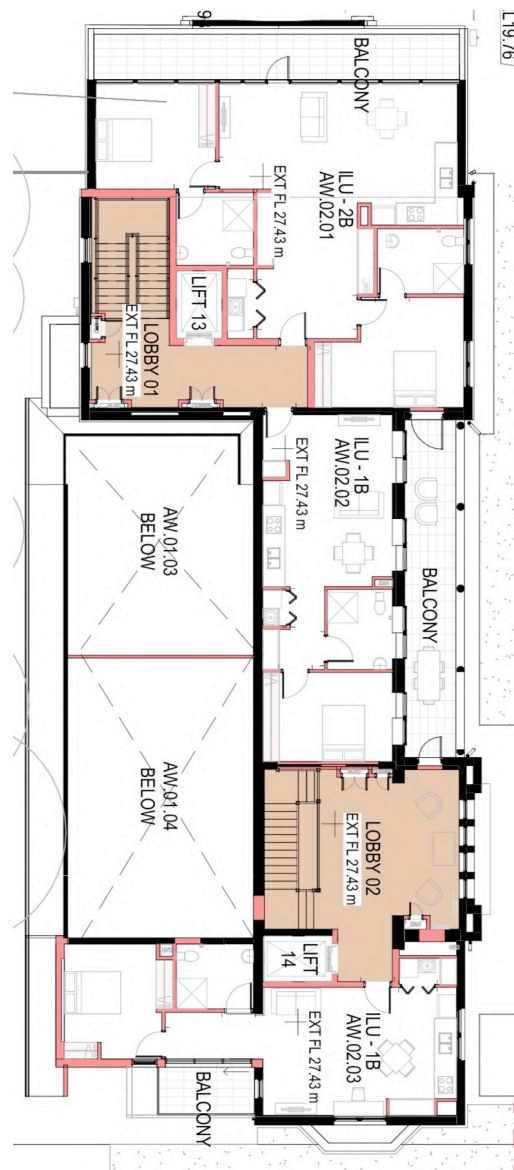
Figure 8.5.12 First Floor Plan as Proposed

The area will be reconfigured for aged care use with new lifts and stairs. The main entry stair and external verandah will be retained largely as is.

AREA	ITEM	COMMENT/IMPACT
S1	Infill of the stained glass window	The window is original and of very high significance
	<i>Recommendation</i>	<i>The window be retained and conserved even if blanked off behind to provide fore protection</i>
	Infill of the door to the roof space	Minor
	Infill of the door to S3 and new service cupboard	The door is later alteration and the service cupboard is sensibly located
	Infill of the opening to S5	The infill will replace the current infill to a more appropriate form

AREA	ITEM	COMMENT/IMPACT
S2	New lift and hall	Neutral. The works will replace the later lift and lobby
S3	Reconfiguration and new opening	Neutral. The works are in the later extension and there are no features of note
S5-S6	Reconfiguration	Neutral. The external door cases to the verandah will be conserved
	Infill of the windows	The reasoning for the change is unclear
	<i>Recommendation</i>	<i>The windows be retained as is</i>
S8-S13	Reconfiguration	The impact will be per the rooms below
	<i>Recommendation</i>	<i>Joinery be salvaged for reuse in other areas or for fixing to walls in the common area</i>
		<i>The vaulted ceilings to S12 and S13 be left in place with a new ceiling under</i>
S10-S13	Reconstruction of the north facade	The north wing will be retained and the addition over the north wing will be rebuilt with the external balcony retained

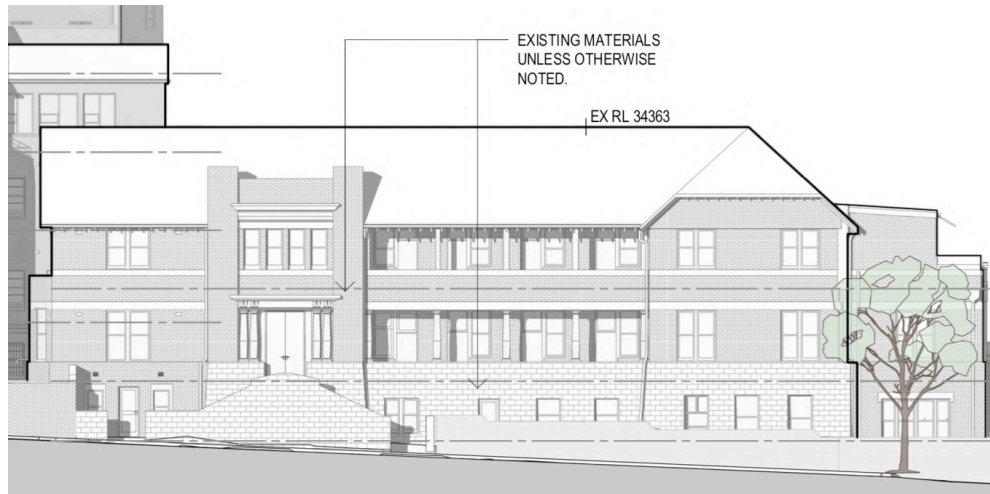
Figure 8.5.13 Ann Walsh - East Elevation as Proposed

The north wing will be retained maintaining the current composition.

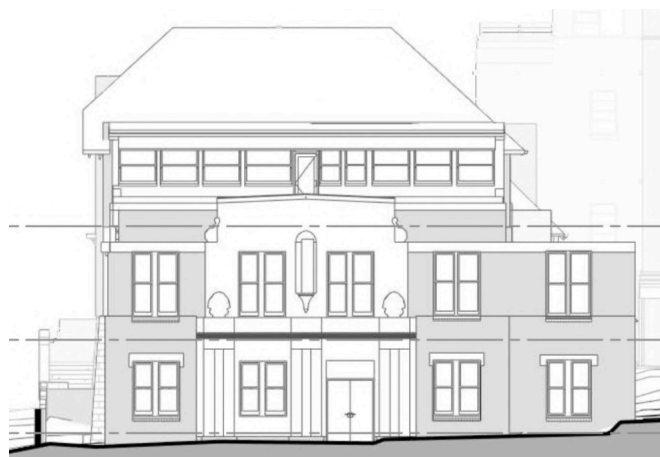
Figure 8.5.16 Ann Walsh - North Elevation as Proposed

The northern addition and annexe will be retained with the upper level addition rebuilt with new glazing.

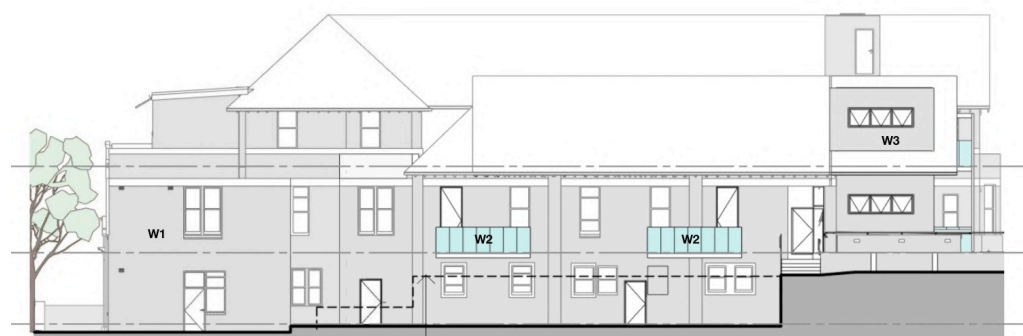
Figure 8.5.19 Ann Walsh - North Elevation as Proposed

AREA	ITEM	COMMENT/IMPACT
W1	Demolition of the northern wing	Positive. The north wing and annexe are to be retained
W2	New balconies	The works are one of the few interventions on the facades and take advantage of the views over the north garden
		The balconies are discrete elements at low level
	Recommendation	The balconies have open metal balustrades rather than glass

AREA	ITEM	COMMENT/IMPACT
W3	Replacement of the service wing and addition	The service wing is mish-mash of detail and partly derelict
		There is evidence that it was intended to extend the waiting room and the addition has a simple form set back from the main elevation to the waiting room
	<i>Recommendation</i>	<i>The area be the subject of design development</i>

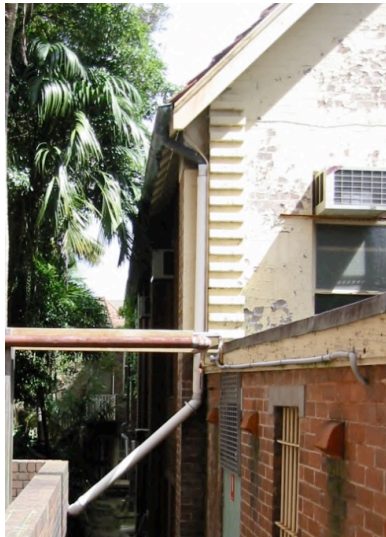
Figure 8.5.20 View to the southwest corner of the waiting room showing brick toothing suggesting that an extension was planned

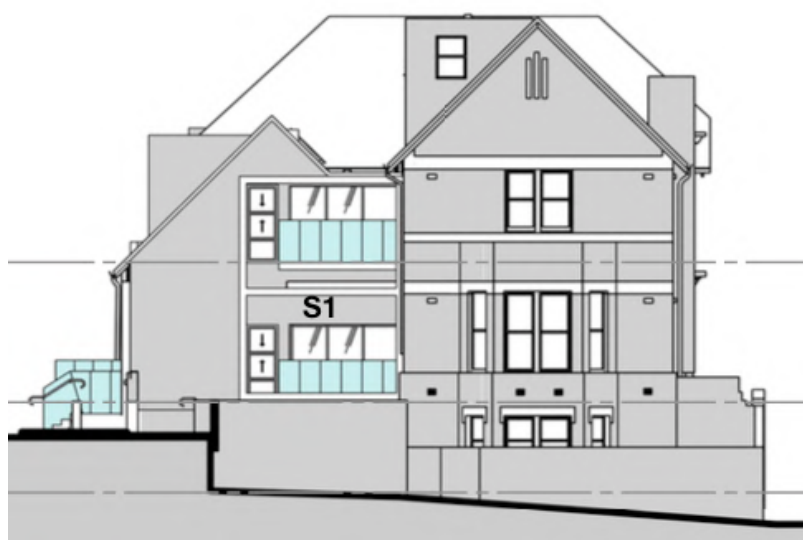
Figure 8.5.22 Ann Walsh - South Elevation as Proposed

AREA	ITEM	COMMENT/IMPACT
S1	Replacement of the service wing and addition	The service wing is mish-mash of detail and partly derelict
		There is evidence that it was intended to extend the waiting room and the addition has a simple form set back from the
	<i>Recommendation</i>	<i>The area be the subject of design development</i>
		The balconies are discrete elements at low level
