Report on
Geotechnical Investigation

Proposed Residential Aged Care Facility Upgrade
2B West Street, Lewisham

Prepared for
Catholic Healthcare Ltd

Project 85469.01
July 2018

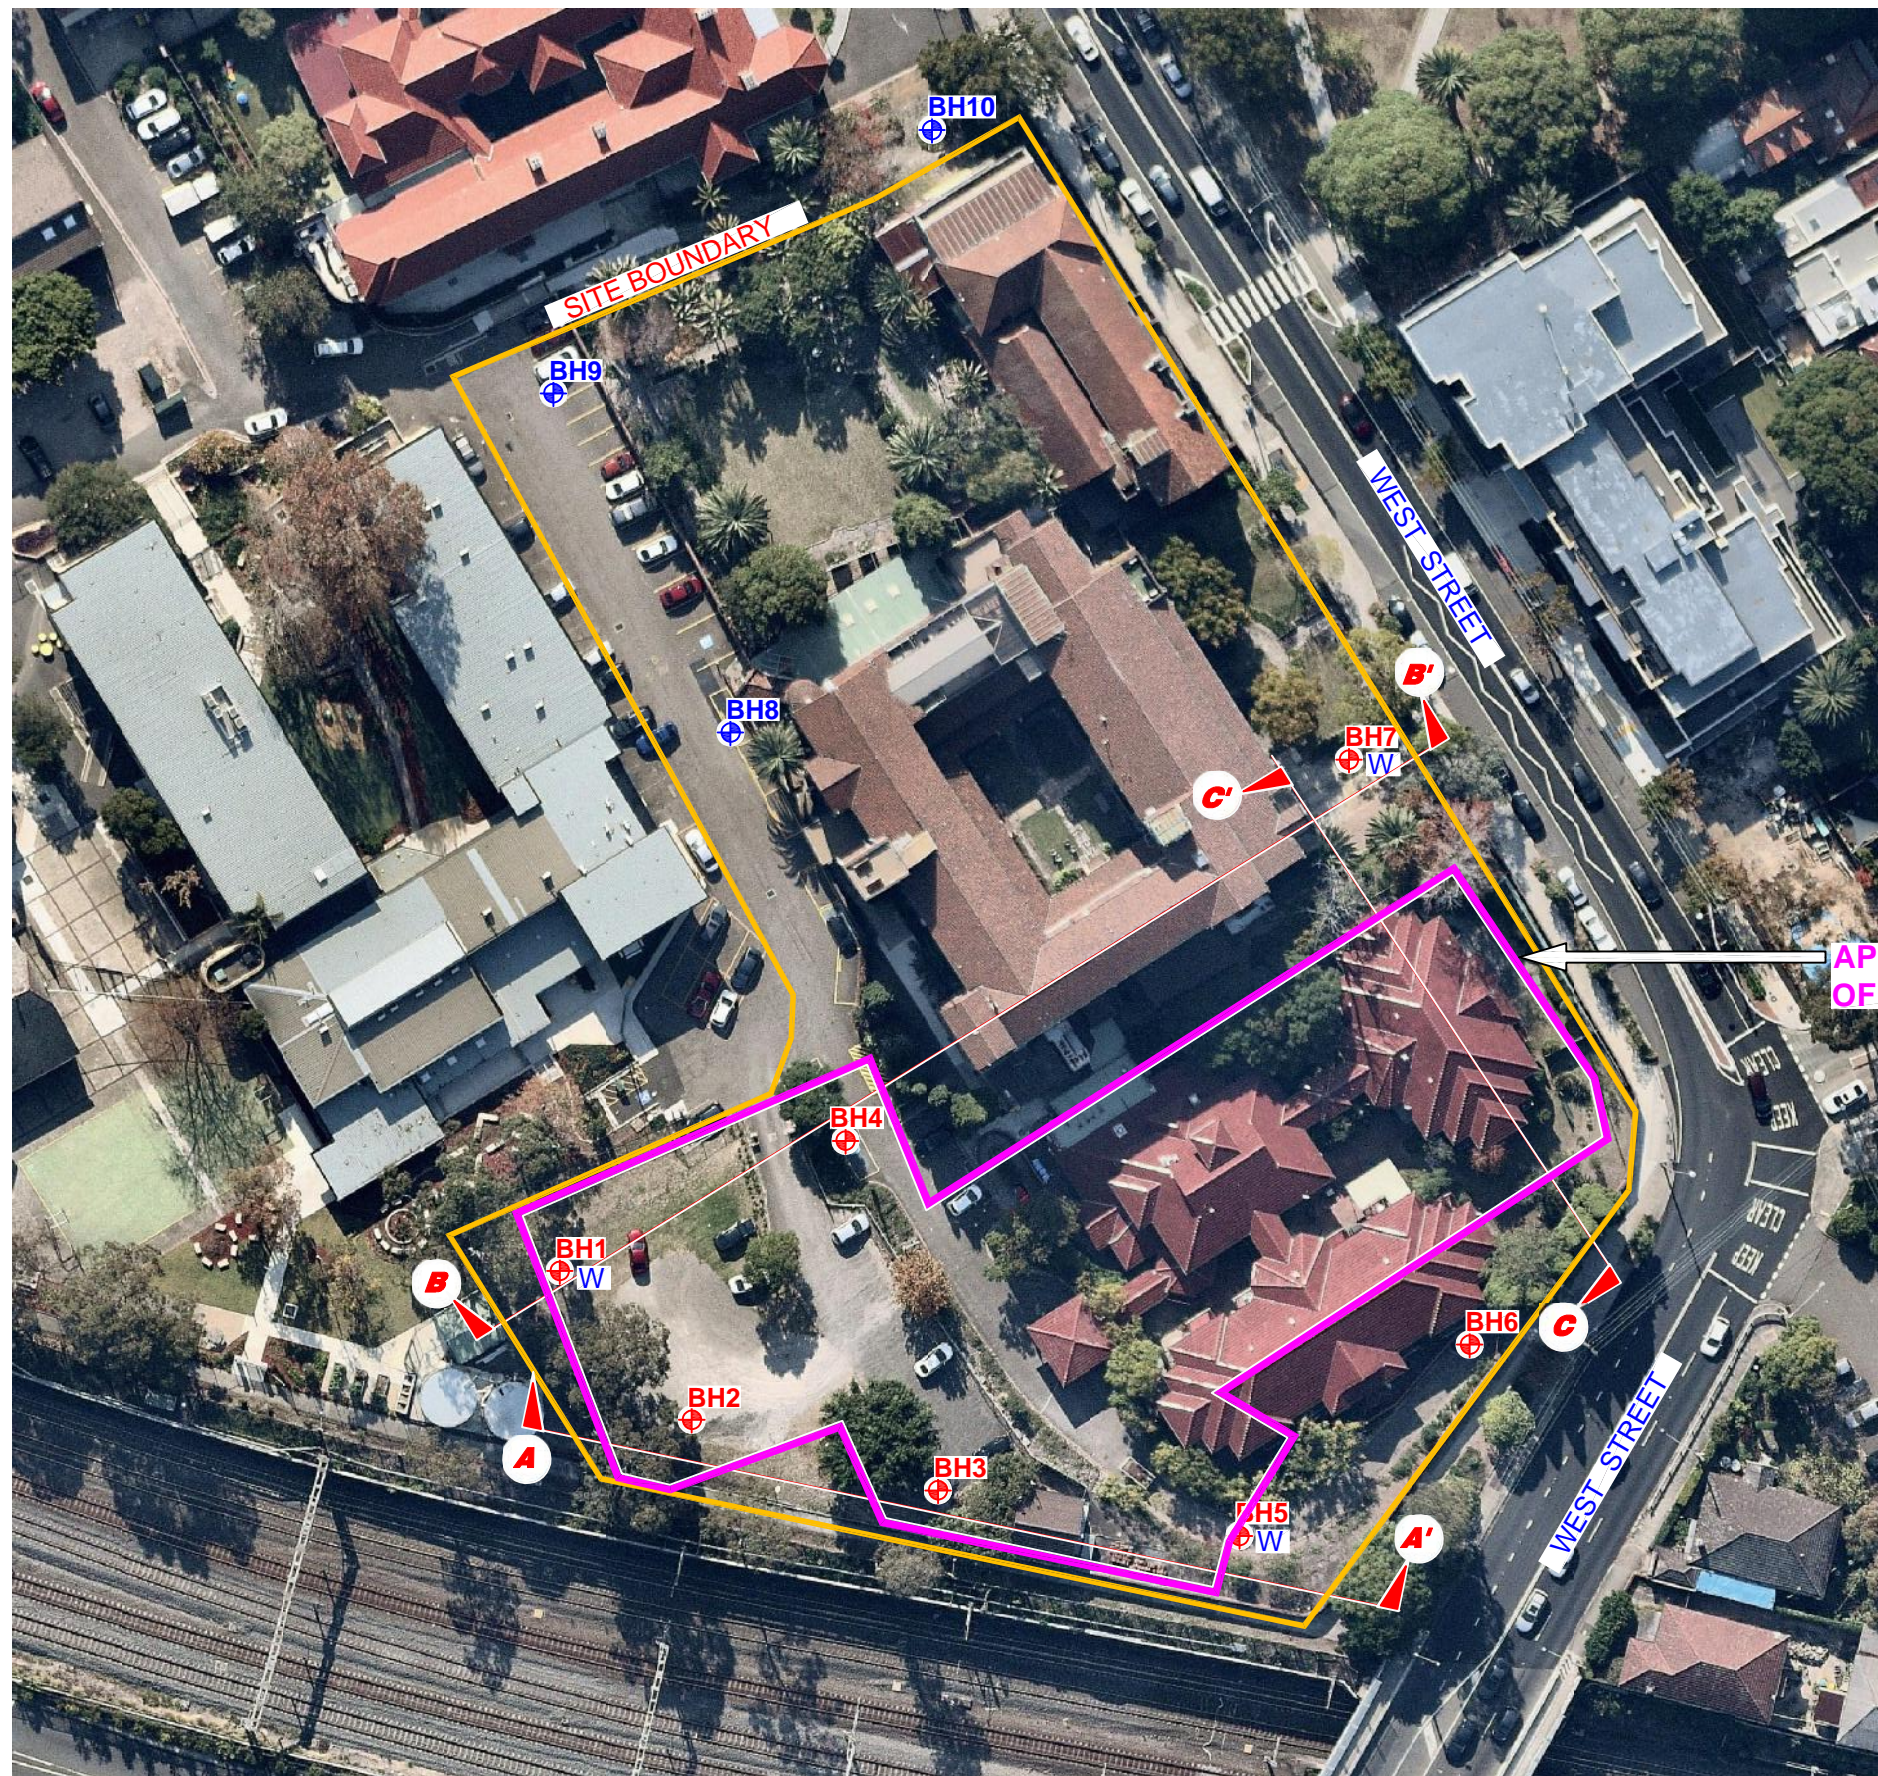
APPROXIMATE OUTLINE
OF PROPOSED EXCAVATION

- Rock cored bore
- Augered bore
- Groundwater well
- Geotechnical Cross Section A-A'

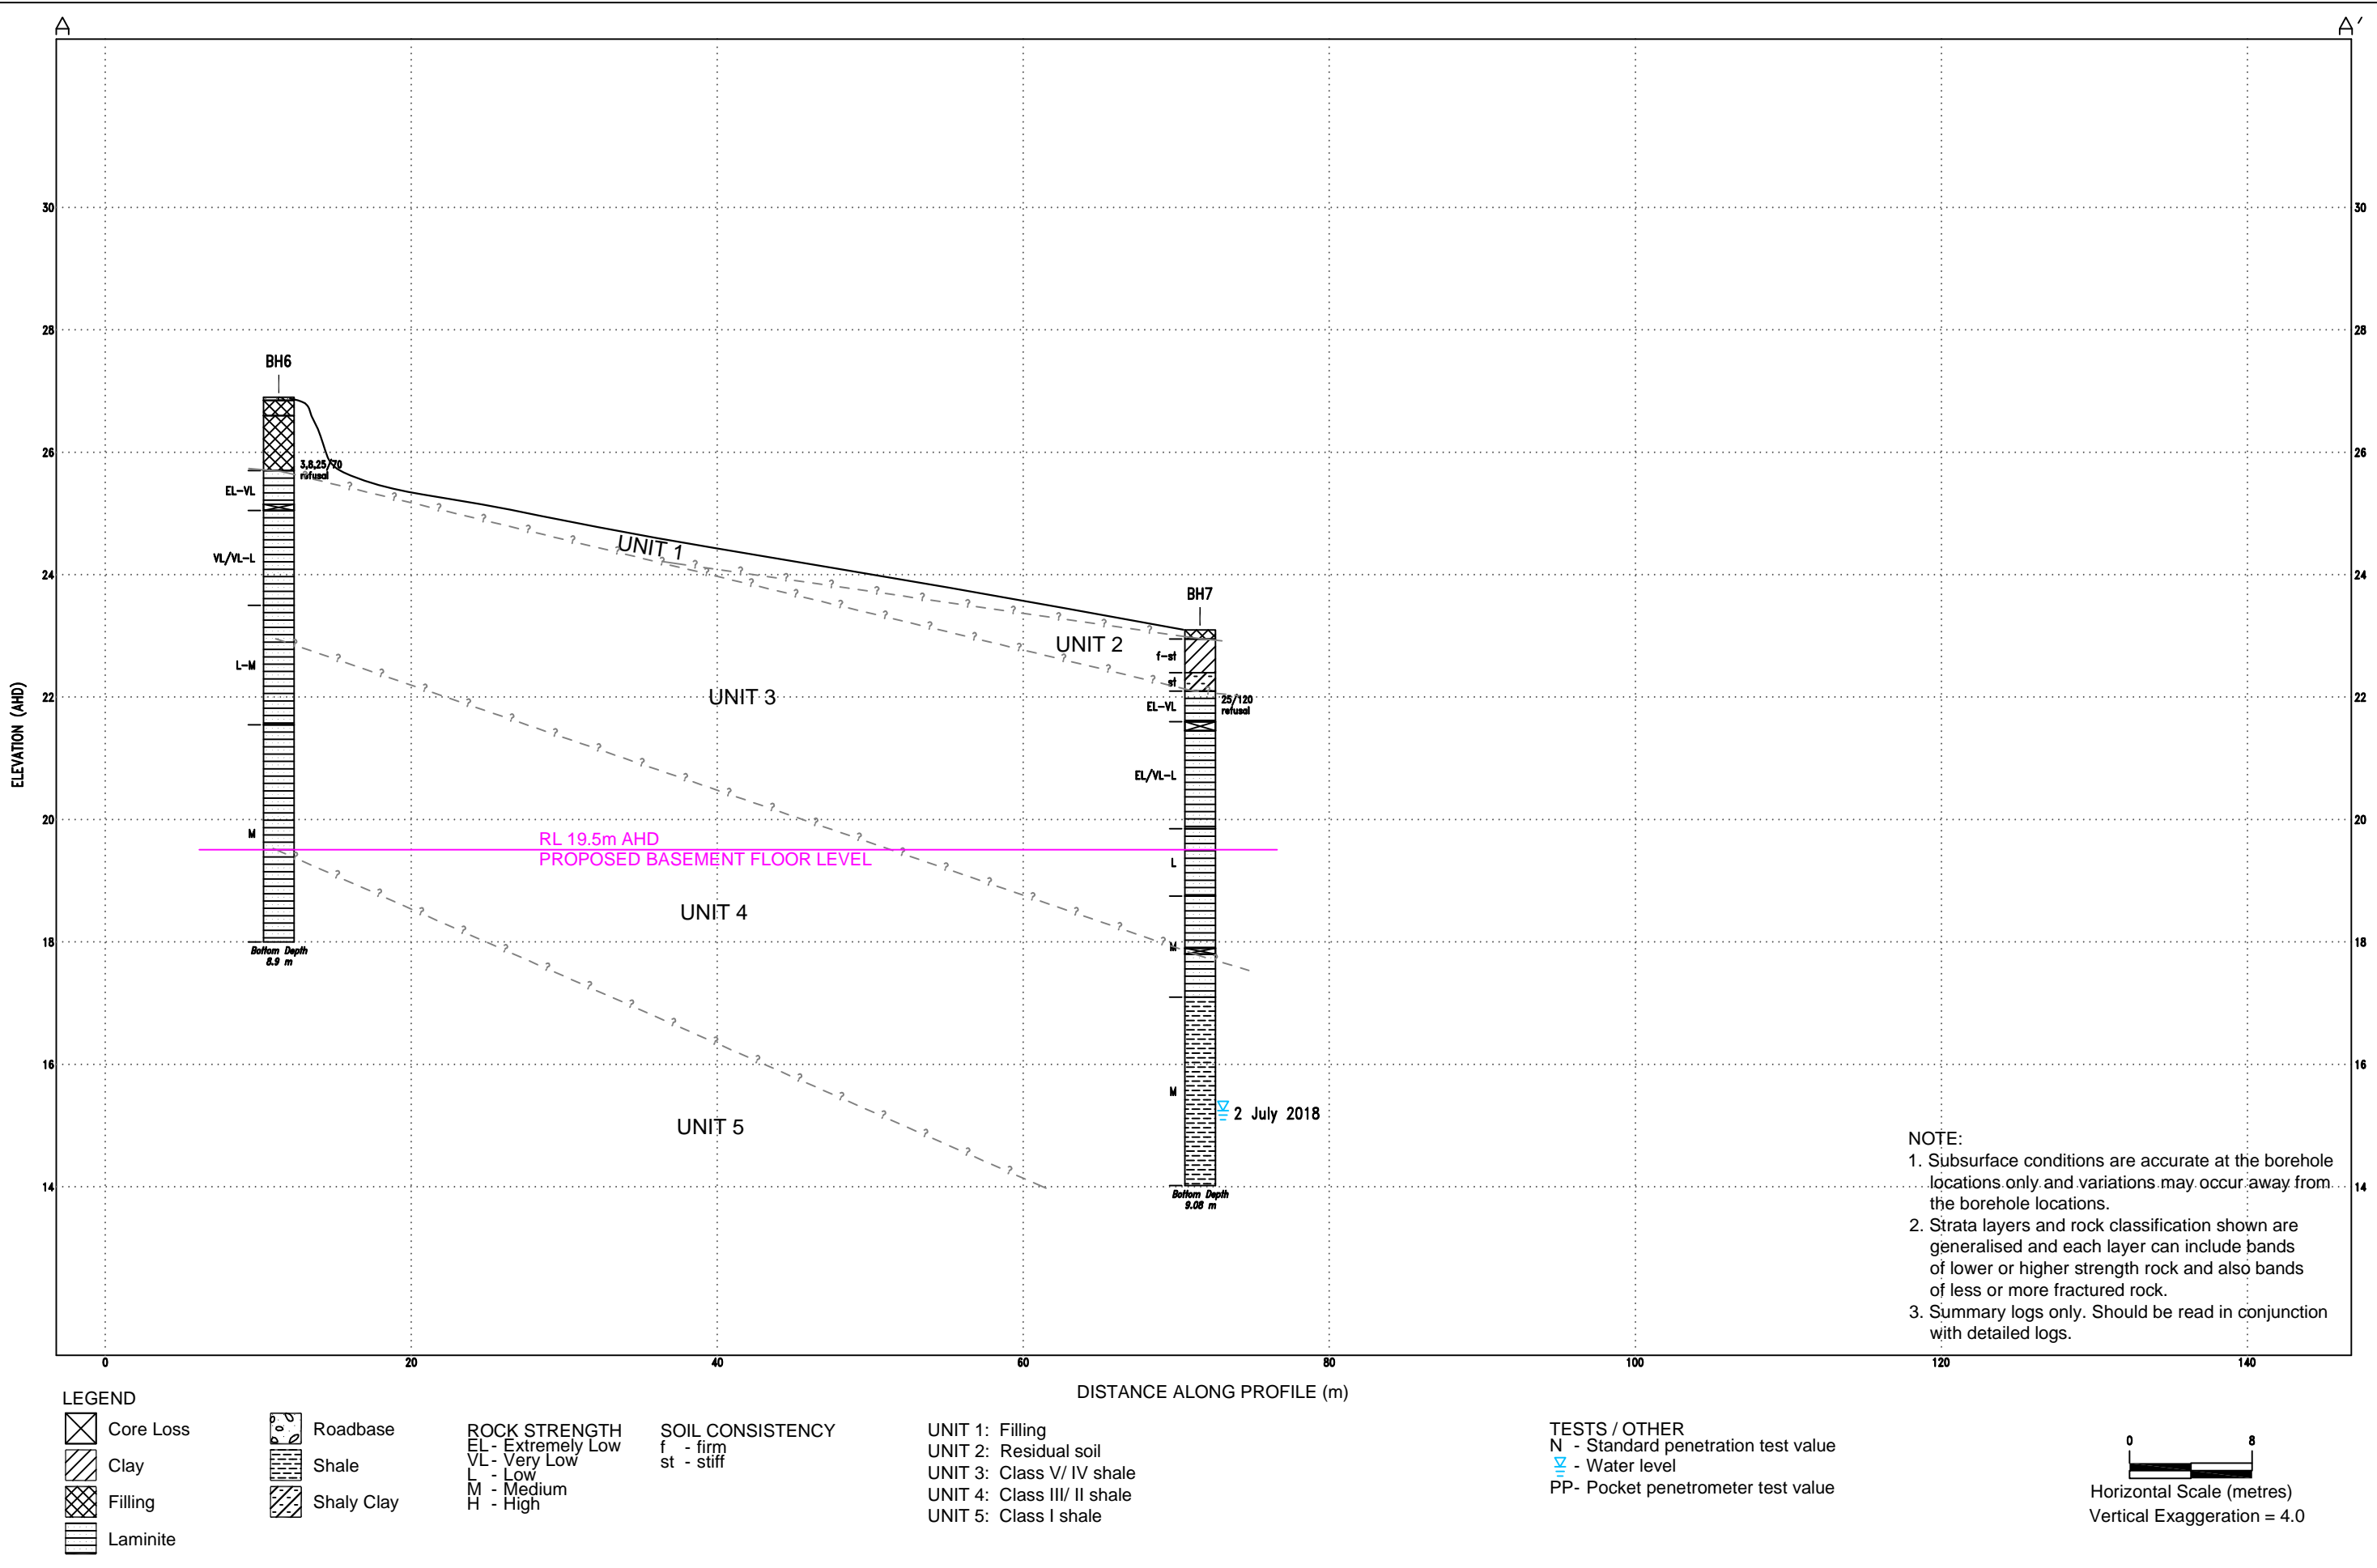
Three geotechnical cross-sections (Sections A-A', B-B' and C-C'), showing the interpreted subsurface profile between selected bores, are presented as Drawings 2 to 4 in Appendix B. The sections show interpreted geotechnical units of soil and rock, together with the proposed basement level. It should be noted that the interpreted boundaries shown on the sections are accurate only at the bore locations and layers shown diagrammatically on the drawings are inferred only. Bands of lower and higher strength rock should be expected within the generalised layers. The interpreted depth and Reduced Level (RL) at the top of the interpreted geotechnical units are shown in Tables 2A and 2B.

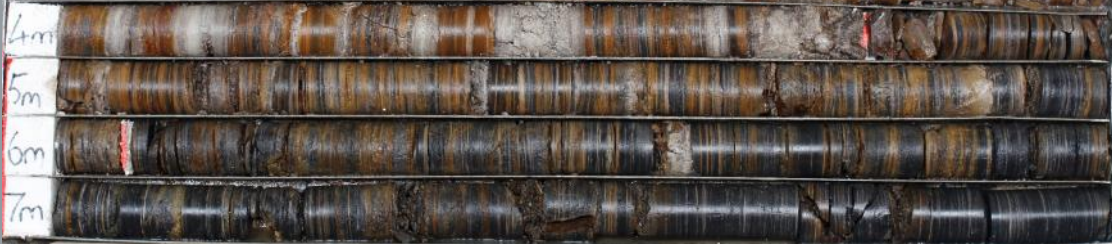
3.2 – 8.0m

85469-01 START CORE @ 3.2m
LEWISHAM BH-1 20.06.18

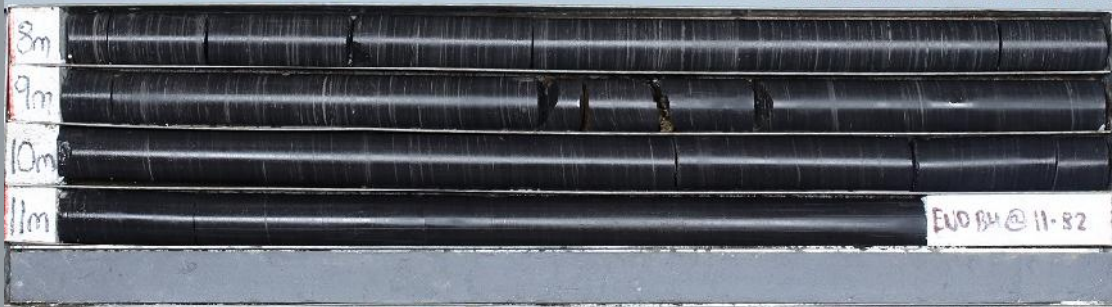
8.0 – 11.82m

Project No: S5469.01
BH ID: BH-1
Depth: 8.00 - 11.82m
Core Box No.: 2 of 2

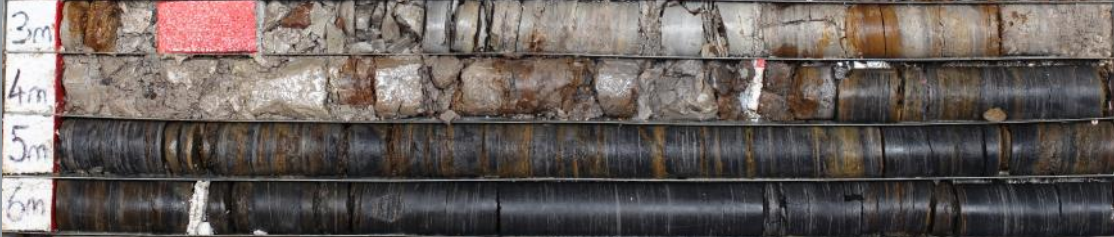
2.6 - 7.0m

85469-01 19-06-15 BH-2. CORE START @ 2.60m

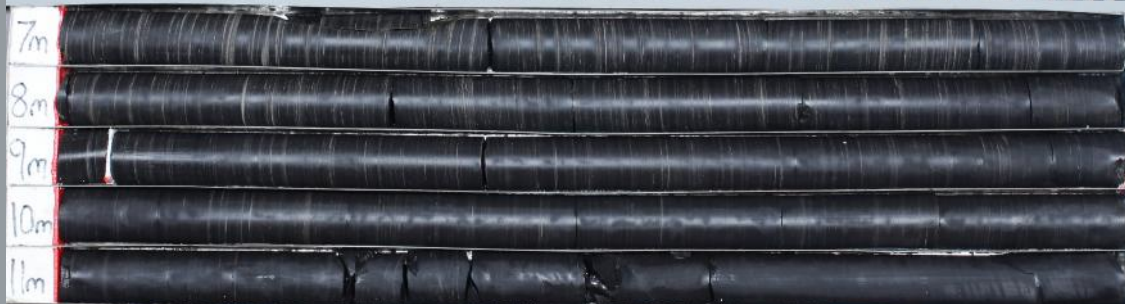
7.0 - 12.0m

Project No: 85469-01
BH ID: BH-2
Depth: 7.00 - 12.00m
Core Box No.: 2 of 2

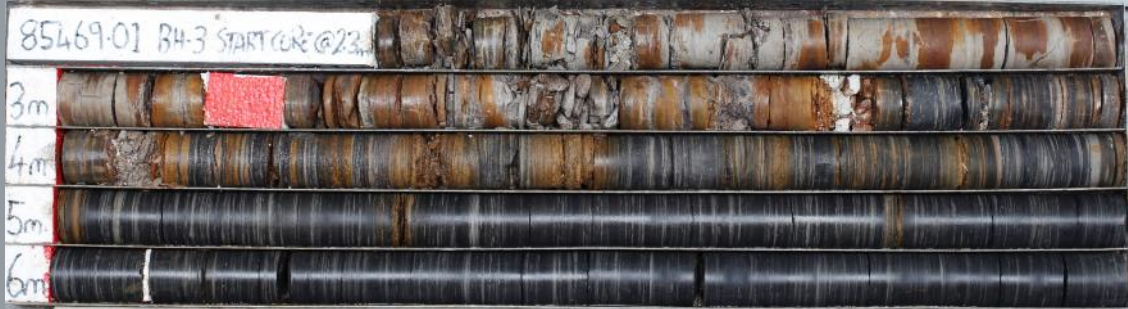
2.3 – 7.0m

Project No: 85469.01
BH ID: BH-3
Depth: 2.30m - 7.00m
Core Box No.: 1 of 2

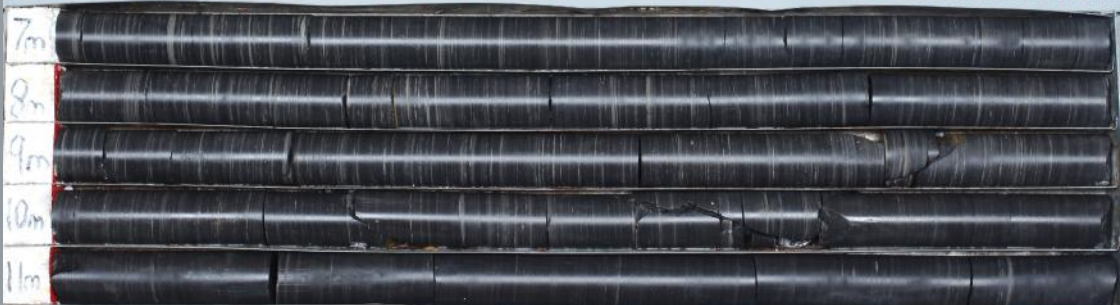
7.0 – 12.0m

Project No: 85469.01
BH ID: BH-3
Depth: 7.00m - 12.00m
Core Box No.: 2 of 2

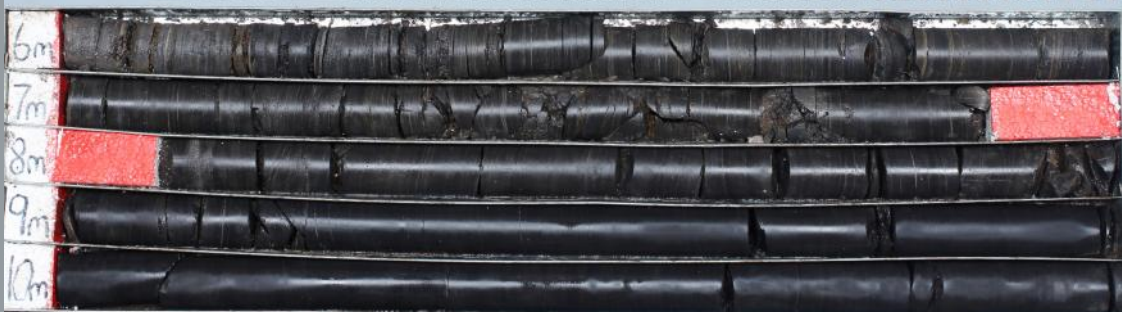
6.0 – 11.0m

Project No: 85469.01
BH ID: BH-4
Depth: 6.00m - 11.00m
Core Box No.: 2 of 3

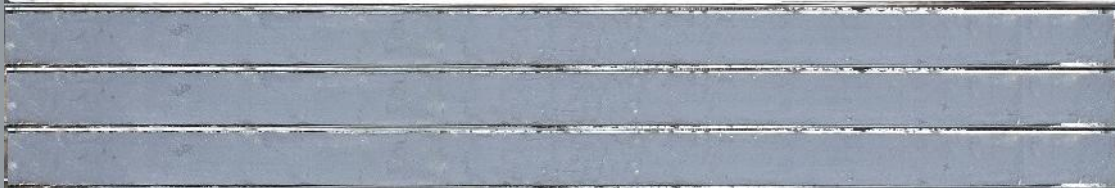
11.0 - 12.0m

END BH-4 @ 12.00m

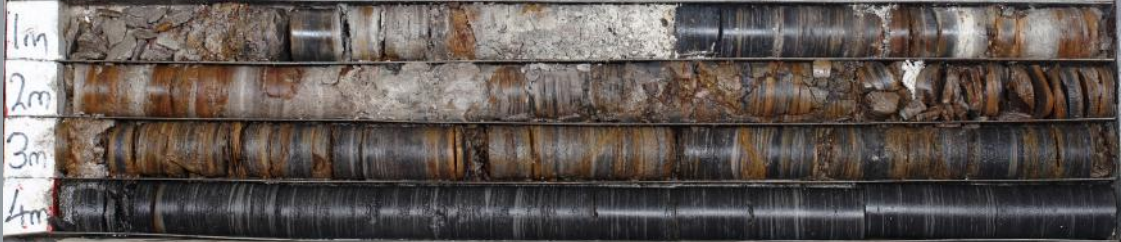
1.0 – 5.0m

85469.01 LEWISHAM BH-5 21.06.18 START CORE @ 1.0m

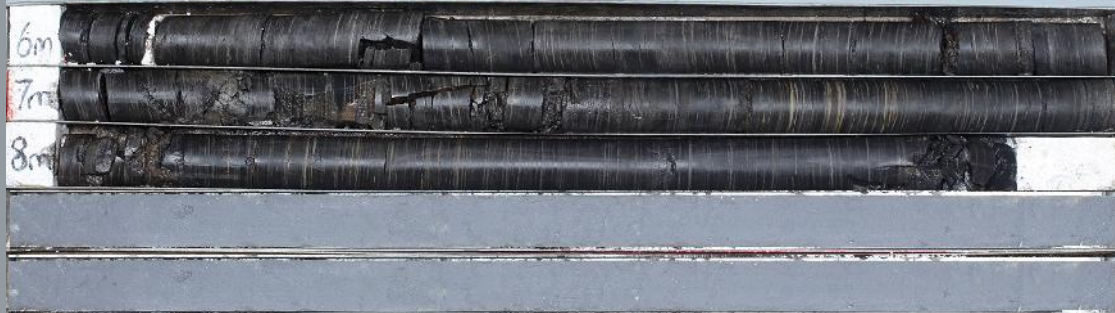
6.0 - 8.9m

Project No: S5469.01
BH ID: BH-6
Depth: 6.00 - 8.90m
Core Box No.: 2 of 2

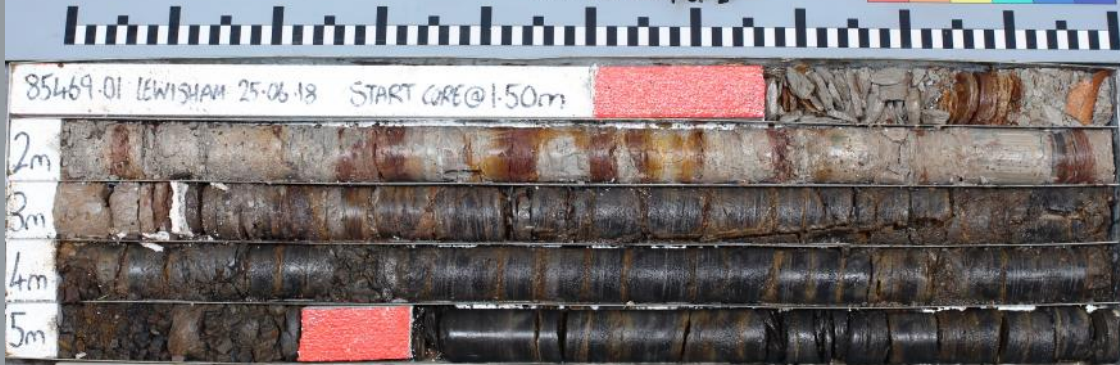
1.5 – 6.0m

Project No: 85469.01
BH ID: BH-7
Depth: 1.50m - 6.00m
Core Box No.: 1 of 2

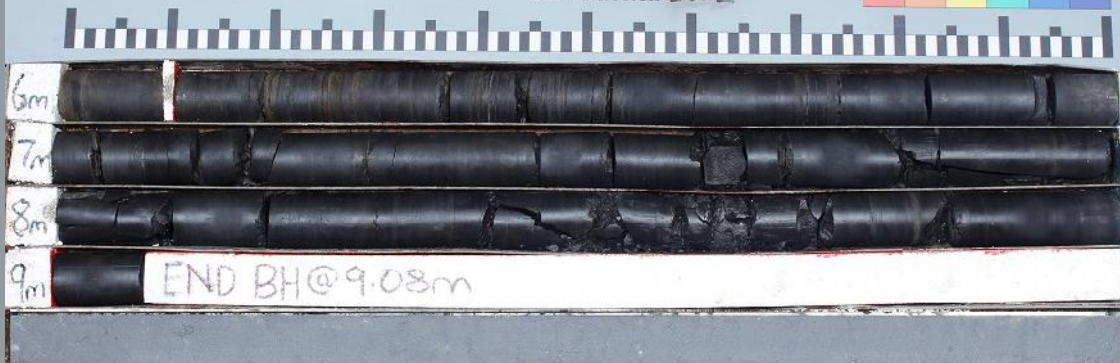
6.0 – 9.08m

Project No: 85469.01
BH ID: BH-7
Depth: 6.0 - 9.08m
Core Box No.: 2 of 2
