# HERITAGE IMPACT STATEMENT

## 74 Carlton Crescent Summer Hill

**Weir  
Phillips**  
Heritage  
and Planning

**December 2018**

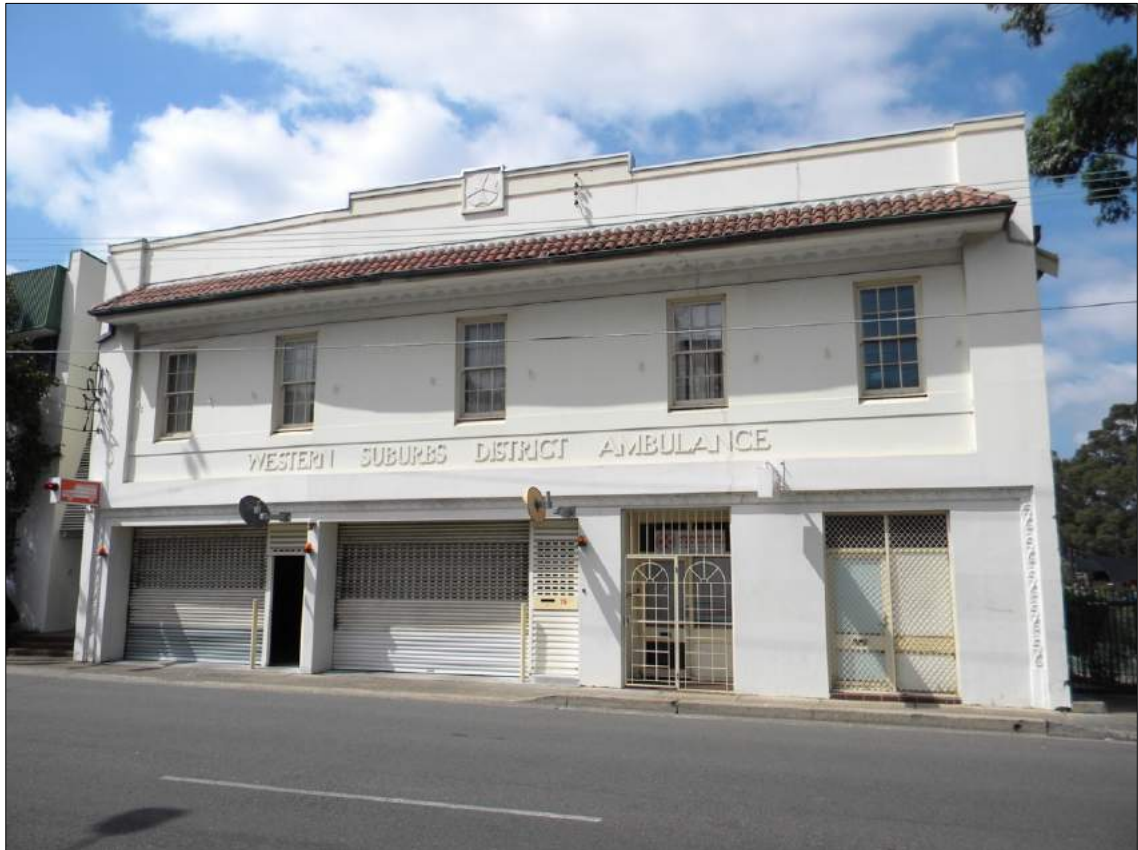
**Figure 20: Front elevation.**

Figures 20 to 24 illustrate the front elevation.

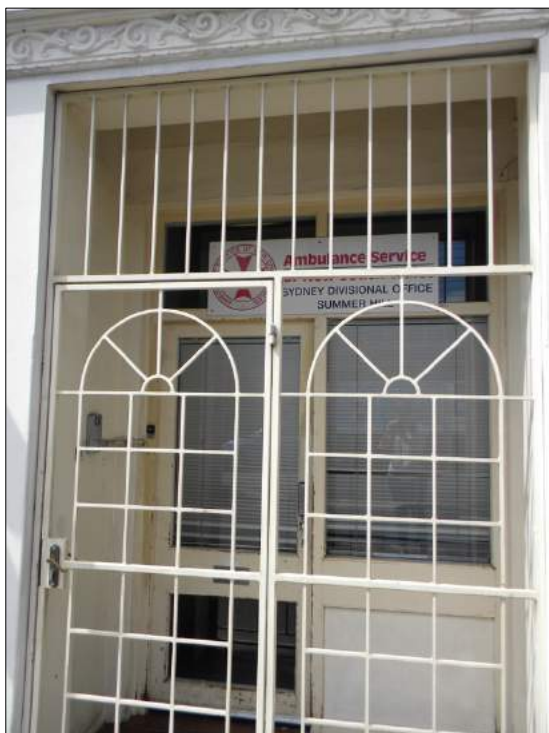
**Figure 21: Detail of the main pedestrian access into the building. The floor is finished in no-original quarry tiles.**

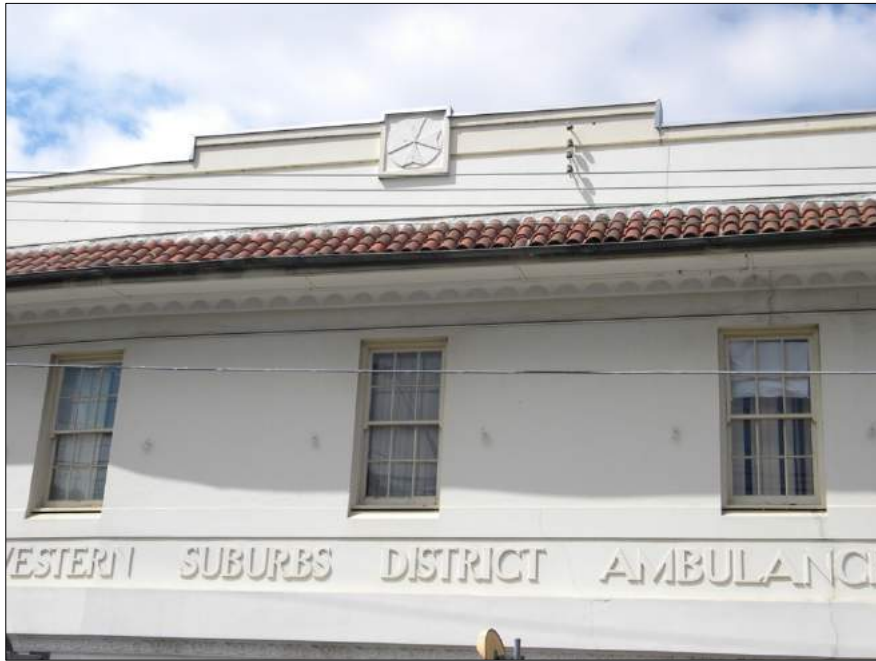
**Figure 23:**  
Detail of the first floor, showing the windows, shutter clips, lettering, decorative banding below the hood, cordova tiles to the hood and the Maltese Cross in the parapet.

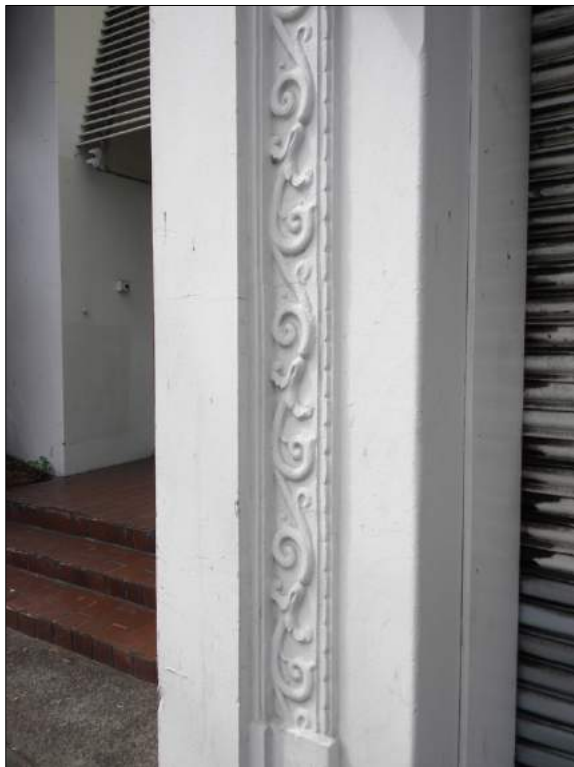
**Figure 24:**  
Detail of the decorative banding at ground floor level.

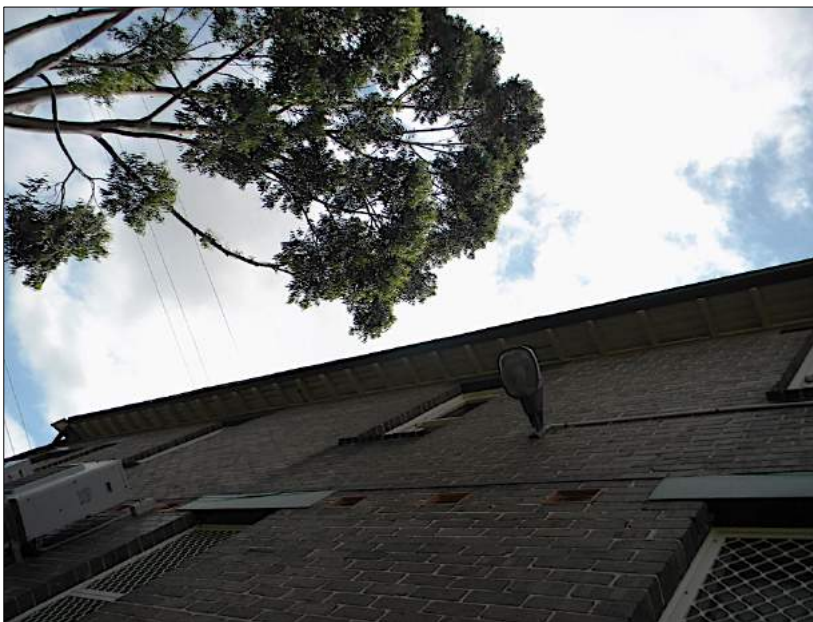
**Figure 26:**  
Detail of the timber lined  
eaves with exposed rafters.

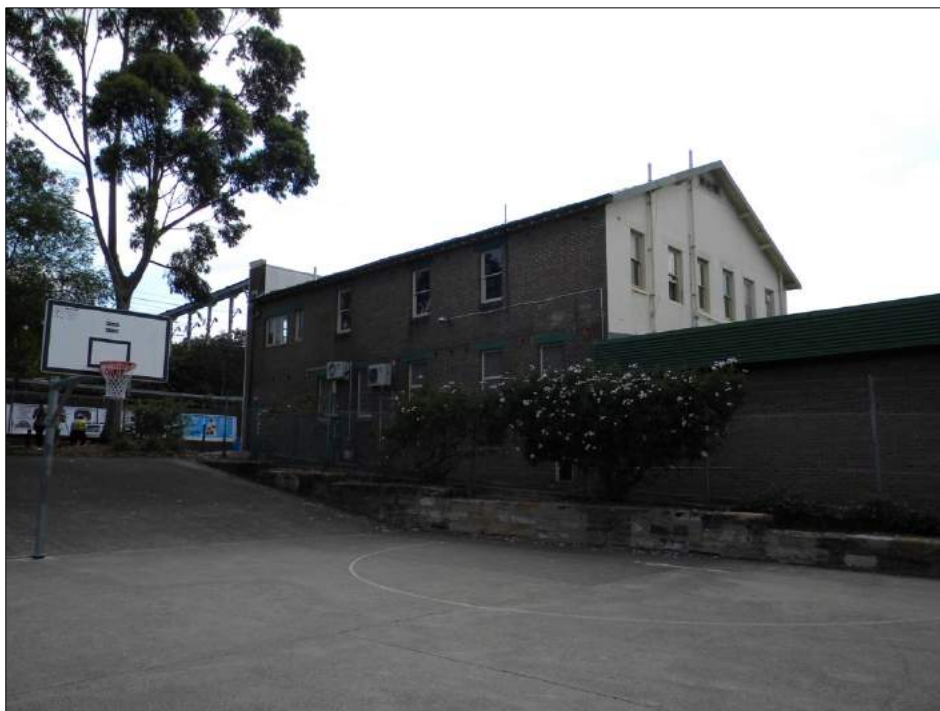
The **southern elevation** of the original building is largely concealed by the 1980s addition to the rear. Where visible above the addition, the elevation is constructed of painted brickwork. There are six timber framed double hung sash windows with one pane to each sash at first floor level. There is a timber vent set into the wide gable. The eaves are wide and timber lined with supporting timber brackets. Refer to Figure 29.

**Figure 29:**  
**First floor of the rear elevation of the original building, southern elevation.**

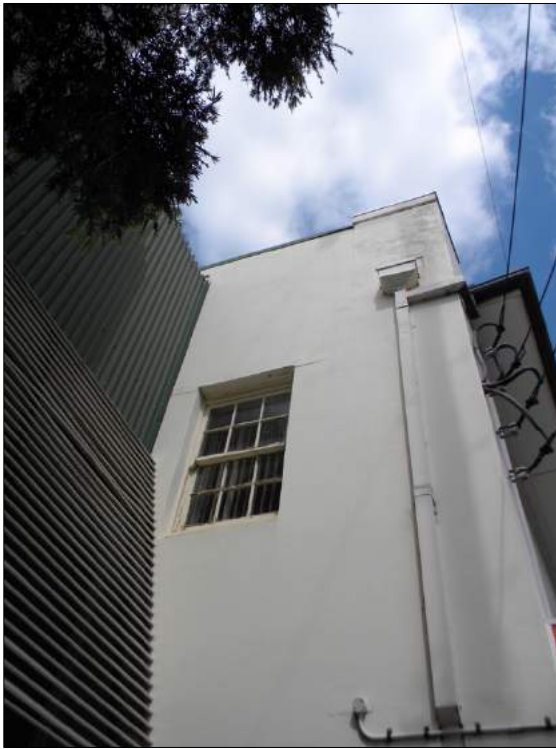
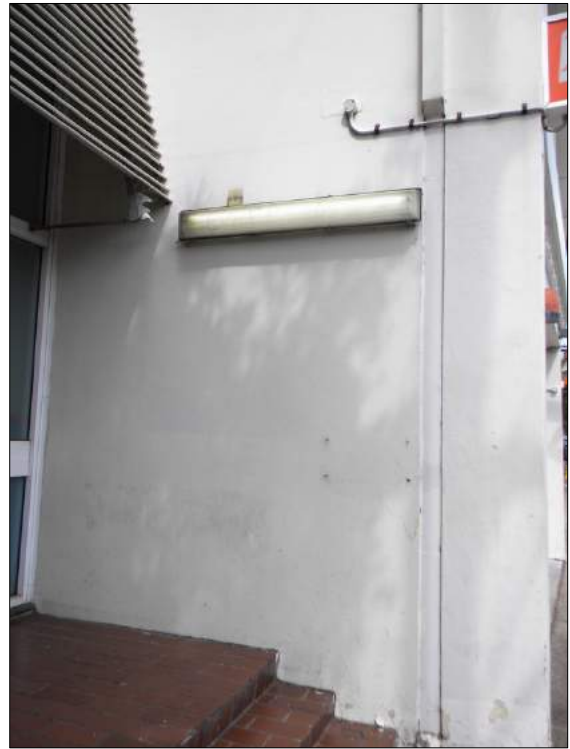
floor level. At first floor level there is a timber framed double hung sash window with six panes to each sash. The front parapet returns the corner to conceal the hipped roof form above. Refer to Figures 30 and 31.

**Figures 30 and 31: Northern end of the eastern elevation.**

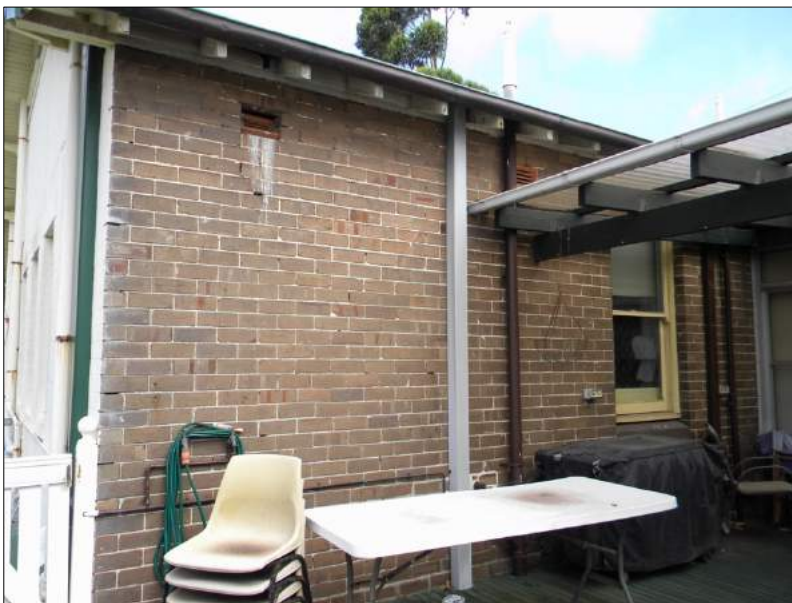
Figures 32 and 33 illustrate the exterior walls of the deck located to the rear of the building at first floor level. The detailing of the eastern facing wall, including the window, matches the western elevation. The original doors and windows in the southern wall have, however, all been replaced with aluminium framed doors and windows. The deck has a timber floor and a timber balustrade.

**Figure 32:  
Eastern facing wall  
addressing the rear deck.**

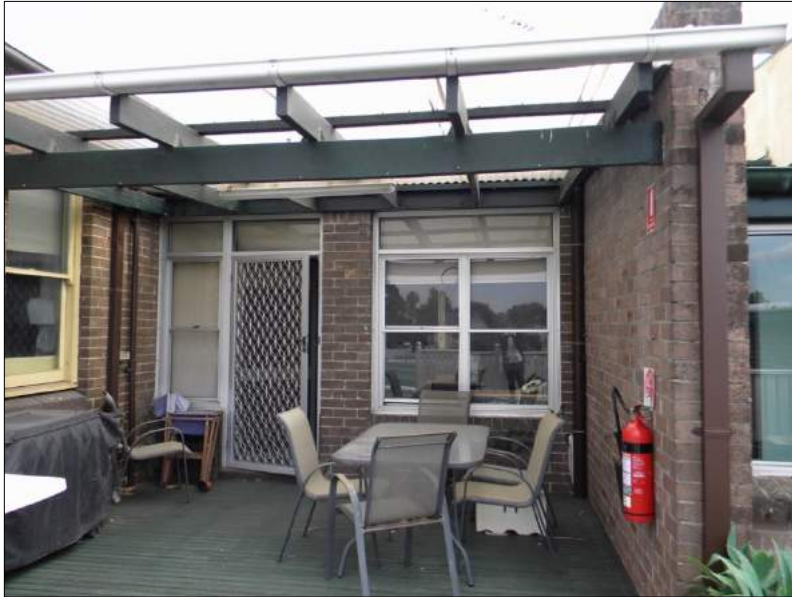
**Figure 33:**  
Southern facing wall  
addressing the rear  
deck.

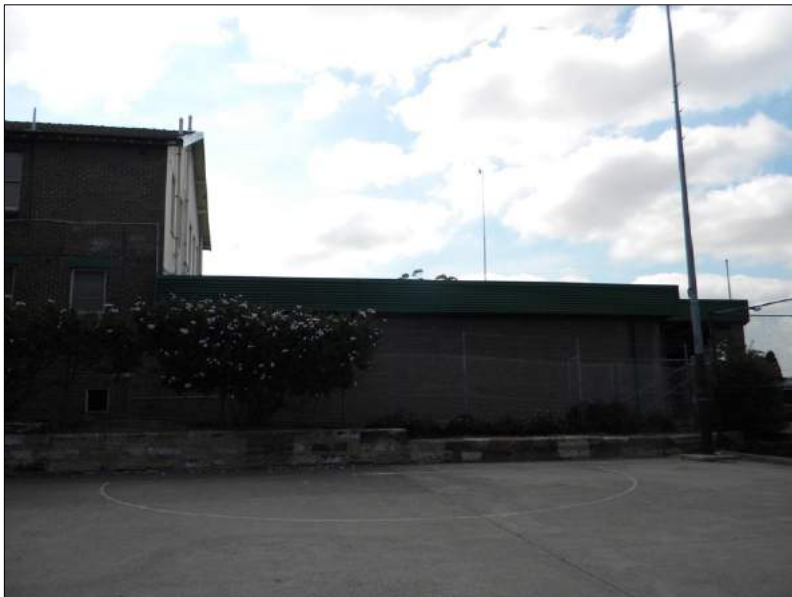
A single storey extension was constructed to the rear in the 1980s. The extension has face brick walls and a low pitched roof clad in corrugated metal. The western elevation is blind. There is a covered dock at the southern end. Refer to Figures 34 to 37.

**Figure 34:**  
Western elevation of  
the 1980s extension.

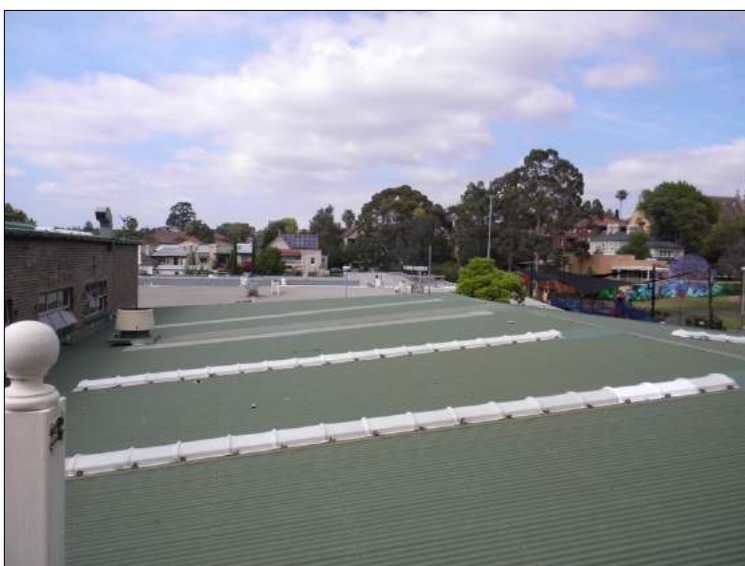
**Figure 37:**  
Roof over the 1980s  
addition.

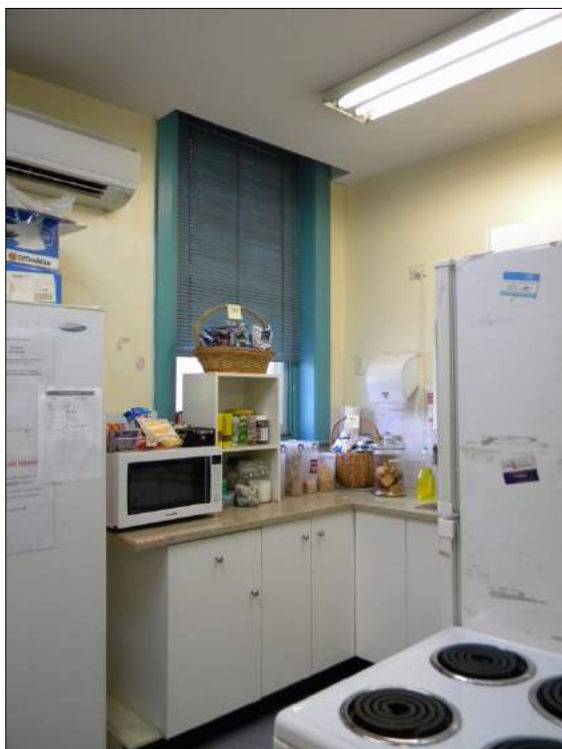
**Figure 45: Modern kitchen facilities. Note how the ceiling height has been lowered.**

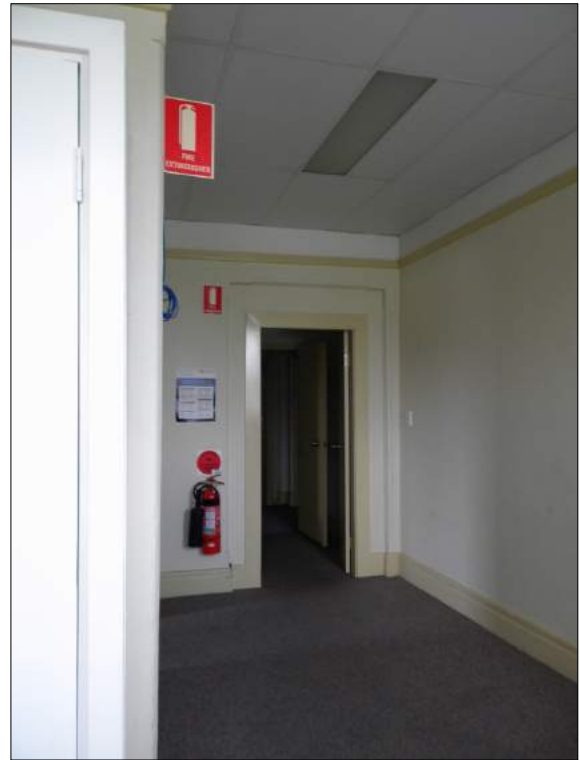
**Figure 51: Door leading from Room 2 into Room 1. An earlier opening has been partially infilled and the door added.**

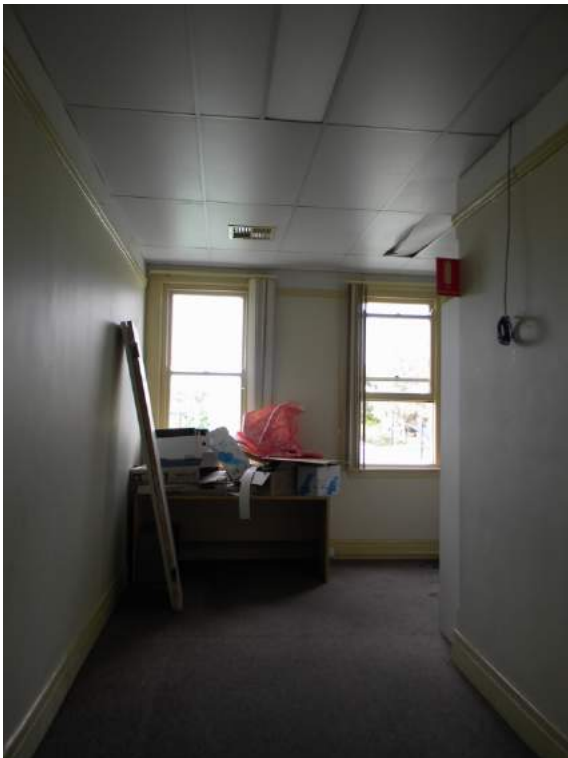
**Figure 52: Original skirting boards, picture rail and windows in Room 2.**

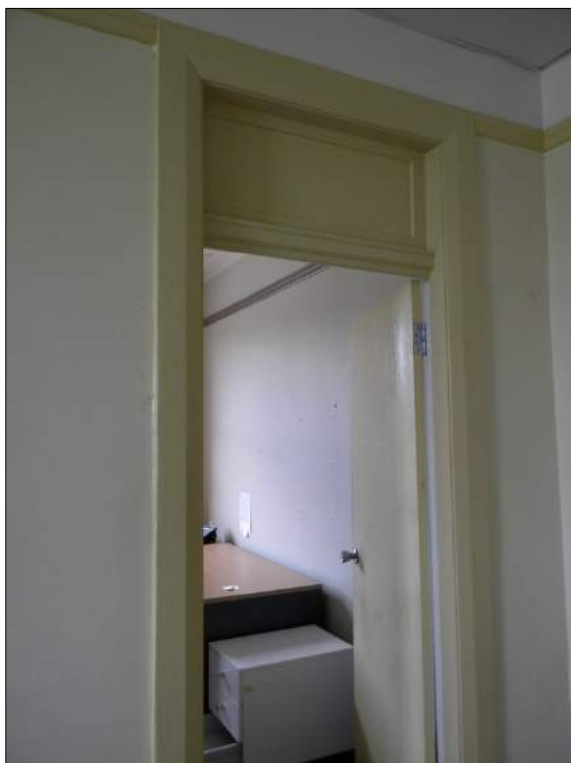
**Figure 54:**  
Original door with blocked in toplight and later  
door panel (Room 5).

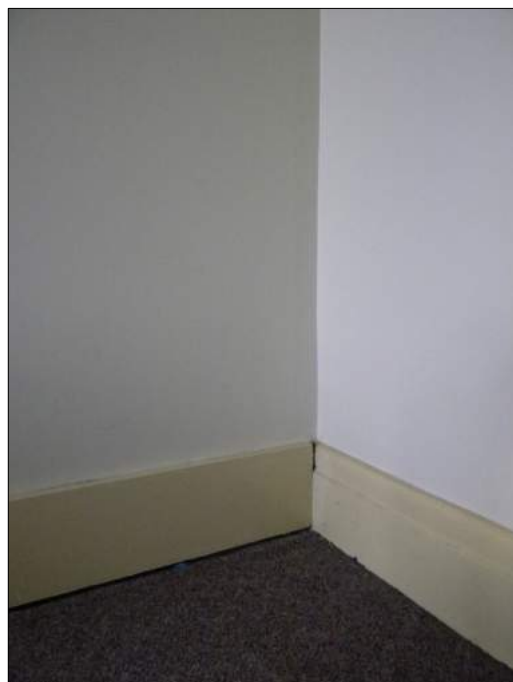
**Figure 58:**  
Example of original and later skirting boards  
in Room 9.
