On-site Wastewater Management Plan

Proposed Worimi Eco-Tourism Development

Lot 227 DP 1097995
Stockton Bight Track, Fullerton Cove

June 2019

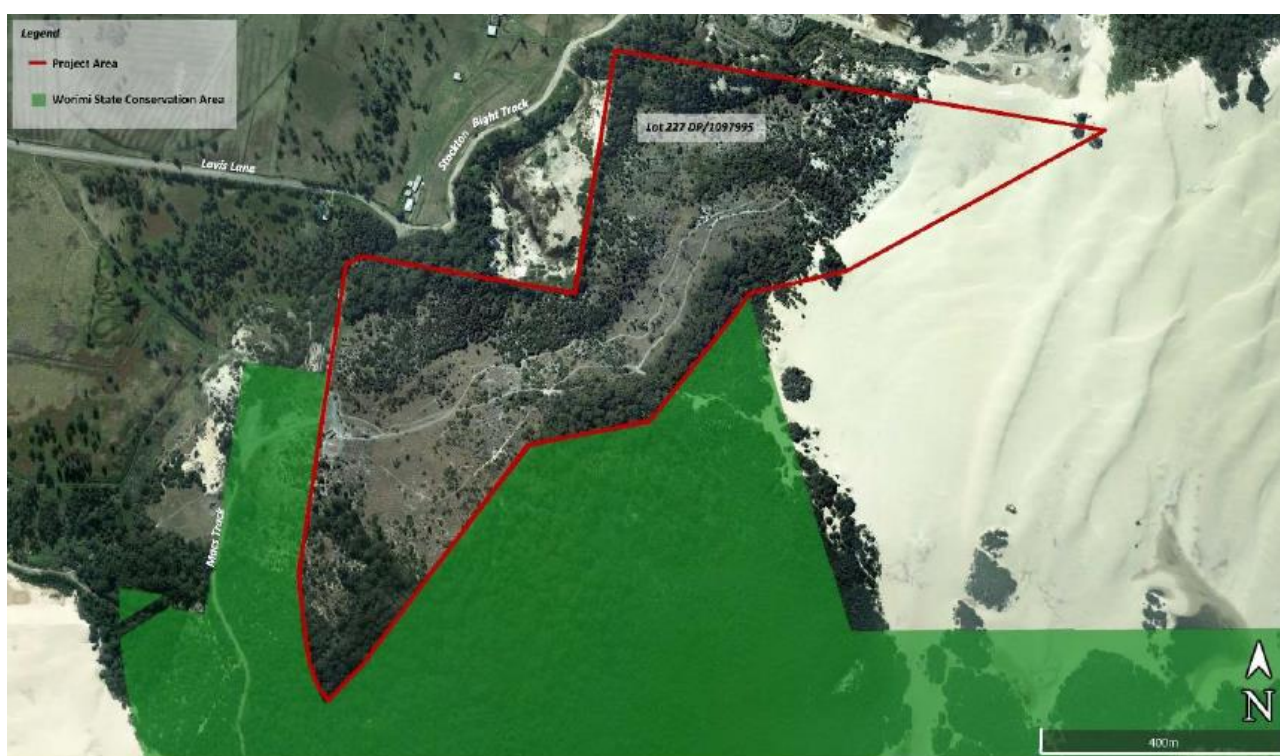
Figure 2 – Locality Map

The subject site is located close to the end of Lavis Lane, Williamtown, along Stockton Bight Track, see **Figure 2**. It is located south-east of Newcastle Airport, within Worimi Conservation Lands. The subject site is approximately 18 km from Nelson Bay and 28 km from Newcastle City Centre.

The site is defined as an irregular shaped parcel of land, extending west off Stockton Bight Track, Fullerton Cove and bounded by undeveloped bushland to the north and south; Stockton Bight Track to the west; and Stockton sand dunes to the east.

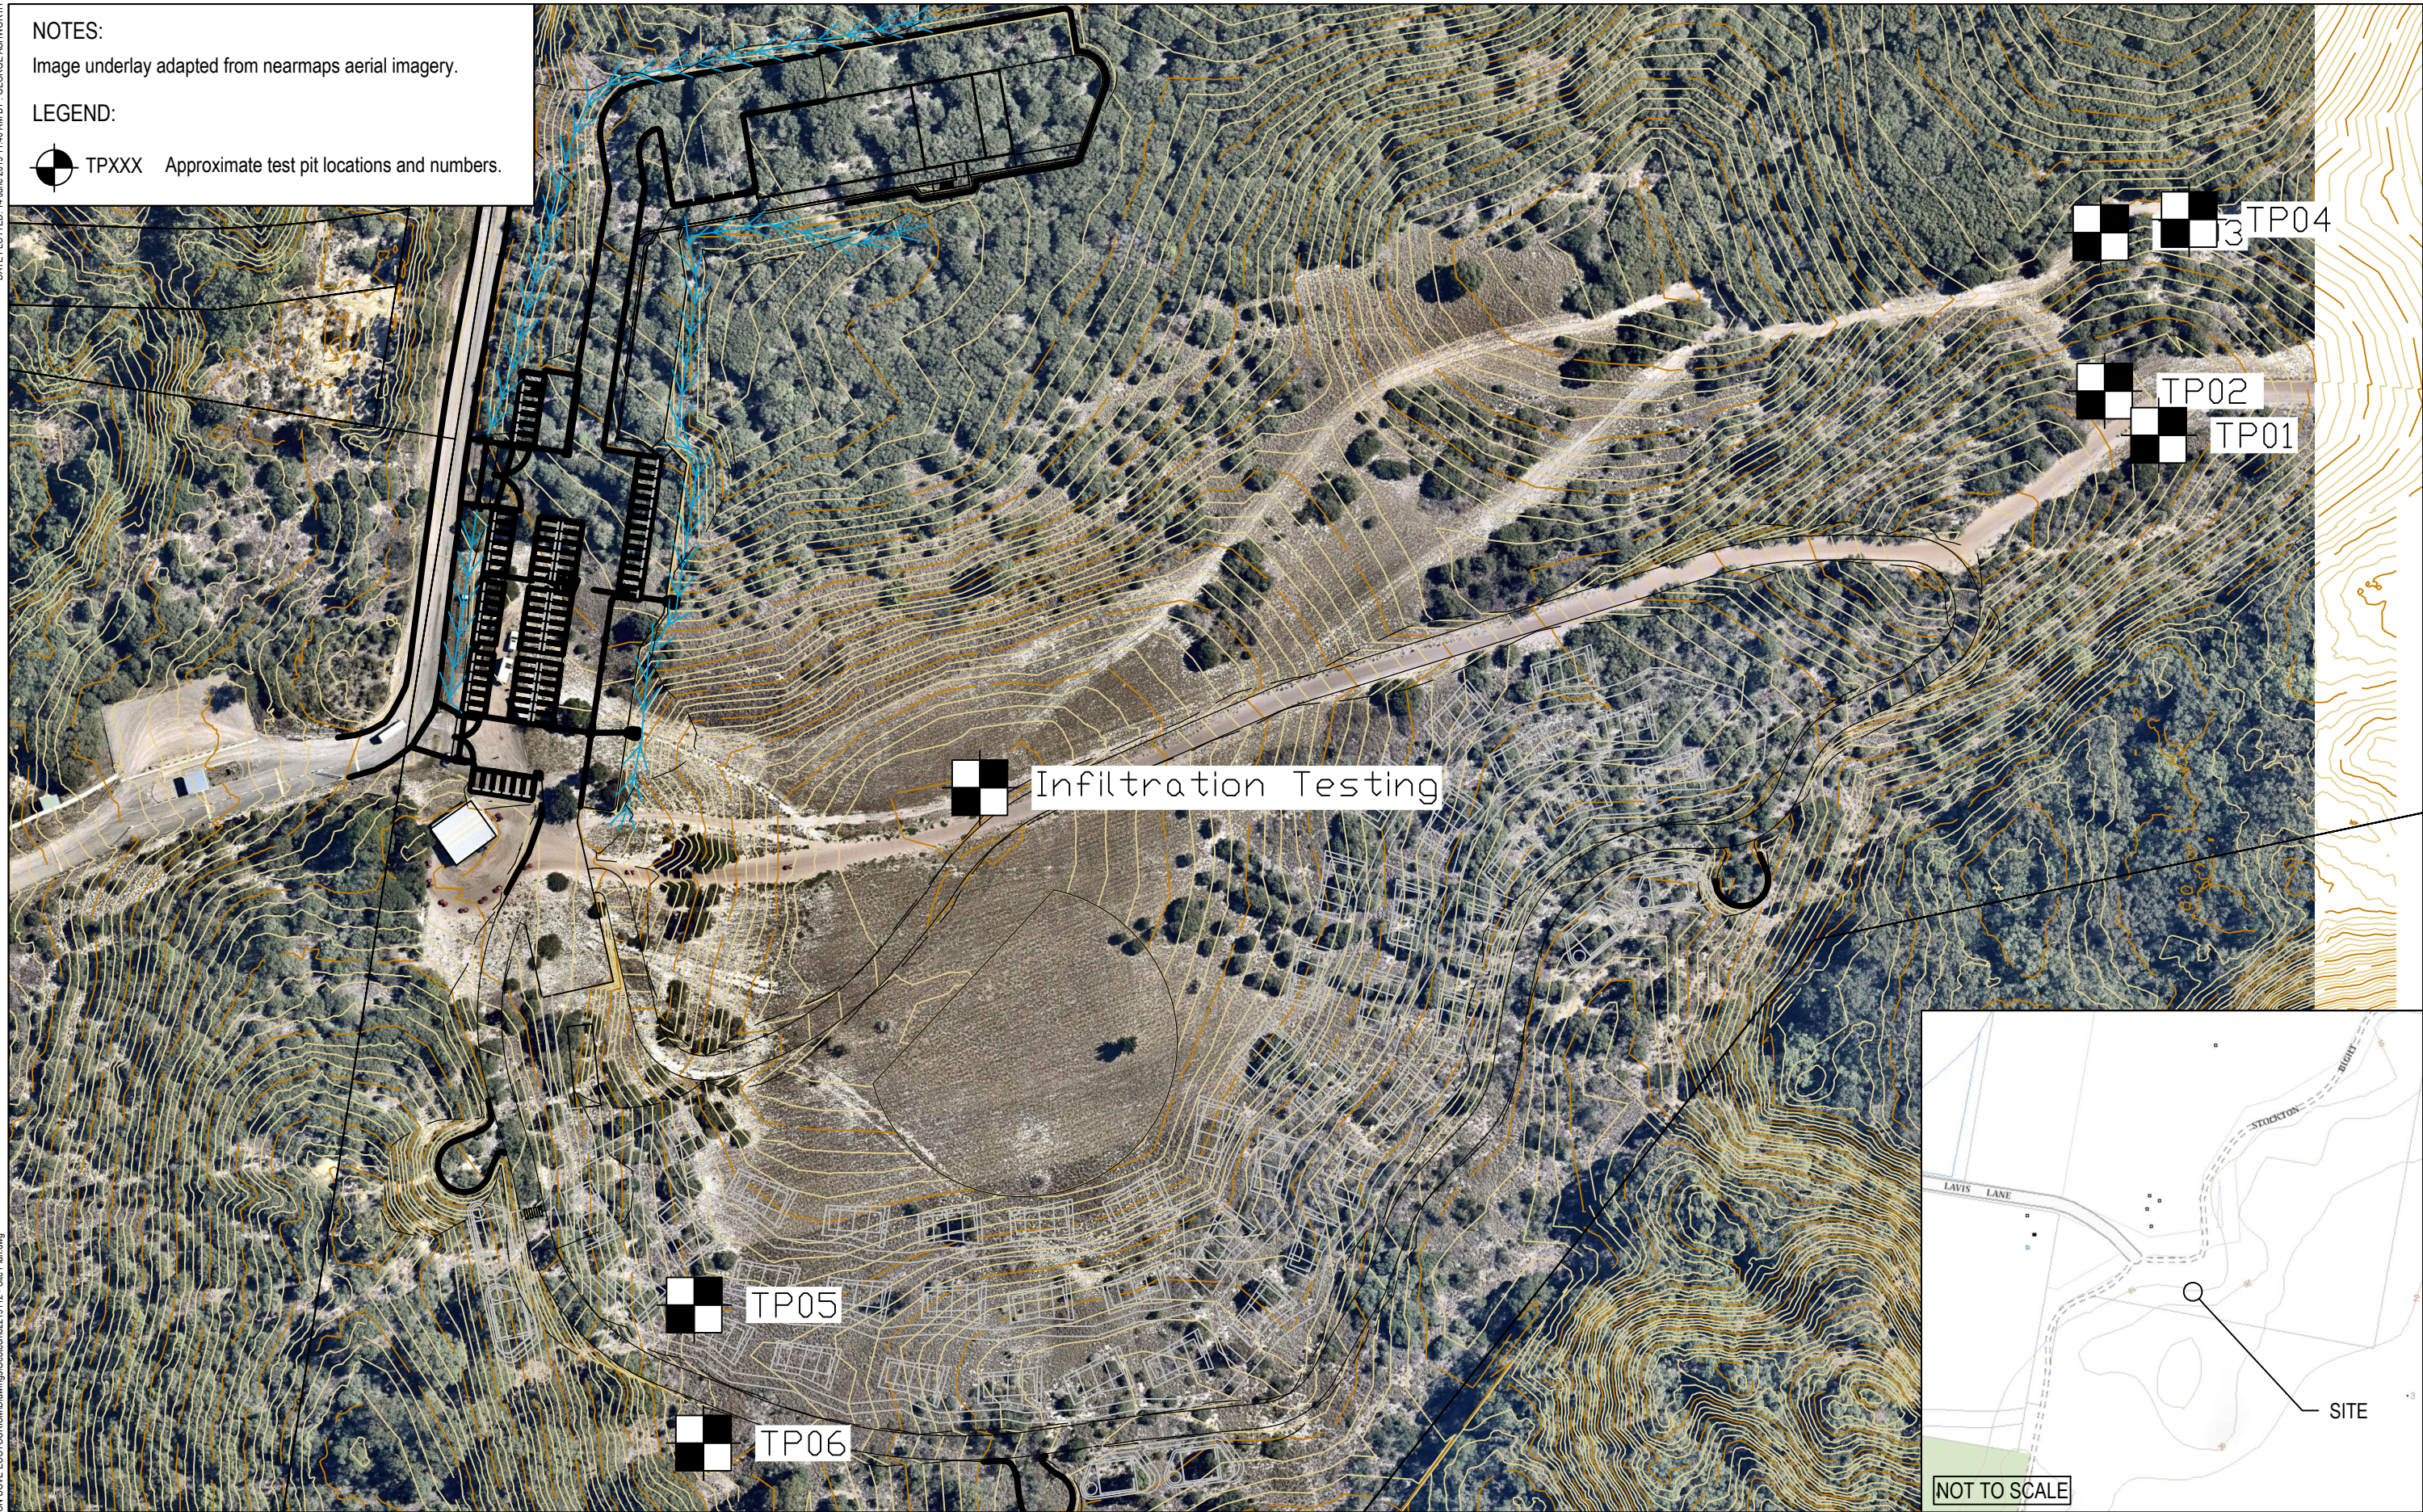
LEGEND:
TPXXX Approximate test pit locations and numbers.

Field investigation including logging of subsurface profiles and collection of samples was carried out by an experienced geotechnical engineer from Cardno. The location of test pits are shown on Figure 1, attached in Appendix A. Subsurface conditions are summarised in the Section 0 and detailed in the engineering logs attached in Appendix B, together with explanatory notes.

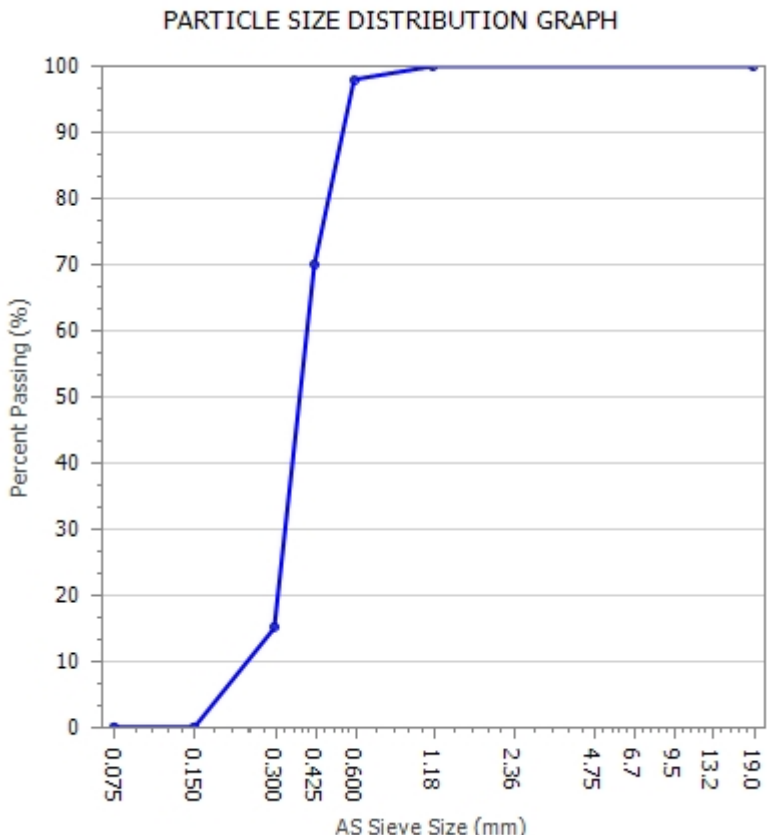
Test Procedures:	AS1289.3.6.1		
Sample Number	16822/S/69179	Sample Location	
Sampling Method	Tested As Received	Pit No.	TP01
Date Sampled	16/05/2019	Sample Type	Bulk Bag
Sampled By	Client Sampled	Sample Depth	m 0.6-0.8
Date Tested	29/05/2019		
Material Source	Not Supplied	Material Type	-

AS Sieve (mm)	Specification Minimum	Percent Passing (%)	Specification Maximum
19.0		100	
1.18		100	
0.600		98	
0.425		70	
0.300		15	
0.150		0	
0.075		0

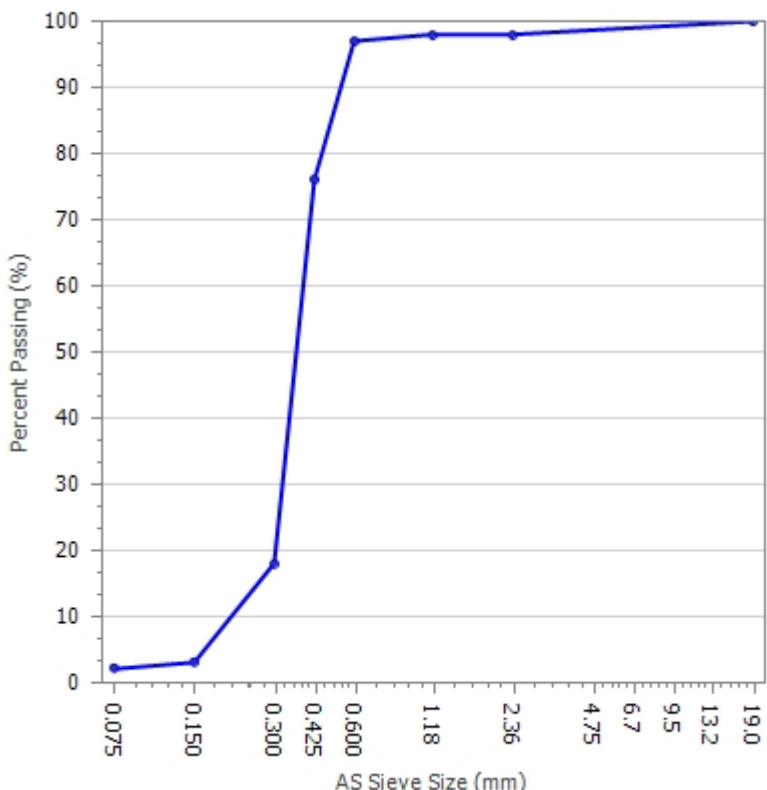
PARTICLE SIZE DISTRIBUTION GRAPH

AS Sieve (mm)	Specification Minimum	Percent Passing (%)	Specification Maximum
19.0		100	
2.36		98	
1.18		98	
0.600		97	
0.425		76	
0.300		18	
0.150		3	
0.075		2

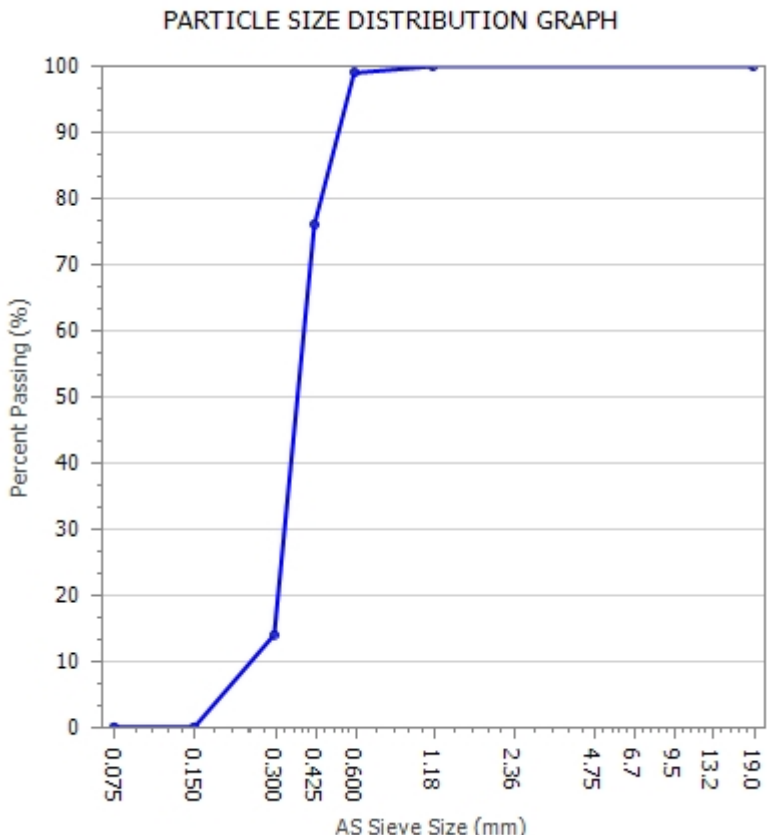
Test Procedures:	AS1289.3.6.1		
Sample Number	16822/S/69181	Sample Location	
Sampling Method	Tested As Received	Pit No.	TP03
Date Sampled	16/05/2019	Sample Type	Bulk Bag
Sampled By	Client Sampled	Sample Depth	m 0.4-0.6
Date Tested	29/05/2019		
Material Source	Not Supplied	Material Type	-

AS Sieve (mm)	Specification Minimum	Percent Passing (%)	Specification Maximum
19.0		100	
1.18		100	
0.600		99	
0.425		76	
0.300		14	
0.150		0	
0.075		0

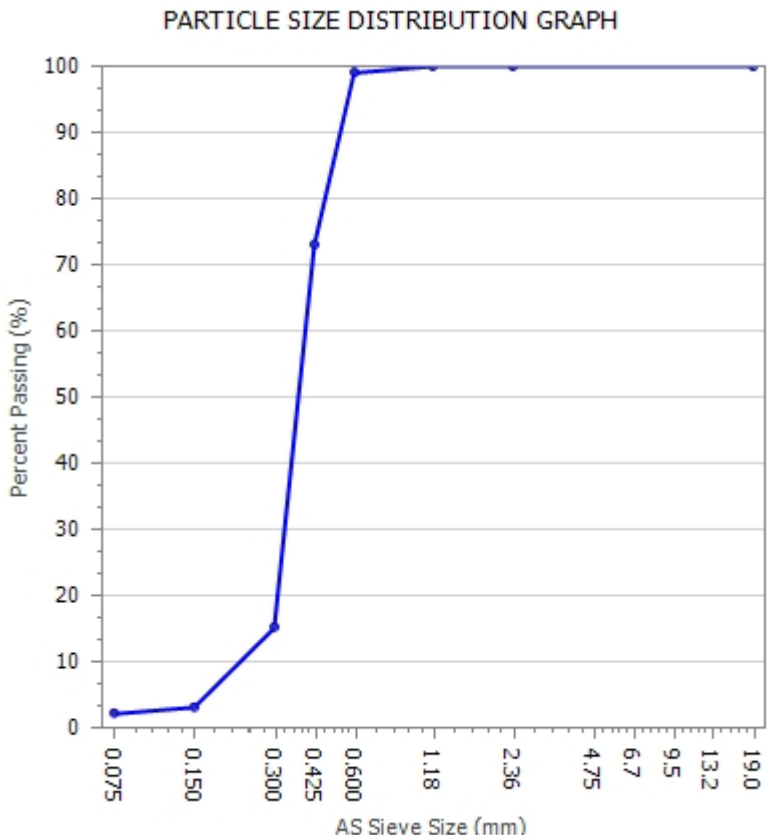
Test Procedures:	AS1289.3.6.1		
Sample Number	16822/S/69183	Sample Location	
Sampling Method	Tested As Received	Pit No.	TP05
Date Sampled	16/05/2019	Sample Type	Bulk Bag
Sampled By	Client Sampled	Sample Depth	m 0.2-0.4
Date Tested	29/05/2019		
Material Source	Not Supplied	Material Type	-

AS Sieve (mm)	Specification Minimum	Percent Passing (%)	Specification Maximum
19.0		100	
2.36		100	
1.18		100	
0.600		99	
0.425		73	
0.300		15	
0.150		3	
0.075		2

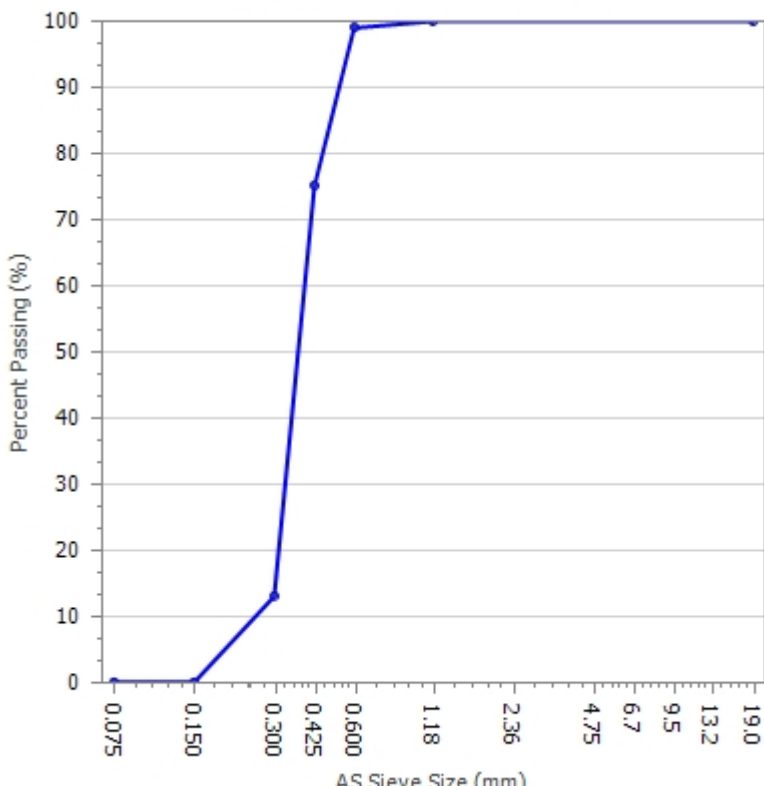
PARTICLE SIZE DISTRIBUTION GRAPH

AS Sieve (mm)	Specification Minimum	Percent Passing (%)	Specification Maximum
19.0		100	
1.18		100	
0.600		99	
0.425		75	
0.300		13	
0.150		0	
0.075		0
