Report on Closebourne House, Morpeth

Structural Report

LendLease Building (LLB) propose to construct a new residential aged care facility on a site adjacent to Closebourne Estate Retirement Living, near Morpeth, within the site of the State heritage listed item SHR00375.

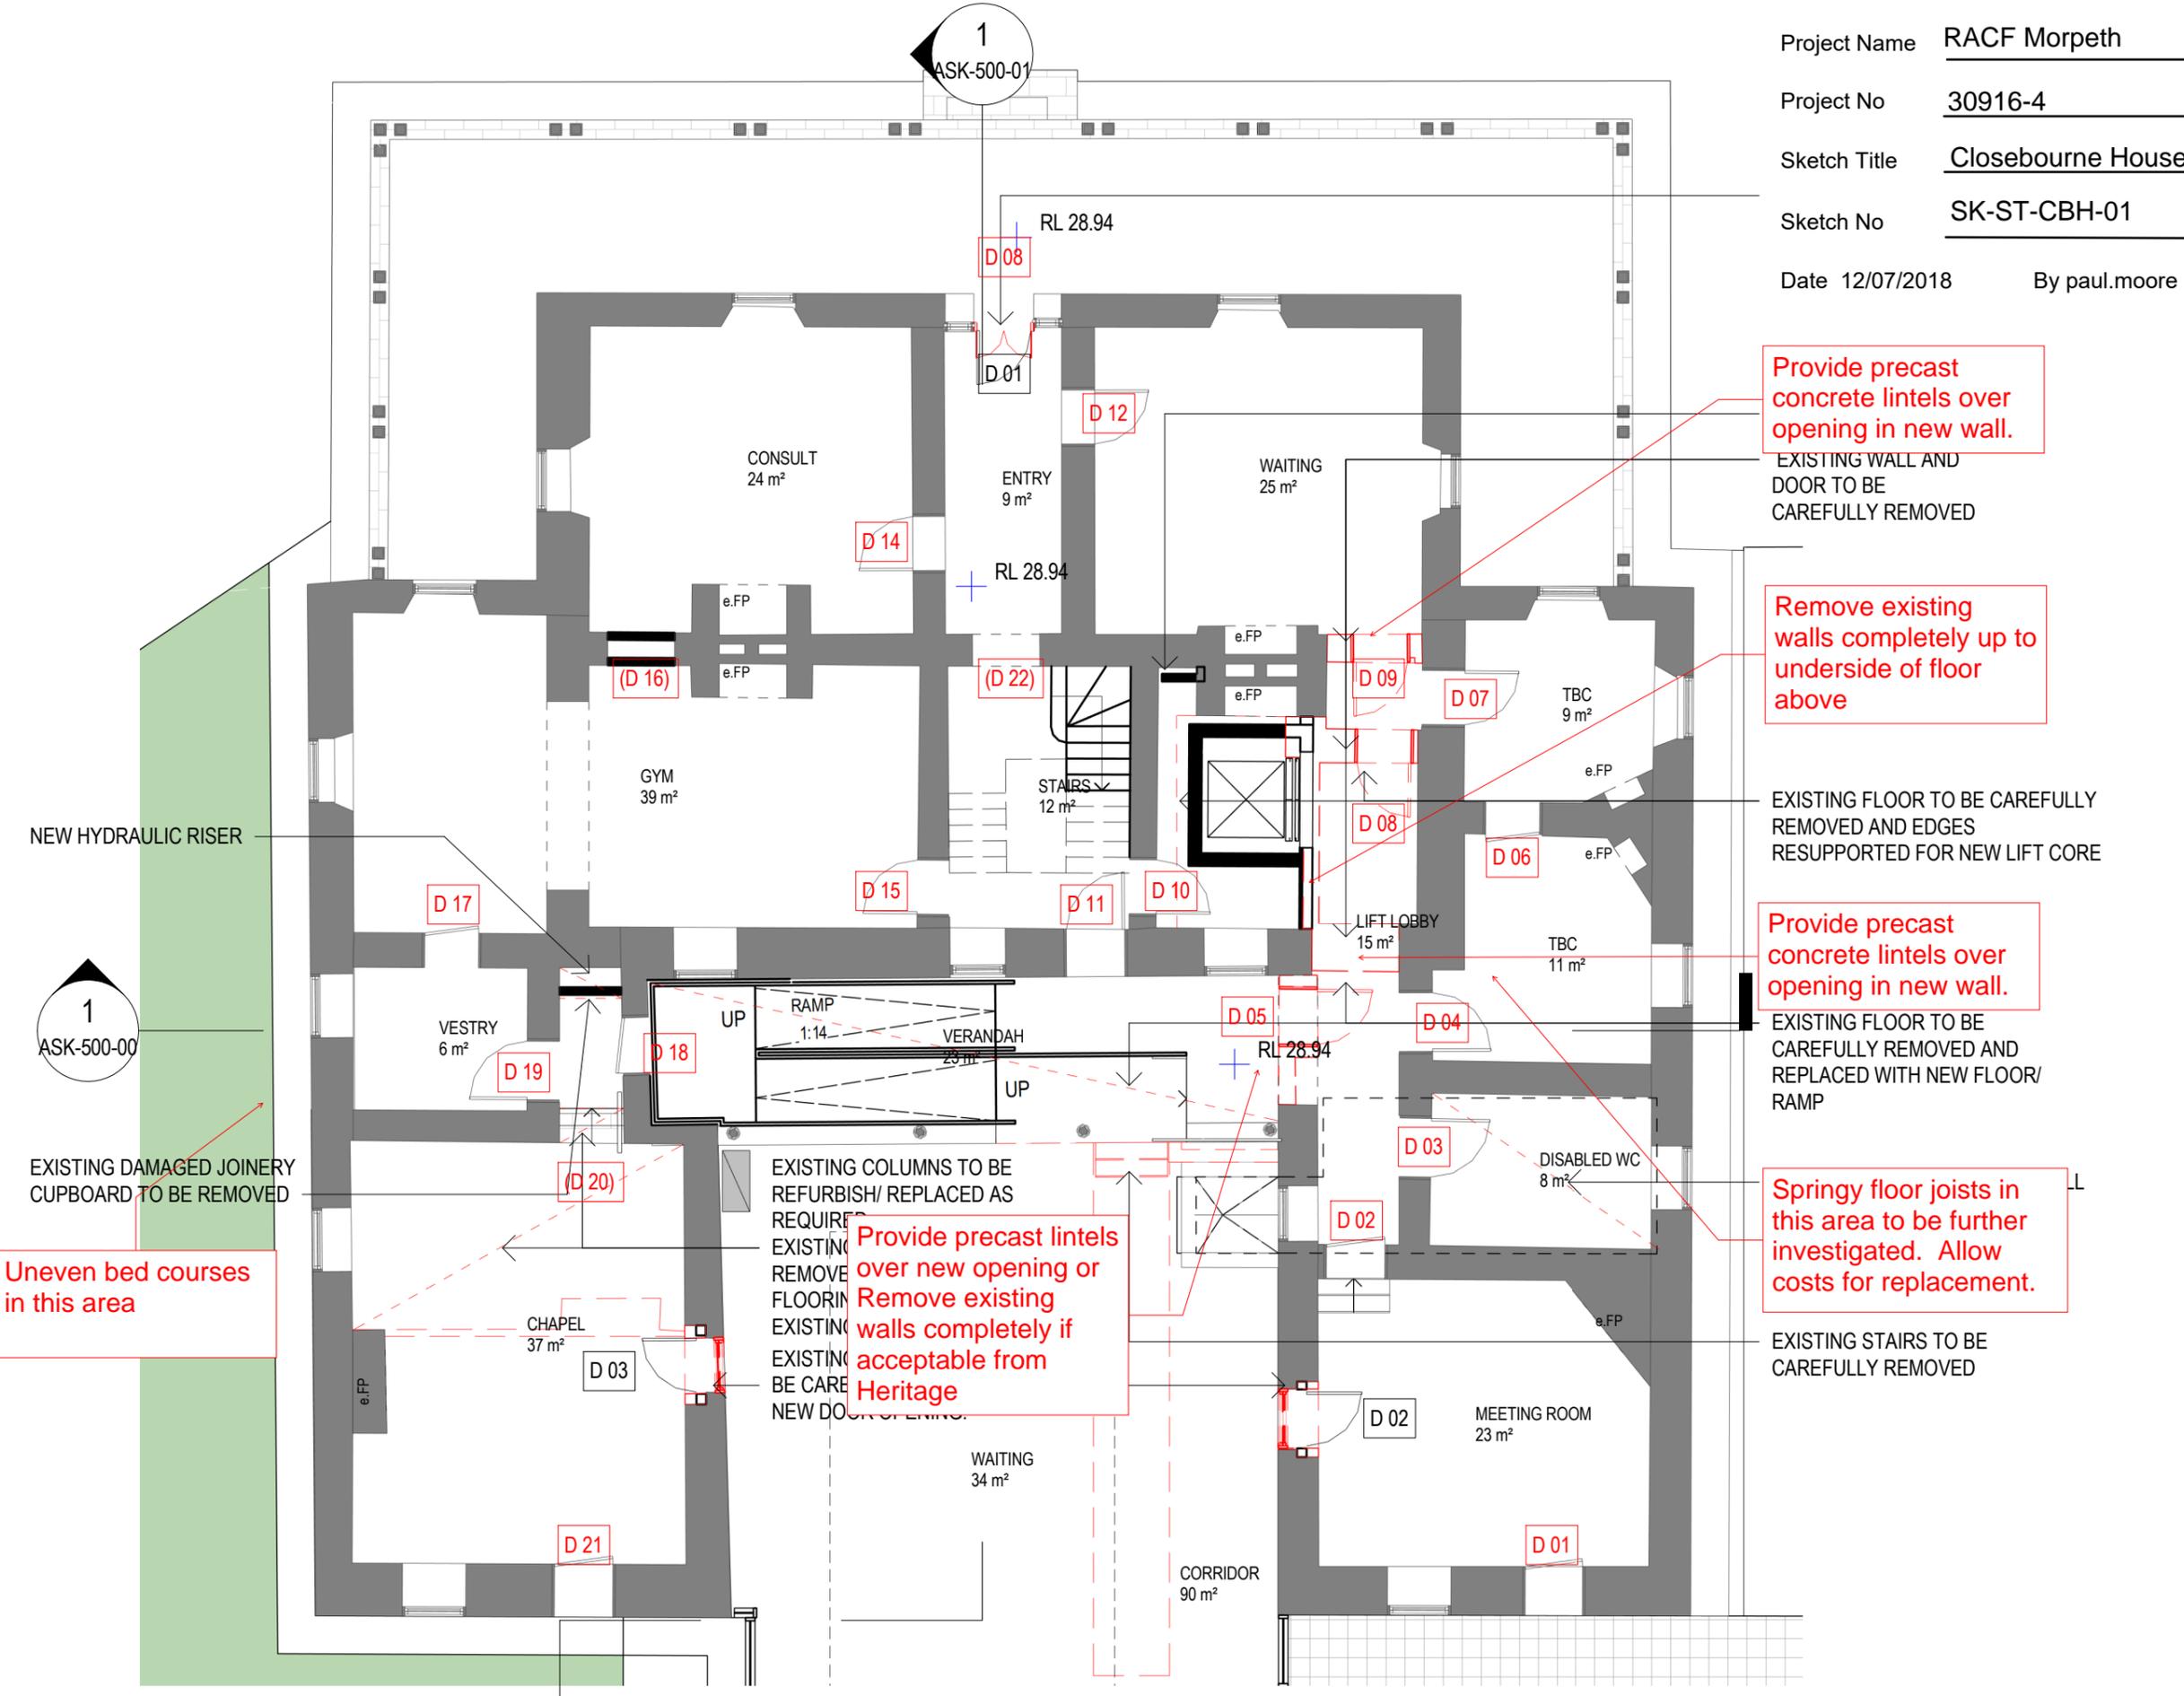
Project Name RACF Morpeth
 Project No 30916-4
 Sketch Title Closebourne House
 Sketch No SK-ST-CBH-01
 Date 12/07/2018 By paul.moore

- Leaking roof in many locations resulting in damp walls and floors on the upper storey.
- Uneven stone wall bed courses in the external wall of the west elevation as a result of settlement related movements. There are two very large trees nearby.
- 'Dropped' window head arches and minor cracks in the wall of the east elevation, alongside the area where there is a cellar under. We suspect that this is the result of long-standing minor settlement of footings locally.
- Extremely springy floor joists, possibly associated with rotten timber joist in one of the rooms in the East wing at ground floor level. This area is noted on the sketch SK-ST-CBH-01 in the Appendix.

Springy floor joists in this area to be further investigated. Allow costs for replacement.

Uneven bed courses in this area

- Replacement of the existing roof covering to prevent rainwater ingress.
- Re-pointing of cracks in the external bed joints over window arches and the installation of 5mm stainless steel reinforcing rods within bed courses locally in this area. Construction details will be provided as part of detailed design works.
- Further investigation of springy floor joists and replacement of joists found to be rotten. At this stage, we recommend that budget cost estimates allow for replacement of ground floor joists in the affected room – refer to sketch SK-ST-CBH-01.

Provide precast concrete lintels over opening in new wall.

Remove existing walls completely up to underside of floor above

Provide precast lintels over new opening or Remove existing walls completely if acceptable from Heritage

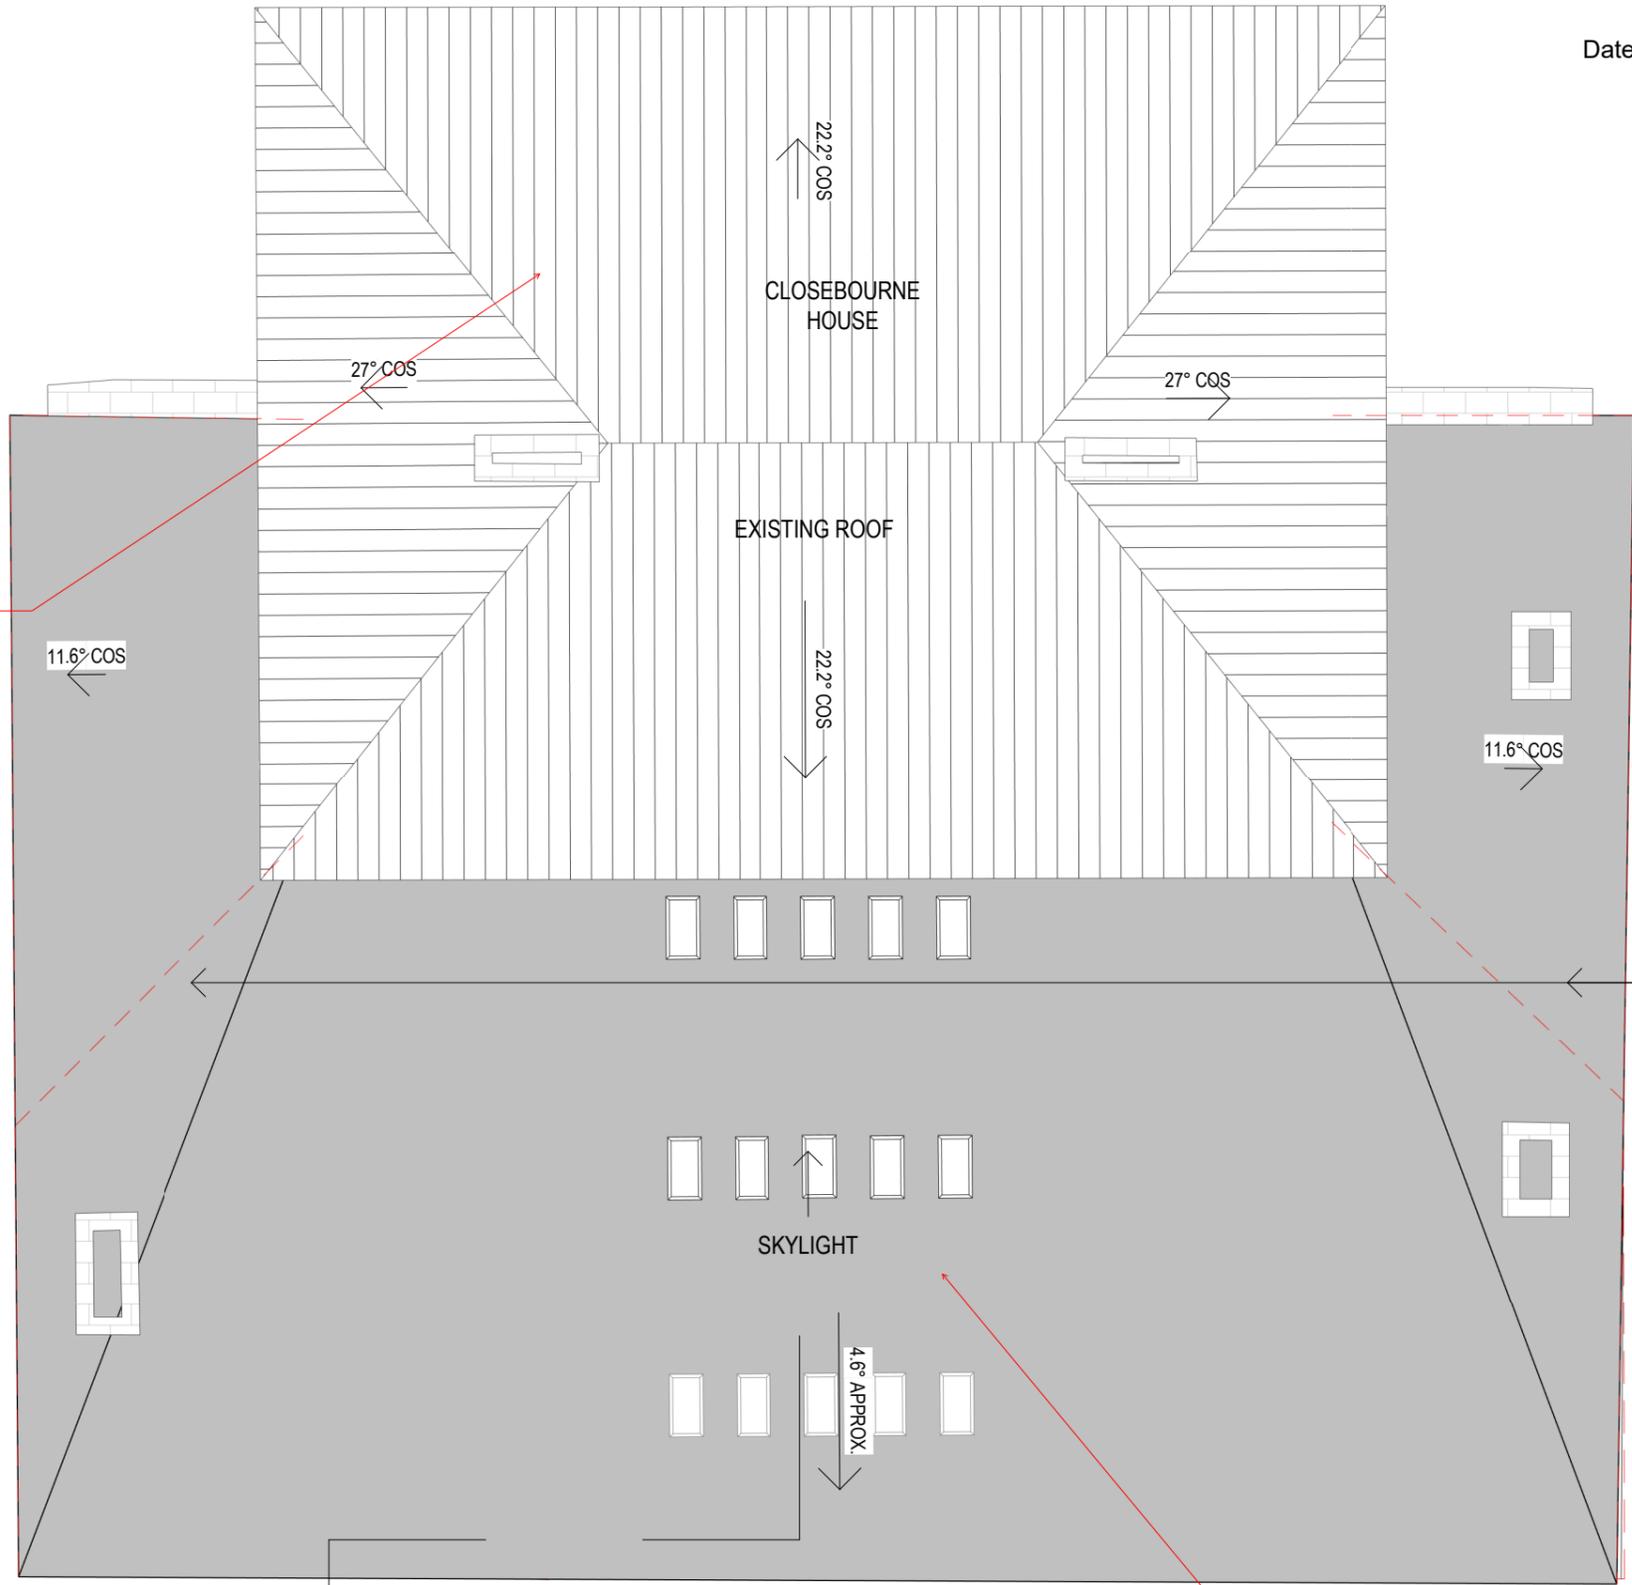
Project Name RACF Morpeth
 Project No 30916-4
 Sketch Title Closebourne House
 Sketch No SK-ST-CBH-03
 Date 12/07/2018 By paul.moore

New roof covering on existing roof structure - roof members to be checked for rot when existing roof is removed.

CAREFULLY REMOVE ROOF SHEETING. REPLACE WITH NEW METAL ROOF SHEETING. PROVIDE NEW FASCIA BOARD, EAVES GUTTER, SOFFIT LINING AND DOWNPIPES TO MATCH EXISTING TO FUTURE DETAILS

Structural details of new roof to be developed during detailed design stage

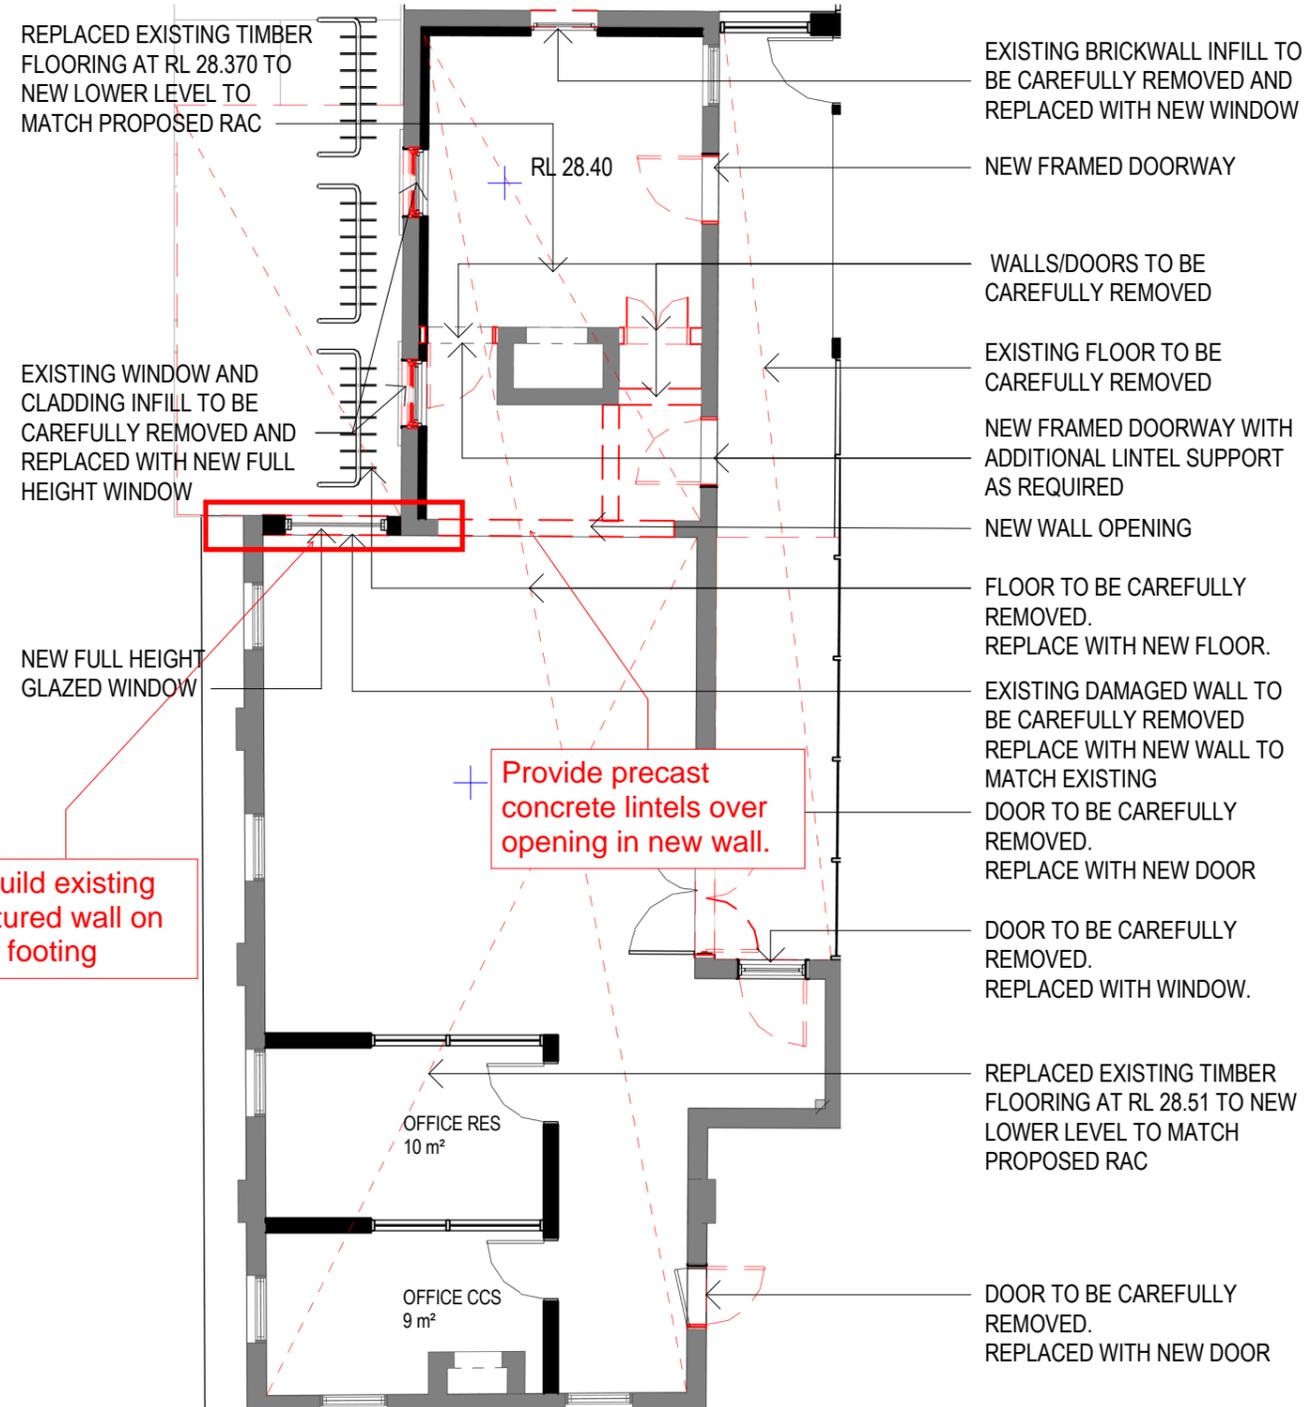
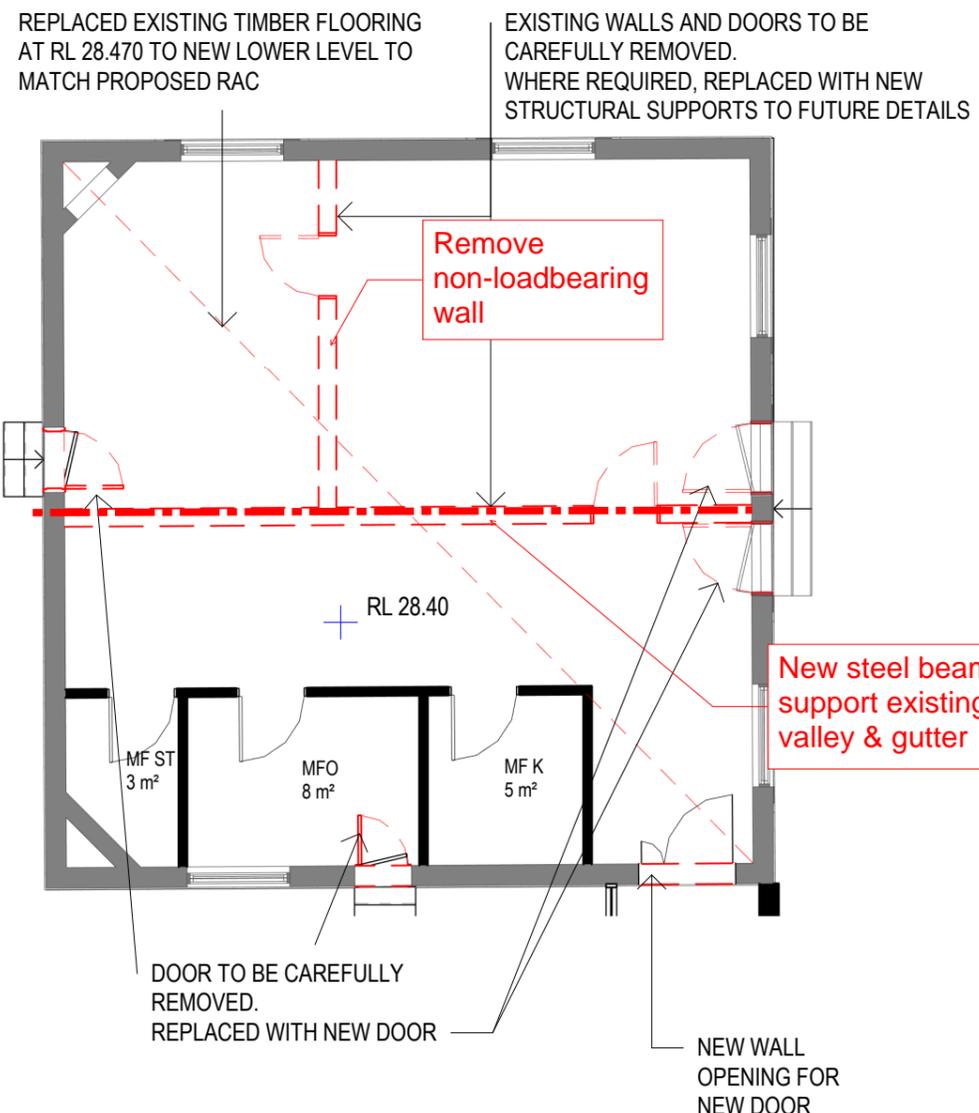
Project Name RACF Morpeth
Project No 30916-4
Sketch Title Closebourne House et al
Sketch No SK-ST-CBH-06
Date 12/07/2018 By paul.moore

The most significant defects in evidence relate to cracks in the brick wall on the north facing return wall on the rear (west) elevation. Cracks are located in a wall of the former Chapel building, close to where this return wall butts up against the former Laundry building. It appears that the newer section has suffered subsidence – related movement, possibly associated with nearby trees and their roots. The cracks are quite wide (75mm) and diagonal in nature, extending almost the full height of the wall.

It is also proposed to create an opening in the wall between the two sections of the building. We recommend that some portion of this wall be retained since this is the main element providing lateral stability to the central part of the building. It may be that this can be readily achieved by rebuilding the damaged section of return wall and a part of the internal cross wall as a continuous element. This is shown on sketch plan SK-ST-CHB-06 in the Appendix.

- Reconstruction of the short return wall of the newer building, which contains significant cracks. The replacement wall will be constructed on new footings. We recommend that this new construction be extended into the building to maintain lateral stability after the creation of a new opening in the internal wall.

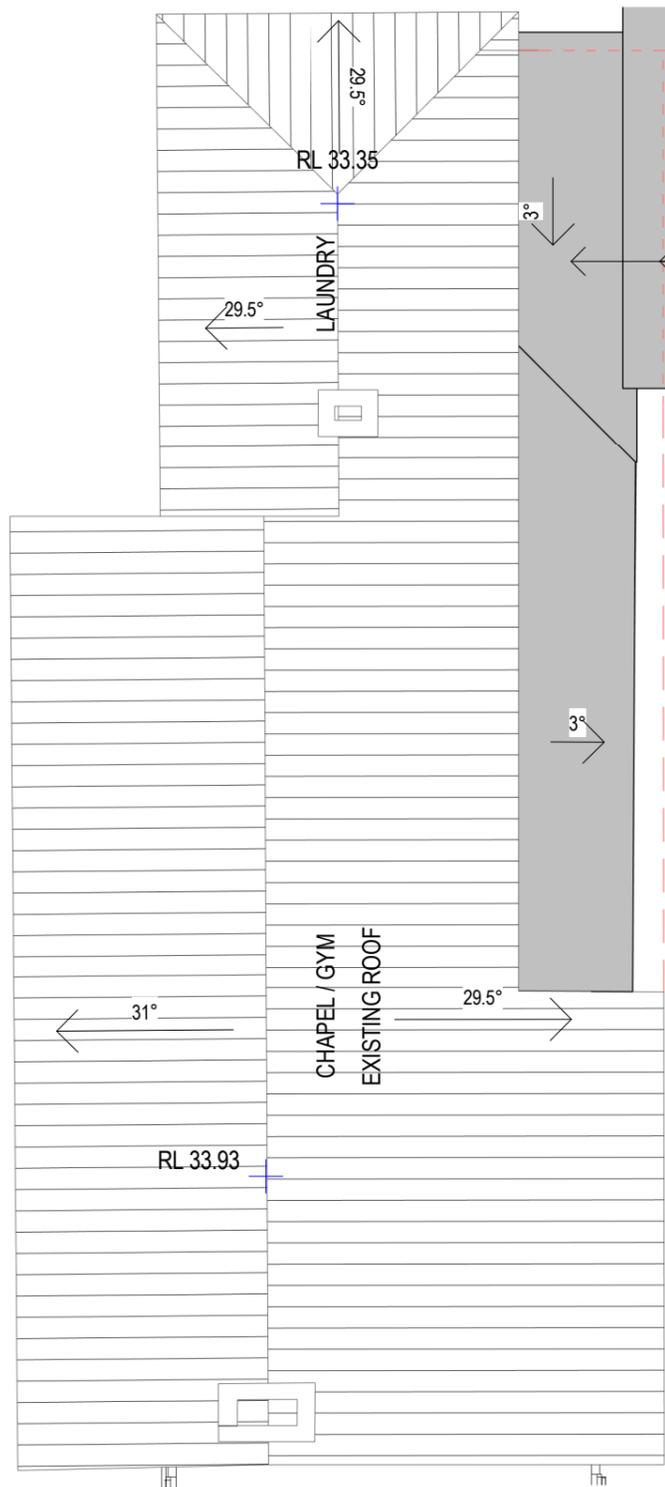
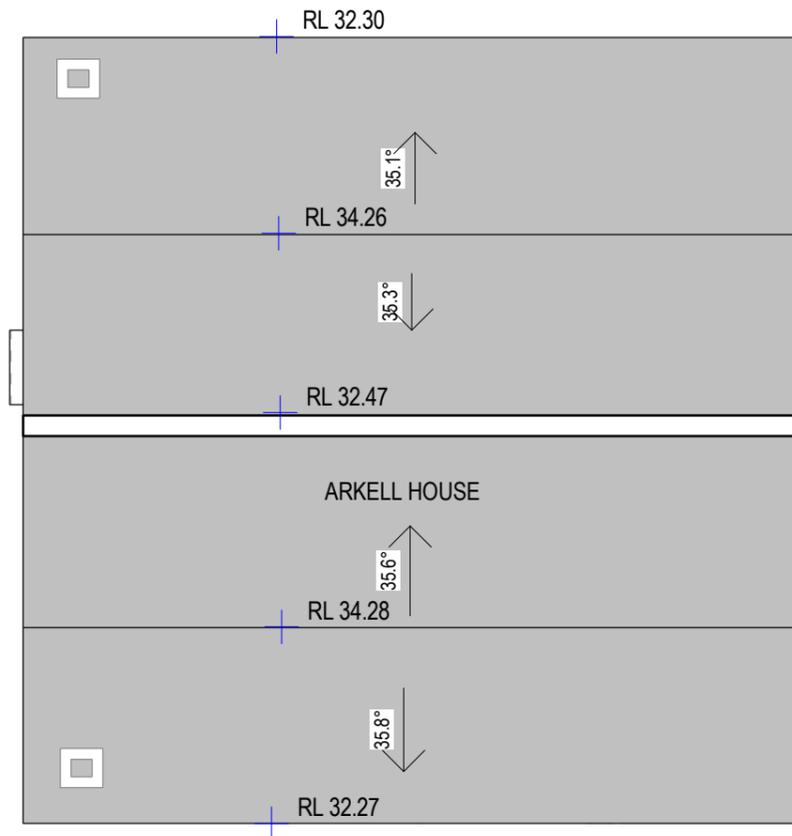
Project Name RACF Morpeth
 Project No 30916-4
 Sketch Title Closebourne House et al
 Sketch No SK-ST-CBH-07
 Date 12/07/2018 By paul.moore

The building forming Arkell House is a single storey building built in brick beneath a double pitched roof with a central wide box gutter. Between the two duo-pitches is a valley gutter, which appears to be blocked by leaves and debris in places.

EXISTING BOX GUTTER TO BE REPLACED

- Removal and replacement of corroded steel lintels over window and door openings, couple with repositioning of resulting cracks in brickwork.
- Cleaning out the valley gutter and relining, along with replacement of downpipes to ensure good draining of the roof.

CAREFULLY REMOVE EXISTING ROOFING AND REPLACE WITH NEW LOWER METAL ROOF

CAREFULLY REMOVE ROOFING AND REPLACE WITH NEW METAL ROOF SHEETING
