Our ref: 754-NTLGE220504-1-AC.Rev2

Proposed Multi-Storey and Multi Building Development - DA 2019/00061 - 11-17 Mosbri Crescent The Hill - Slope Stability Risk

Project 81843.00
November 2015

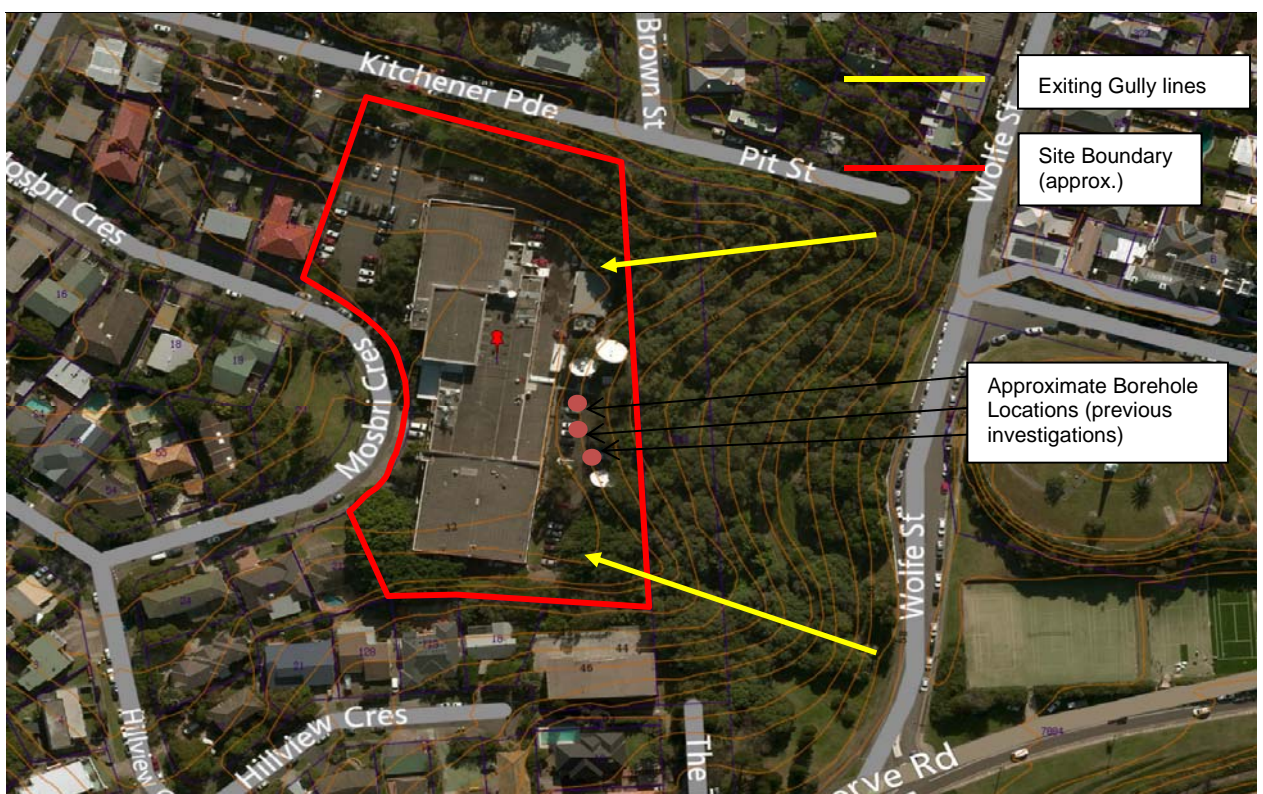
Figure 2: Elevation contours (2 m) at Mosbri Street Site Location

Elevation contours for the site are shown in Figure 2. Two existing gully lines were observed during the site visit extending from the eastern site boundary adjacent to Wolfe Street through the adjacent vegetated reserve towards the site.

- Based on the site walkover, no evidence of deep seated or overall slope instability was observed;
- Some evidence of very minor creep or translational sliding was observed in the gullies of the adjoining property to the east (Figure 2);

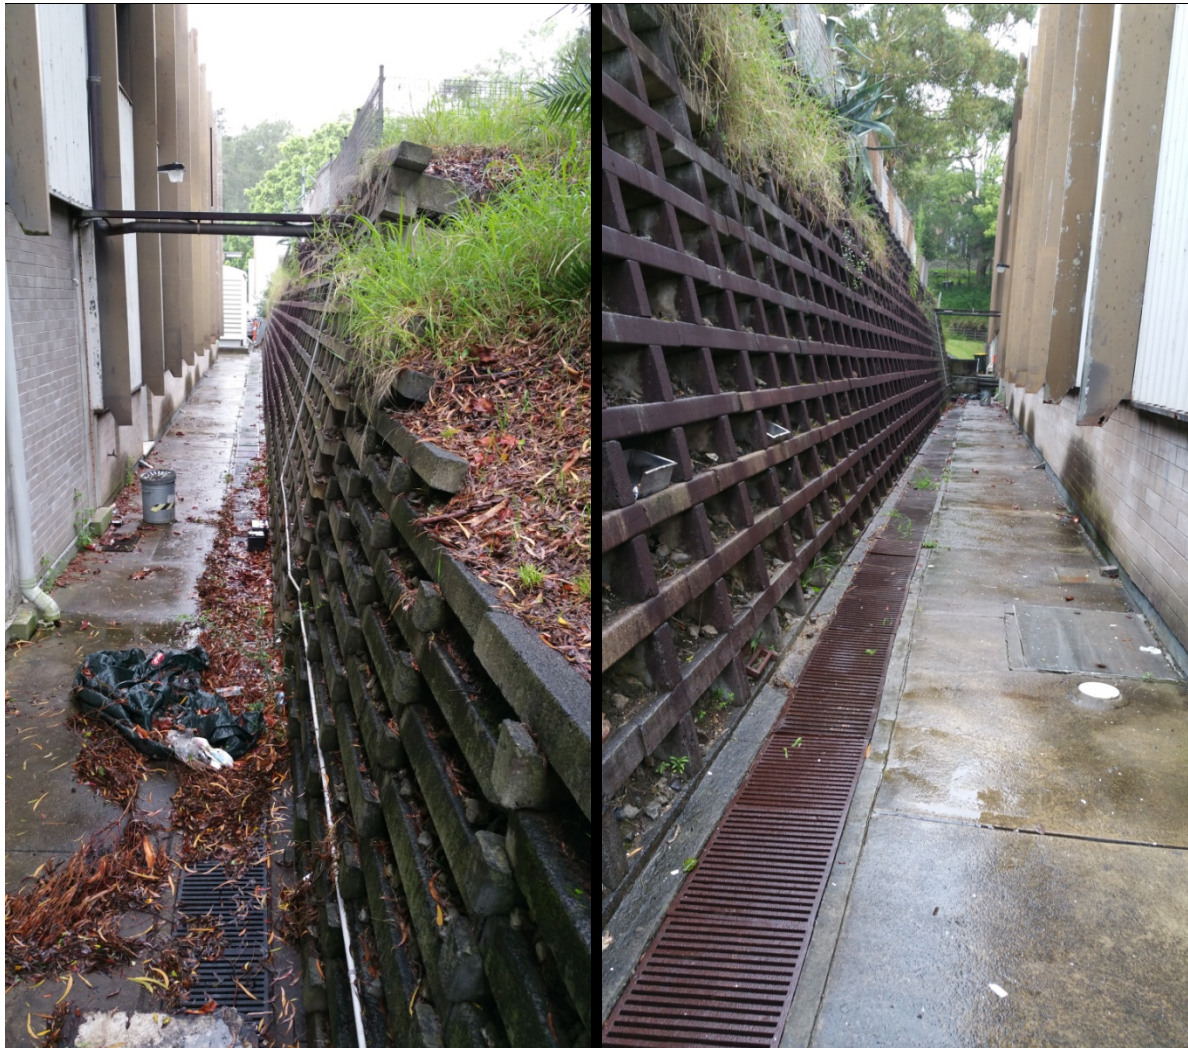
Figure 3: Existing Crib Retaining Wall along Eastern edge of existing NBN building (looking north, looking south)

The existing NBN building has been extensively cut into the landscape and is surrounded on the northern, eastern and southern edges by crib retaining walls (refer Figure 3).

- In the absence of detailed design and works-as-executed drawings, it is not possible to comment on the suitability of an existing retaining wall. Nonetheless, the existing crib walls immediately surrounding the NBN building (Figure 3 and Figure 6) do not appear to show evidence of significant distress. The crib walls along the southern, eastern and northern site boundaries (Figure 4 and Figure 6) do show signs of localised distress and spalling that has exposed the internal reinforcement. This reinforcement has corroded significantly where spalling has occurred;

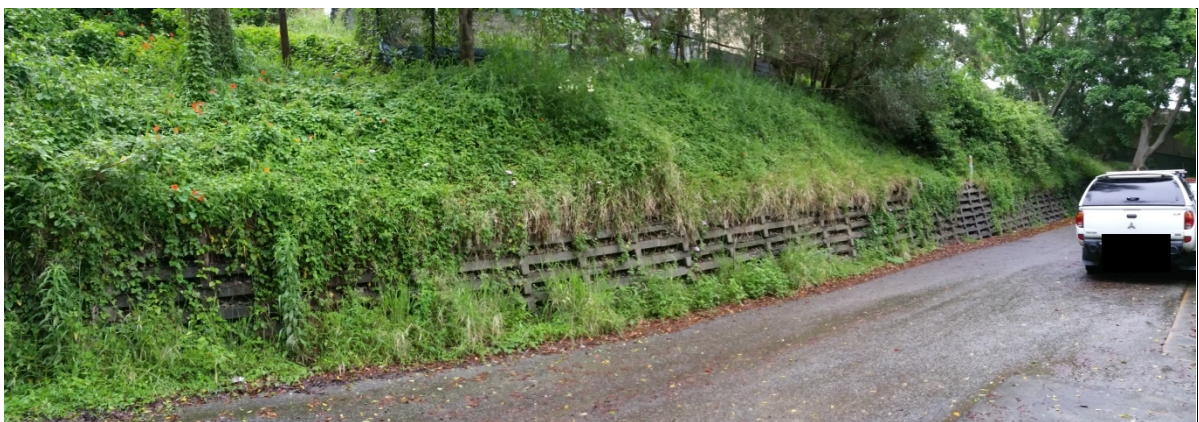
Figure 4: Existing Crib Retaining Wall along Southern Site Boundary (looking west)

In addition to the retaining walls surrounding the main NBN building, the northern, eastern and southern car park / pavement areas are also supported by a mixture of crib and rock retaining walls (refer Figure 4, Figure 5 and Figure 6).

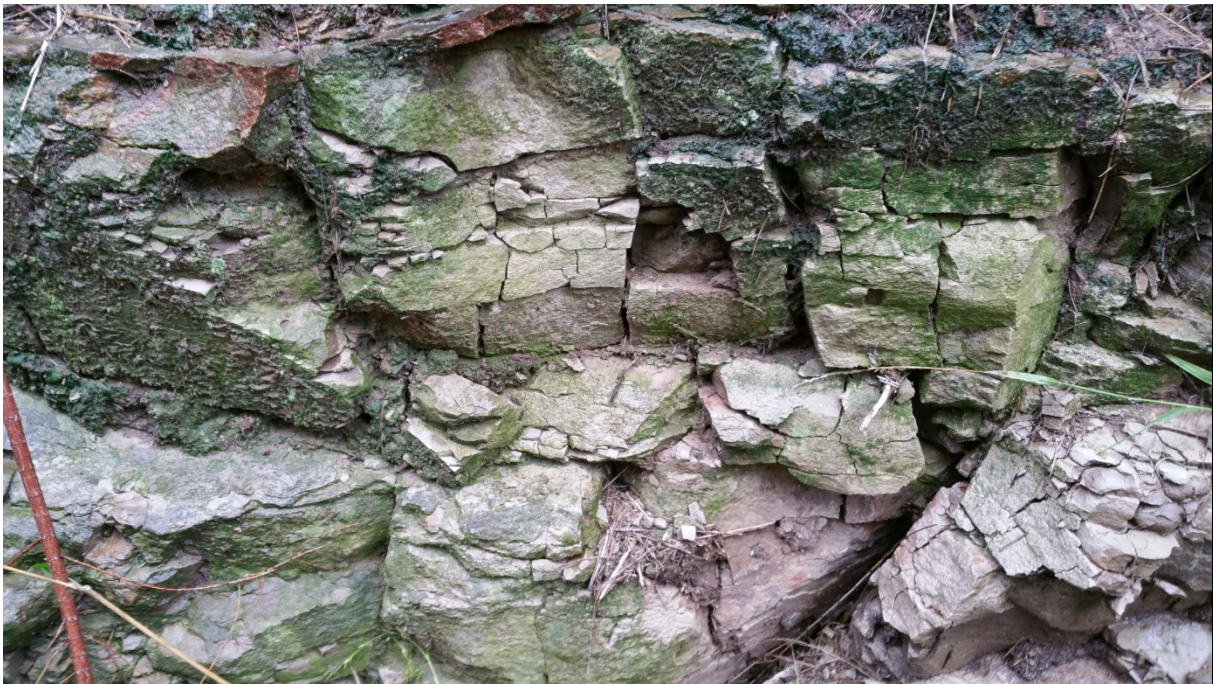
Figure 7: Exposed Siltstone along parts of eastern boundary (adjacent to air conditioning containers)

From the eastern boundary of the site the terrain slopes down to the west with a slope of about 14° to 17° which terminates at the crest of a cutting which ranges in height from about 1.25 m to 1.75 m. The bottom 1.25 m of the cutting is battered at a 75° angle and faced with mortared rock blocks. No weep holes were observed in the rock facing (Figure 5). The upper section of the cutting, where present, has been battered to a slope ranging from 35° to 50°. The material exposed on the face of the cut batter is predominantly clay soil with some intermittent exposures of extremely weathered siltstone.

From the toe of the rock facing, the terrain slopes at about 5° to the west for a distance of about 12 m. This area is presently a bitumen paved car park.

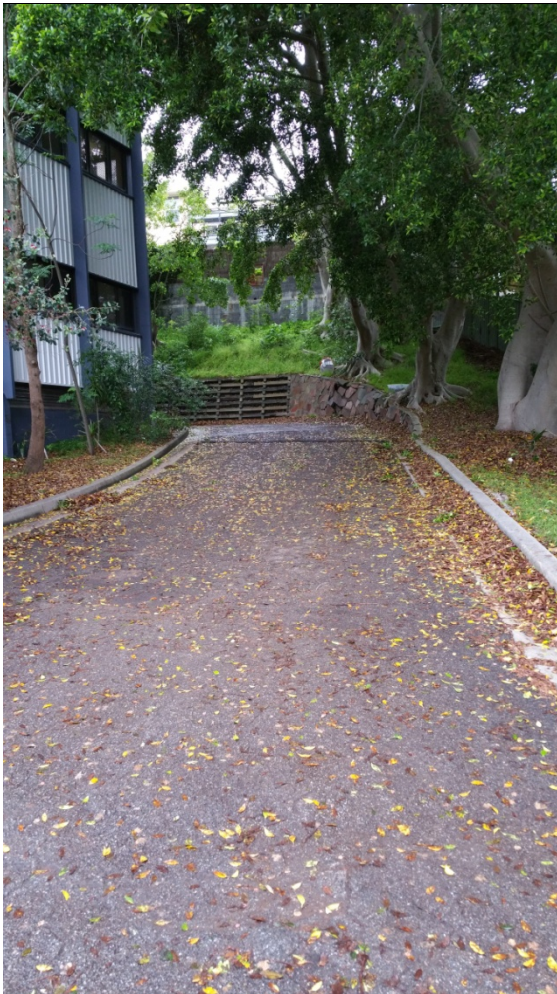
Figure 8: Large diameter trees along far southern boundary adjoining Mosbri Crescent

The northern and southern boundaries are grass covered with she-oaks and other shrubs with a basal diameter of up to 200 mm, several very large diameter trees exist along the very far length of the southern boundary.

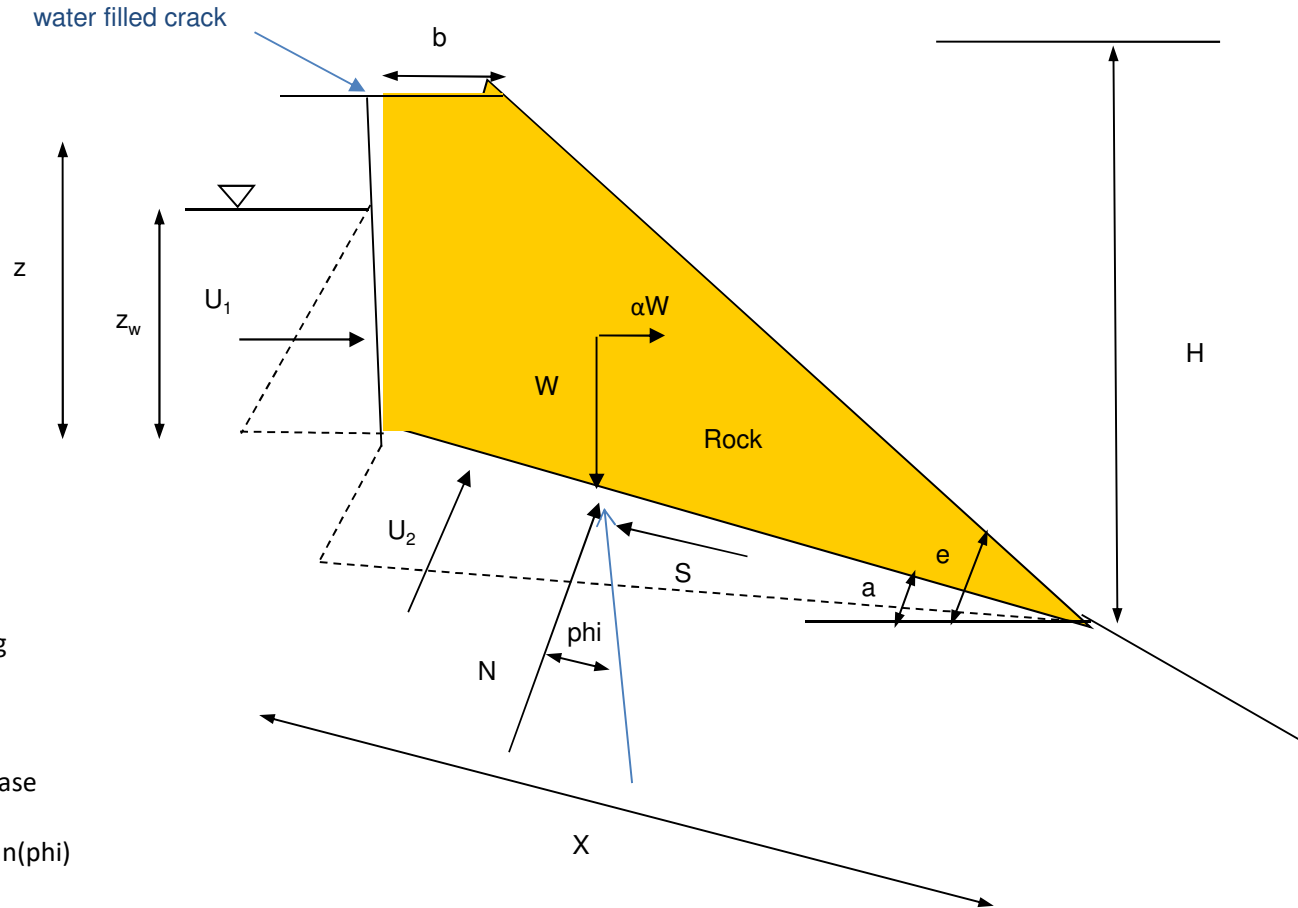
Ref: Hoek, 2000

- Key:
- H = Slope Height
 - b = distance crack behind crest
 - e = slope dip angle
 - a = bedding dip angle
 - X = Rock Wedge basal Contact Length
 - W = Rock Wedge Weight
 - g = gravity constant
 - α = earthquake acceleration as proportion of g
 - z = crack depth
 - z_w = water depth in crack
 - U_1 = Horizontal Water Pressure Force
 - U_2 = Normal water pressure force acting on base
 - N = Normal resistance force acting on base
 - S = Shear Strength of bedding plane = $c' + N \tan(\phi)$

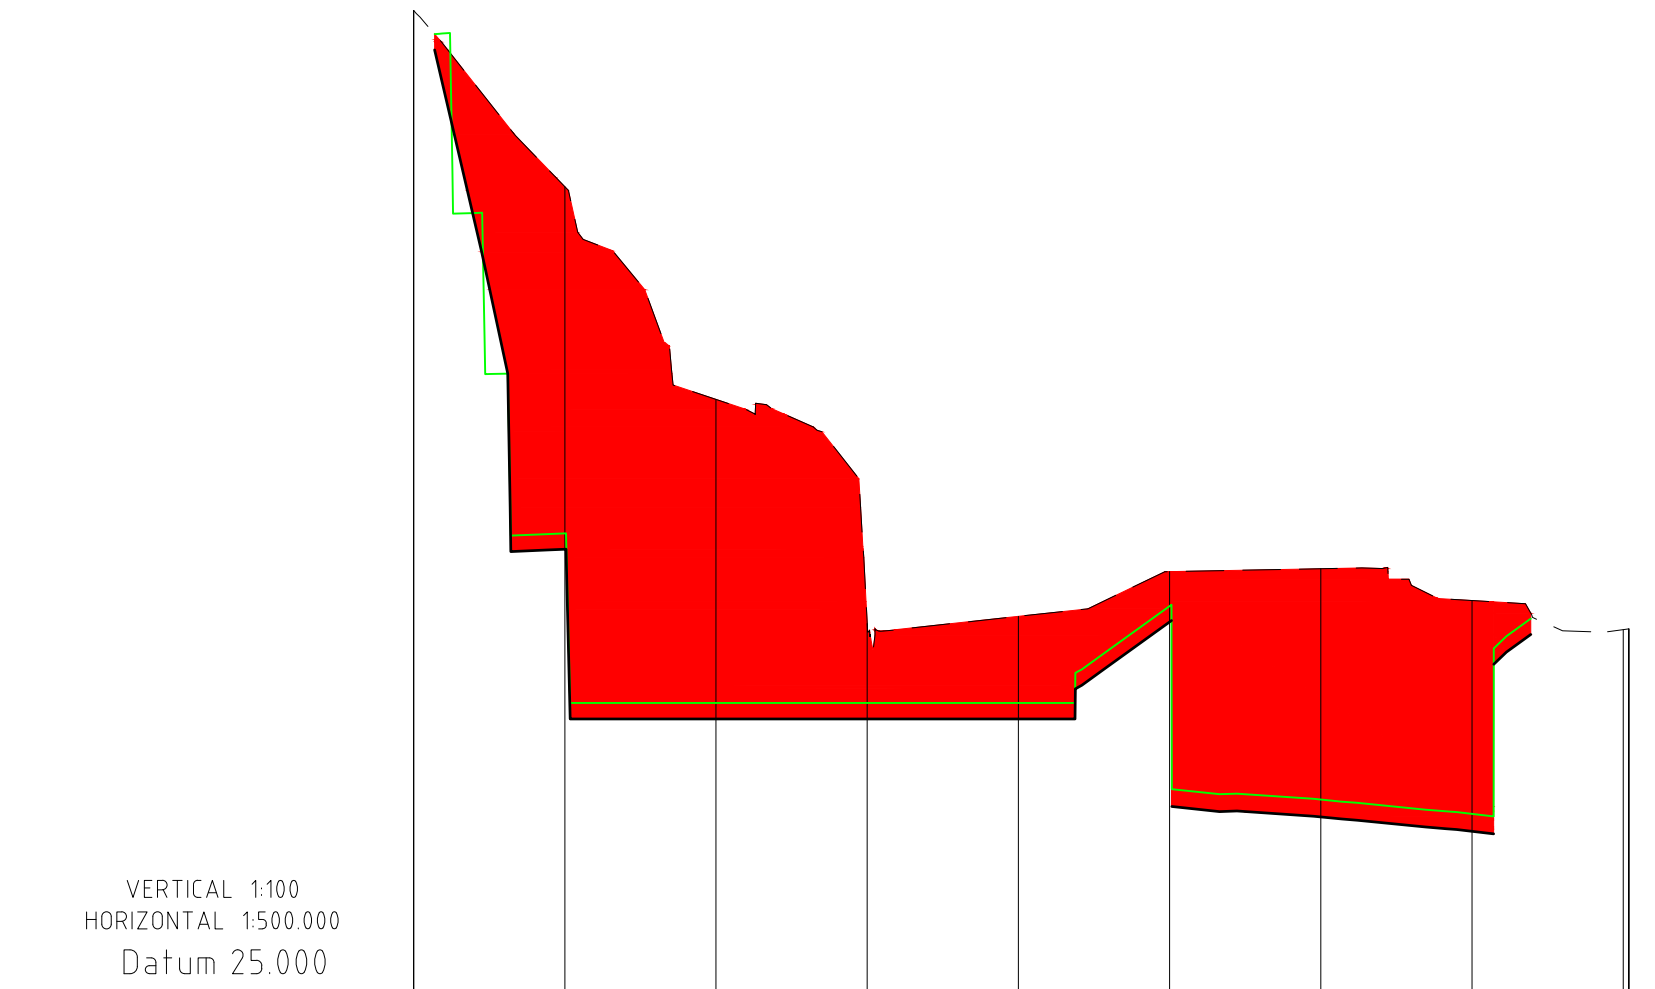
SECTION D - LONG SECTION

DESIGN - BEL	EXISTING LEVELS	DEPTH	DESIGN - FSL	CHAINAGE
31.034	35.829	-4.795	31.244	0.000
28.790	33.016	-4.226	29.000	10.000
28.790	30.051	-1.261	29.000	20.000
28.790	30.147	-1.357	29.000	30.000
30.072	30.738	-0.666	30.282	40.000
27.493	30.777	-3.284	27.723	50.000
27.304	30.356	-3.052	27.534	60.000
27.304	29.970	-3.052	27.534	70.000
27.304	29.970	-3.052	27.534	80.000
27.304	29.970	-3.052	27.534	80.375
