**Crescent Newcastle Pty Ltd C/- Stronach  
Property Pty Ltd.**

**Preliminary Contamination Assessment**

Proposed Multi-Building Residential  
Development 11-17 Mosbri Crescent, Cooks Hill

754-NTLGE220504-AB

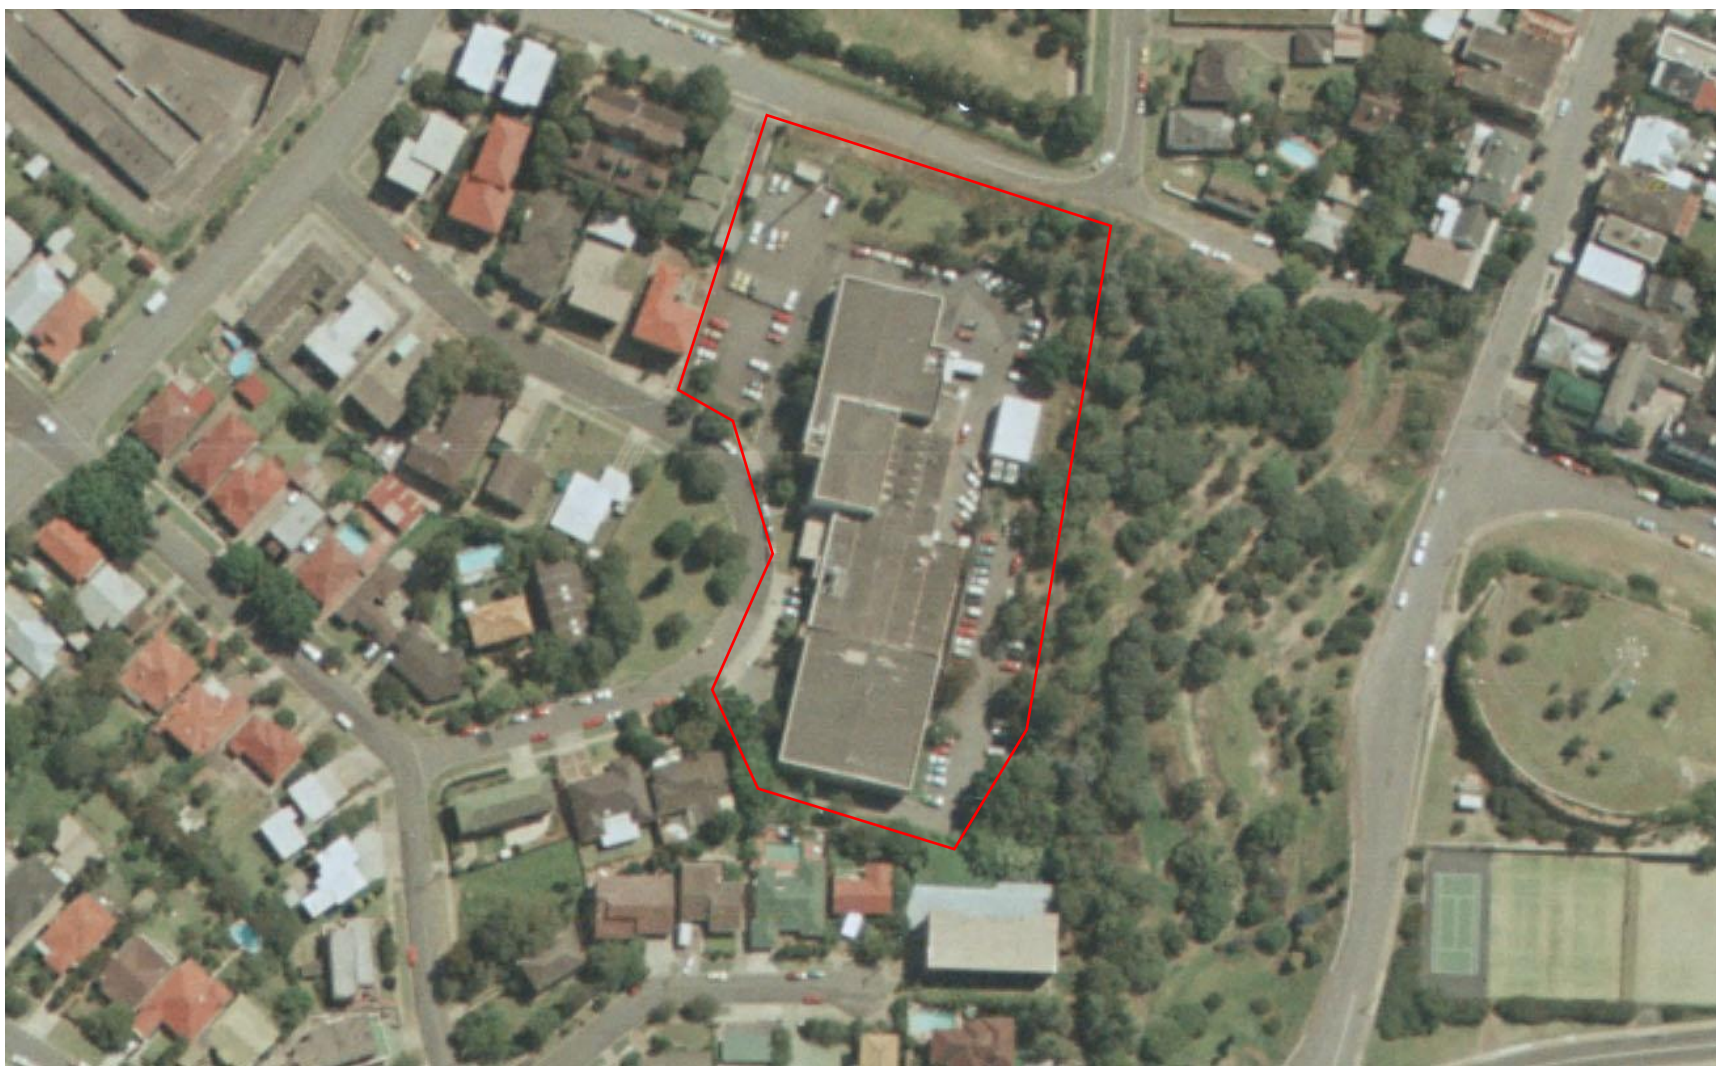
| Date | Site | Surrounding Land |
|---|---|---|
| 1993 | The site is generally unchanged when compared to the 1987 photograph. | No changes in the general surrounds are observed. Vegetation regrowth continues in the eastern vacant lot. |

*Historical Aerial 5 - 1993 Generally Unchanged Site Arrangement*

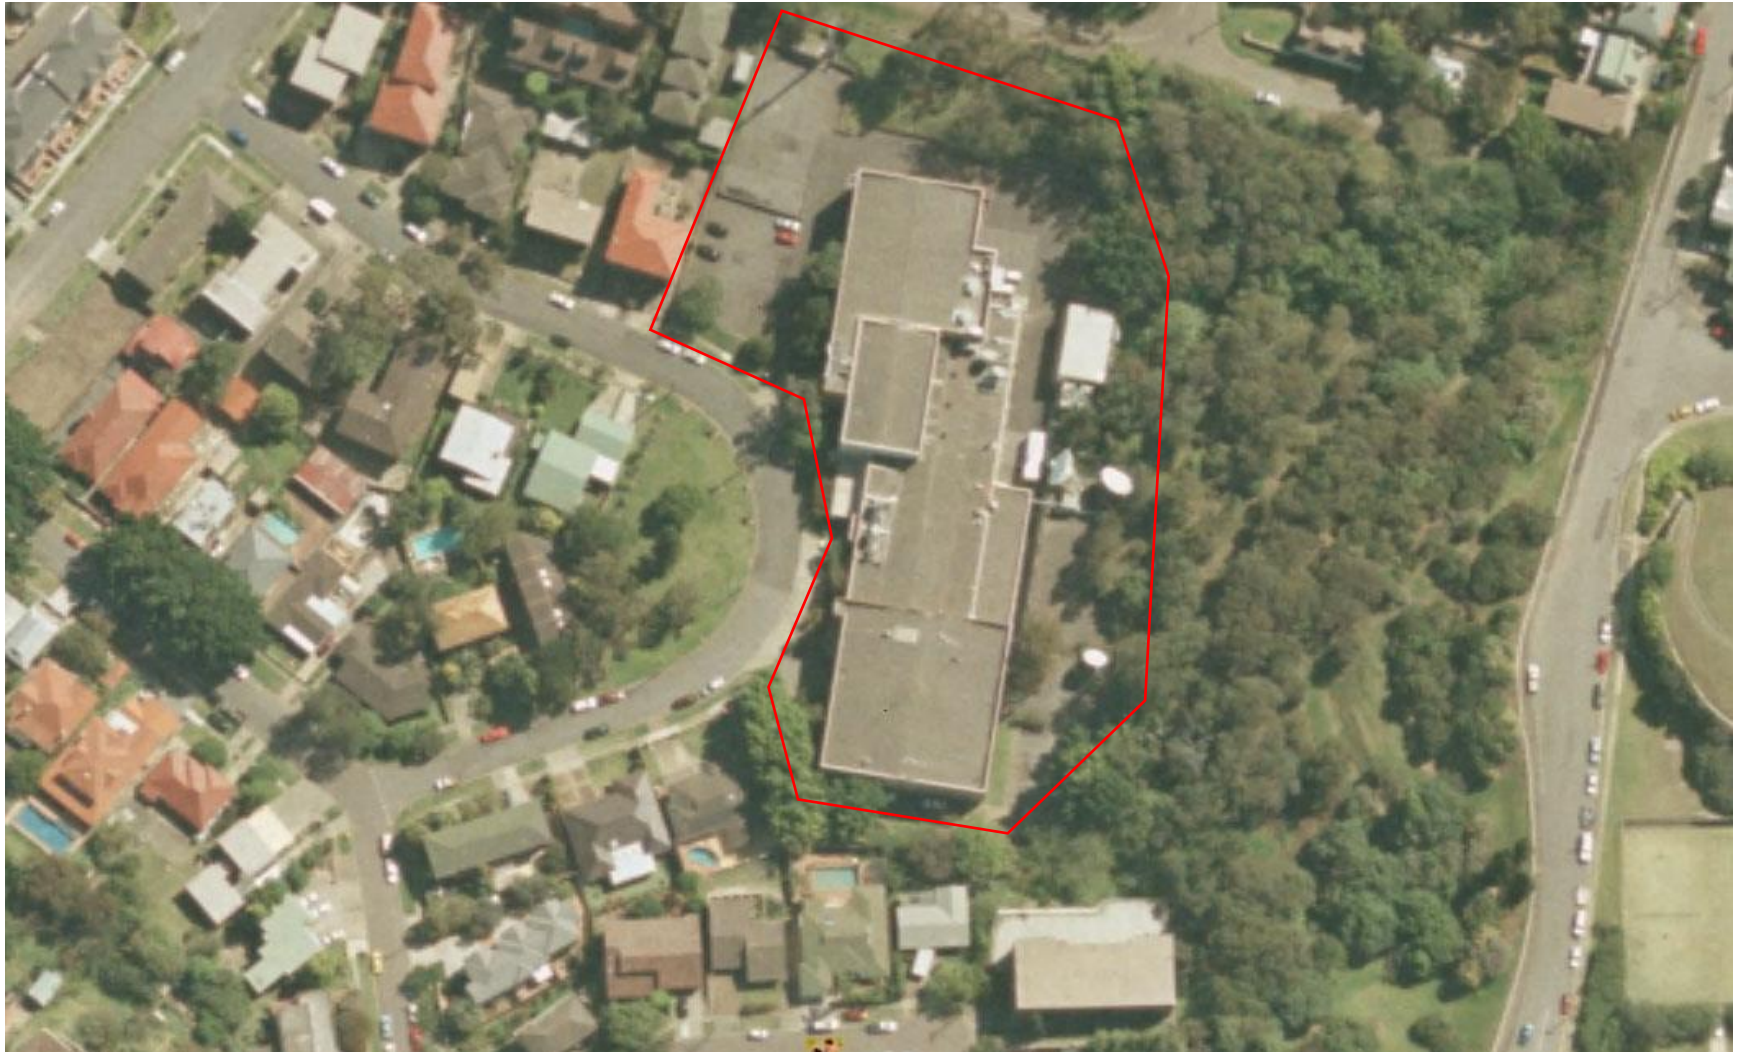
| Date | Site | Surrounding Land |
|---|---|---|
| 2004 | The site is generally unchanged when compared to the 1993 photograph. Three satellite/communication dishes are visible on the eastern side of the main building. | No changes in the general surrounds are observed. Vegetation regrowth continues in the eastern vacant lot with a well-established tree canopy now in place. |

*Historical Aerial 6 - 2004 Showing a Generally Unchanged Site Arrangement*

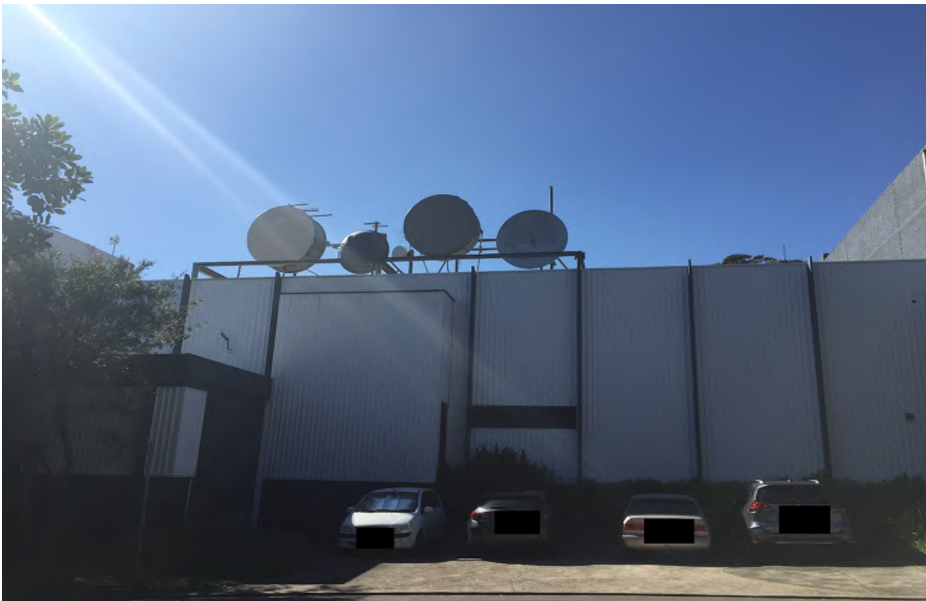
Photo 2: Looking east across the site with communications infrastructure visible on the roof

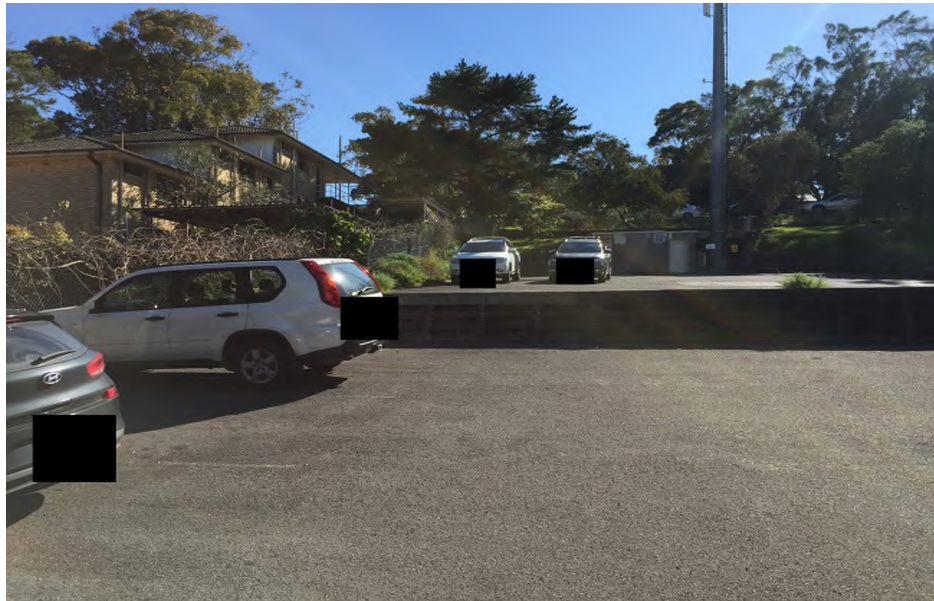
Photo 3: Car parking on multiple terraced levels (western section of the Site)

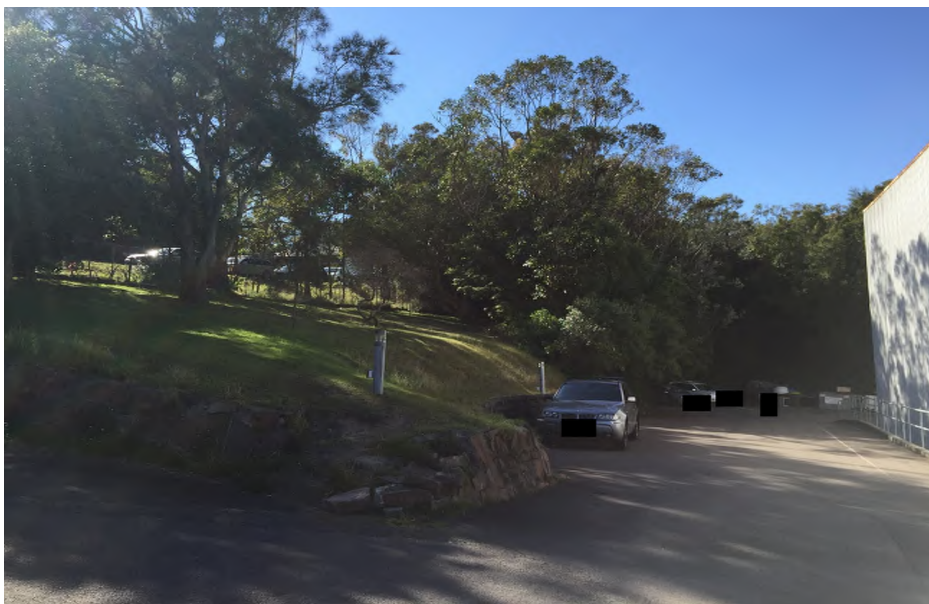
Photo 4: Terracing of the landscape at the northern section of the Site.

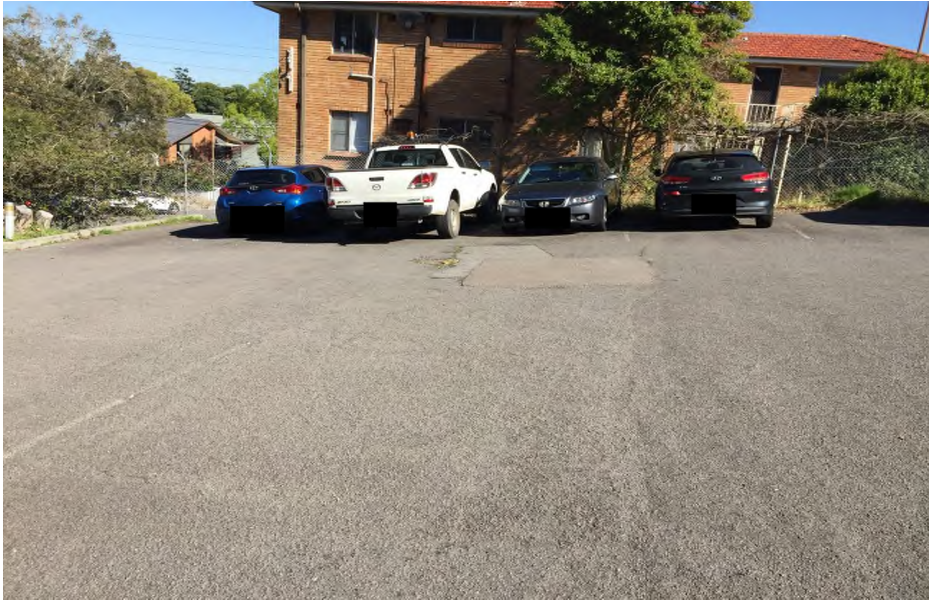
- The asphalt surfaces were generally observed to be in good condition. Some cracking was observed in areas – Appendix E, Photos 5 and 6;
- A cooling tank/tower was observed in the eastern portion of the site – Appendix E, Photo 7;

Photo 5: Asphalt surface condition in car park

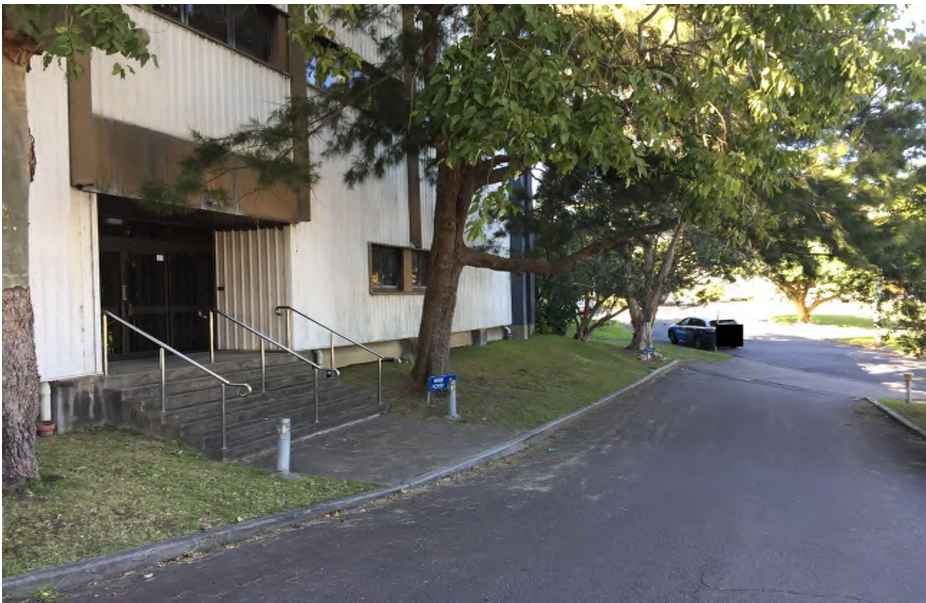
Photo 6: Asphalt surface condition along internal roadway

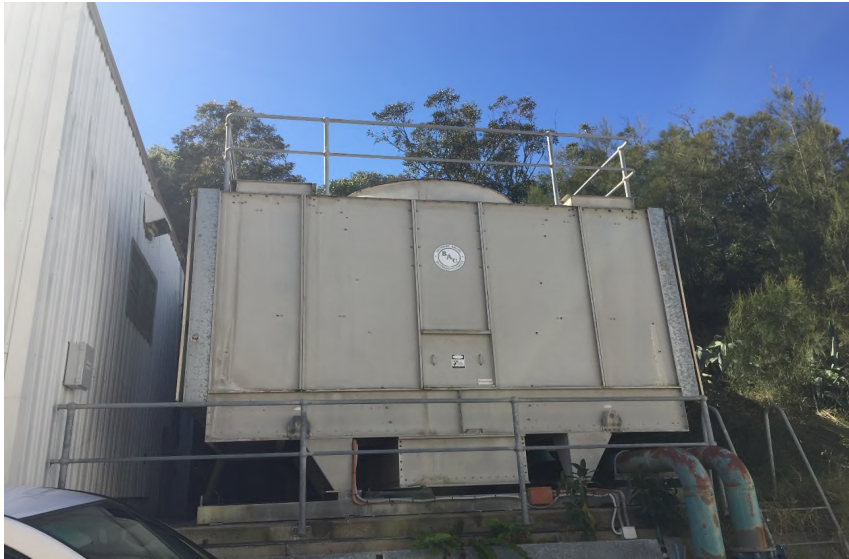
Photo 7: Cooling Tank on the eastern portion of the Site

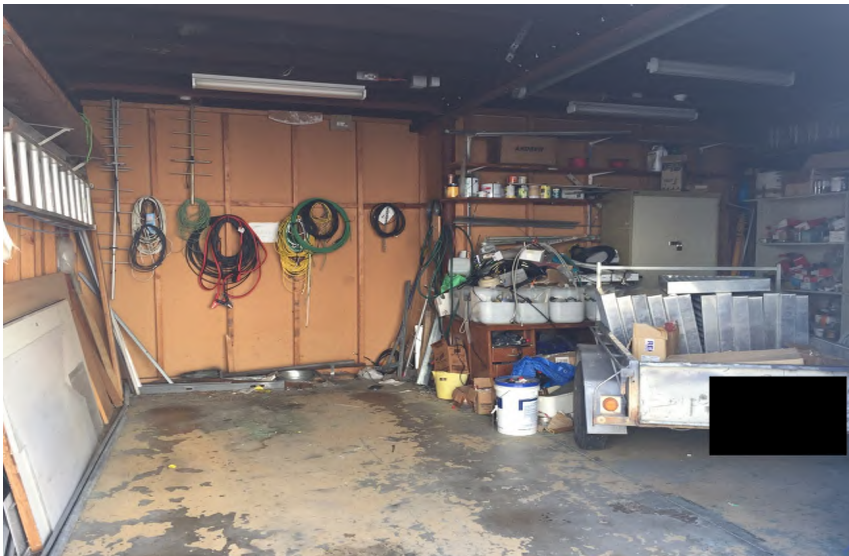
- There were no chemical storage sheds observed, however there was some paint (a few paint cans of different volumes) observed in storage sheds on the eastern side of the property – Appendix E, Photo 8;

Photo 8: Paint stored in shed on the eastern portion of the Site

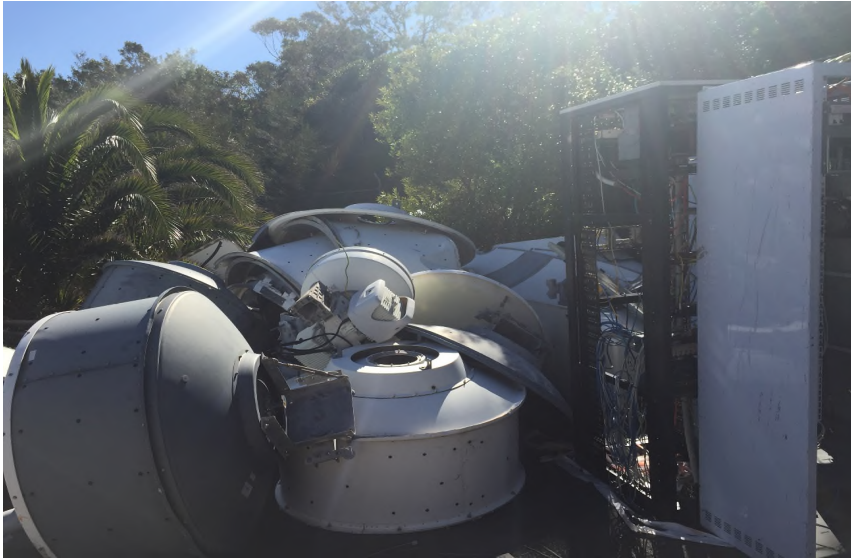
- There was some disused and scrap machinery and other pieces of large solid waste observed to the eastern side of the property – Appendix E, Photo 9;
- Satellite/communication dishes were observed along the eastern side of the property – Appendix E, Photo 10;

Photo 9: Scrap machinery on the eastern portion of the property

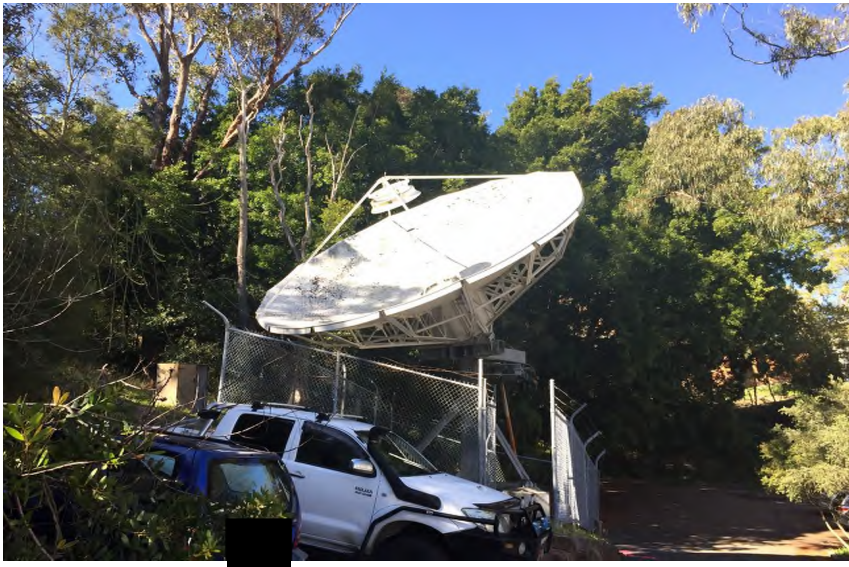
Photo 10: Satellite dish (disused) on the eastern portion of the property

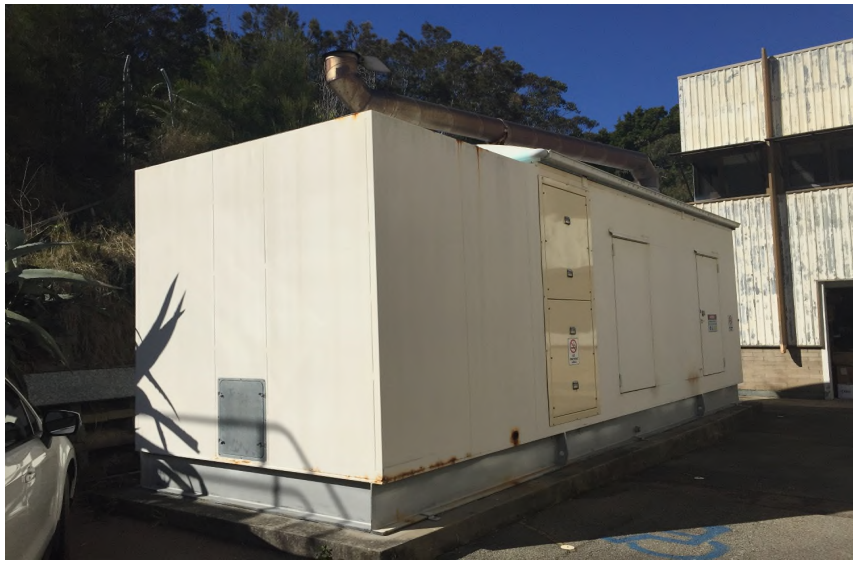
- An electrical stand-by generator was observed to the north-eastern extent (eastern side) of the property – Appendix E, Photo 11.

| AEC | Potentially Contaminating Activity | Potential COCs | Likelihood of Contamination* | Comments |
|---|---|---|---|---|
| 3 Electrical generator | Potential for leaks and spills of oil and fuel | TRH, PAH | Low | Generator was placed on a hardstand pad, in a closed bunded enclosure. |

Photo 11: Stand-by generator located in the eastern section of the Site

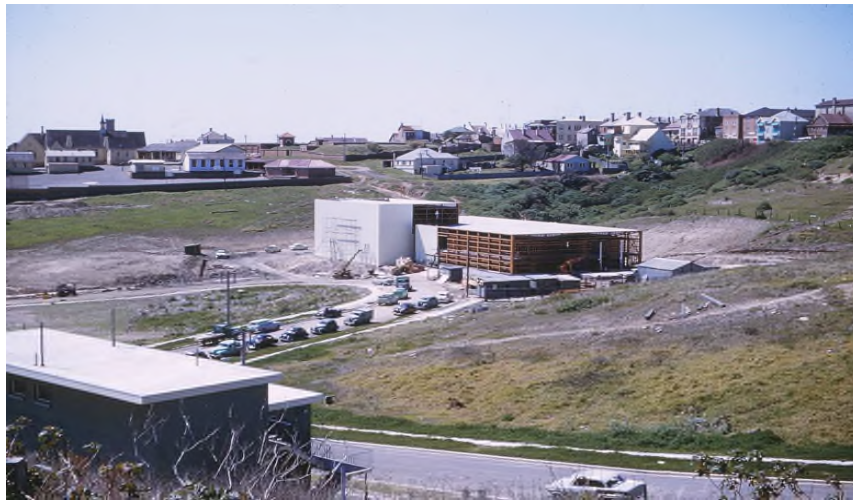
Photo 12: Historic image of progression of construction taking place into the cut in the hill. Photo Credit (Unknown) - Sourced Newcastle Lost Facebook Page (September 2018)
