Crescent Newcastle Pty Ltd
Proposed Development 11-17 Mosbri Crescent, The Hill
Groundwater assessment
NTLGE220504-SB

Groundwater Assessment Report - 11-17 Mosbri Crescent, Newcastle

NTLGE220504-SB

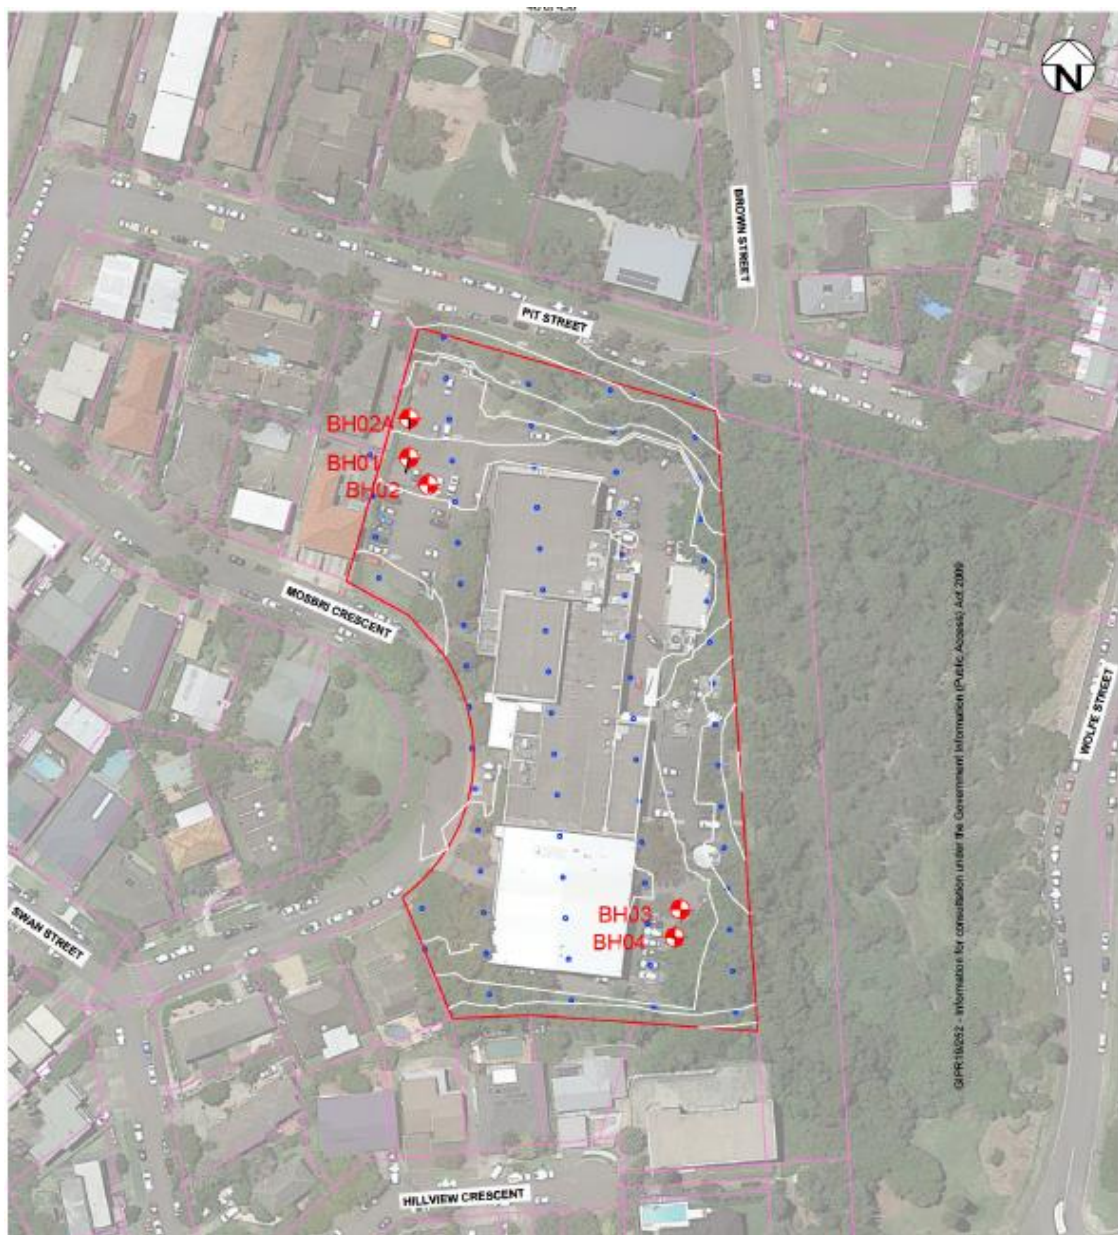
Figure A – Site location and borehole locations

Coffey report 754-NTLGE220504-AH.rev3 dated 14 January 2019 provides borehole logs for five boreholes drilled at the site. The locations of these boreholes designated BH01, BH02, BH02A, BH03 and BH04 are illustrated in Figure A overleaf. The logs from these boreholes (included as Appendix A) show the presence of thin fill cover (less than 1 m thickness) overlying up to 4 m thickness of sandy clay and clay interpreted as being residual clay arising from weathering of sandstone overlying sandstone grading from distinctly weathered to fresh. Borehole BH02a recorded the presence of highly weathered sandstone beneath pavement fill.

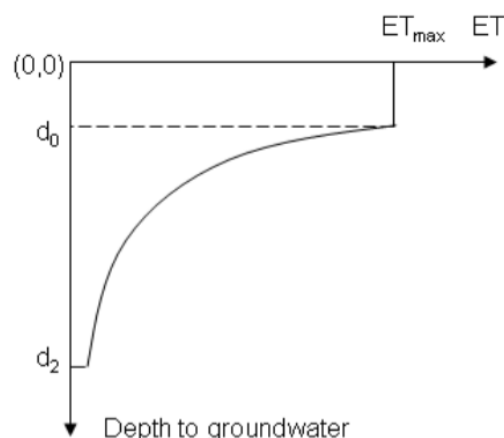
Figure F: Typical relationship adopted for evapotranspiration (ET) with depth to groundwater

Losses from evapotranspiration and evaporation are a function of the vegetation type and the soil type. The form of the relationship generally adopted is illustrated in Figure F. Simplifications involving a linear relationship are often adopted for numerical modelling. The relationship is characterised by surface evapotranspiration (ET) which applies to nominated depth and then the evapotranspiration rate is considered to fall to an extinction depth below which no further evapotranspiration losses occur. The loss at the surface is commonly considered to be equal to the pan evaporation rate.

A result of this relationship is that as the depth to the water table increases the losses reduce while the rate of surface infiltration remains the same. This suppresses the extent of influence of a disturbance to the groundwater level.
