Report on Geotechnical, Preliminary Site Investigation (Contamination) and Salinity Investigation

North Shearwater Residential Subdivision, Stage 1 Viney Creek Road, Tea Gardens

Prepared for Wolin Investments Pty Ltd

Project 81259.01 May 2018

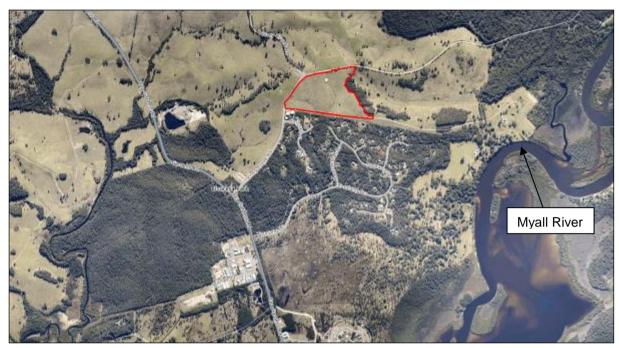
Figure 1: Approximate extent of proposed Stage 1 development

The site is irregularly shaped and covers approximately 18 hectares. The site is bound to the west by Viney Creek Road, to the north by an unnamed private road, to the east by grazing land and to the south by existing large lot residential development. The site is located within the Mid Coast Council local government area.

The site comprising Stage One of the North Sheawrwater residential subdivision is described as part of Lot 2, DP 1154170, Viney Creek Road, Tea Gardens, New South Wales. The approximate site extent is shown on Drawing 1 in Appendix E and in Figure 1 below.

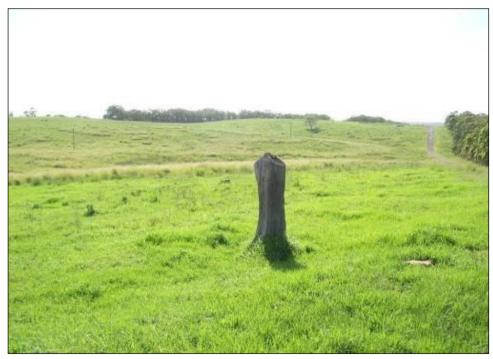
The topography of the site is dominated by two gullies, which converge approximately halfway along the southern boundary of the site (see

Figure 2), where culverts carry the water under the access road. The gullies generally fall towards the culvert to the south at approximately 5°. Side slopes on the ridges and gullies in the western and central portions of the site were approximately 5°.

Figure 2: Looking east across the site towards the convergence of the two main gullies (March 2013)

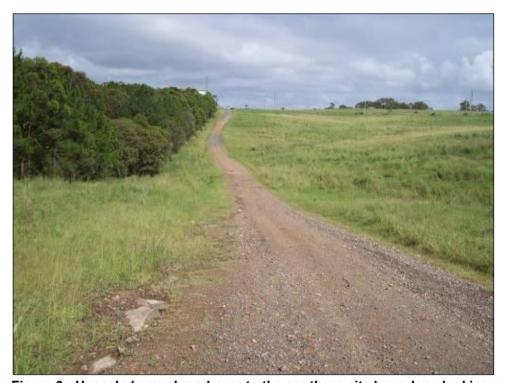
The unsealed gravel road, observed within the site near its southern boundary, is shown in Figure 3 below.

Figure 3: Unsealed gravel road near to the southern site boundary, looking west. Rock outcrop in bottom left of figure (March 2013)

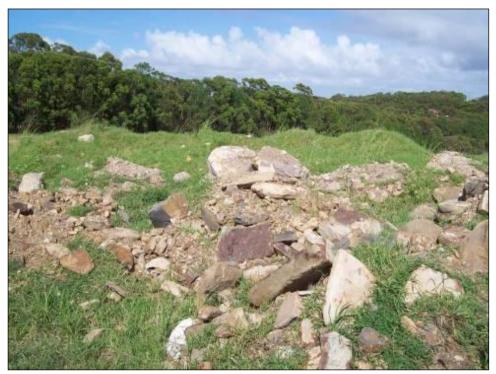
Approximately 70 dumped stockpiles of generally soil and rock were observed in the south-eastern portion of the site as shown in Figure 4 below. The material observed at the surface of the stockpiles comprised natural silty clay, gravel, cobbles and boulders. The stockpiles were up to approximately 1 m to 2 m in height and had a footprint of about 50 m by 30 m.

Figure 4: Stockpiled soil, gravel, cobbles and boulders in the south-eastern portion of the site (March 2013)

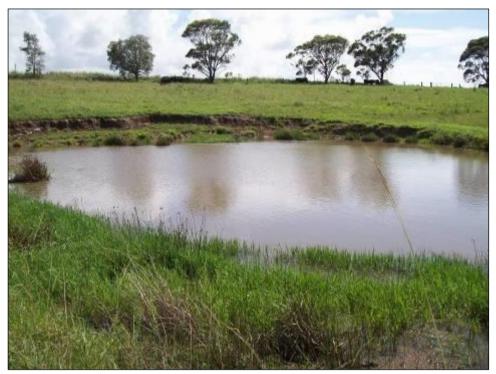
A dam was observed in the northern portion of the site as shown in Figure 5 below. Slopes of approximately 18° to 20° were observed on the dam embankment.

Figure 5: Dam in the northern portion of the site (March 2013)

Dam water was observed to be turbid, with no obvious indicators of gross contamination within the dam water.

The hazard associated with the existing dam embankment has not been considered further here because the dam is proposed to be filled and associated risks would be managed in the design and construction of subdivision earthworks.

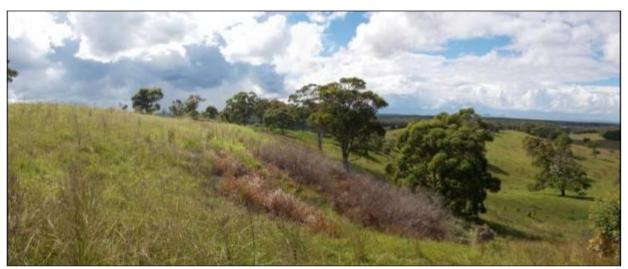
The slopes observed near the north-eastern and eastern parts of the site ranged up to about 20°. The slopes were well vegetated with grass and, near the eastern part of the site, medium dense cover of trees.

Figure 7 and Figure 8 below show the slopes in the vicinity of the eastern / north-eastern area of Stage 1

Figure 7: North-eastern slope

Hazard 1 relates to the slow creep of the shallow soil on the steeper slopes at, and just beyond, the eastern and north-eastern parts of Stage 1 site. It has been assessed as 'unlikely'. The consequences of creep to the residential development proposed for Stage 1 would be 'minor' provided the footings for the structures near the eastern part of Stage 1 are founded on rock. It is noted that bedrock was encountered at depths ranging from 0.1m to 0.4 m (Lots 45, 46, 82 to 85) in the pits excavated within these lots.

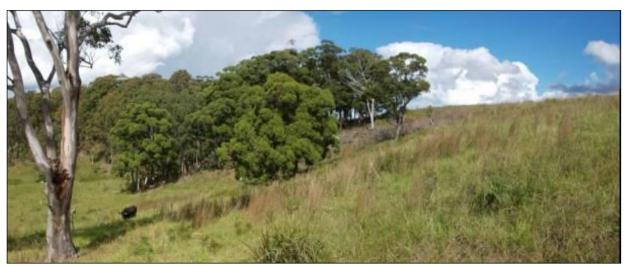
Figure 8: Eastern slopes

No signs of slope instability were observed near the eastern boundary of Stage 1.

Hazard 2 relates to a slope failure of the soil and rock on the steeper slope immediately to the east of Stage 1 and its effect on Stage 1 development. It has been assessed to be 'rare' owing to geological / geomorphology setting of the site and the proximity of the hazard to the Stage 1 boundary, the presence of shallow residual soils of very stiff consistency and the presence of bedrock at depths of about 0.5 m in Stage 1. The consequences of a deep seated failure, if it progressed to the boundary with Stage 1, would be 'minor' because structures will be set back from the Stage 1 boundary due to the asset protection zone.

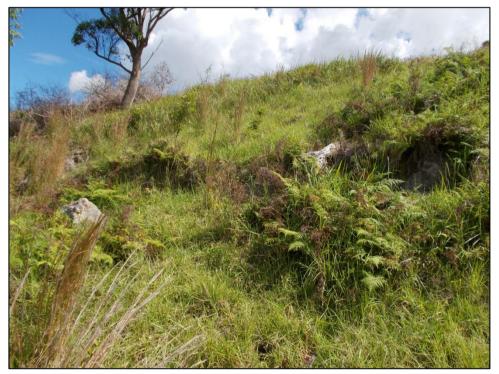
Figure 9 below shows a scarp that probably indicates past landslip activity. The scarp was about 0.5 m high and was located just beyond the north-eastern boundary of Stage 1. Vegetation at the toe of the scarp indicated probable seepage in the past.

Figure 9: Landslip scarp, north-eastern area

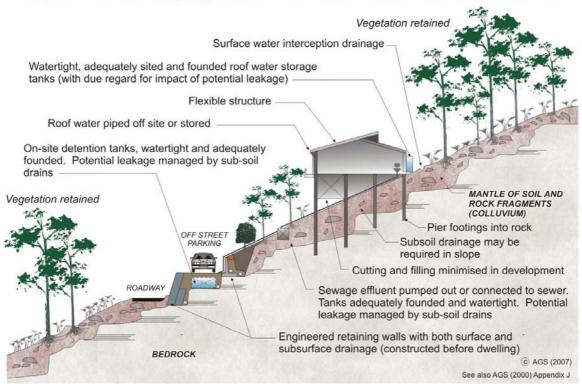
EXAMPLES OF GOOD HILLSIDE CONSTRUCTION PRACTICE

WHY ARE THESE PRACTICES GOOD?

Roadways and parking areas - are paved and incorporate kerbs which prevent water discharging straight into the hillside (GeoGuide LR5).

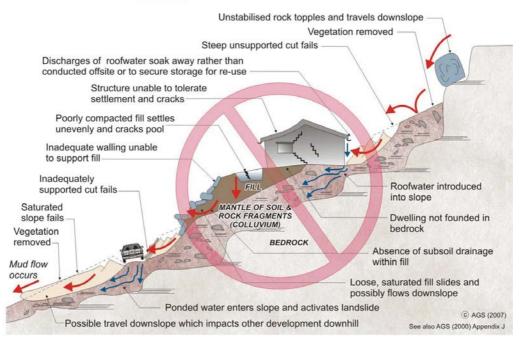
EXAMPLES OF **POOR** HILLSIDE CONSTRUCTION PRACTICE

WHY ARE THESE PRACTICES POOR?

Roadways and parking areas - are unsurfaced and lack proper table drains (gutters) causing surface water to pond and soak into the ground.

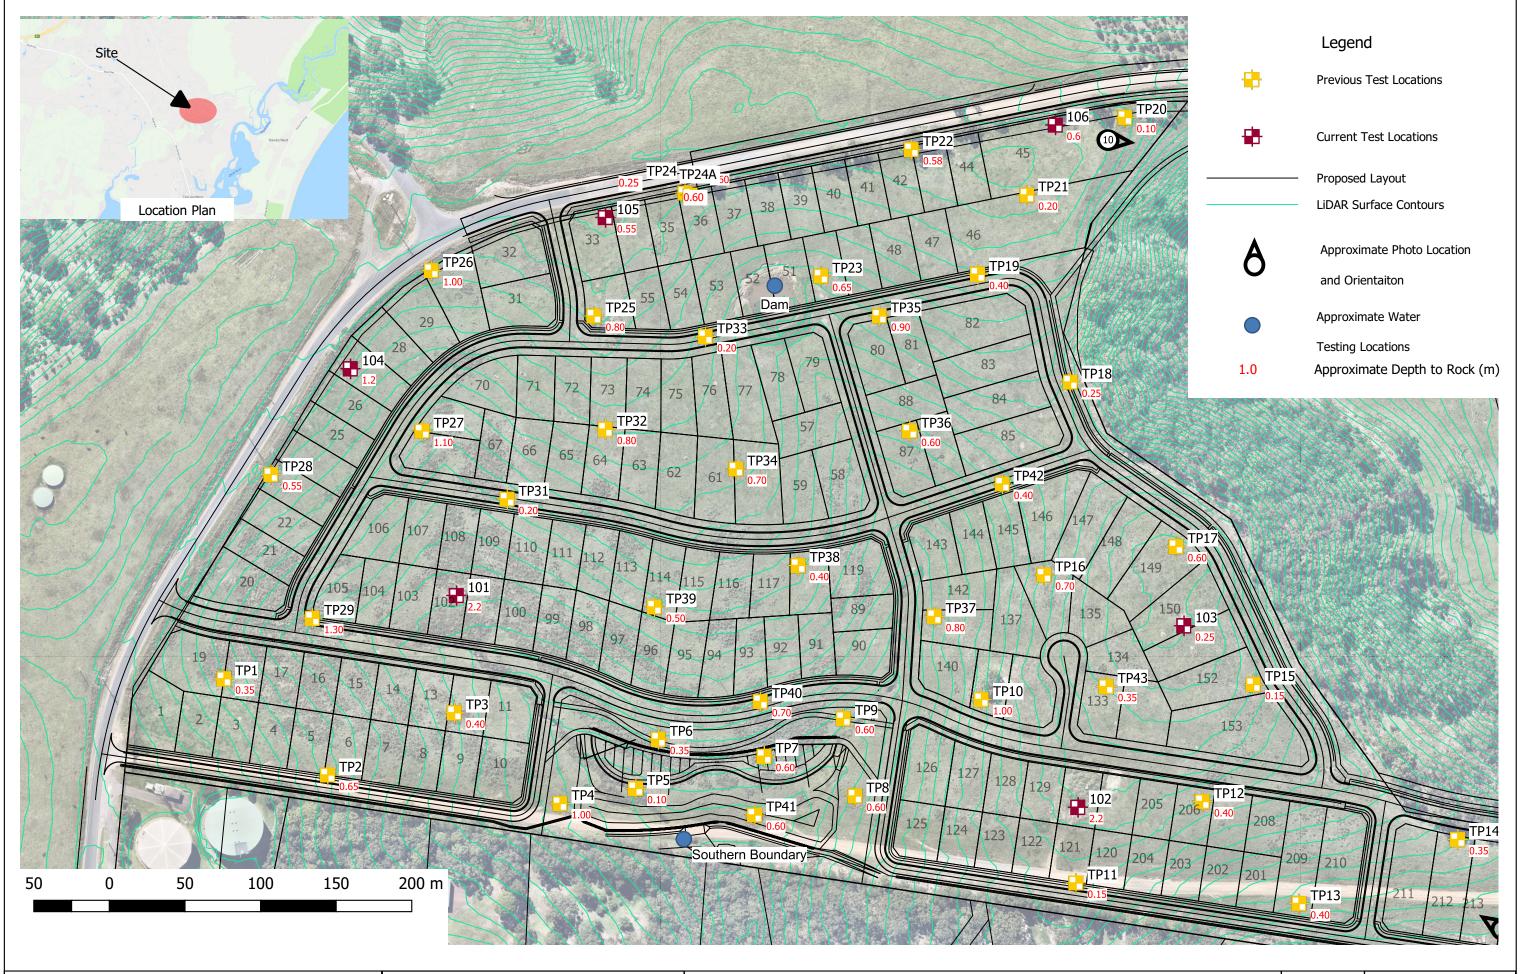
PROPOSAL:	81259.01		
DRAWING No:	1		
REVISION:	0

The approximate location of the test pits are presented on the attached Test Location Plan (Drawing 1 in Appendix E). It should be noted that TP01 is the same as Pit 1.
