# DA MODIFICATION ADDENDUM NO. 3 to Environmental Impact Statement

**Lookout Road Quarry**

DA 2015-953

March 2019

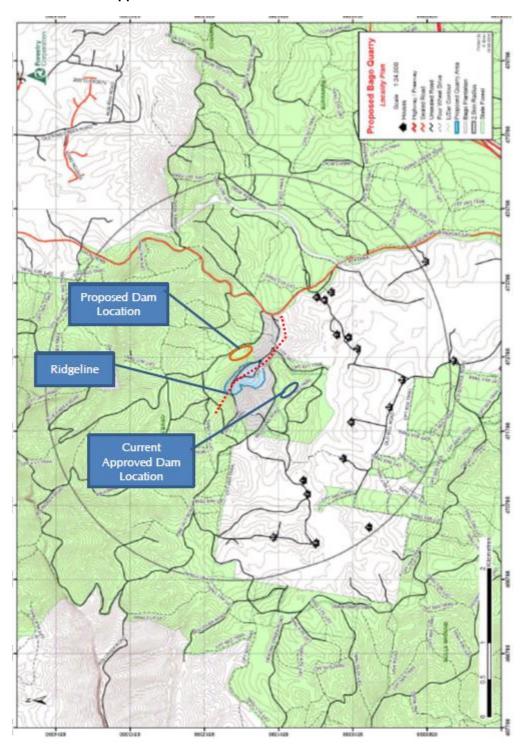
#### Illustration 1.1 Approved and Modified Dam Location

The application seeks to relocate the position of the water storage dam (and the pump house) associated with the approved quarry.

The proposed (preferred) location of the dam is situated in a second order stream within the subject land approximately 100 m to the north east of the south-eastern corner of the approved quarry precinct.

Those drawings demonstrate that the currently proposed dam site is further away from all of the dwellings within the district than the originally approved dam site. Furthermore, the proposed dam site is situated in a totally separate catchment to the regional dwellings. A significant ridgeline now separates those dwellings from the proposed dam and pump house.

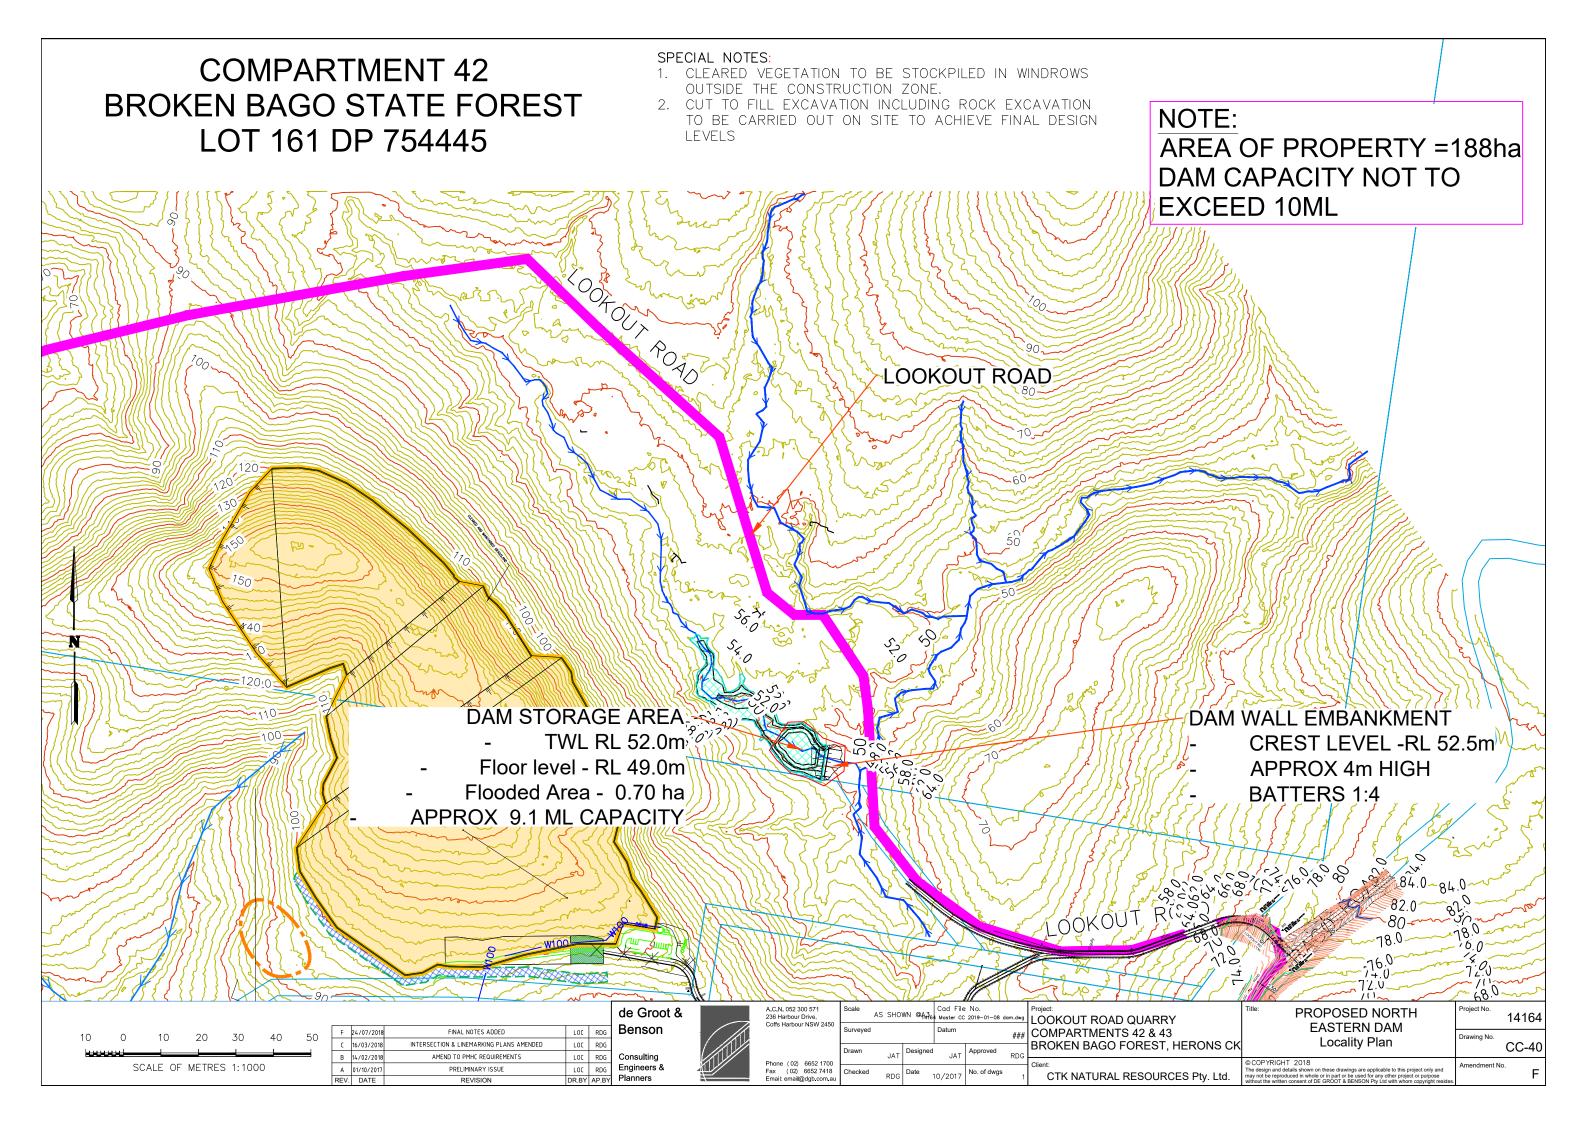
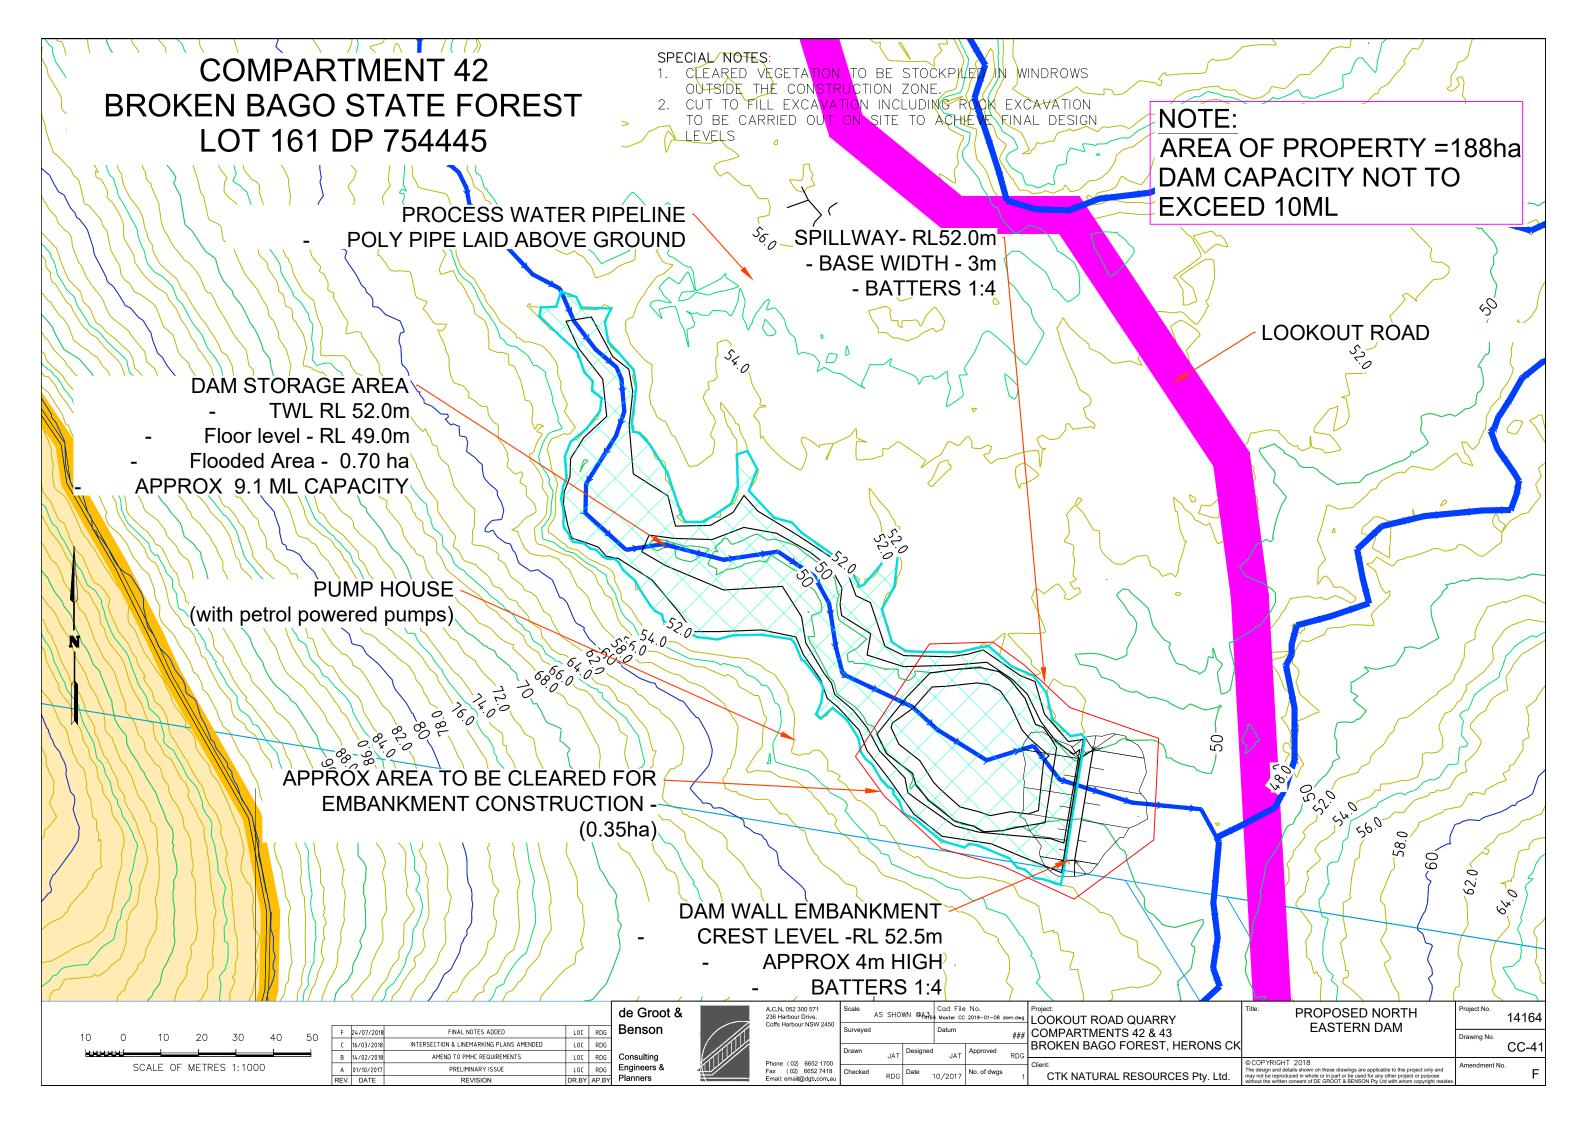
# **Appendices Concept Drawings**

The location and the conceptual engineering attributes of the dam are illustrated on the drawings which accompany this application.

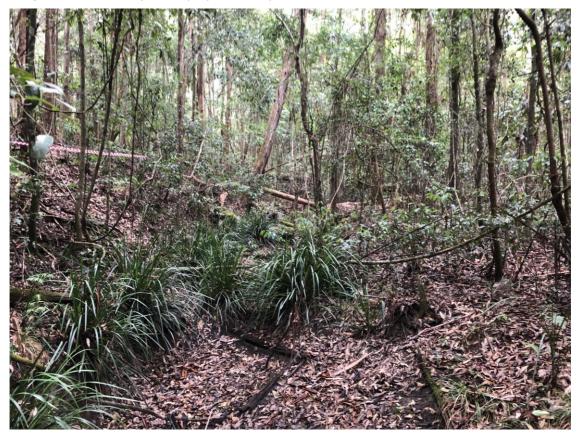
Photo 2: Vegetation community in the proposed footprint

Vegetation Community (NSW PCT)	No 827: Flooded Gum - Tallowwood - Brush Box moist open forest of the coastal ranges of the North Coast		
EEC Status	Not an EEC		
Location	Occurs within dam footprint and extends further off site in all directions. Grades into dry sclerophyll forest upslope to the west.		
Description	<ul> <li>(a) Canopy:  Structure and Species: Canopy consists of an open canopy of eucalypts dominated by Flooded Gum (Eucalyptus grandis) with occasional Pink Bloodwood (Corymbia intermedia). Tallowwood (Eucalyptus microcorys) and Turpentine (Syncarpia glomulifera) are rare occurrences. Height ranges from approximately 20-28m and canopy cover is approximately 40%. </li> <li>(b) Midstory:  Structure and species: Consists of a mix of canopy juveniles and rainforest species including Lilly Pilly (Acmena smithii), Callicoma (Callicoma serratifolia) and Grey Myrtle (Backhousia myrtifolia) with a cover of approximately 20%. Height ranges in this layer are between 8-15m.</li> <li>(c) Shrub Layer:  Structure and Species: Consists of an open to dense shrub layer dominated by Wilkiea (Wilkiea huegliana), Narrow-leaved Palm Lily (Cordyline stricta) and Bolwarra (Eupomatia laurina). Height ranged from 1-4 m.</li> <li>(d) Ground Layer:  Structure and Species: A sparse to open layer herbs and ferns is present ranging from 0.1-0.5 m in height. Dominant species were Rainbow Fern (Calochlaena dubia), Settlers Flax (Gymnostachys anceps), Gristle Fern (Blechnum cartiligenium) and Spiny Matrush (Lomandra longifolia).</li> </ul>

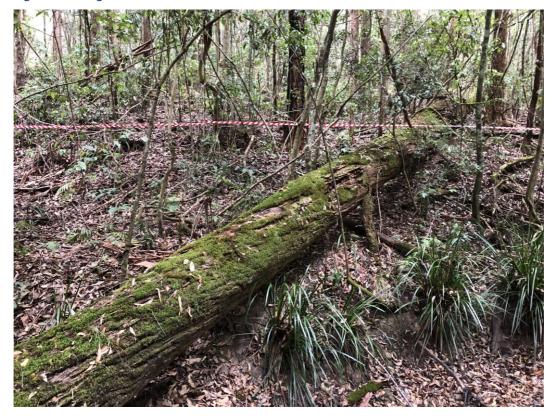
Photo 4: Large habitat log

Fallen hollow logs which potentially provide habitat for fauna were identified within the dam footprint. These are recommend to be relocated into adjacent forest where possible so as to continue to provide habitat for fauna.

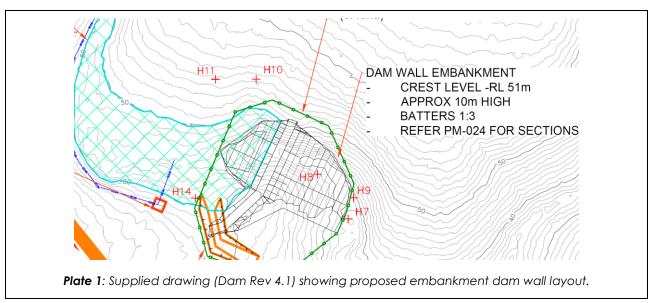
The proposed storage dam will have a capacity of 10MegL and the dam wall embankment will be up to approximately 10m in height, have a 4m crest width, 80m crest length and wall batters of approximately 1V:3H. It is proposed to source the embankment fill from site won material in the vicinity of the storage dam.

An excerpt from the supplied drawing showing the proposed dam embankment wall location is presented in Plate 1.

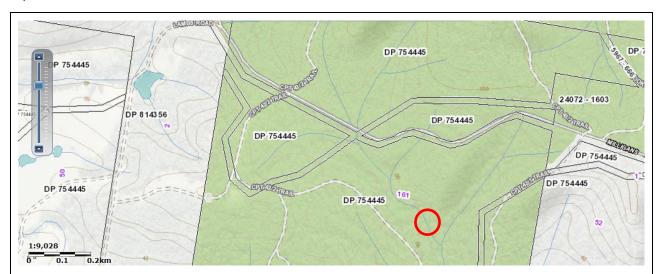
The site is located within moderately undulating topography that is thickly vegetated. Surface elevations across the width of the proposed dam wall range from approximately 41m AHD to 51m AHD. The creek line where the dam wall will be located flows to the south west and is an unnamed upper tributary of Herons Creek. An image that shows the location of the site and the site setting is reproduced in Plate 2.

**Plate 2**: Image obtained from the NSW Government 'Six Maps' website that illustrates the site location and setting. The approximate position of the proposed dam embankment wall is circled in red.

The creek line includes an incised channel of approximately 5m width and variable height within a broader gully that is approximately 80m wide. Slightly weathered rhyolite rock, fractured, high strength was exposed on the southern side of the incised channel and gravel bar deposits up to 1m in height were present to the north.
