# Acid Sulfate Soil Management Plan

## Saint John Paul Collage Redevelopment

Prepared for: DRA on behalf of the Catholic Church  
© GeoLINK, 2019

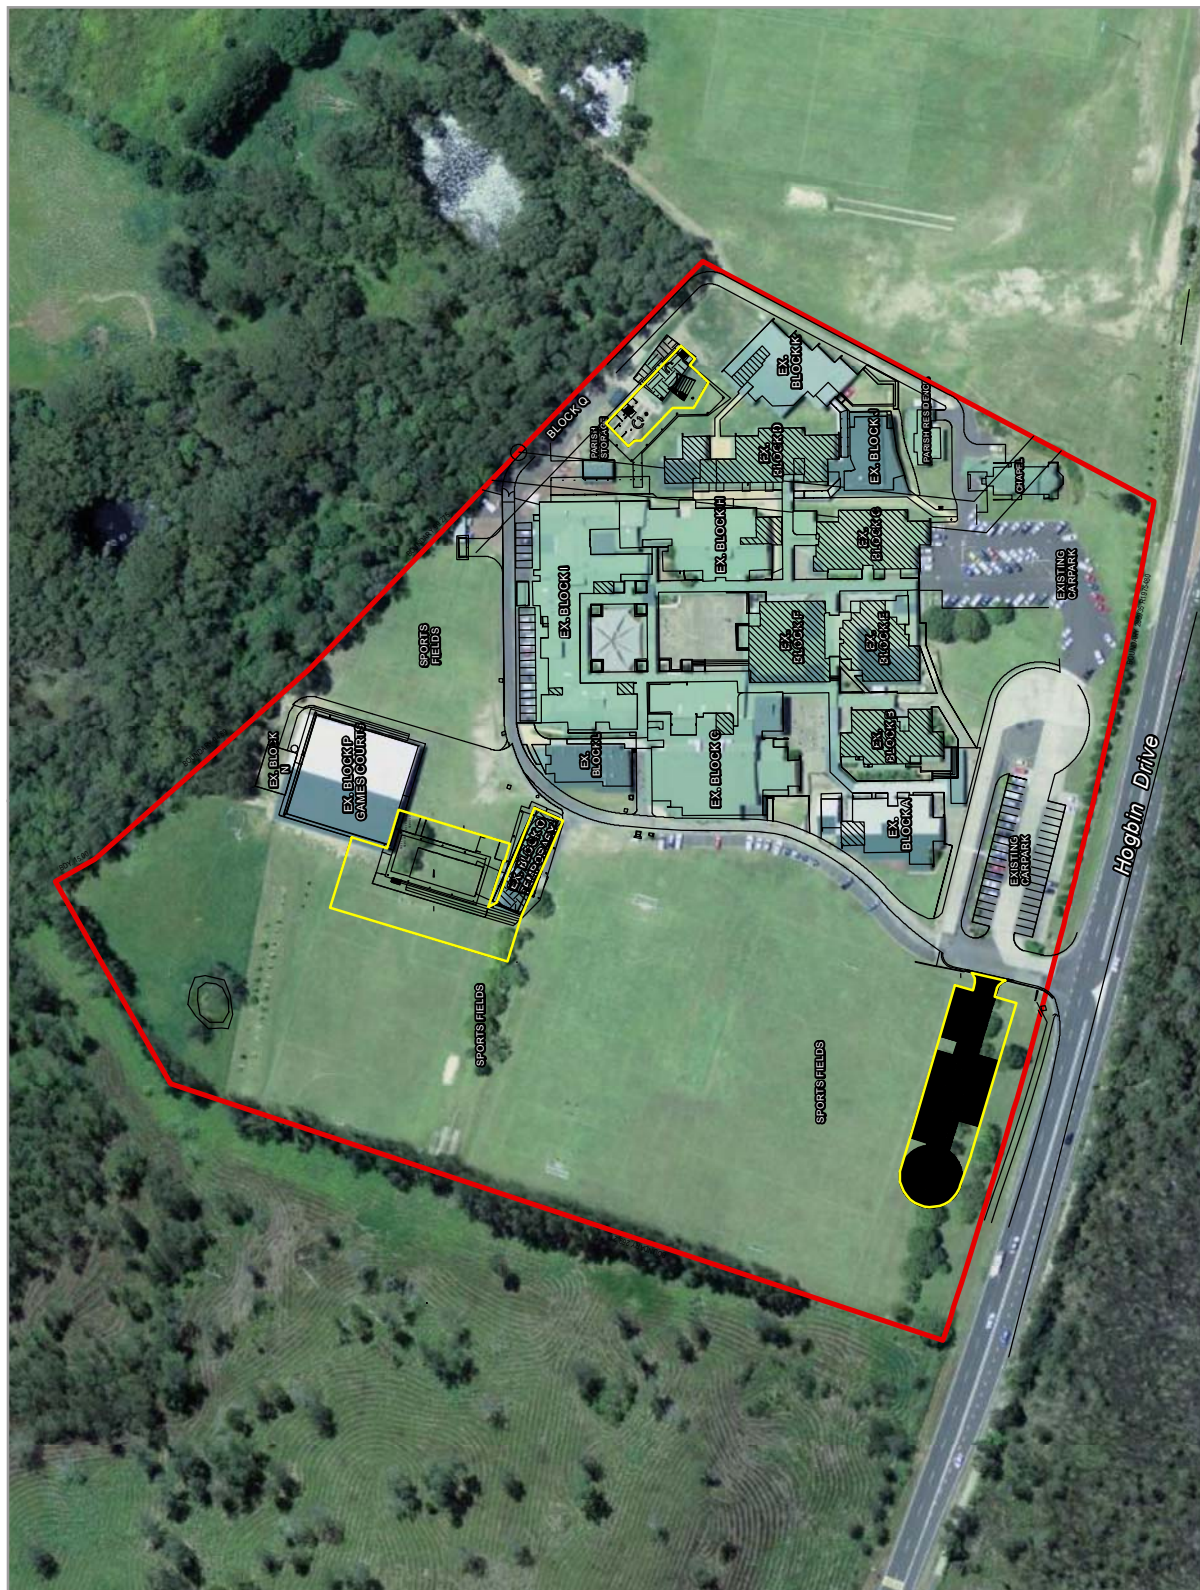
Illustration 1.2

## The Site

The location of the proposed alterations and additions within Blocks A-O and the proposed new library and PDHPE buildings are shown in **Illustration 1.2**.

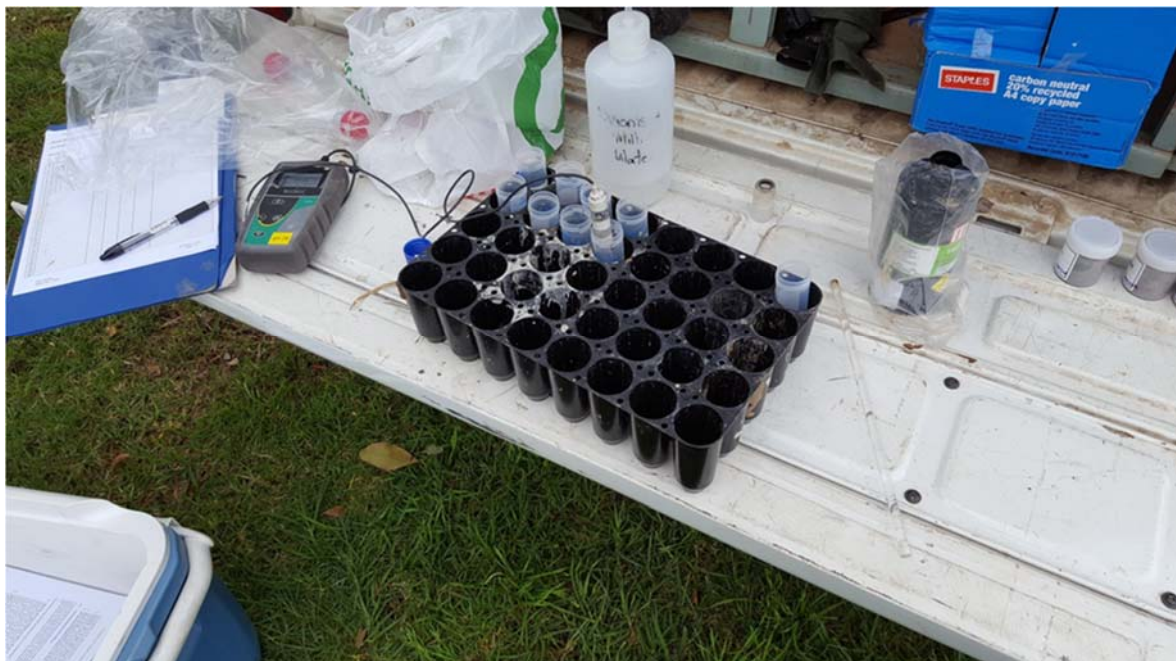
**Plate 3.1** Field pH test being undertaken

Analysis of samples were screened by undertaking field pH (pHF) and field peroxide pH (pH<sub>fox</sub>) tests to provide initial indication of PASS/ AASS, the results of which are displayed **Table 3.1**. pHF and pH<sub>fox</sub> tests were in accordance with ASSMAC test method codes 21Af and 21Bf respectively (refer to **Plate 3.1**). Furthermore, pH<sub>fox</sub> testing was carried out using 30 per cent hydrogen peroxide adjusted to pH 5.5.

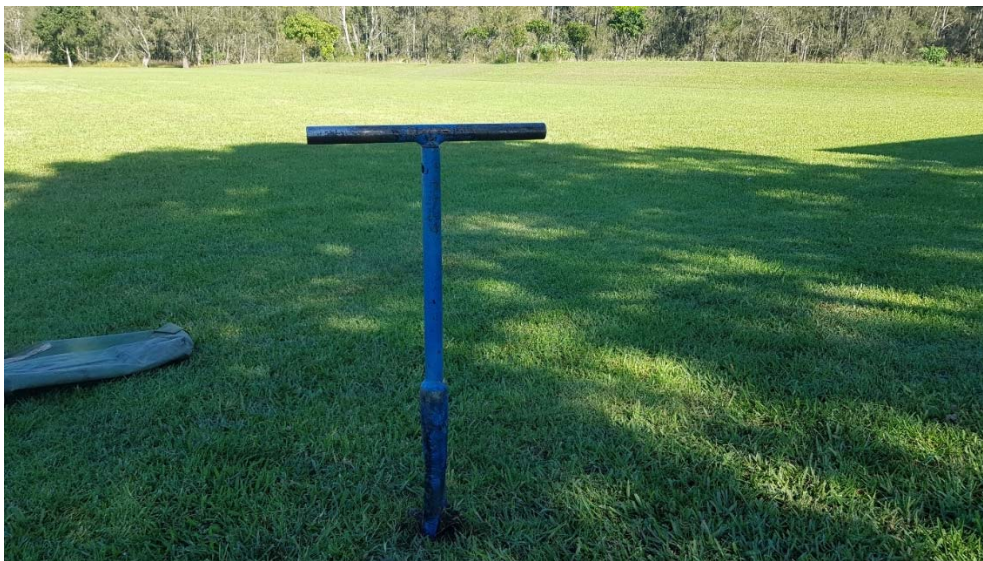
**Plate 3.2** Soil samples were obtained using a hand auger, photo taken looking south from PDHP building 1

Soil samples were obtained using a hand auger (refer to **Plate 3.2**). The hand auger was thoroughly washed and decontaminated between each sample location.

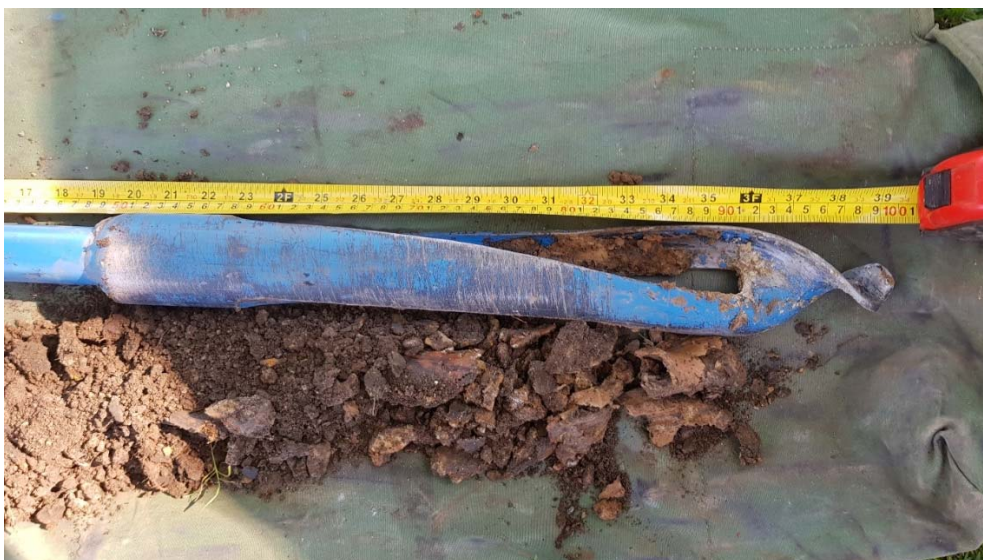
**Plate 3.3** Example of soil profile consisting of granular to light clay fill, photo taken from BH4 (PDHP building 2).

To obtain a representative sample, two bore holes (refer to **Illustration 3.1** for BH3 and BH4) were taken adjacent to both building envelopes on the natural ground level of the sporting field. However, further underlining fill was encountered at depths of approximately 600mm and extended beyond one metre (refer to **Plate 3.3**).

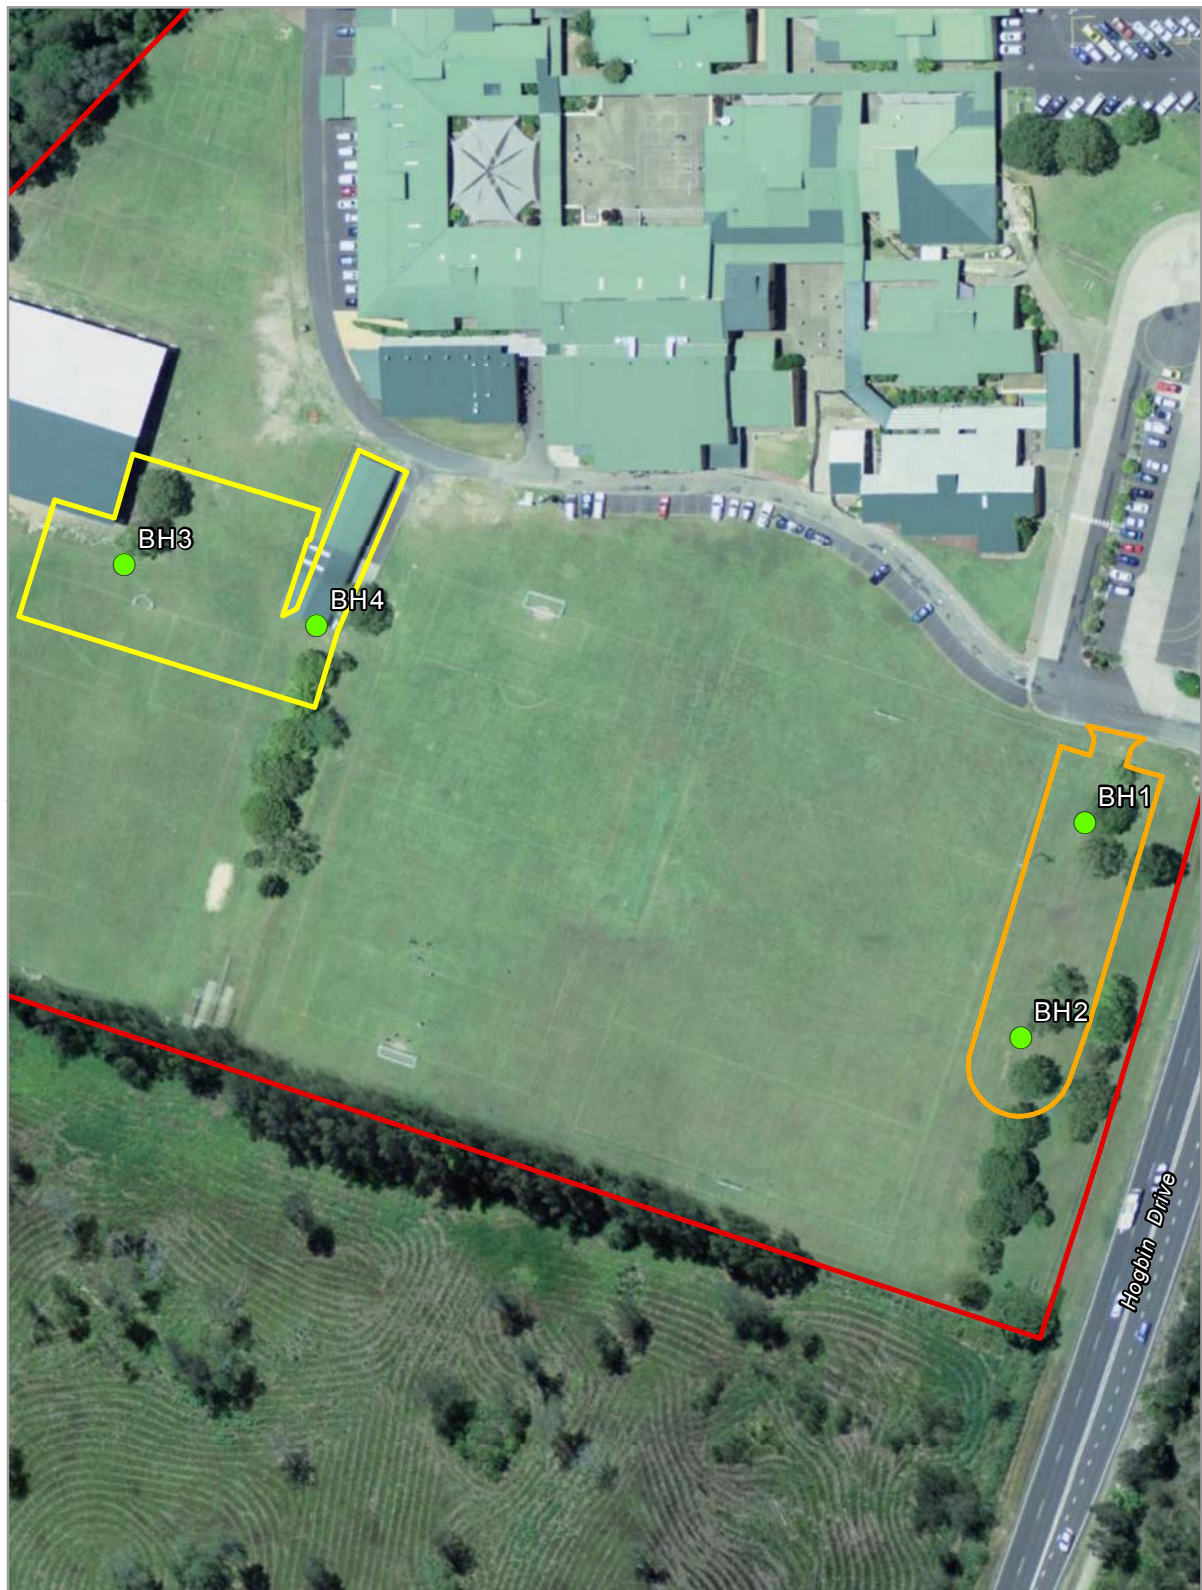
- Saint John Paul College boundary
- Proposed PDHPE building
- Proposed new carpark
- Sample location

In accordance with Table 4.1 of the ASSMAC guidelines, the extent of the works footprint required a total of four boreholes across the proposed development site (locations of each borehole are shown in **Illustration 3.1**). The collection of soil samples for each bore was obtained at 0.5 m intervals to a maximum depth of 1.5 m (for PDHPE building 1). This is in accordance with ASSMAC assessment guidelines which state that the sampling depth of investigations should usually be at least one metre beyond the depth of the proposed excavation.

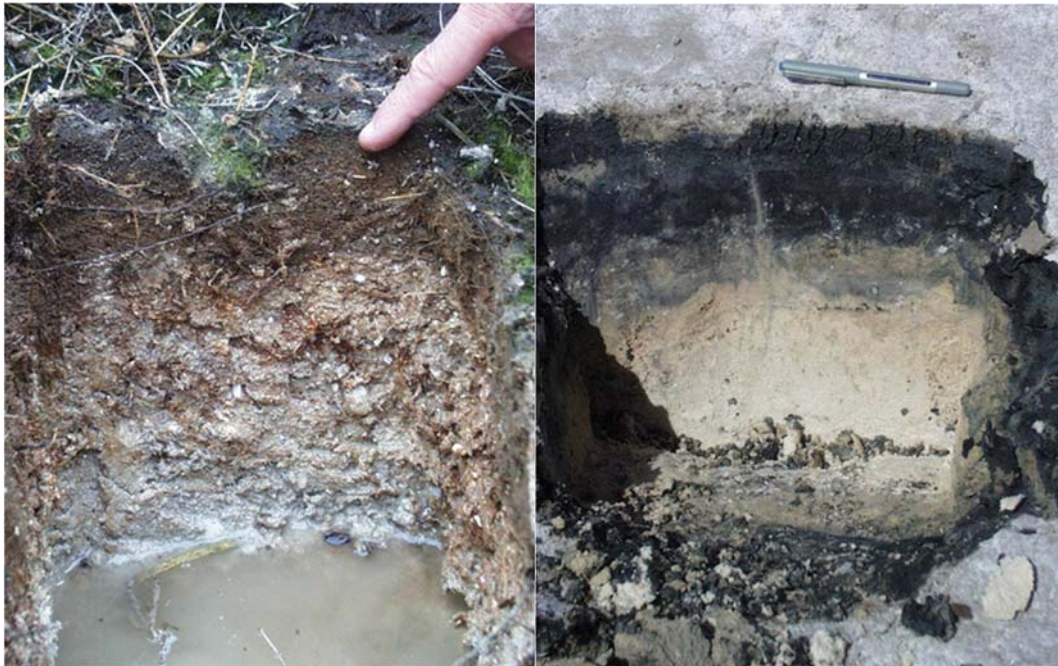
#### Potential ASS Soil Profile

- Waterlogged soils – unripe muds (soft, sticky and can be squeezed between fingers, blue-grey or dark greenish-grey mud with a high water content), silty sands or sands (mid to dark grey) or bottom sediments (dark grey to black e.g. iron monosulfides 'black oozes') possibly exposed at sides and bottom of drains or cuttings, or in boreholes;
- peat or peaty soils;
- coffee rock horizons; or
- a sulfurous smell e.g. hydrogen sulfide or 'rotten egg' gas.

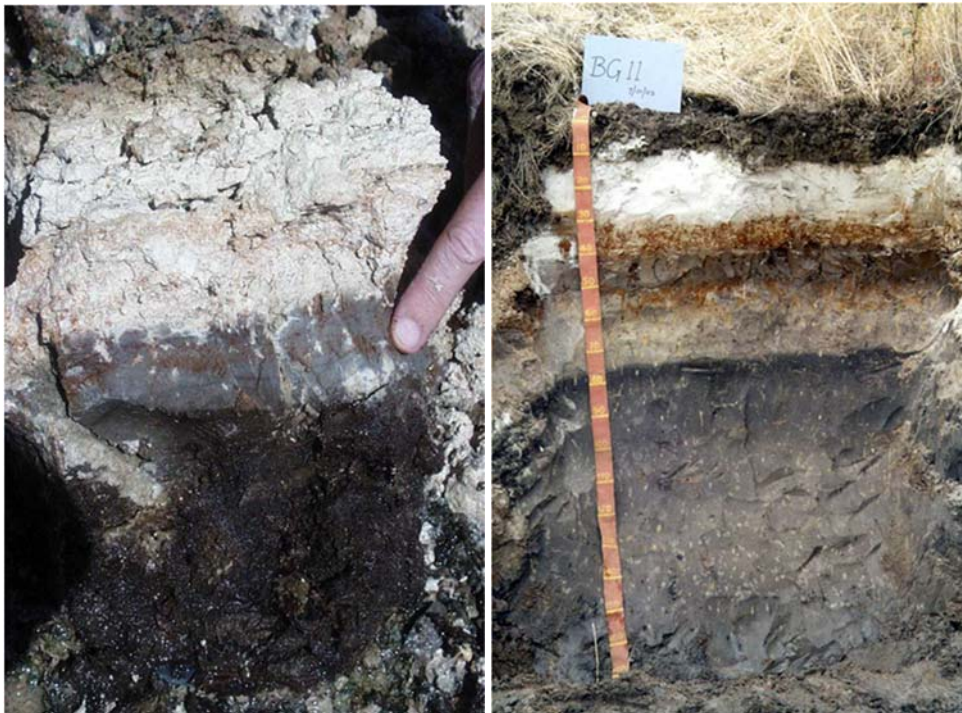
### AASS Soil Profile

- Presence of corroded shell;
- sulfurous smell e.g. hydrogen sulfide or 'rotten egg' gas; and any jarositic horizons or substantial iron oxide mottling in surface encrustations or in any material dredged or excavated and left exposed.

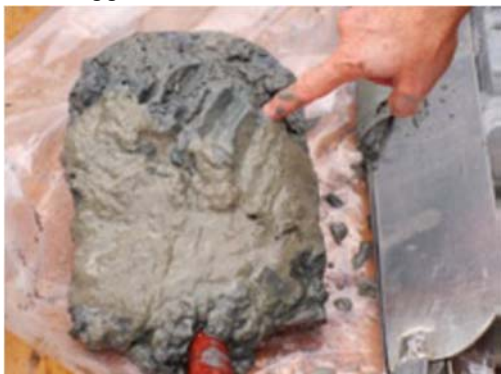
White and yellow **salt efflorescence** on soil surface and with bright yellow mottles in cracks.

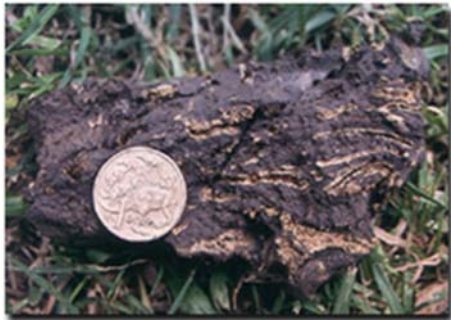
**Sulphuric material** black to dark grey with brownish mottles. Light clay. Become acidic (pH <4) after drainage. Bright yellow and white salts in mottles and on sides of cracks.
