# SOLITARY ISLANDS RETREAT

## Volume 2 - Appendices

### Statement of Environmental Effects

Seniors Living Development , Darkum Road, Mullaway  
Lot 1 DP 1128964

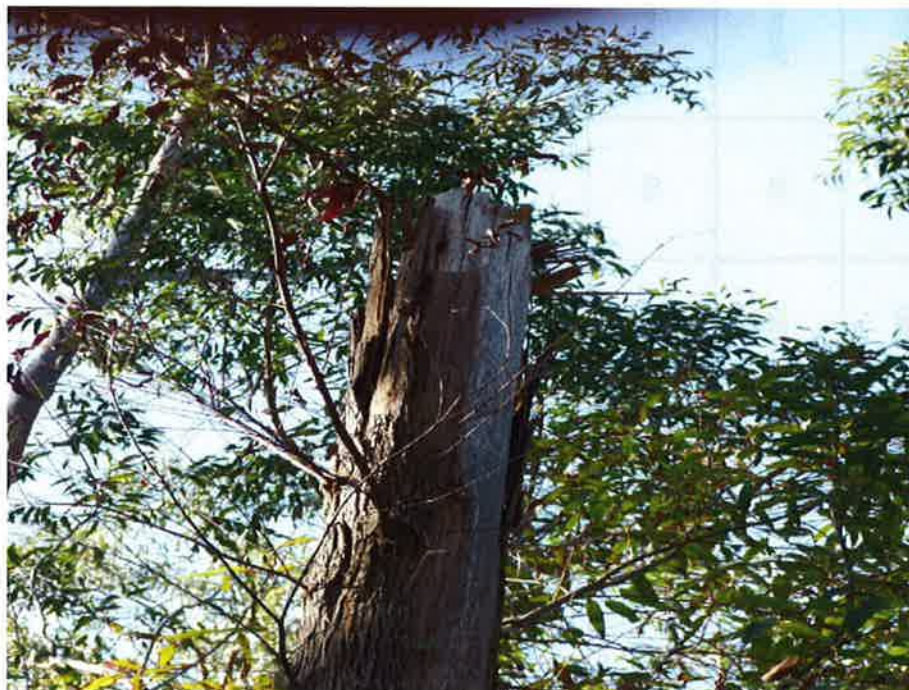
**Figure 3** Crown damage from severe impact, Tree 436

Many trees on site have sustained mechanical wounds due to earlier logging operations and other movement of heavy machinery within the site. Some trees in Area C have sustained moderate to severe crown damage as a result of these operations.

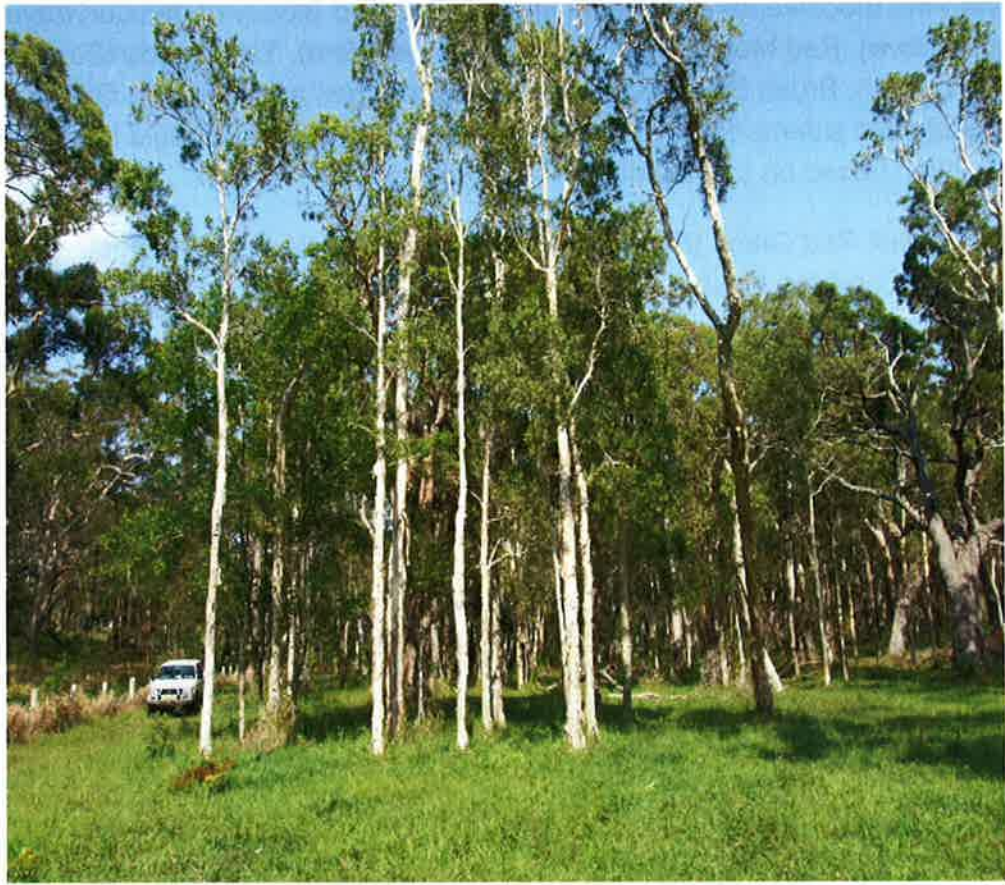
**Figure 4** Paperbarks most suitable for retention as a group. Trees 190-204

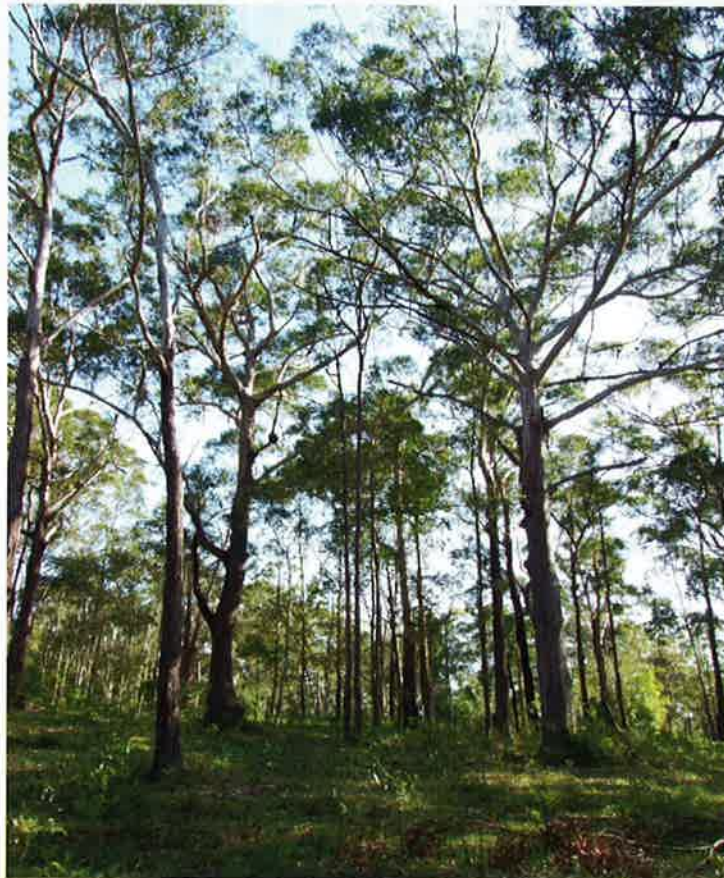
**Figure 5** Blackbutts, 418, 419, 420 displaying forest habit in Area C

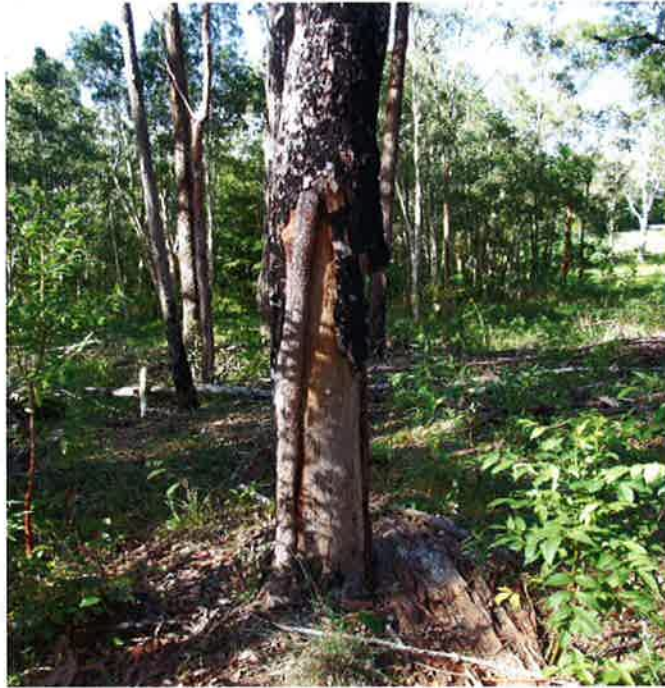
**Figure 6** Typical mechanical wound, Tree 416,

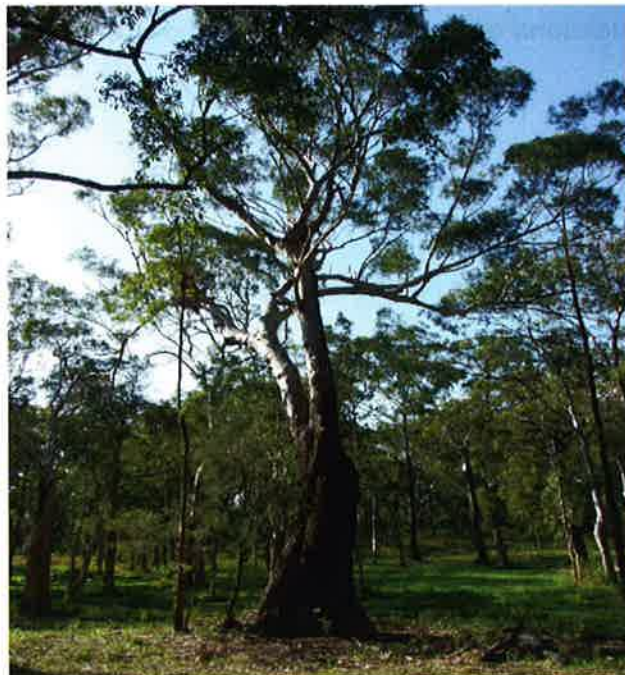
**Figure 7** Old growth Blackbutt, Tree 314

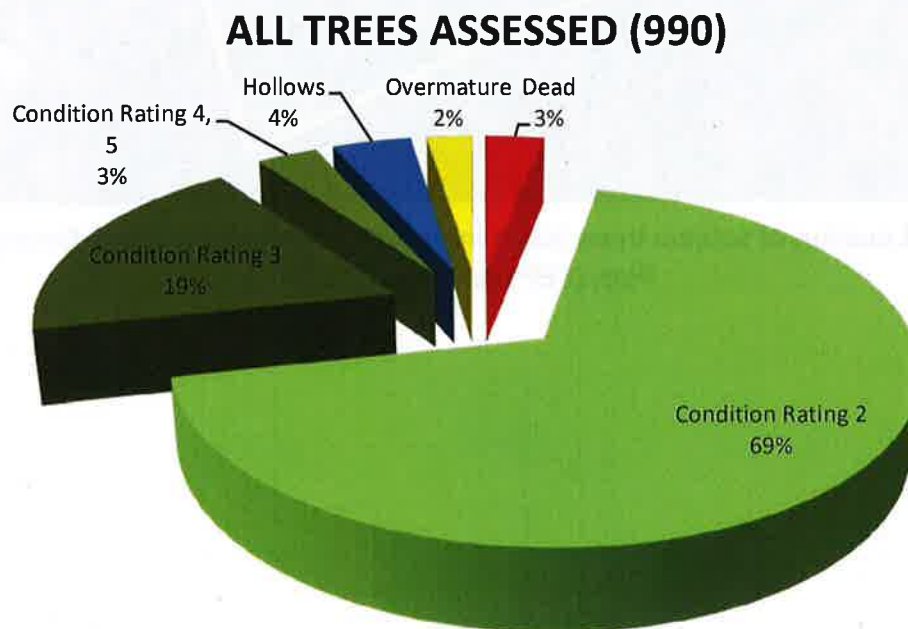
The pie chart below summarises the data collected for all the subject trees in both audits of this property

**Figure 1** Overall assessment

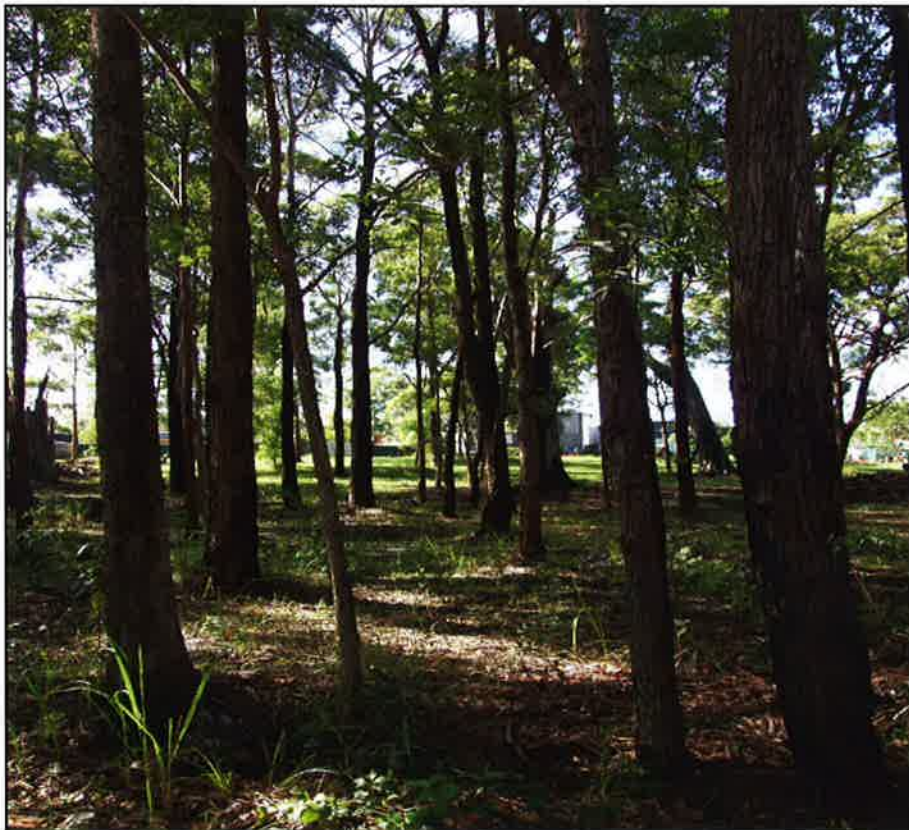
**Figure 3** Typical trees on site displaying forest habitat

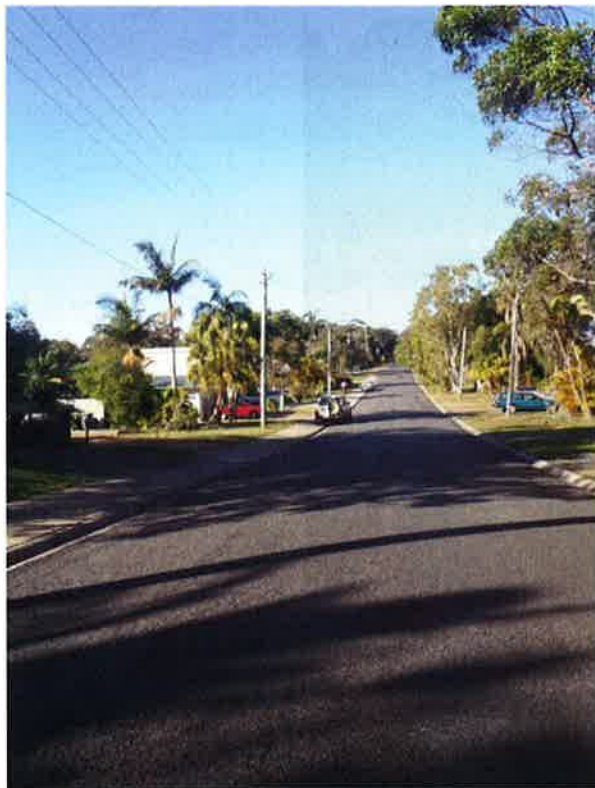
Darkum is sealed full width from Mullaway Drive with roll kerb both sides (7.5 m wide) to approximately 24 m past the intersection of The Boulevarde. Of the 190 m frontage of the development site to Darkum Road, 76 m is kerbed. South of the end of the kerbed frontage the road has a 5.9 m seal and grassed verges and table drains.

**Figure 2-2 View south along Darkum Rd with The Boulevard LHS in background.**

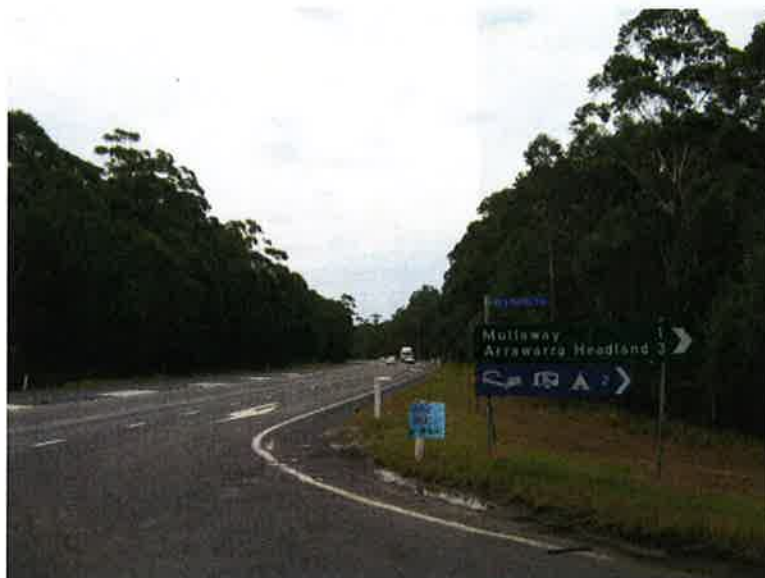
**Figure 2-3 Drivers sight line from Mullaway Dr north along Pacific Hwy.**

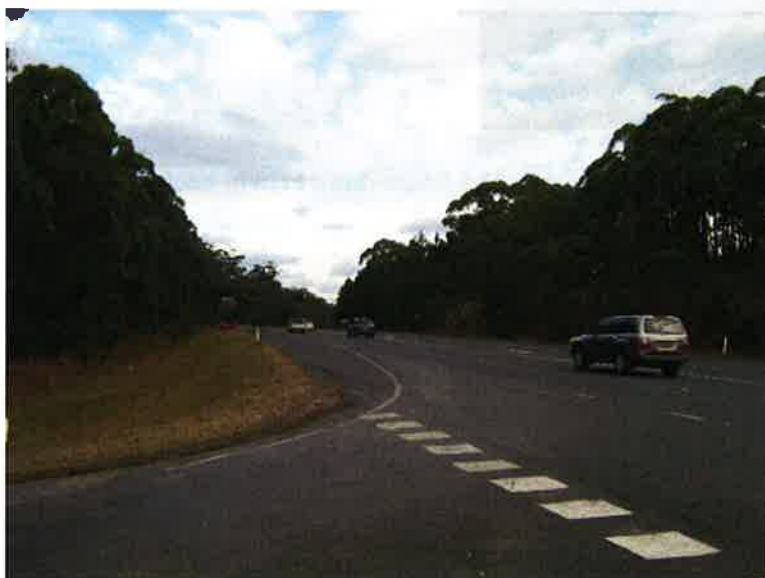
**Figure 2-4 Drivers sight line from Mullaway Dr south along Pacific Hwy.**

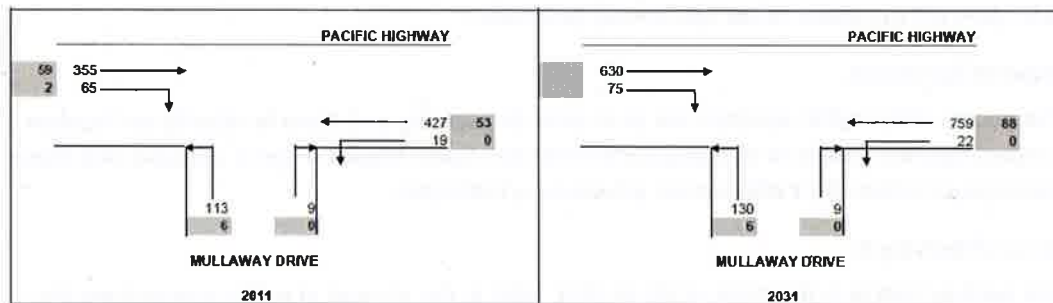
The existing intersection of Mullaway Drive with Pacific Highway has been modelled in the RTA traffic study. The modelled base case peak hour volumes are presented below.

**Figure 2-5 RTA modelled Intersection Volumes AM peak (Source: Ref 1)**

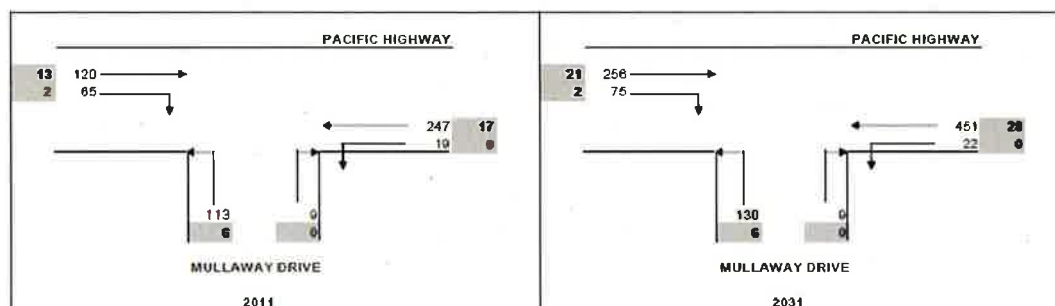
It is normal to project future traffic flows 10 years on top of the base year for traffic impact assessments. The following figures represent the modelling of the intersection of Mullaway Drive with the bypassed Pacific Highway.

**Figure 3-2 RTA modelled Intersection Volumes AM peak (Source: Ref 1)**
