PRELIMINARY STAGE 1 ENVIRONMENTAL SITE ASSESSMENT

PROPOSED SCHOOL ADDITIONS

**CANTERBURY SOUTH PUBLIC SCHOOL, HIGH STREET,
CANTERBURY, NSW**

REF: E31040Krpt

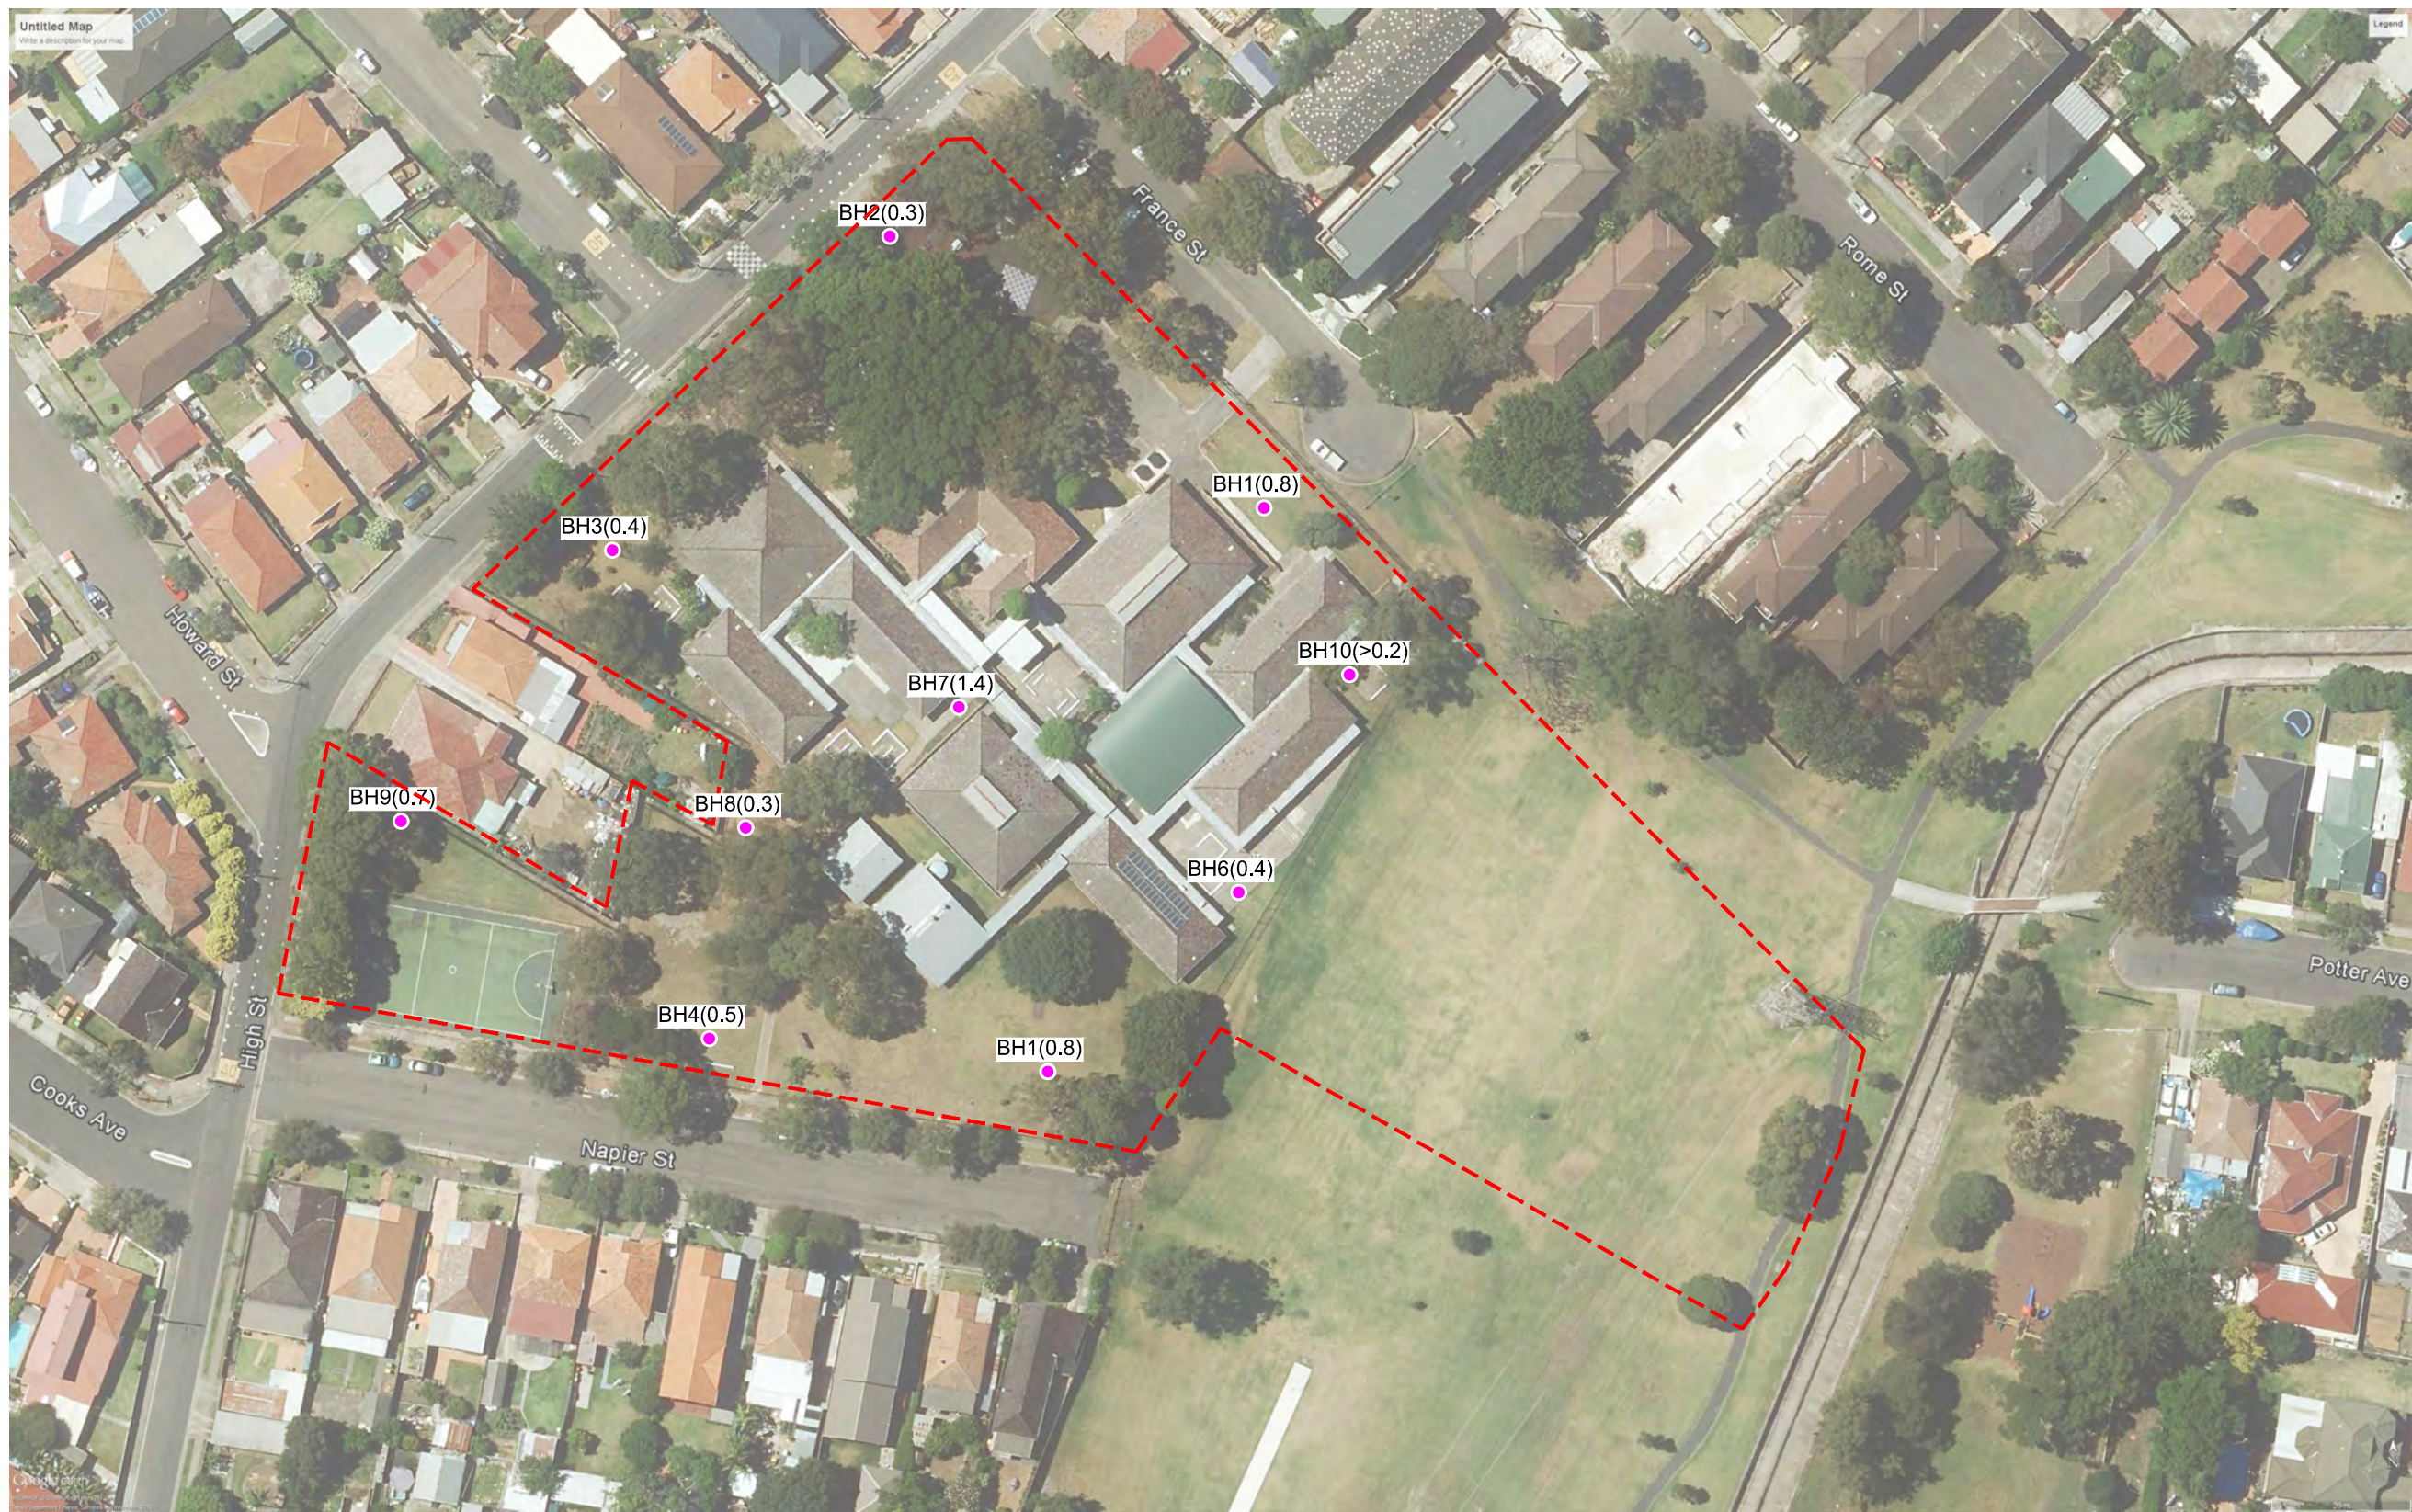
- APPROXIMATE SITE BOUNDARY
- BH (Fill Depth) BOREHOLE LOCATION, NUMBER AND DEPTH OF FILL (m)

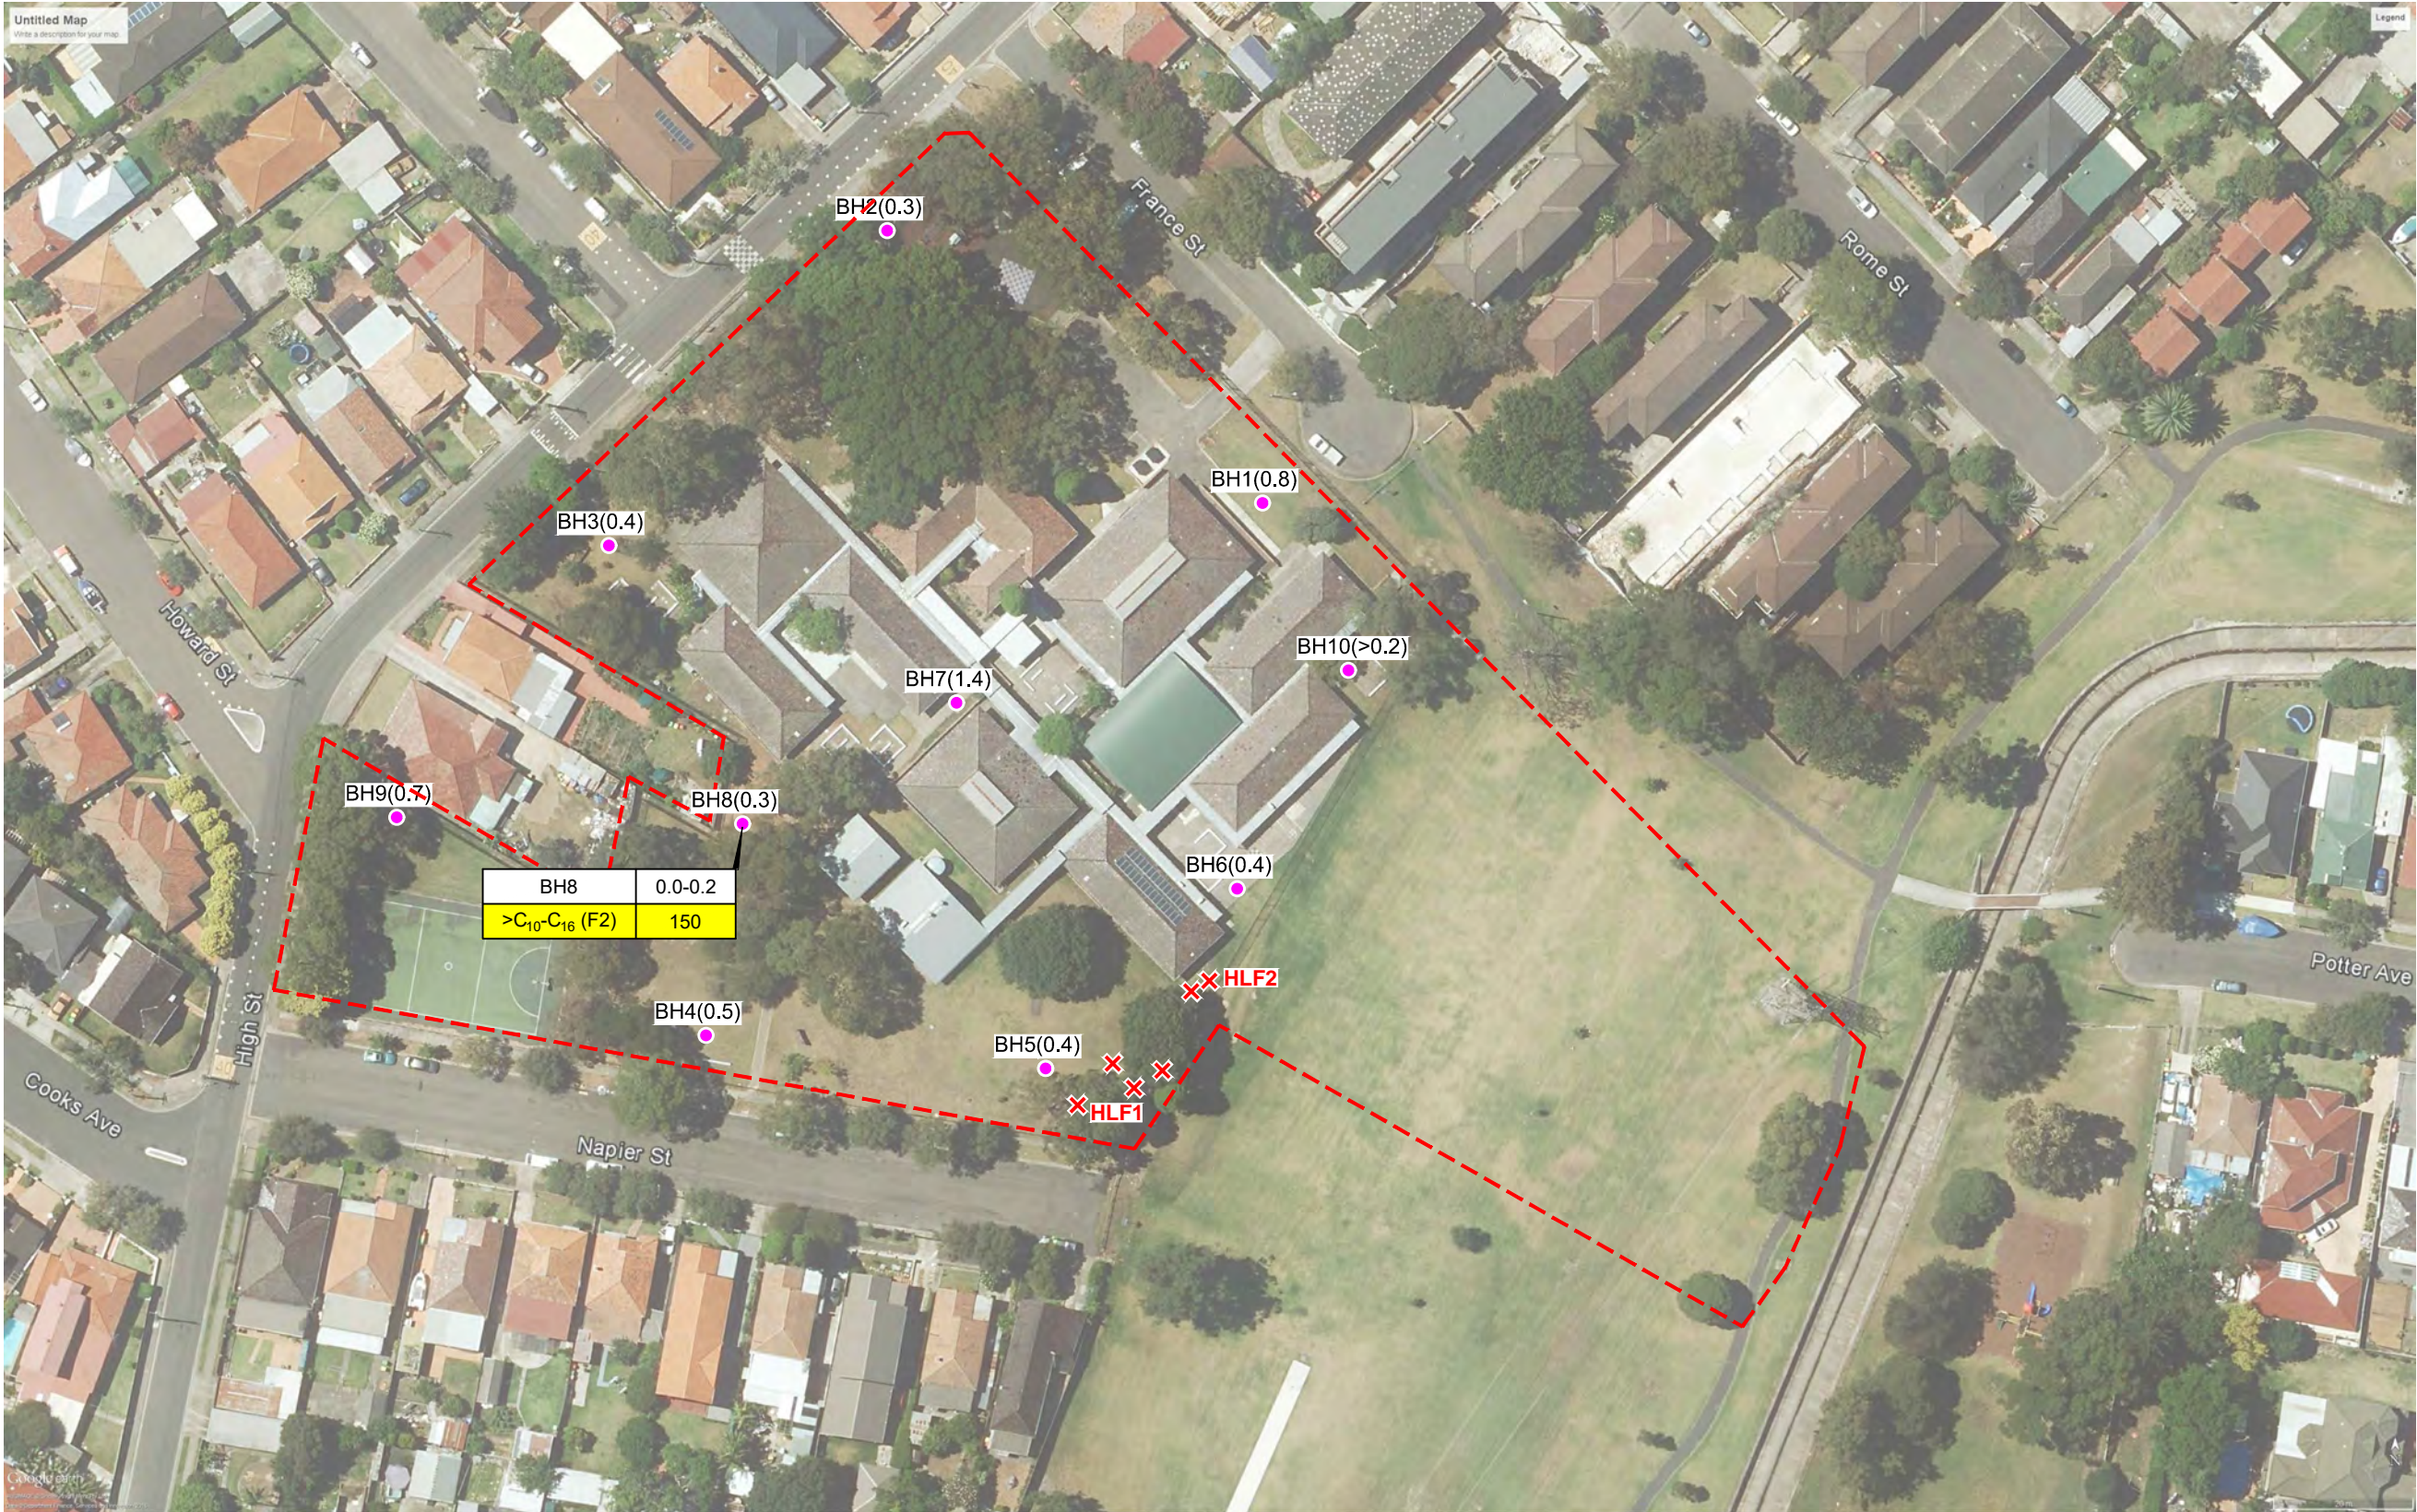
- APPROXIMATE SITE BOUNDARY
- BH (Fill Depth) BOREHOLE LOCATION, NUMBER AND DEPTH OF FILL (m)
- × FCF FIBRE CEMENT FRAGMENTS (FCF)

Completeness
<p><u>Field Considerations:</u></p> <ul style="list-style-type: none">• The investigation was designed as a preliminary screening and sampling was confined to accessible areas of the site (see Figure 2);• Samples were obtained from various depths based on the subsurface conditions encountered at the sampling locations. All samples were recorded on the borehole logs. All sampling points are shown on the attached Figure 2;• The investigation was undertaken by trained staff in accordance with the SSP; and• Documentation maintained during the field work is attached in the appendices where applicable. <p><u>Laboratory Considerations:</u></p> <ul style="list-style-type: none">• Selected samples were analysed for a range of CoPC;• All samples were analysed by a NATA registered laboratory in accordance with the analytical methods outlined in NEPM 2013;• Appropriate analytical methods and PQLs were used by the laboratory; and• Appropriate sample preservation, handling, holding time and COC procedures were adopted for the investigation.
