# APPENDIX G

## Land Resources Assessment

**Land Resources Assessment  
for:  
Andersons Clay Mine  
Environmental Impact Statement  
November 2018**

| Report Number: | 3618_AN_EIS_SL_F0 | |

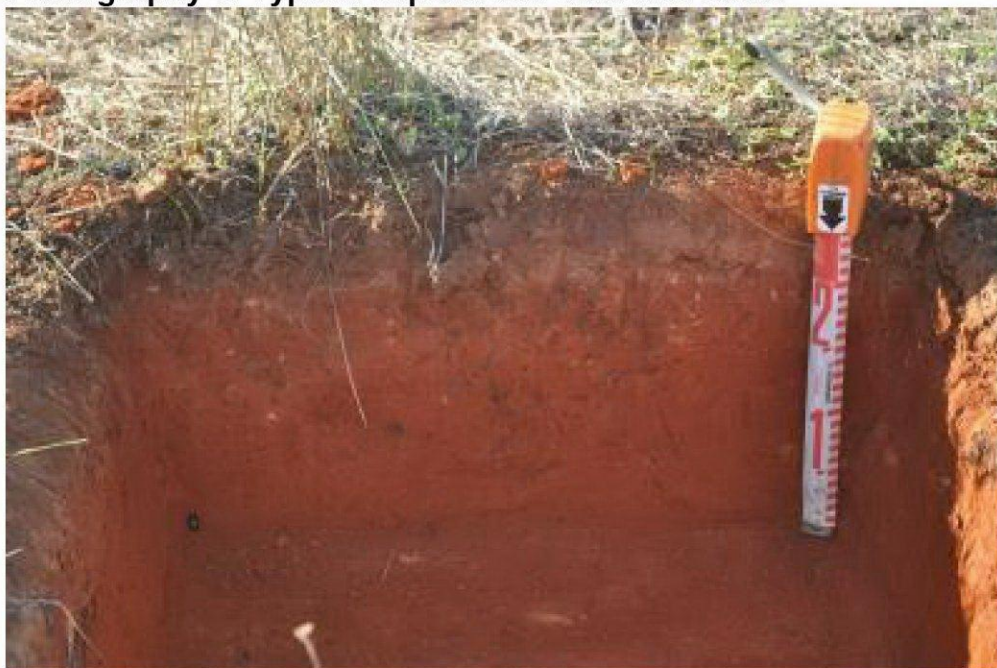
**Photography 4: Typical Topsoil and Subsoil Profile**

The topsoil in the extension area is quite thin (approximately 10 to 20cm in depth) overlaying the very hard weathered Shale shown as the 'C' Horizon in the table above and Photography 4 below. The soils are slightly acidic and have low to moderate conductivities.

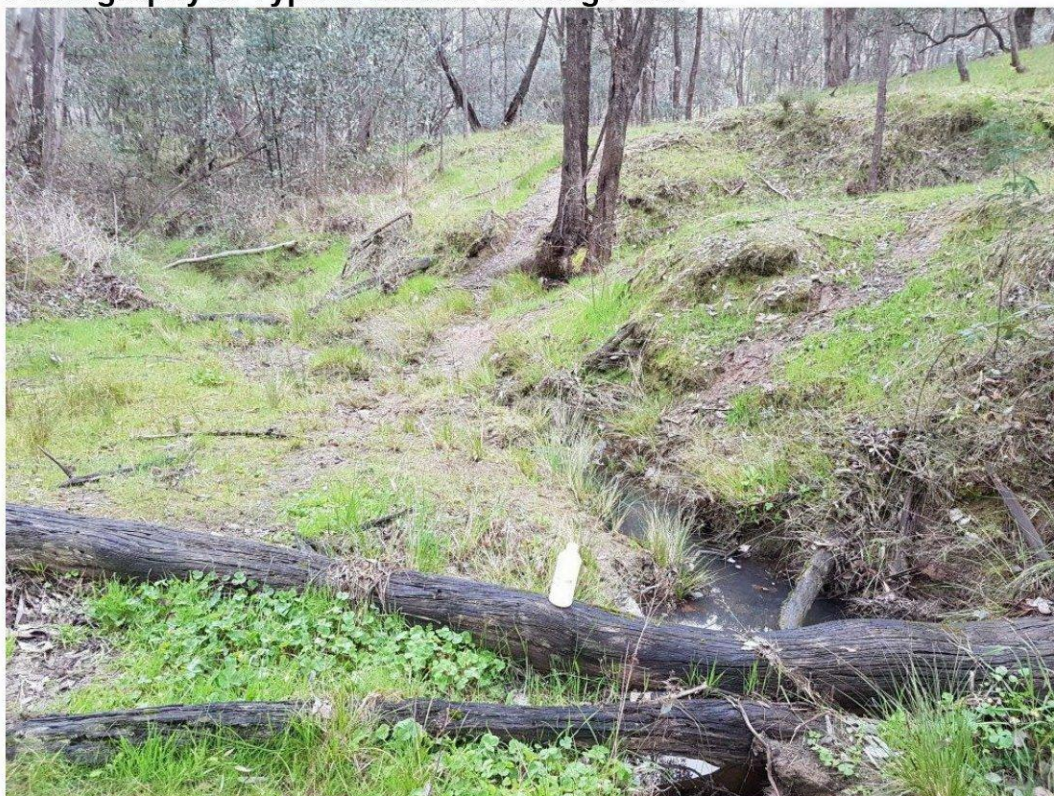
**Photography 6: Typical natural drainage line**

Slopes on the site range from 5 to 45 % with the steeper slopes within the excavation itself.

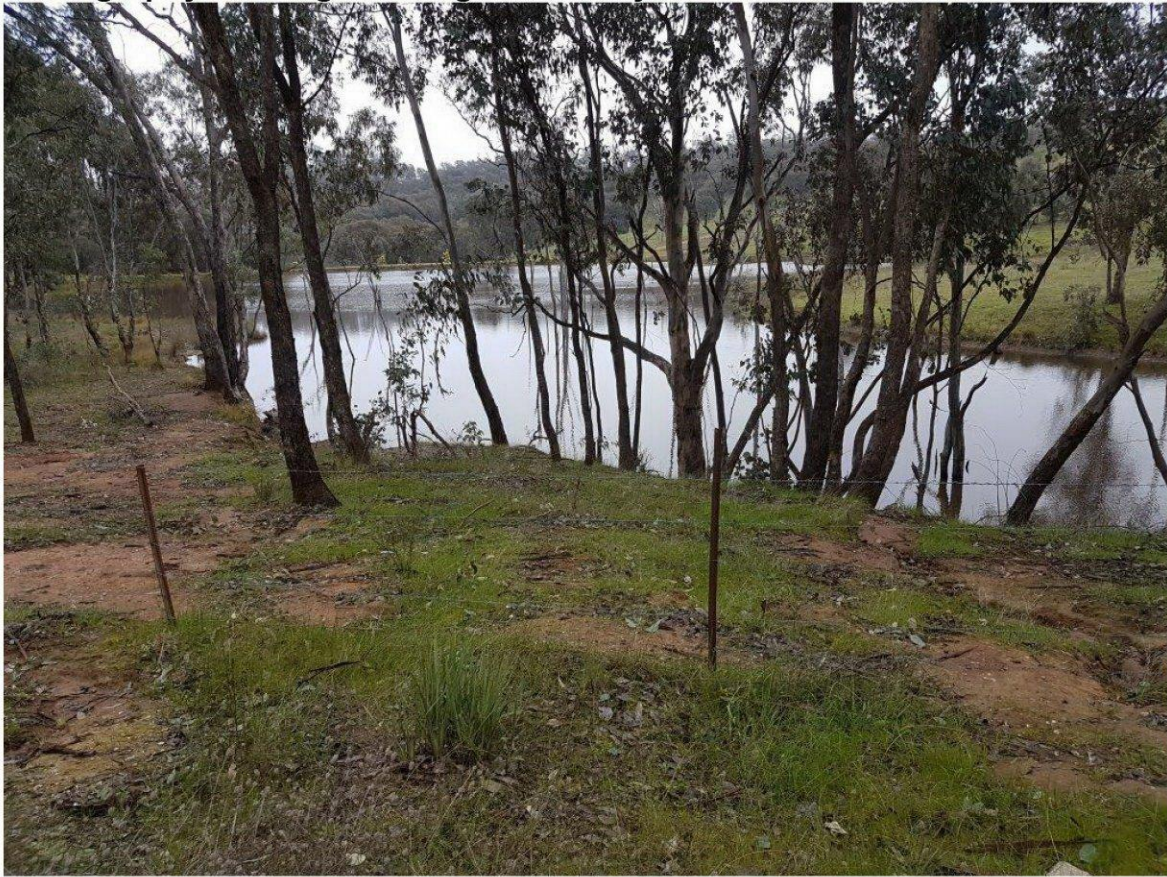
**Photography 10: Neighbouring water body**

The final water body will not be out of character for the area given the dam located in Humbug Gully, less than 100m to the east of the site and other farm dams located in the area.

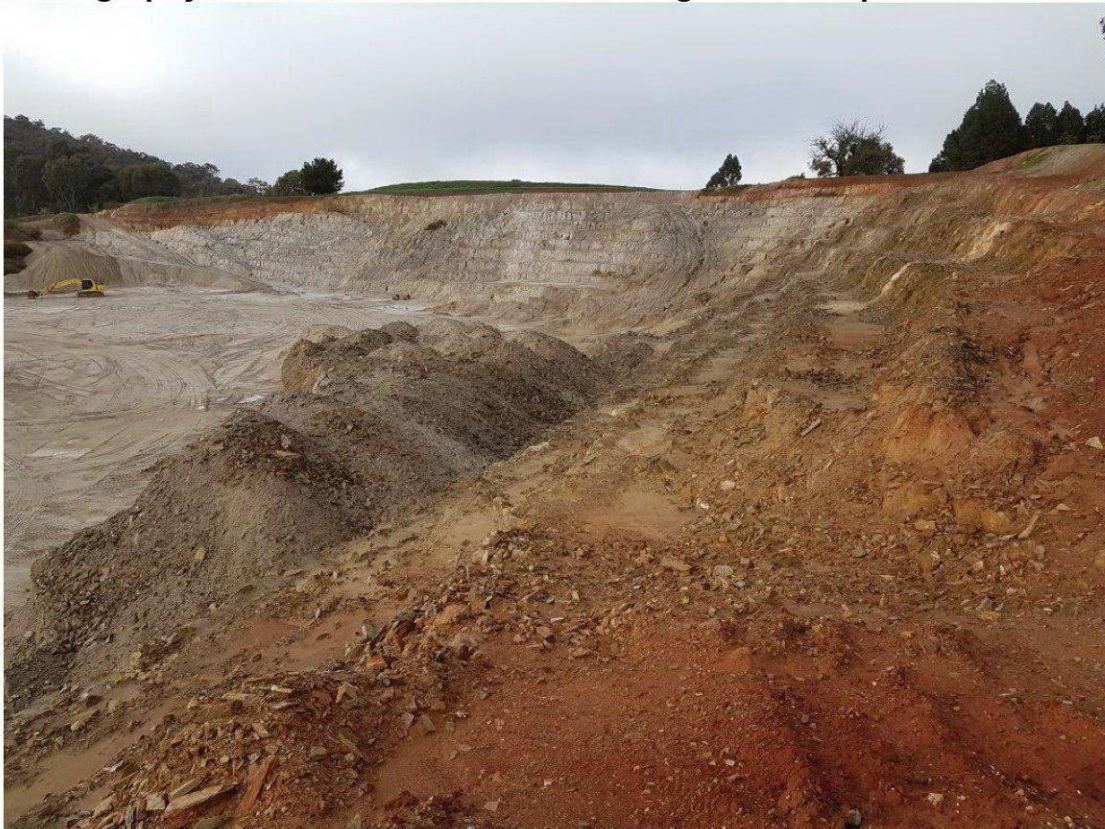
**Photography 11: Stable batters and benching in current pit**

The Clay and Shale material remaining the final landform is geotechnical and chemically stable and is unlikely to fail at these batter angles. Current faces at much steeper slopes have proved resistant to failure over the life of the operation and the risk of failure of the final landform is considered to be minimal. Additionally, previously rehabilitated slopes have proven to be stable as shown in *Photography 12* below.

Walls within the active void are currently at angles of approximately between 1.5 horizontal to 1 vertical and 2 horizontal to 1 vertical with benches cut into the walls in order to maximise resource recovery whilst decreasing the length of slope. As mining progresses and final faces are achieved, walls will be battered to make safer angles of approximately 4 horizontal to 1 vertical. As stated previously, to date the walls have proven resistant to failure over the life of the operation at these angles. Mining will continue in a similar manner with regards to working faces.

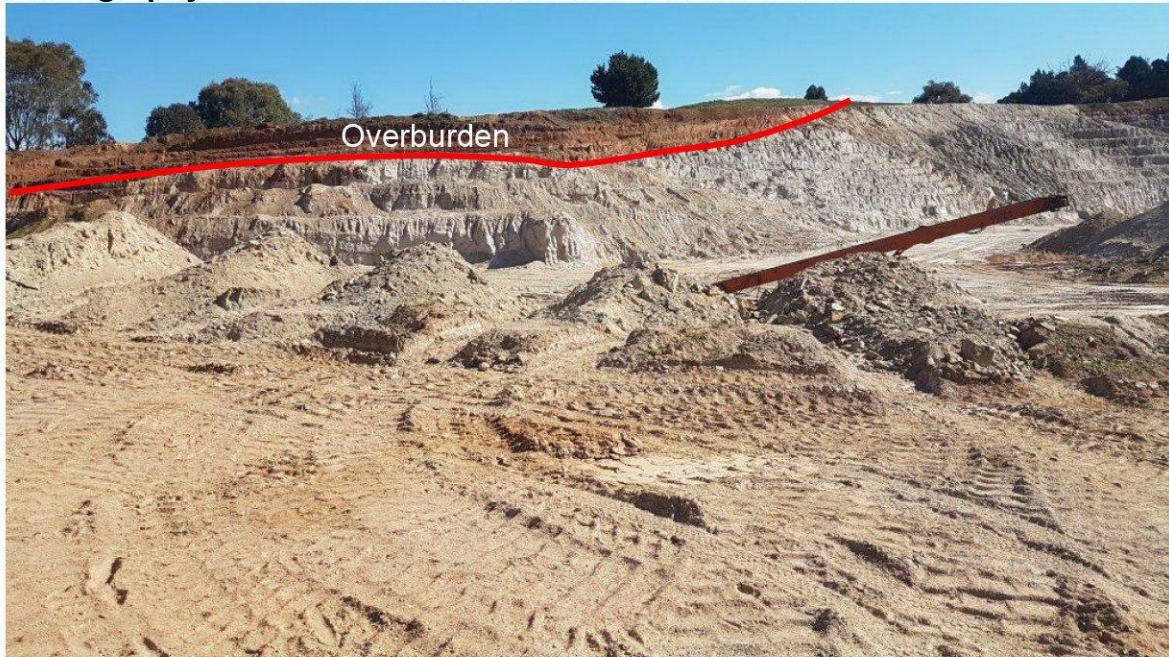
**Photography 14: Subsoils and Overburden in the South**

The 3-4 Horizontal to 1 Vertical mine final face batters will provide gentler slopes and the requirement for overburden to batter final slopes will be reduced. Further exploration activities will identify the volumes, if any, of overburden material expected.

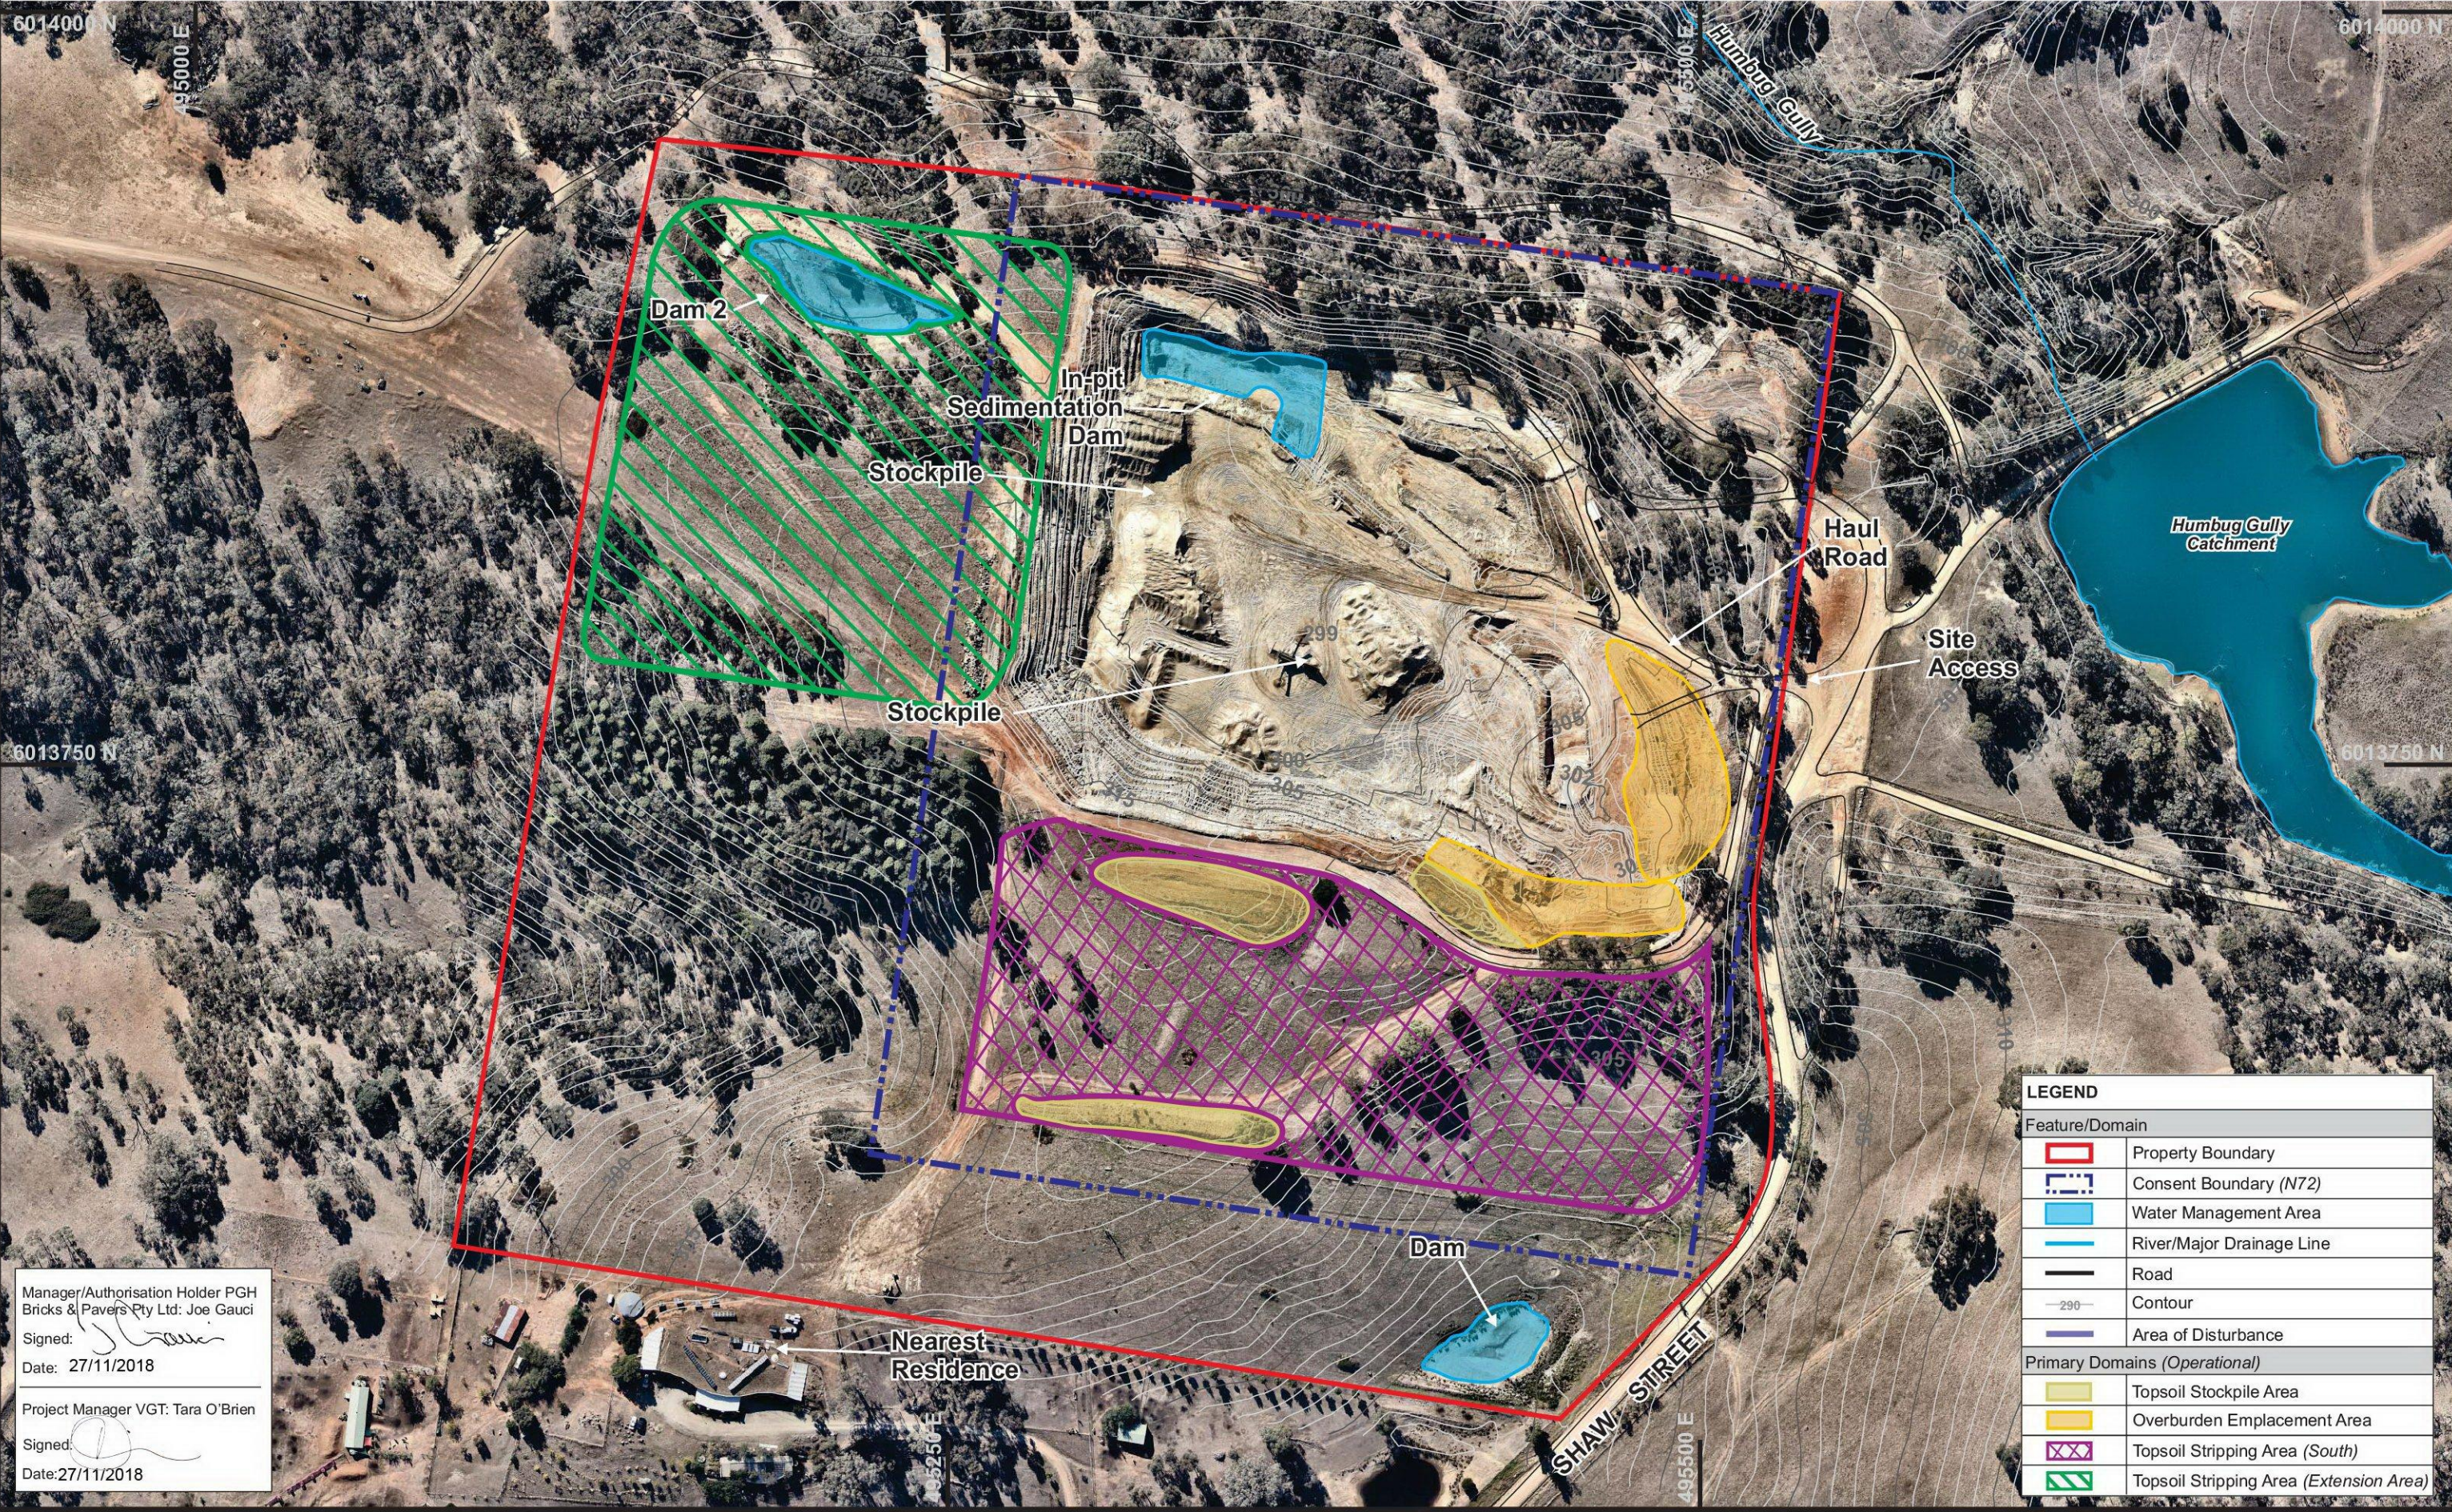
| <b>Plan of:</b> | Land Resources Assessment for Andersons Clay Mine Environmental Impact Statement 2018 - Soil Resources | <b>Location:</b> | 253 Shaw Street, Springdale Heights, NSW | <b>Source:</b> | nearmap - Image Date 01/05/2018 & Landair Surveys | <b>Our Ref:</b> | 3618_BAN_LR_DA17_C004_V1_F6.cdr |
