DA19/0036 – Waste Disposal Facility (Non-Putrescible Landfill)
Council Supplementary Report Following Submission of Peer Reviews
Steven Cook, Senior Town Planner, 8/3/22

Review of Hydrological and Hydrogeological Assessment
Wagga Wagga Waste Disposal Facility
225-265 Trahairs Road, Bomen, NSW 2650

Figure 1 Regional Context
Riverina Oils and Bio Energy Pty Ltd
 Groundwater Review
 Integrated Oilseed Processing and
 Biodiesel Plant

RIVERINA OILS AND BIO-ENERGY PTY LTD – AUSTRALIA
PROPOSED INTERGRATED BIO-DIESEL PLANT
BOMEN, WAGGA WAGGA
BOREHOLE LOCATION PLAN

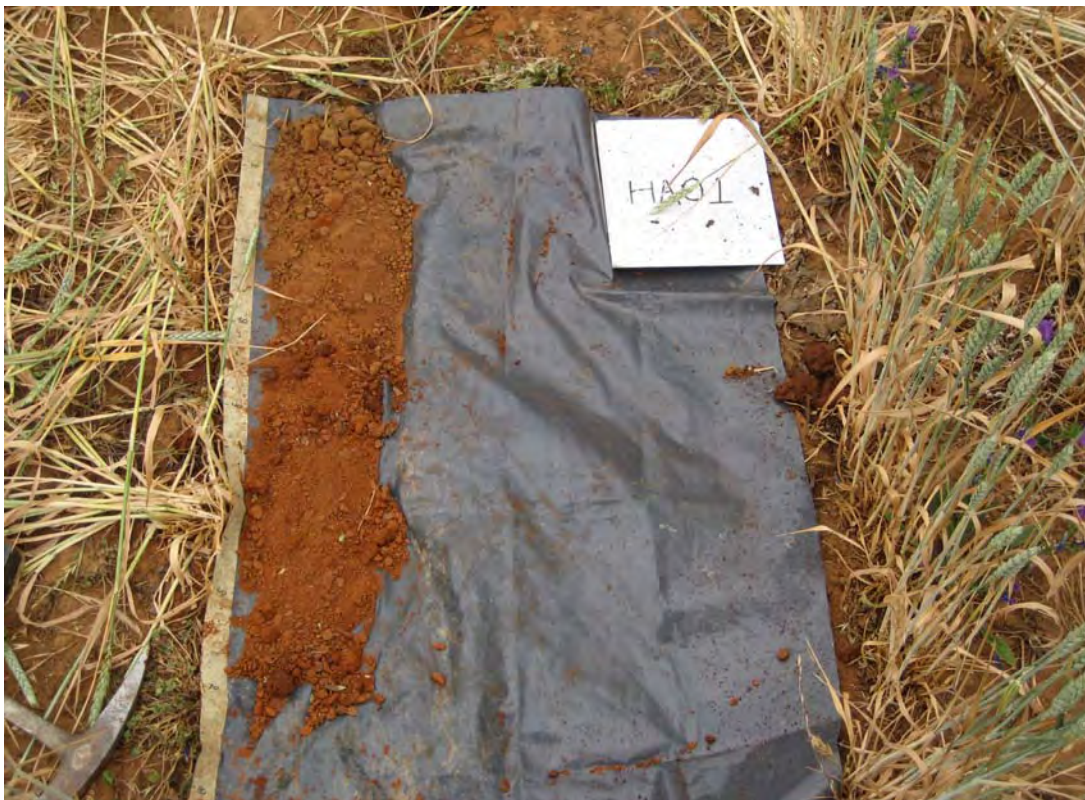
Plate P2: Soil Profile HA01

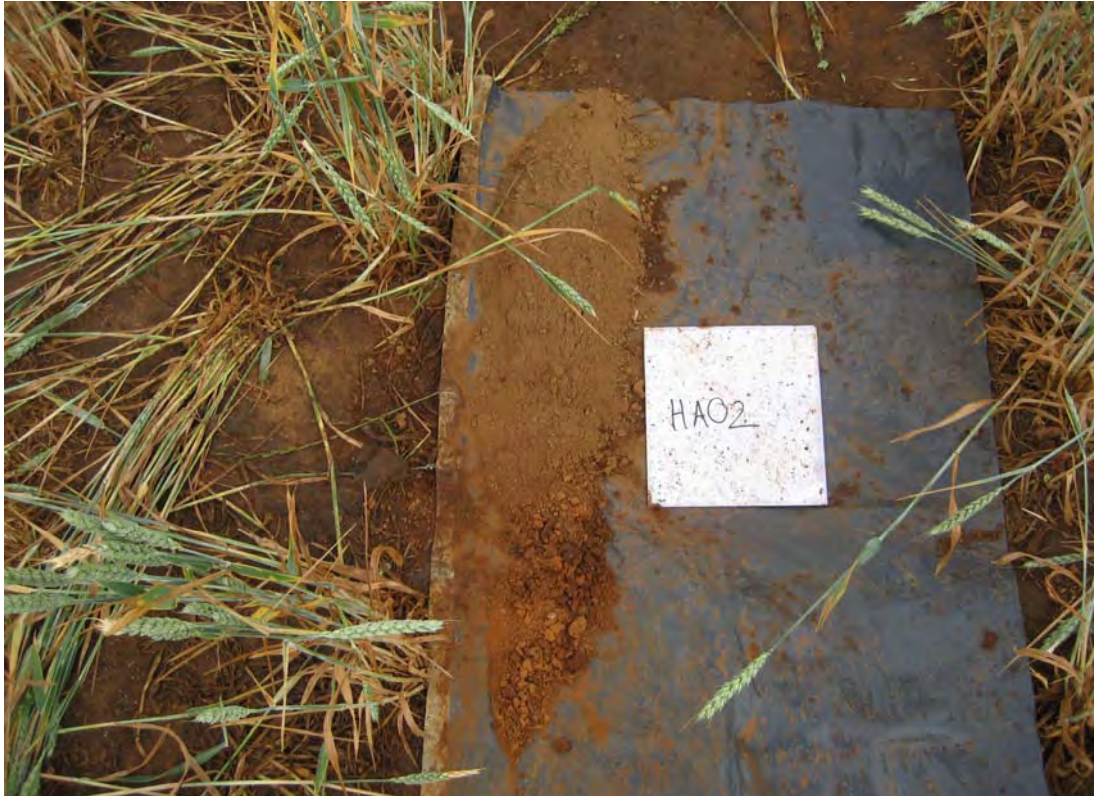
Plate P3: Soil Profile HA02

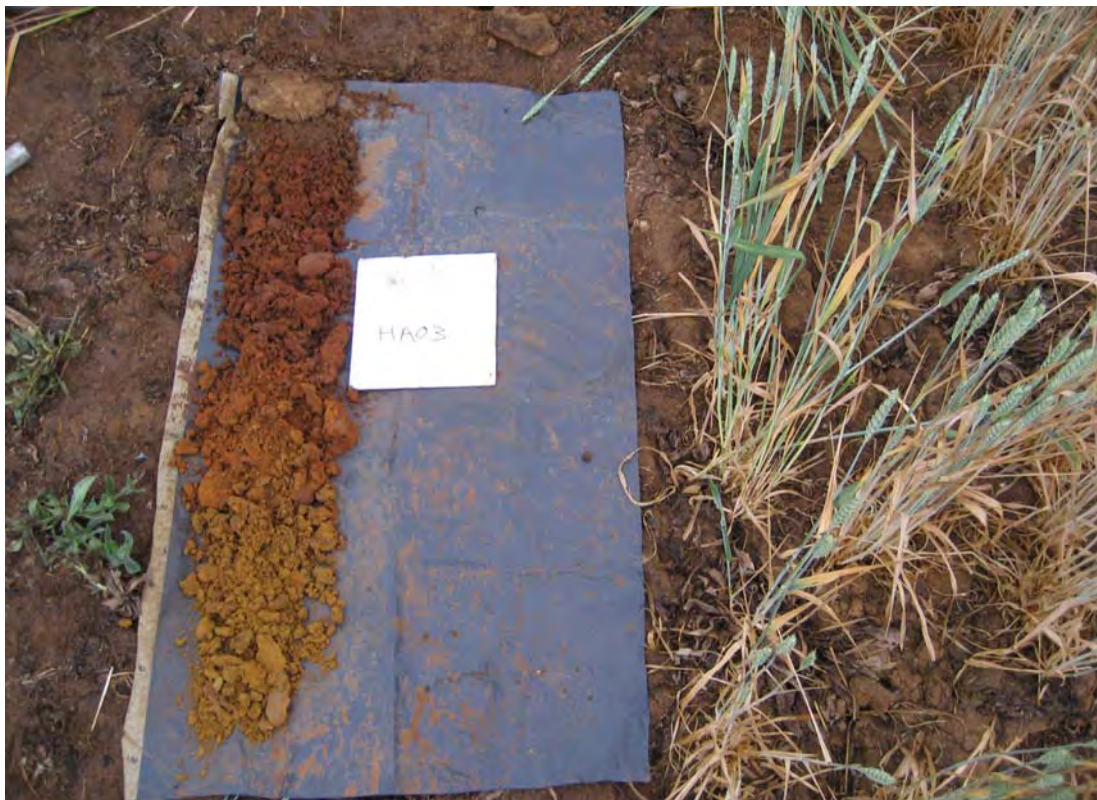
Plate P4: Soil Profile HA03

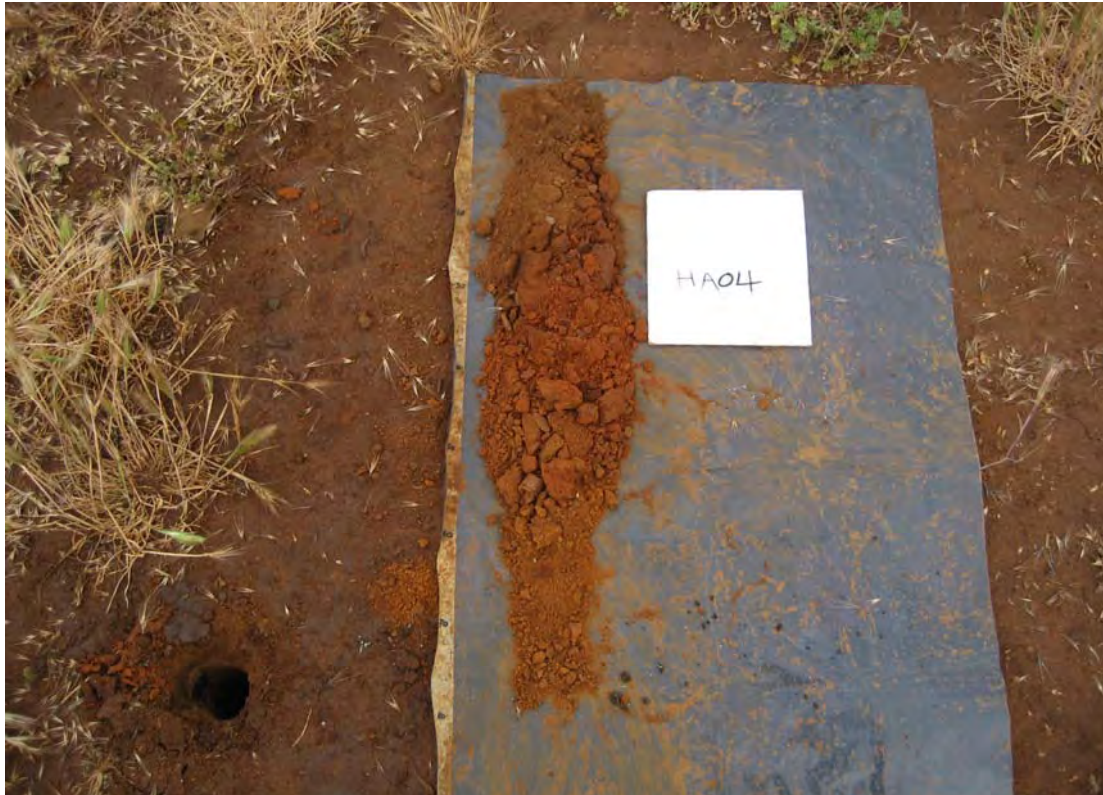
Plate P5: Soil Profile HA04

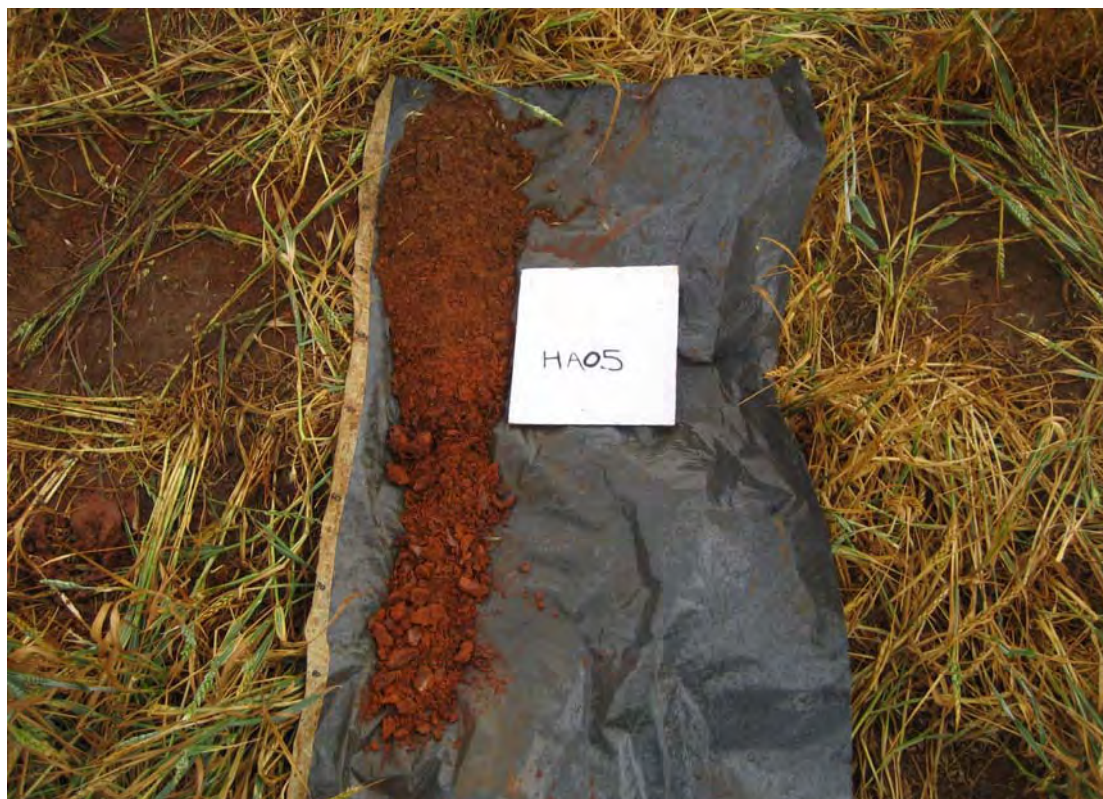
Plate P6: Soil Profile HA05

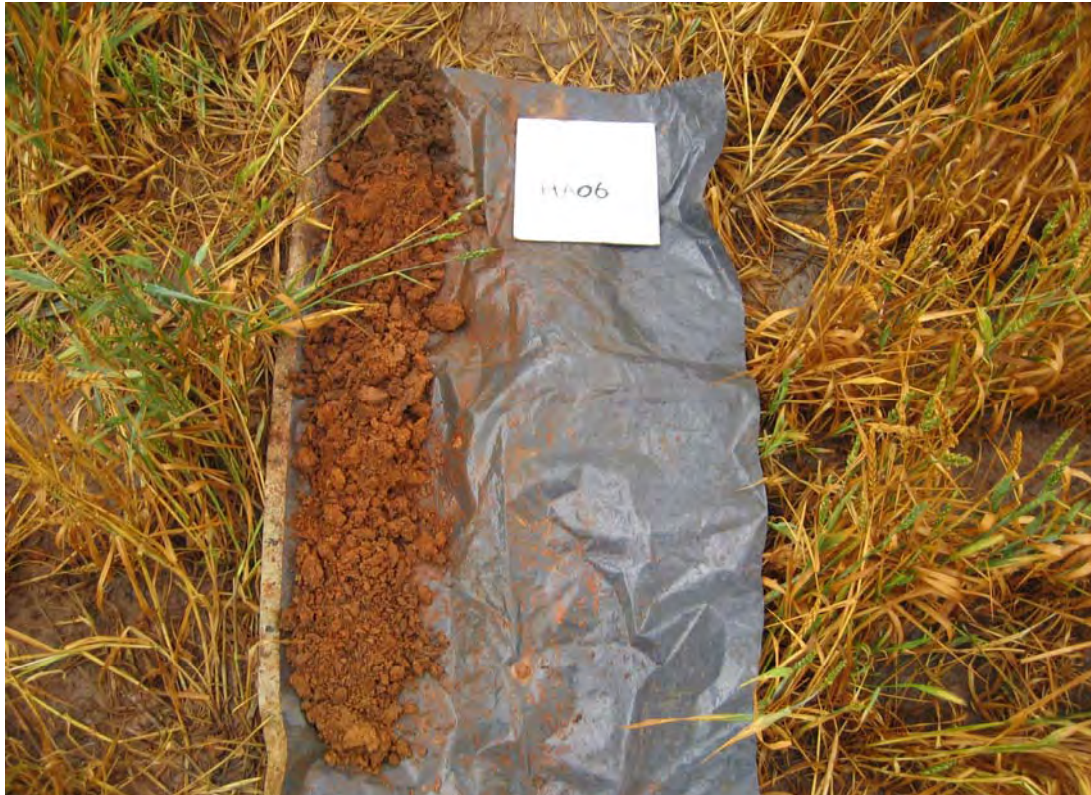
Plate P7: Soil Profile HA06
