### **Additional Geotechnical Investigation Proposed Residential Precinct – RP1 Edmondson Park South Town Centre Soldiers Parade and Campbelltown Road Edmondson Park NSW**

**Ref: JG15942A-r6(rev)**  
**December 2016**

**Re Additional Geotechnical Investigation  
Proposed Residential Precinct – RP1  
Edmondson Park South Town Centre  
Soldiers Parade and Campbelltown Road Edmondson Park**

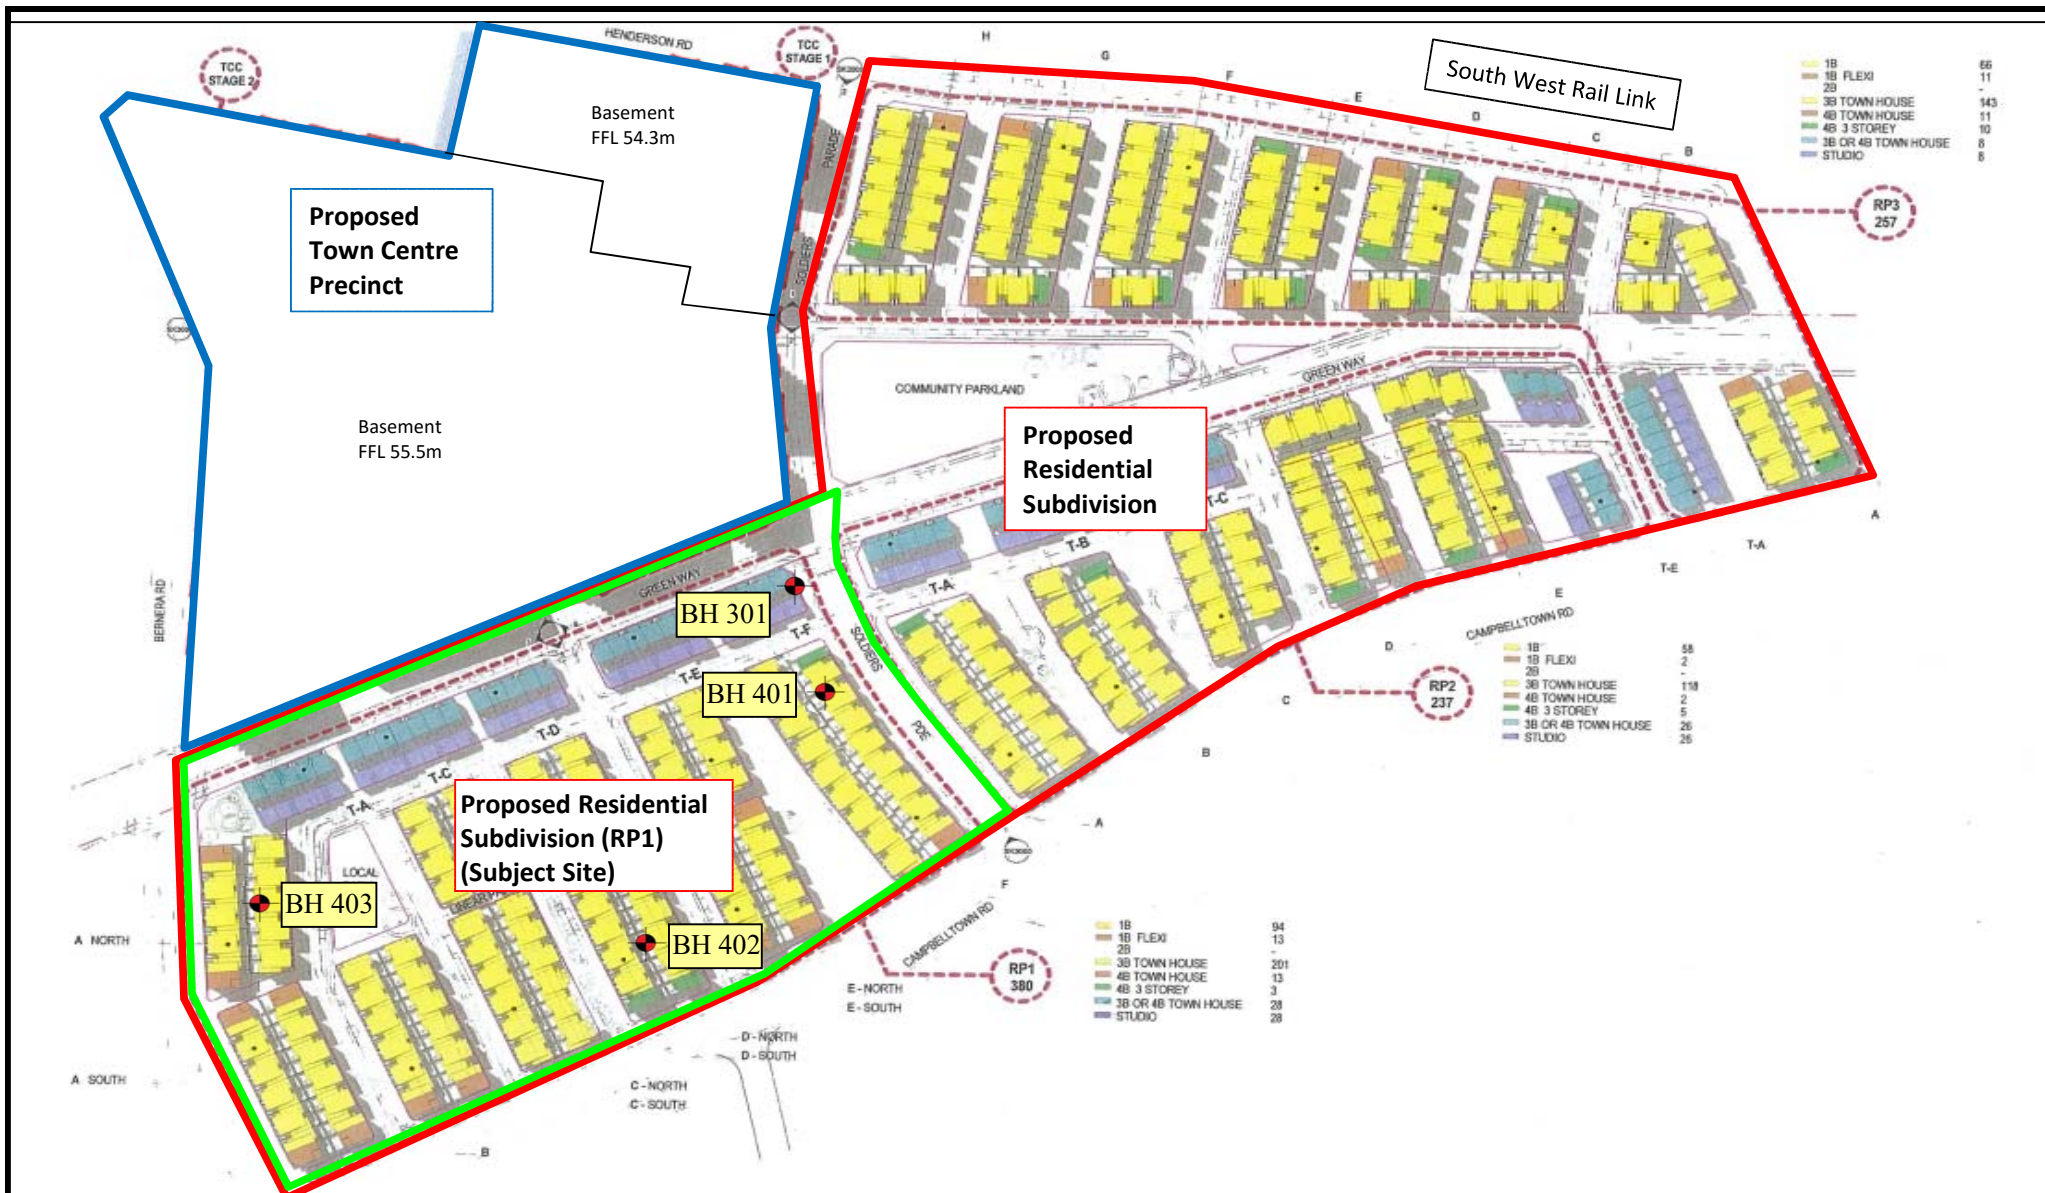
Drawing No: 1

Drawing No 1: Site Locality and Borehole Location Plan

Further to our geotechnical report referenced JC15942A-r2 dated February 2016, this report presents the results of our additional geotechnical investigation carried out on the residential precinct RP1 of the Edmondson Park South Town Centre development site as shown on Drawing No 1.
