Gledswood

Conservation Management Plan

Report prepared for Caldla Pty Ltd
September 2011

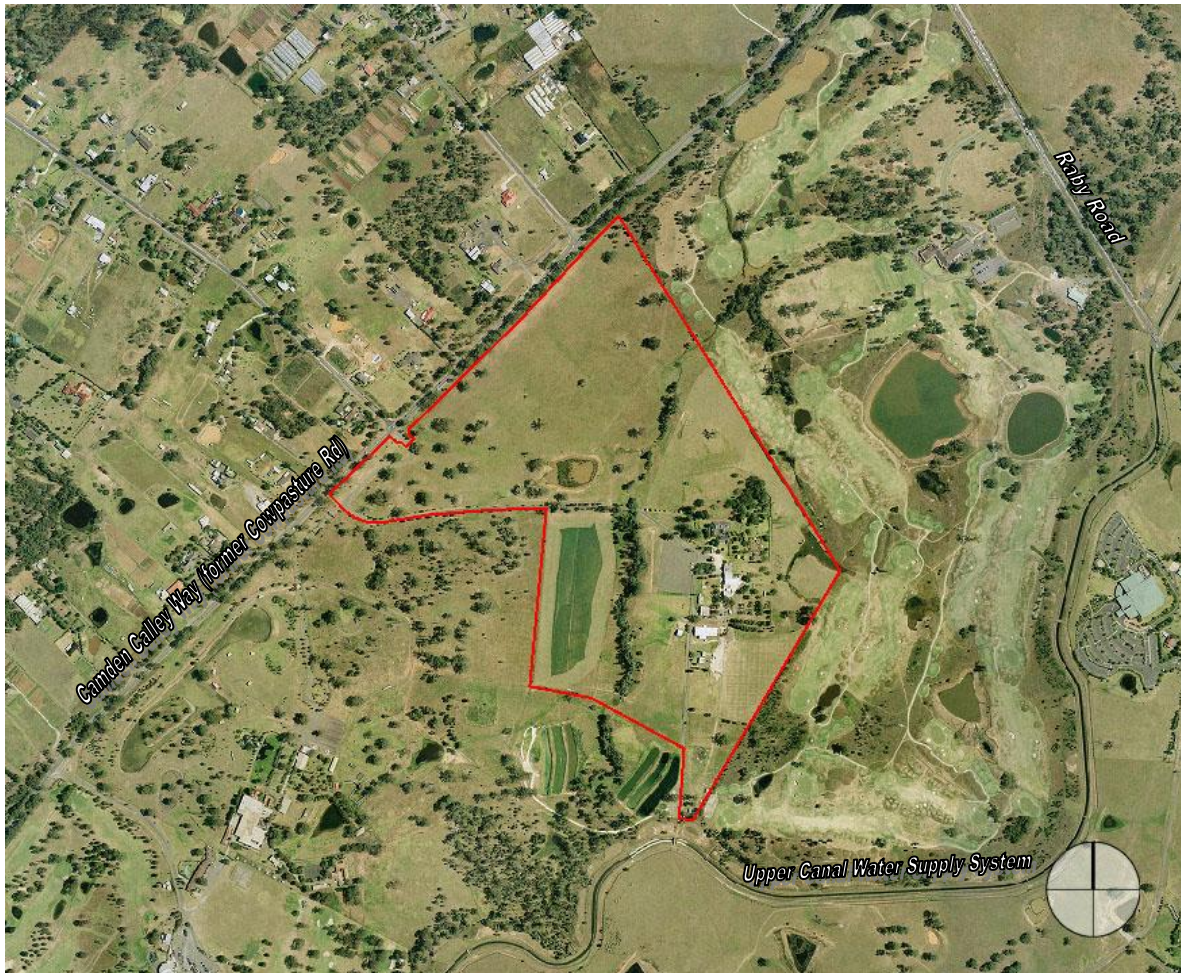
Figure 1.2 Aerial view showing the site boundary and SHR heritage curtilage of Gledswood. (Source: NSW Department of Lands)

The Gledswood estate is located off Camden Valley Way, south of Raby Road, in Catherine Field. Located at 900 Camden Valley Way and set on 65 hectares (150 acres) of pastoral land, the subject site consists of Lot 12 DP 748303. The study area is generally the existing site, as shown in Figure 1.2, plus relevant components of adjacent land. The site is bounded by Camden Valley Way to the northwest and the former El Caballo Blanco ranch (original part of the Gledswood estate) to the southwest. The remainder of the site is bounded by the Lakeside Golf Course and a section of the Sydney Water Upper Canal water supply system (see Figures 1.1 and 1.2). The site is also situated adjacent to the southern boundary of the Catherine Field Precinct in the Southwest Growth Centre of Sydney.

The *Heritage Act 1977* (NSW) affords protection for State significant items through the SHR. The subject site was gazetted on the SHR in December 2006 under the name 'Gledswood' (see Figure 1.2 for SHR heritage curtilage).

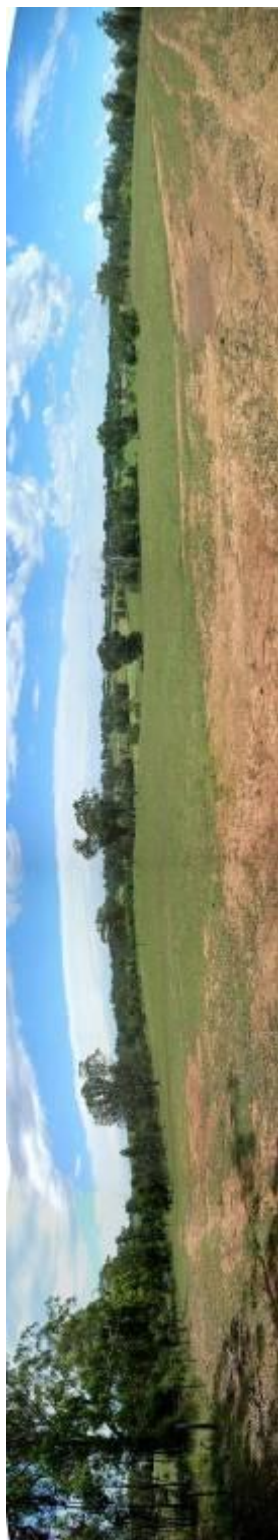
Figure 3.1 View from the northern corner of the site near Camden Valley Way. Note the homestead in the background and Rileys Creek in the middle ground.

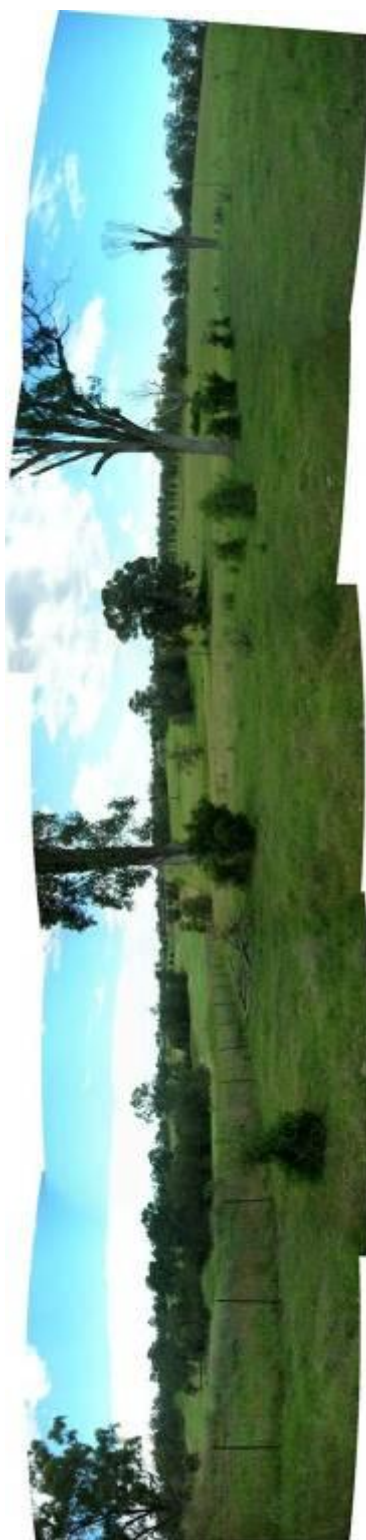
Figure 3.2 View from the north near the eastern boundary fence looking back to the homestead with old woodland trees in the foreground.

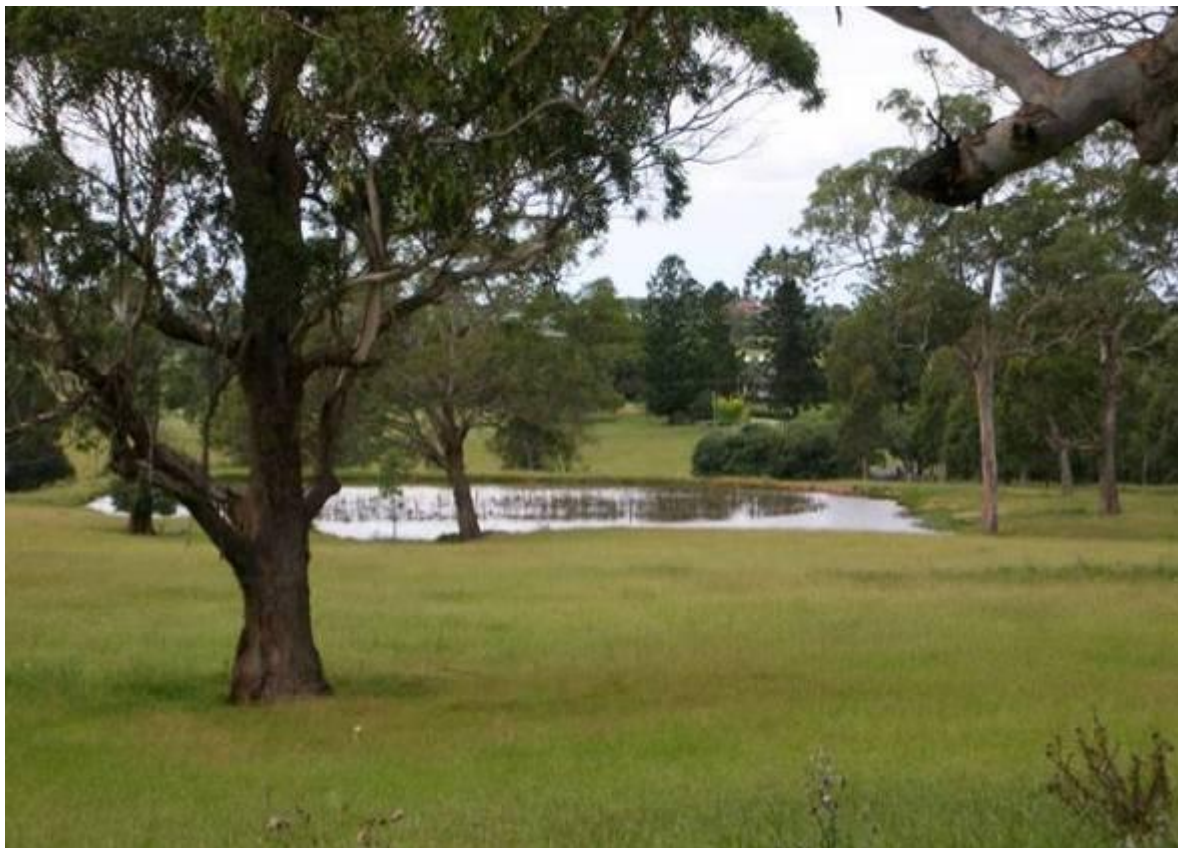
Figure 3.4 Traditional vista from near Camden Valley Way looking across the large dam to the homestead and flanking pines. Note the intrusive recent buildings beyond.

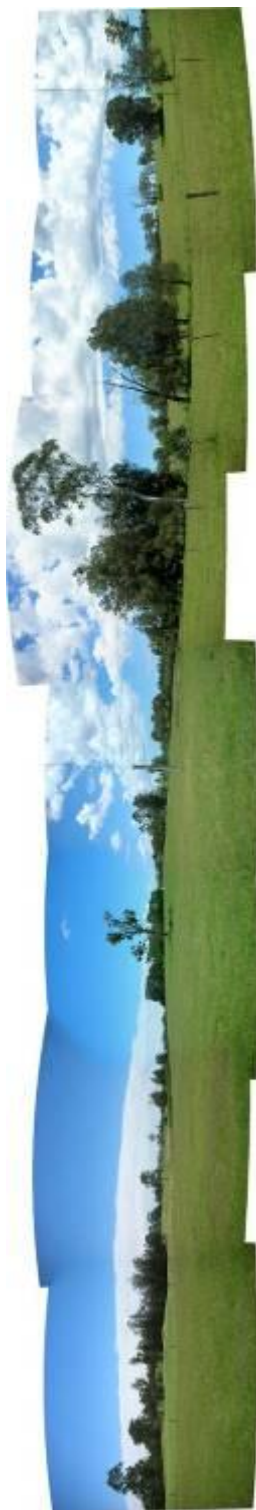
Figure 3.5 Panorama from northern paddock showing the adjoining golf course to the left, the homestead group in the middle and Rileys Creek at right.

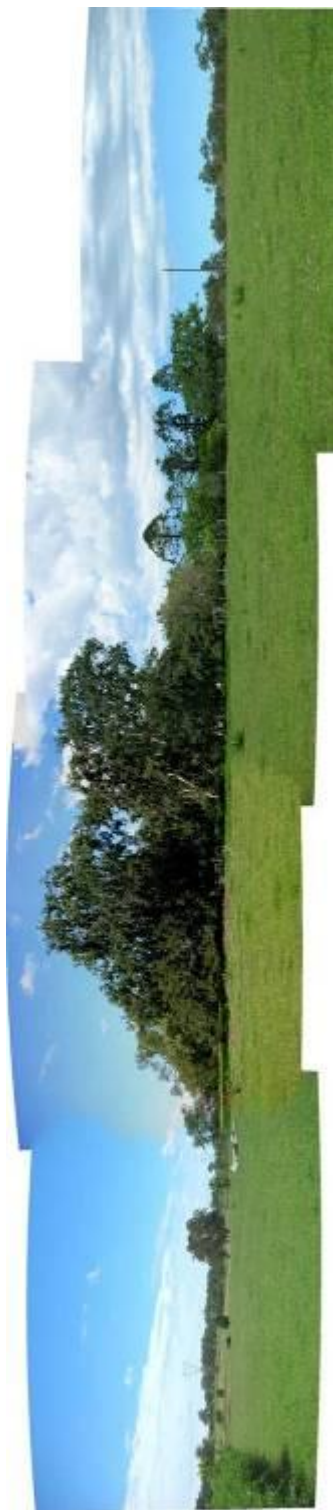
Figure 3.6 View along former northeastern entry drive leading up to the gate and flanking Chinese elms. The former carriage drive formation is intact down to the boundary fence.

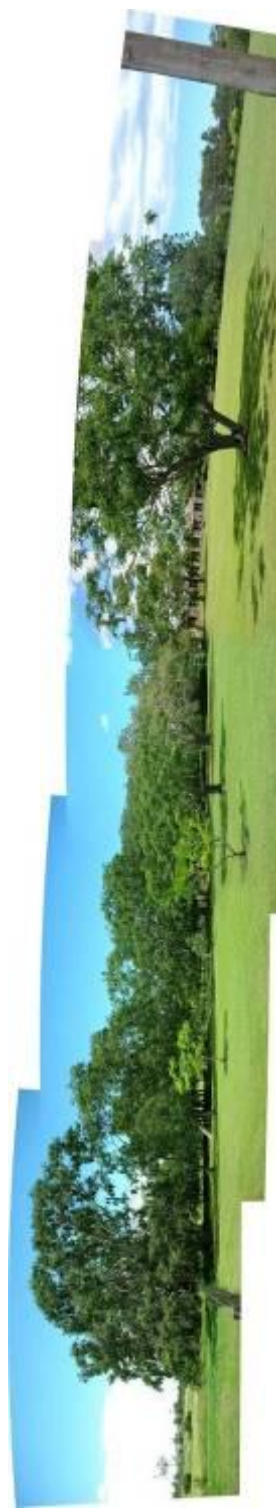
Figure 3.7 View of the northern grounds showing the two main blocks of flanking early gardens either side of the homestead.

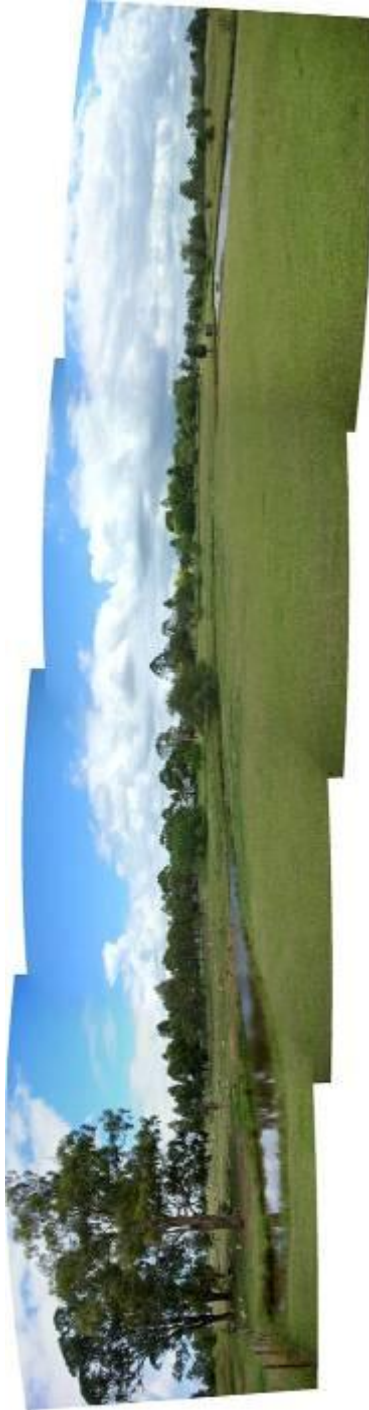
Figure 3.9 Approaching view from the former eastern entry drive from Raby Road. Note the old woodland trees at left. The former creek crossing was located where there is a peppercorn tree near the creek near the middle of the view.

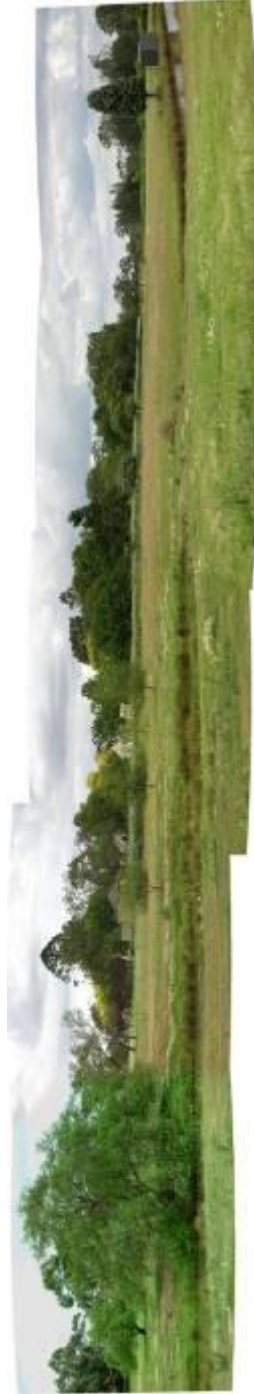
Figure 3.10 View as part of the arrival sequence for the former eastern entry. The peppercorn tree in the foreground marks the location of the former bridge crossing. The former orchard was across the creek.

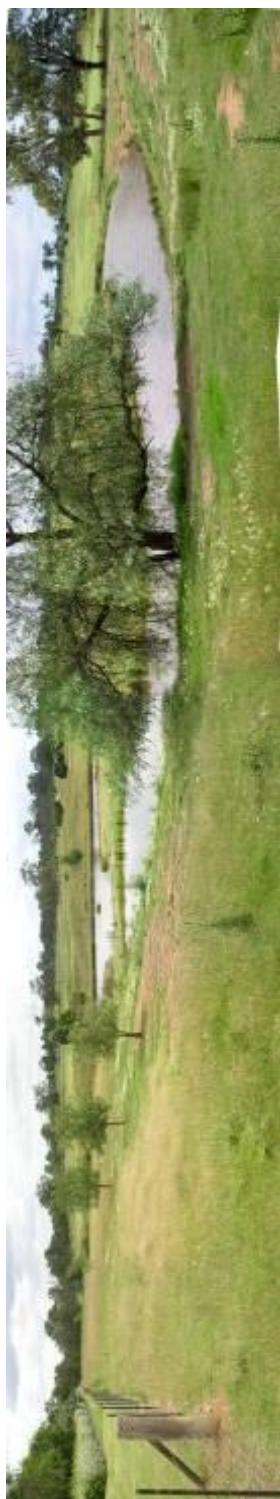
Figure 3.11 Former orchard (between the fence and creek) and former bridge crossing (at larger peppercorn tree).

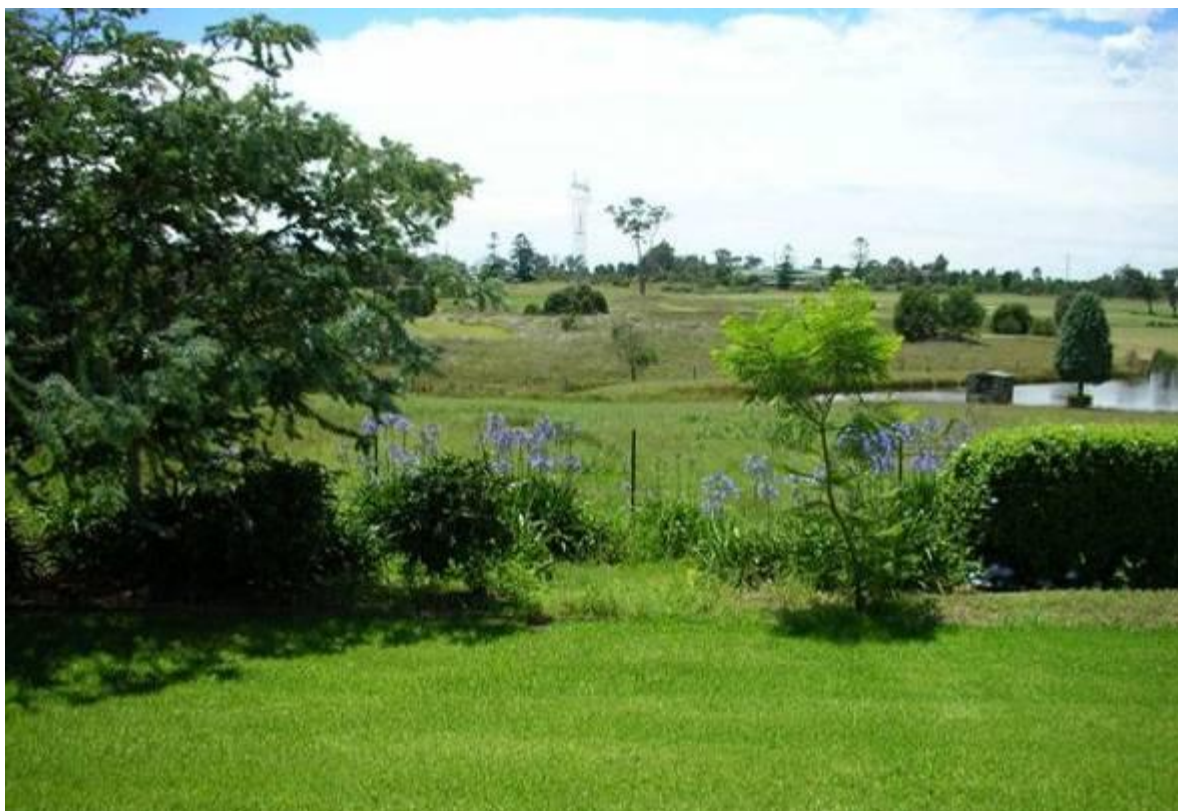
Figure 3.13 View to the east on axis from the homestead with hoop pines along the Upper Canal in the distance.

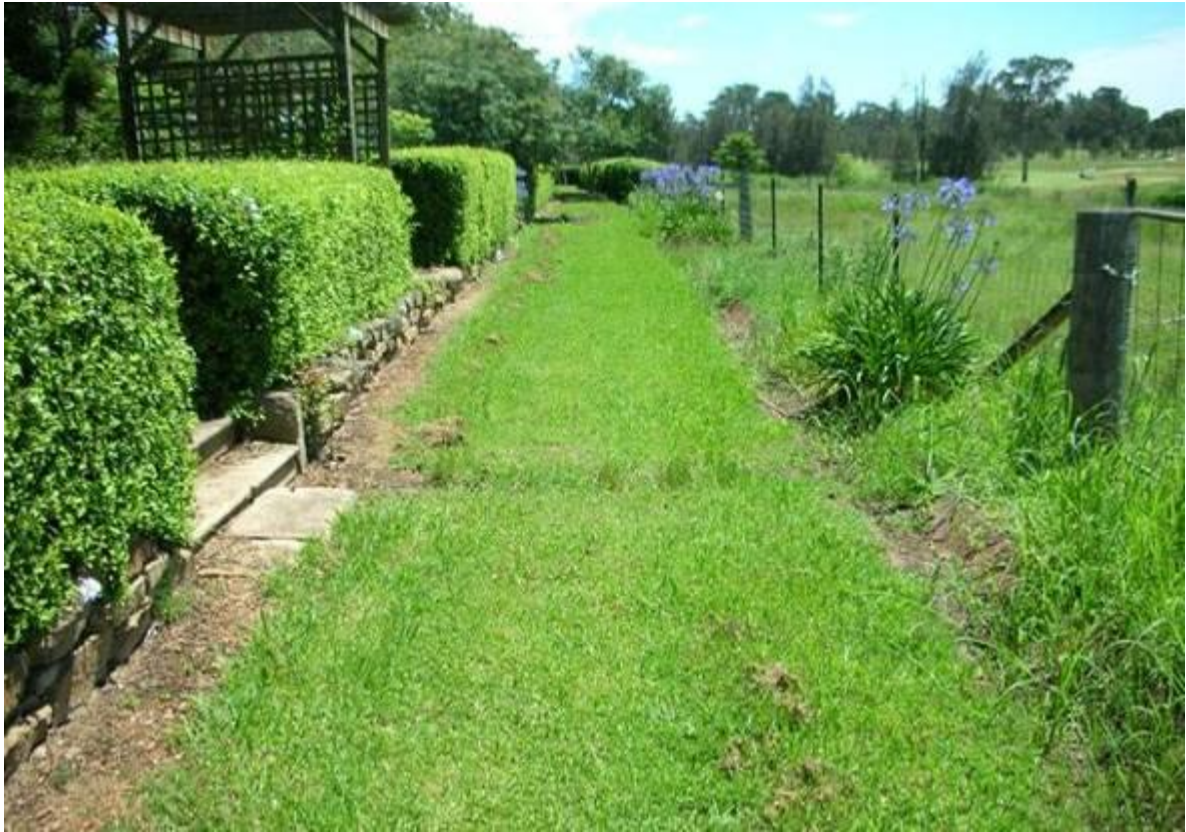
Figure 3.14 View along the site of the famous trellised vineyard looking north.

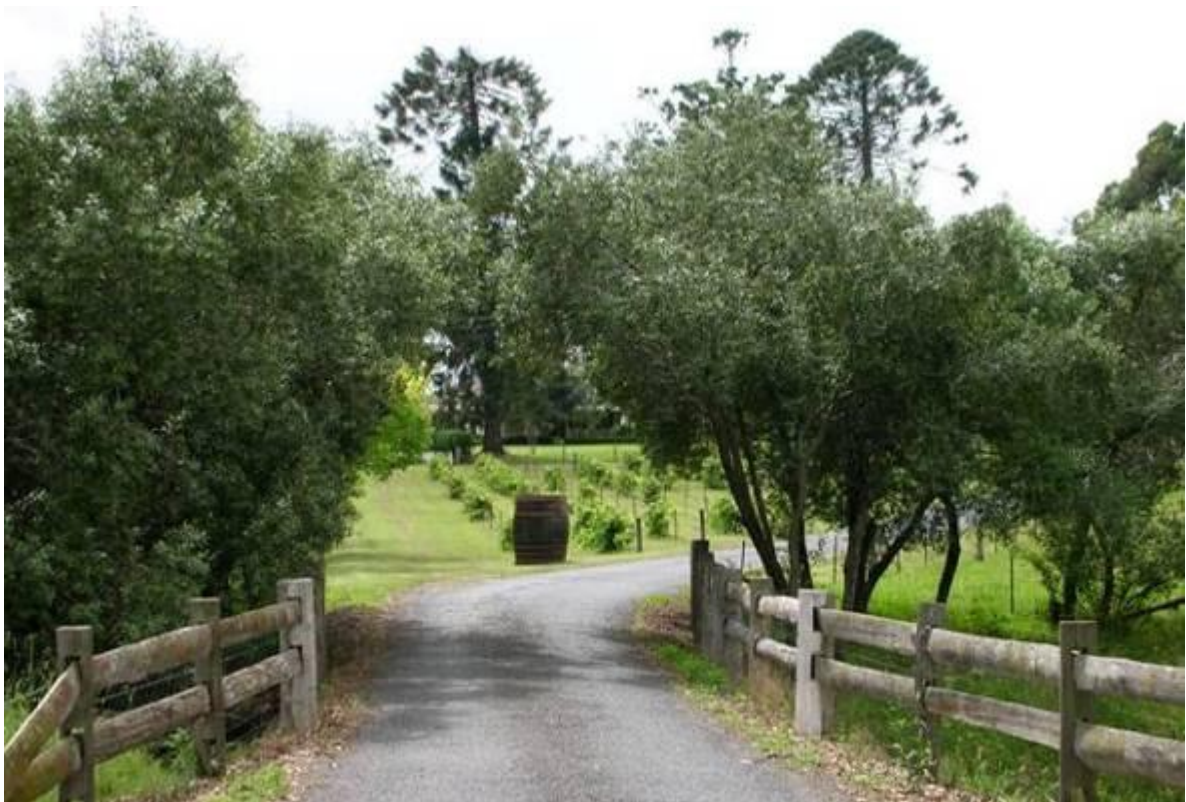
Figure 3.15 Part one of a sequence along the original entry drive looking to the homestead with the Rileys Creek bridge crossing in the foreground.

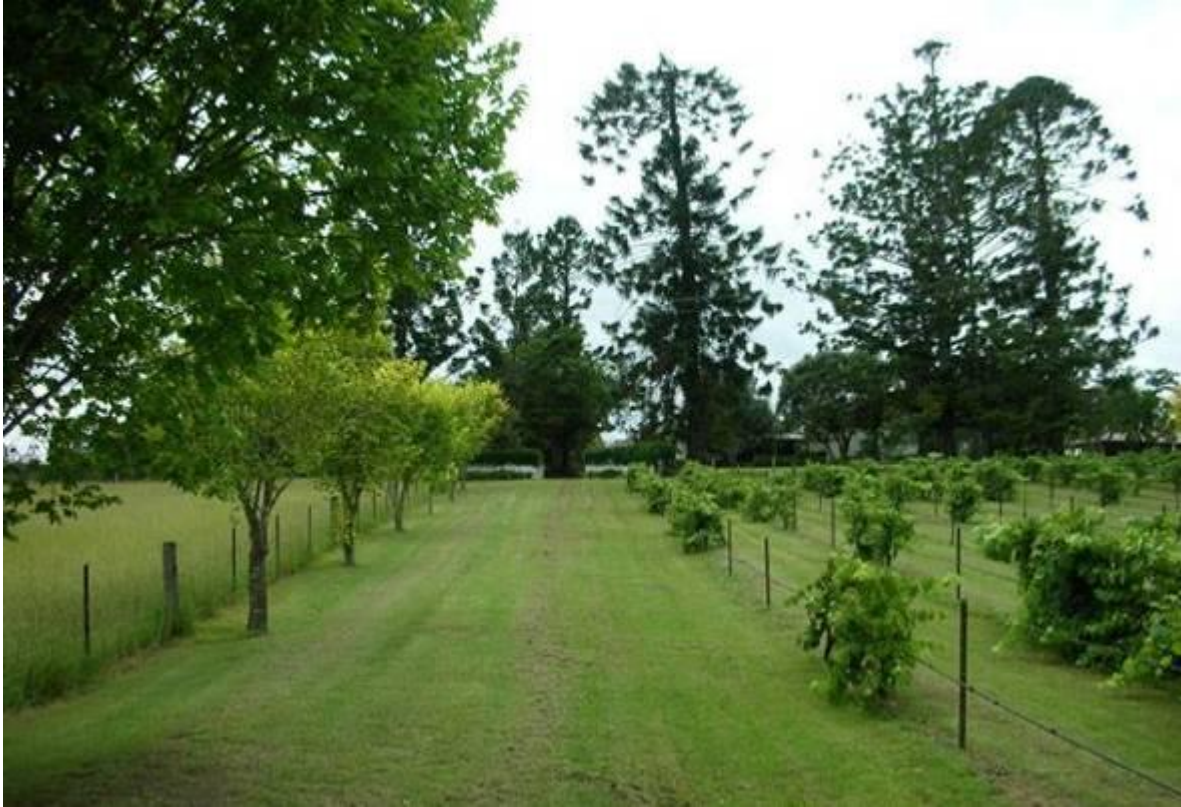
Figure 3.16 Part two of the traditional arrival sequence looking up to the homestead entry gates.

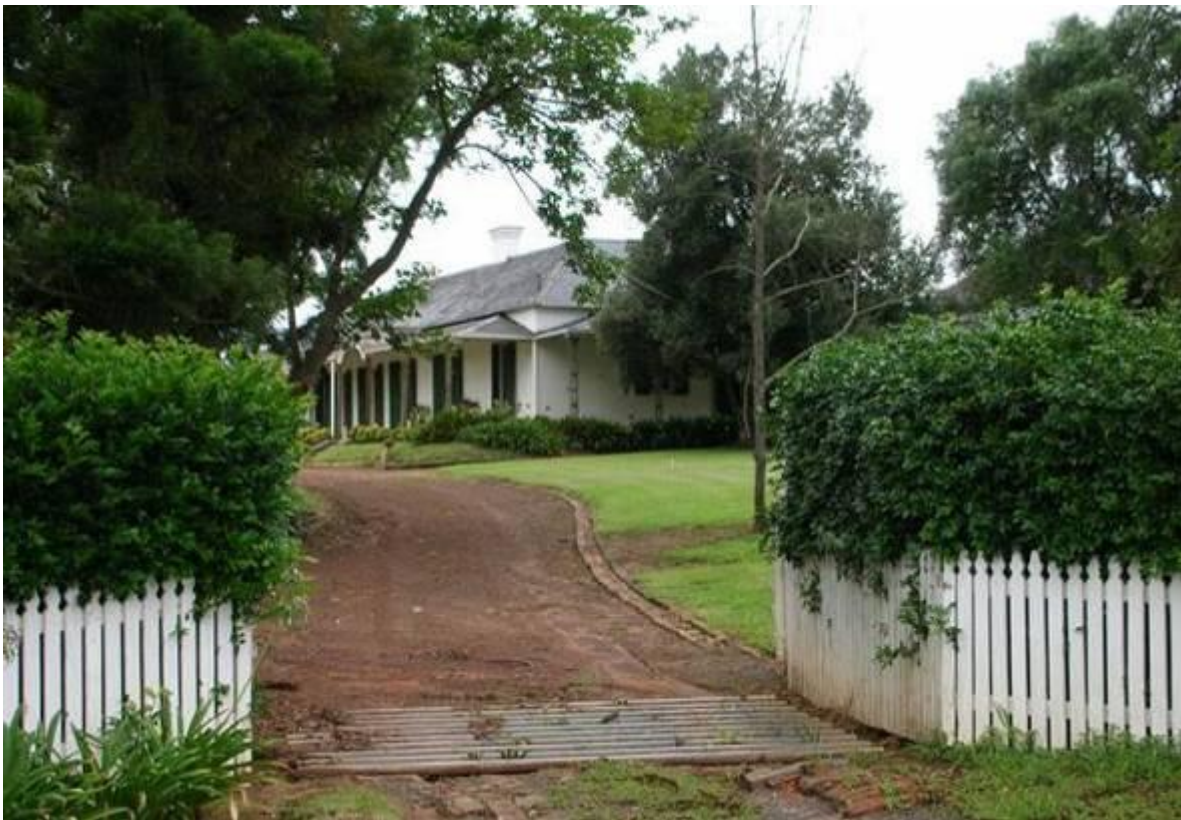
Figure 3.17 Part three, having arrived at the gates with early diamond-frogged bricks used in the foreground near the cattle grid.

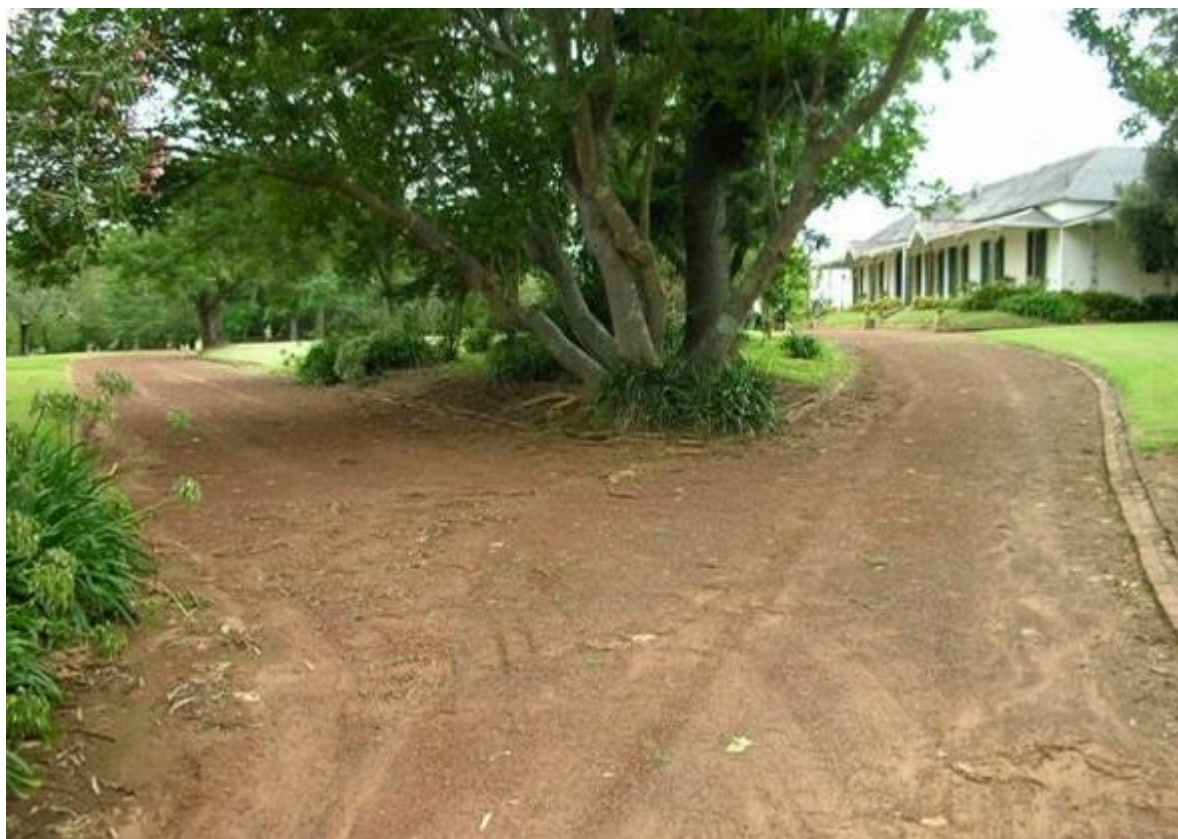
Figure 3.18 Final view in the arrival sequence showing the carriage loop with brick edging and drains.

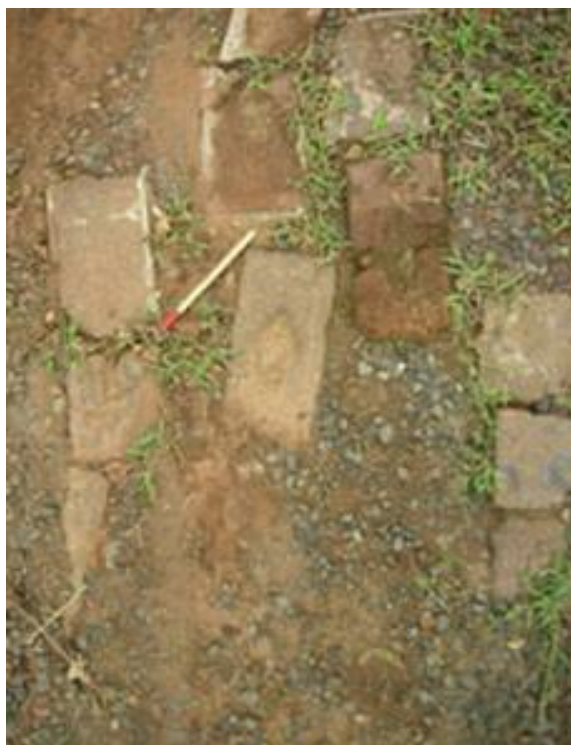
Figure 3.19 Early bricks at cattle grid near entry gates.

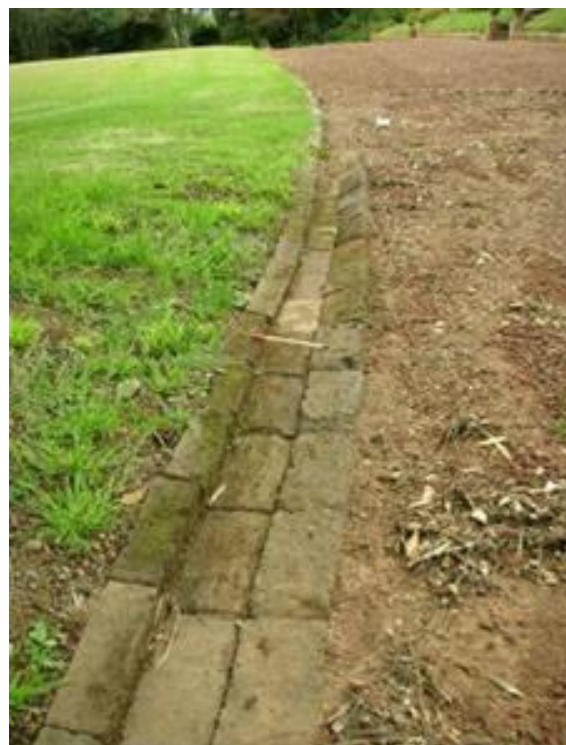
Figure 3.20 Detail of carriage loop brick edging.

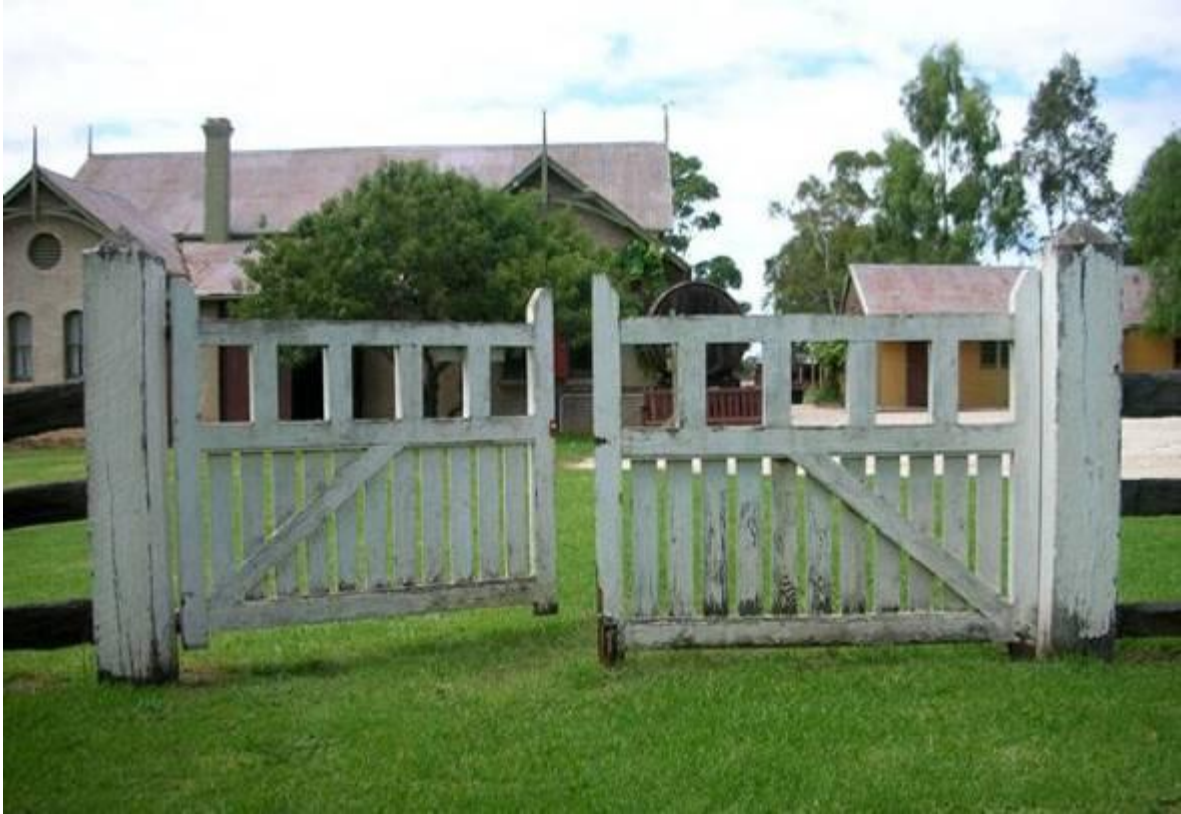
Figure 3.21 Gates on axis behind the homestead with the stables beyond.

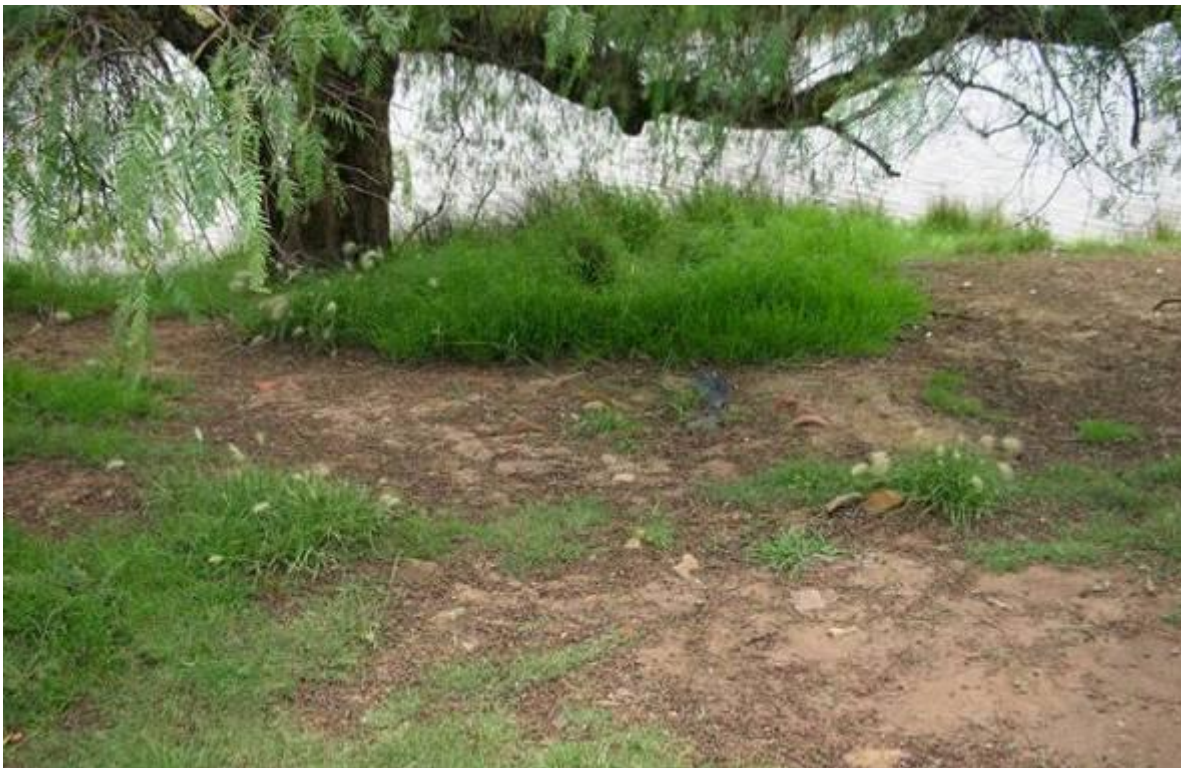
Figure 3.22 Site of the former bridge crossing for the eastern entry. Note the brick debris.

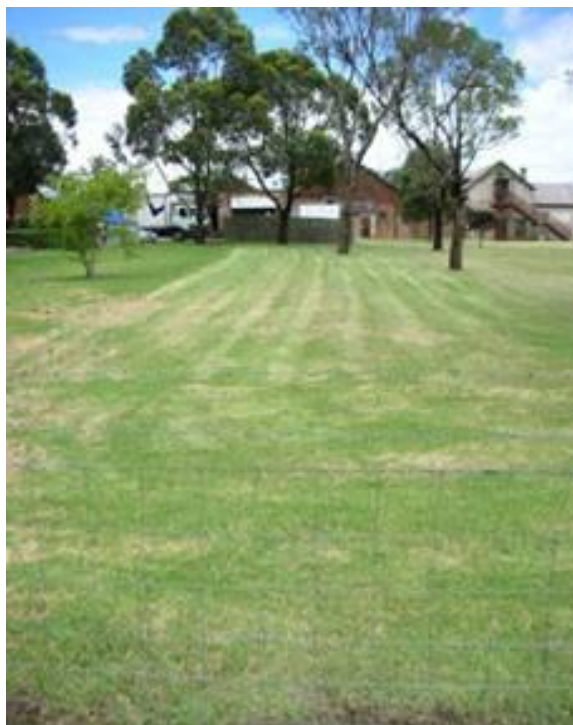
Figure 3.23 Line of the former eastern entry drive (note the slight undulation in the grass) that maintained the orthogonal layout of the homestead and outbuildings.

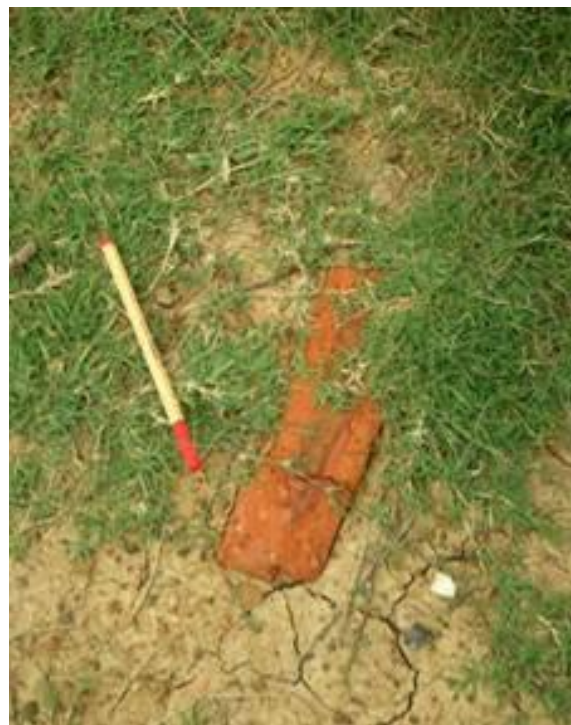
Figure 3.24 An early brick on the causeway to the east of the former orchard.

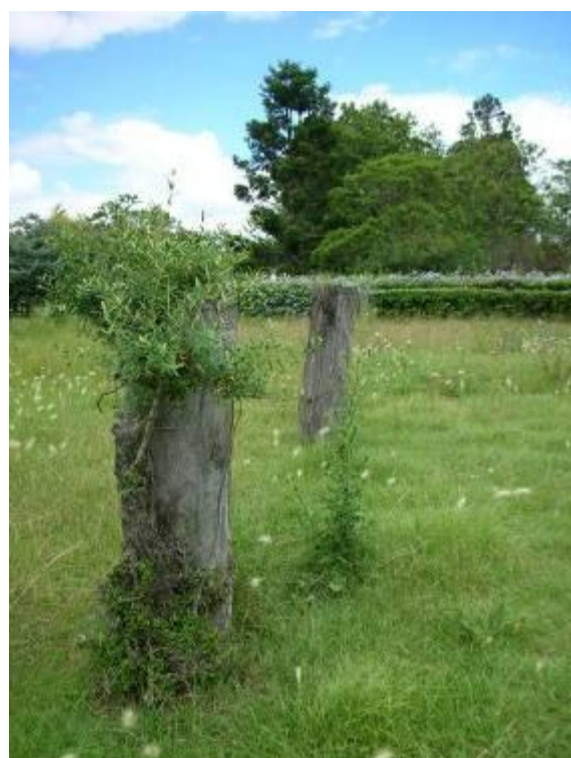
Figure 3.26 Former gateposts at the northern end of the former orchard.

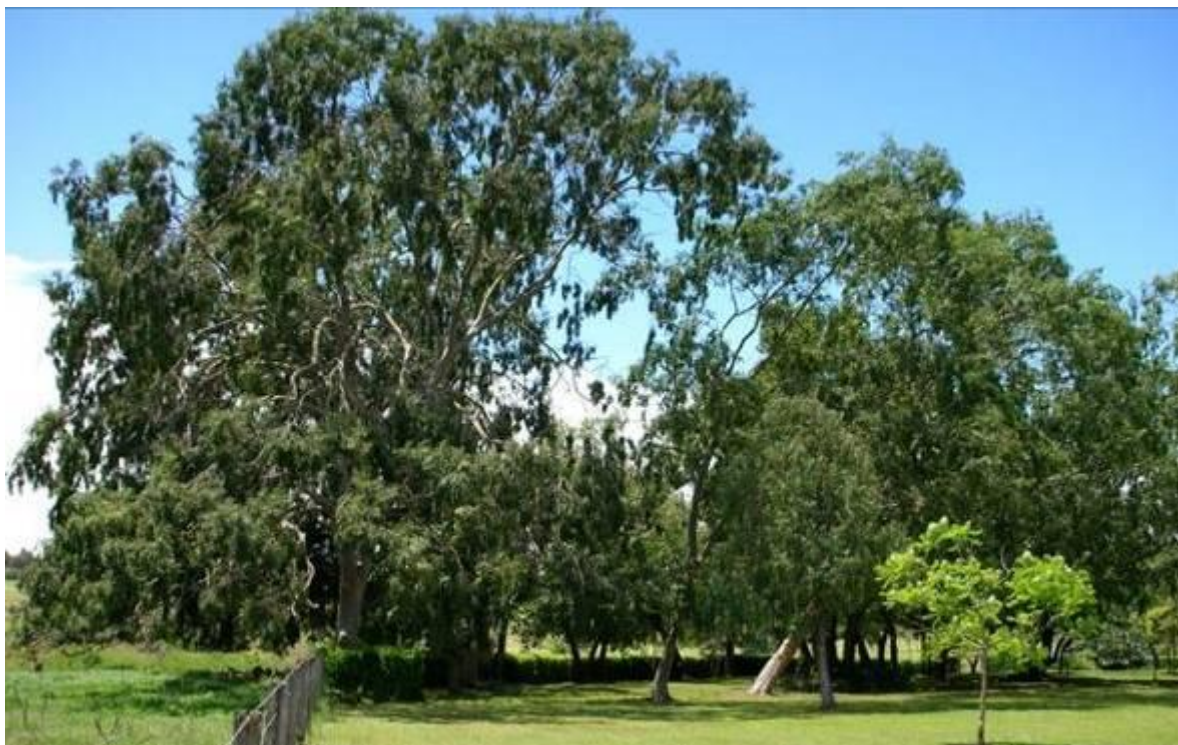
Figure 3.27 Old Chinese elms marking the former northeastern gate.

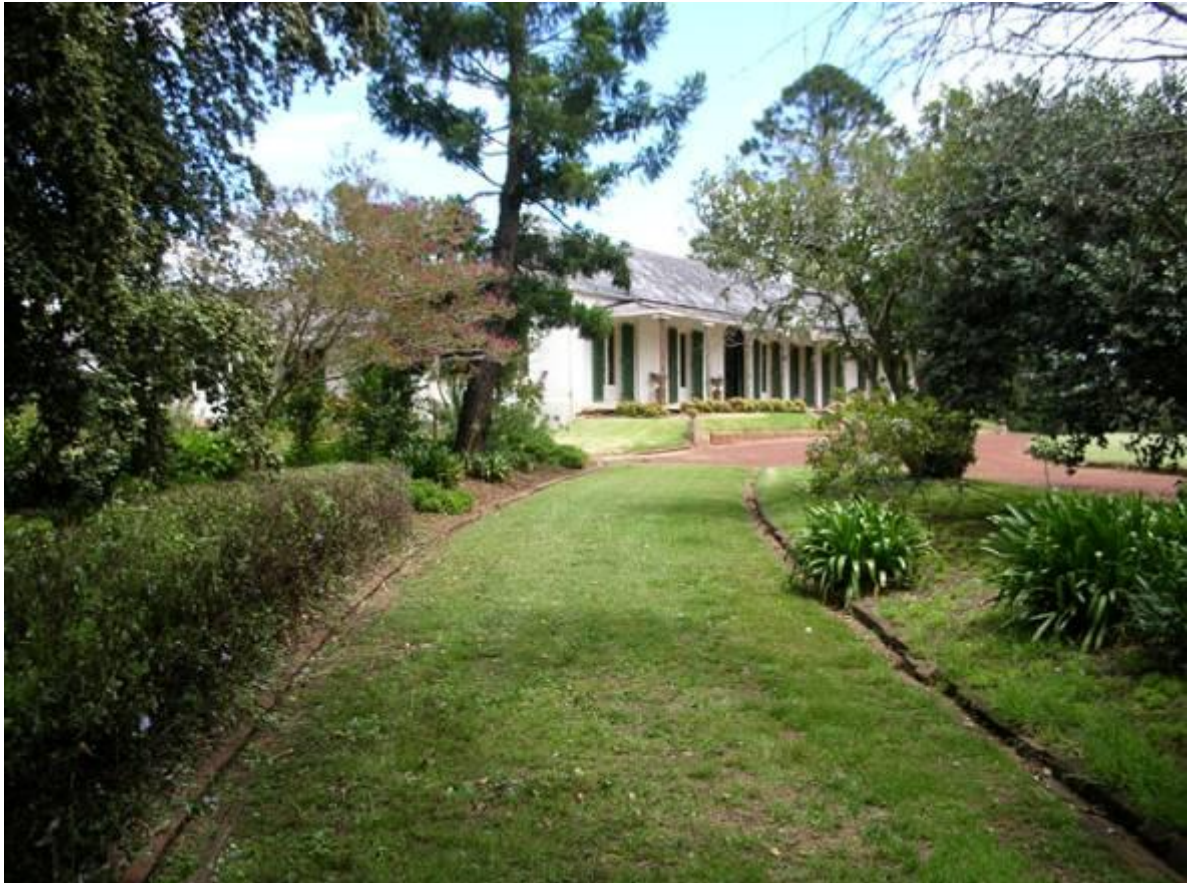
Figure 3.29 Carriage drive to the homestead from the northeastern gate.

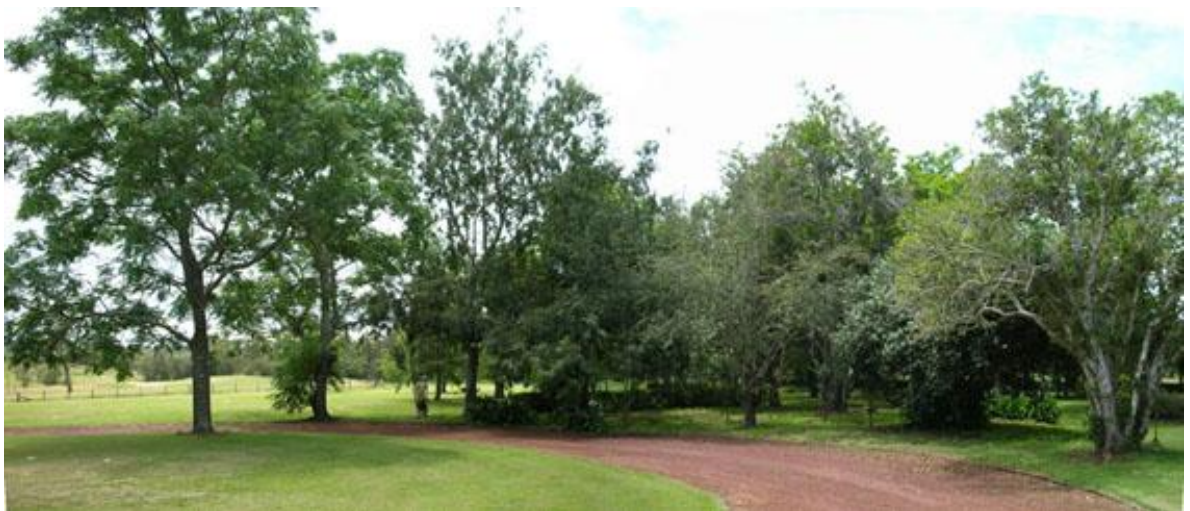
Figure 3.30 Eastern end of the gravelled carriage loop with old plantings beyond.

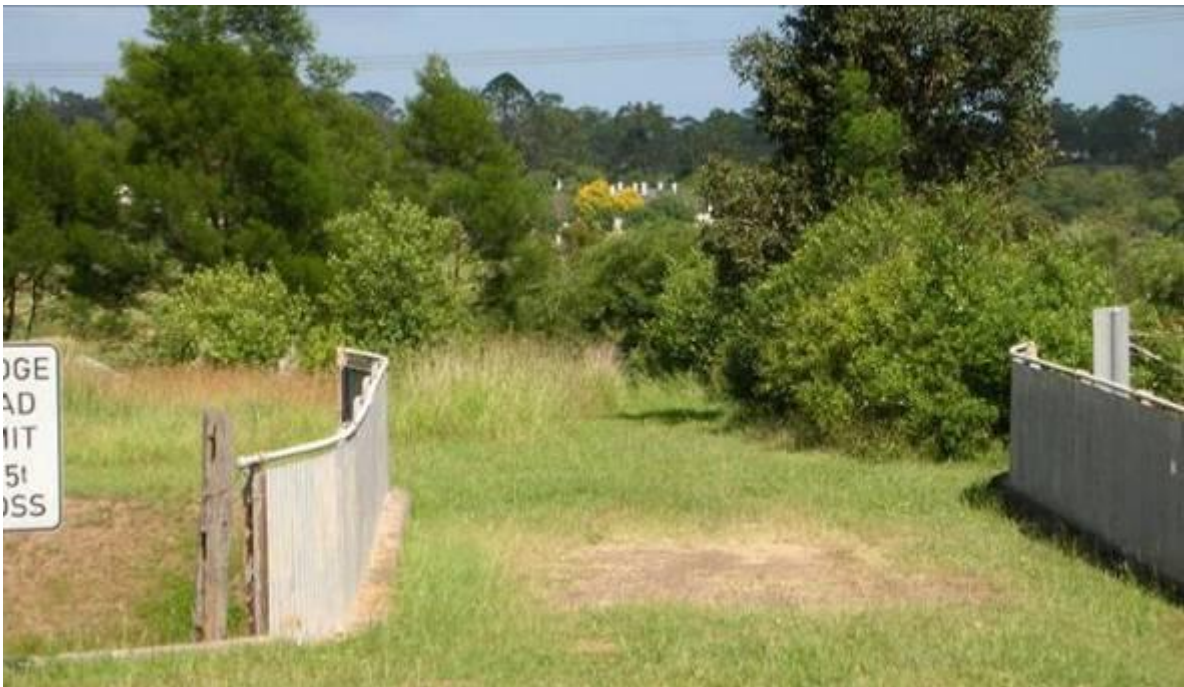
Figure 3.32 View of the homestead at the 1880s bridge crossing of the Upper Canal. Vegetation in the foreground will probably obscure this view within the next few years.

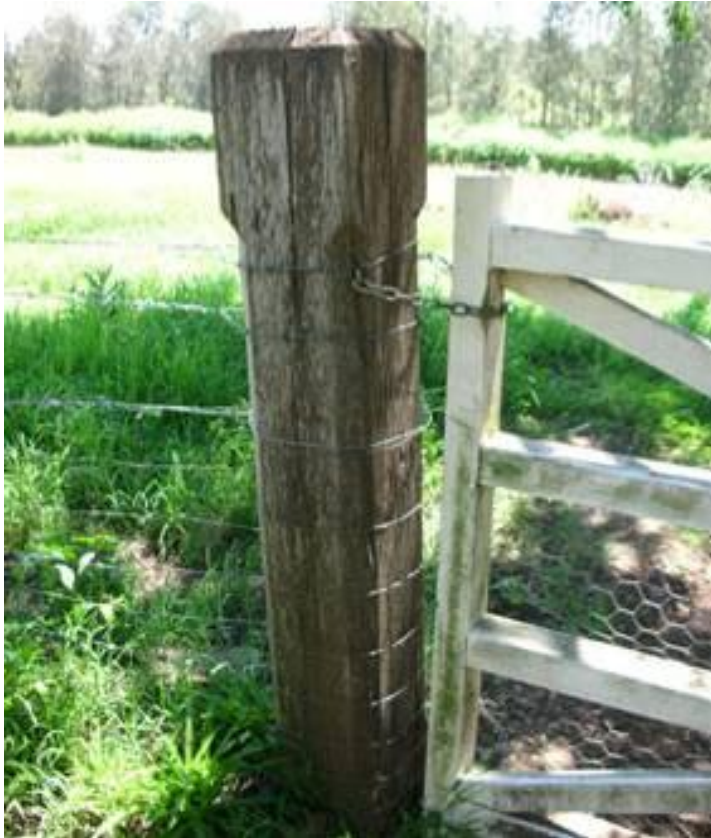
Figure 3.33 Northeastern gatepost detail. (The gate is recent.)

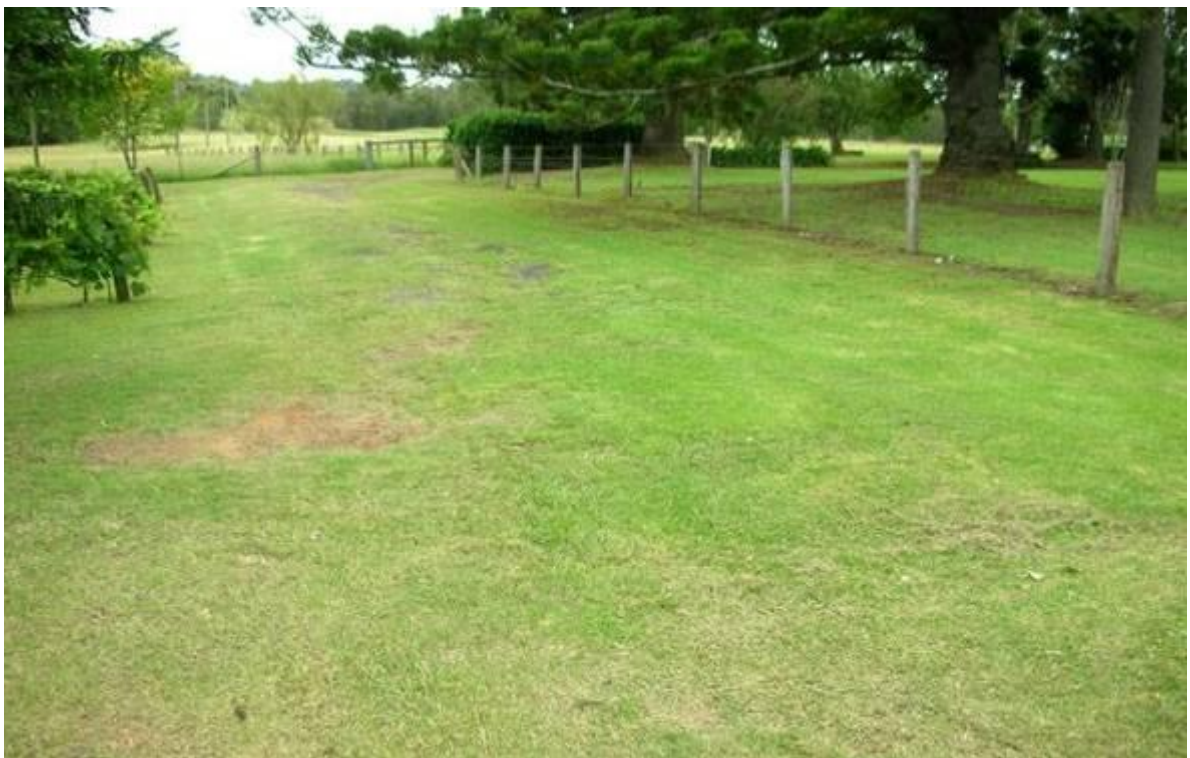
Figure 3.34 This short section of driveway to the west of the homestead is an important early link between the entry drive and the stables.

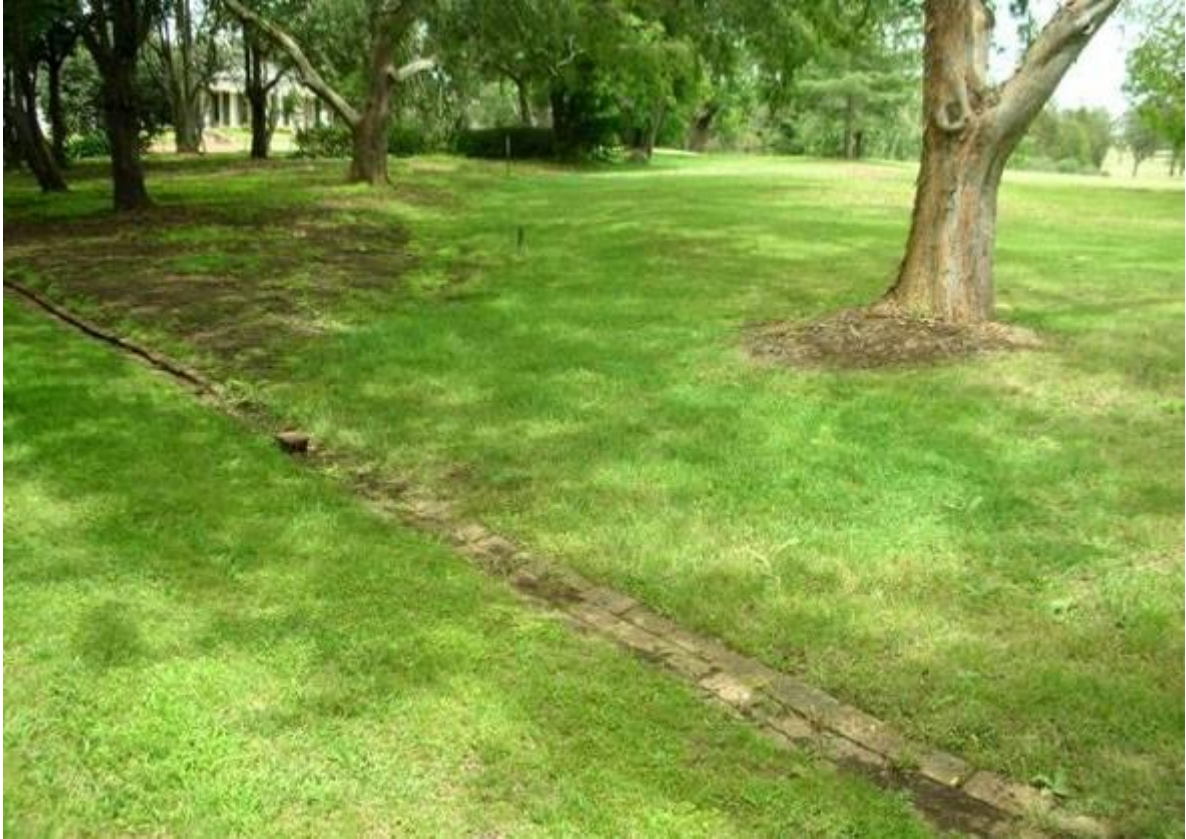
Figure 3.35 An earlier accessway off the northeastern carriage drive—possibly a walk from the eastern pleasure grounds. Note the flattening of the edging bricks at this point.

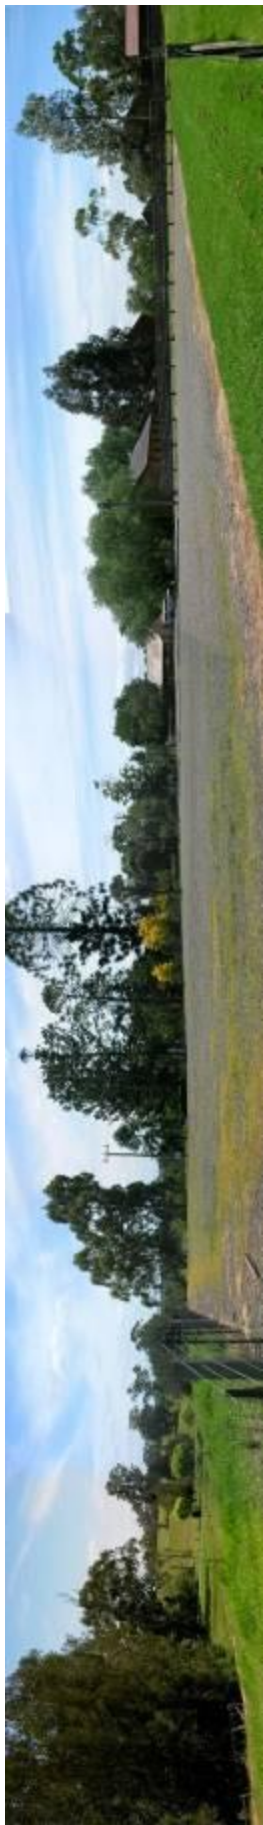
Figure 3.38 The car and bus park to the southwest of the homestead is an intrusive element within the former grounds.
