Gledswood

Conservation Management Plan

Report prepared for Caldla Pty Ltd
September 2011

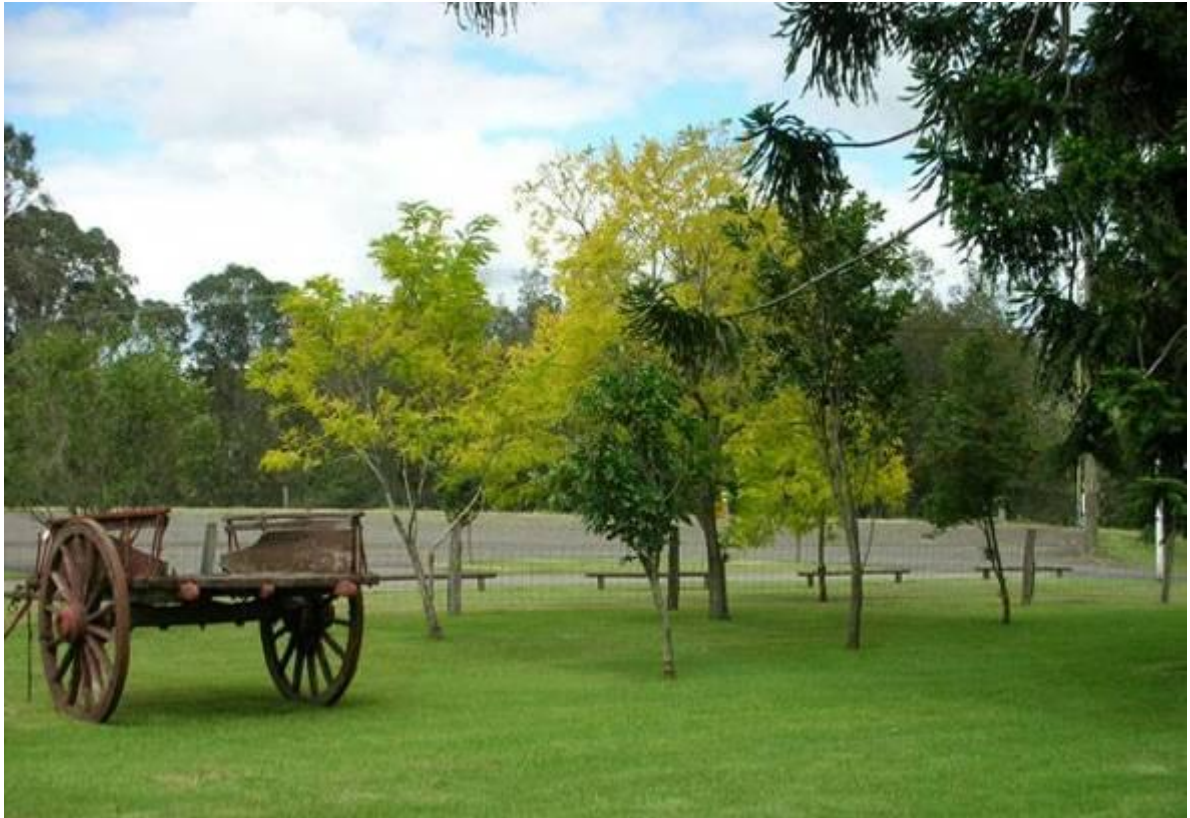
Figure 3.39 The recent plantings of *Robinia pseudoacacia* 'frisia' have introduced an inappropriate plant species within the homestead grounds.

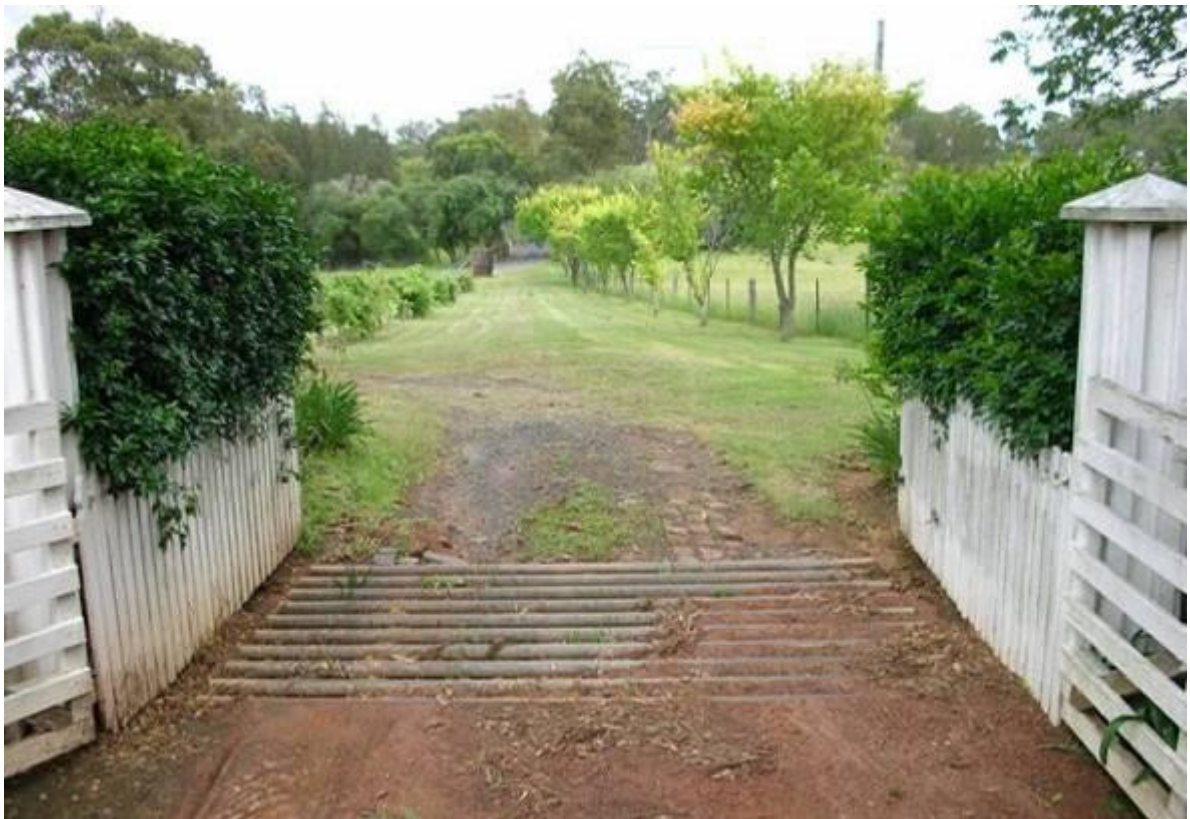
Figure 3.40 This view back along the former main entry drive shows recent vine plantings and avenue trees that are largely out of context in this location and detract from an appreciation of the highly significant early entry drive.

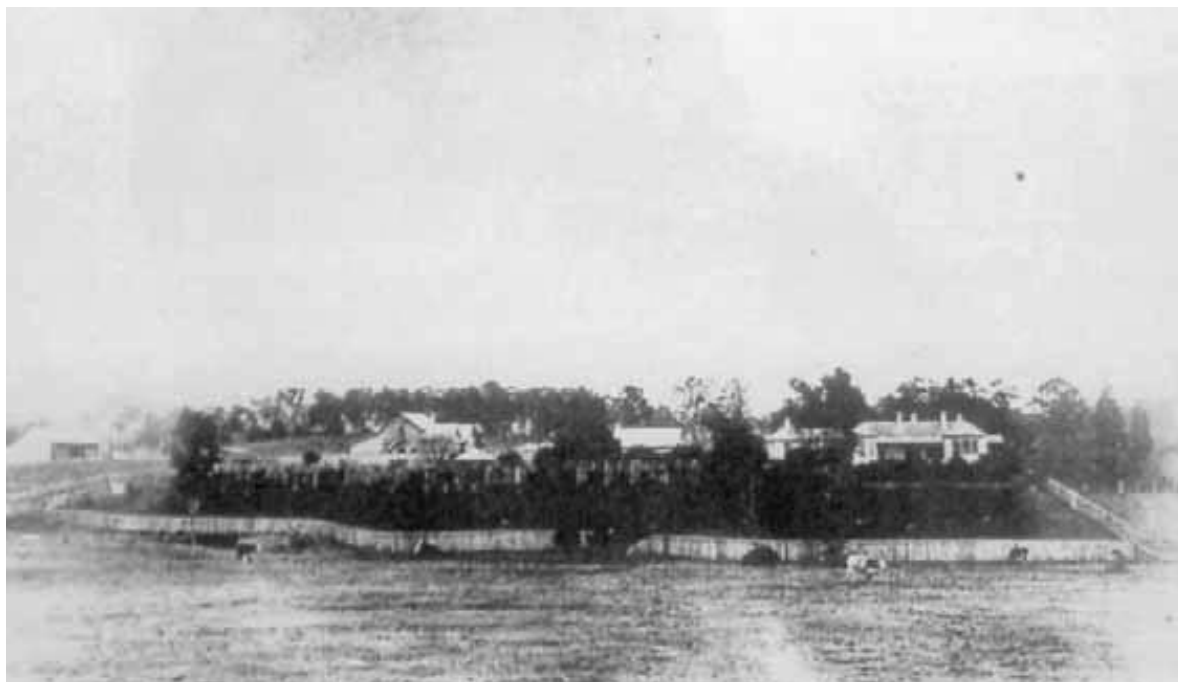
Figure 3.43 Undated photo of eastern elevation of Gledswood, possibly late nineteenth or early twentieth century. (Source: Mitchell Library, Small Picture Files)

From this description it would appear that the orchard area was located beyond the trellised vinery further to the east between the vinery and the creek. An undated early photograph (refer to Section 3.3.2) further corroborates this. Also from this description it is evident that walks were provided that allowed for a contiguous garden or landscape environment all around the homestead.

Figure 3.43 actually records many of the features described in the preceding articles. It appears to have been taken from an elevated position just to the east of the homestead pleasure grounds suggesting either the photographer climbed a tall tree, a scaffold platform was especially built or a hot-air balloon was used.

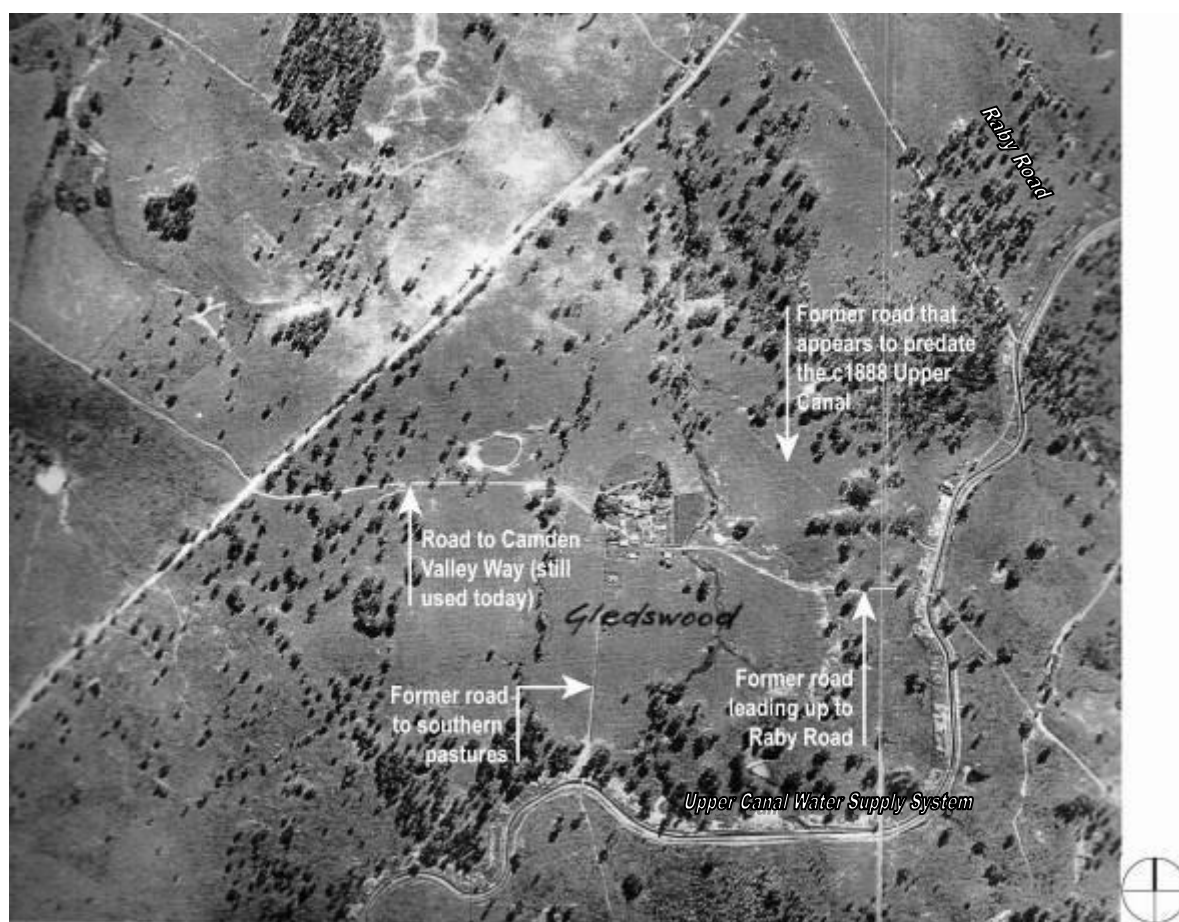
Figure 3.44 1947 aerial photo showing evidence of early roads and vegetation. (Source: RTA)

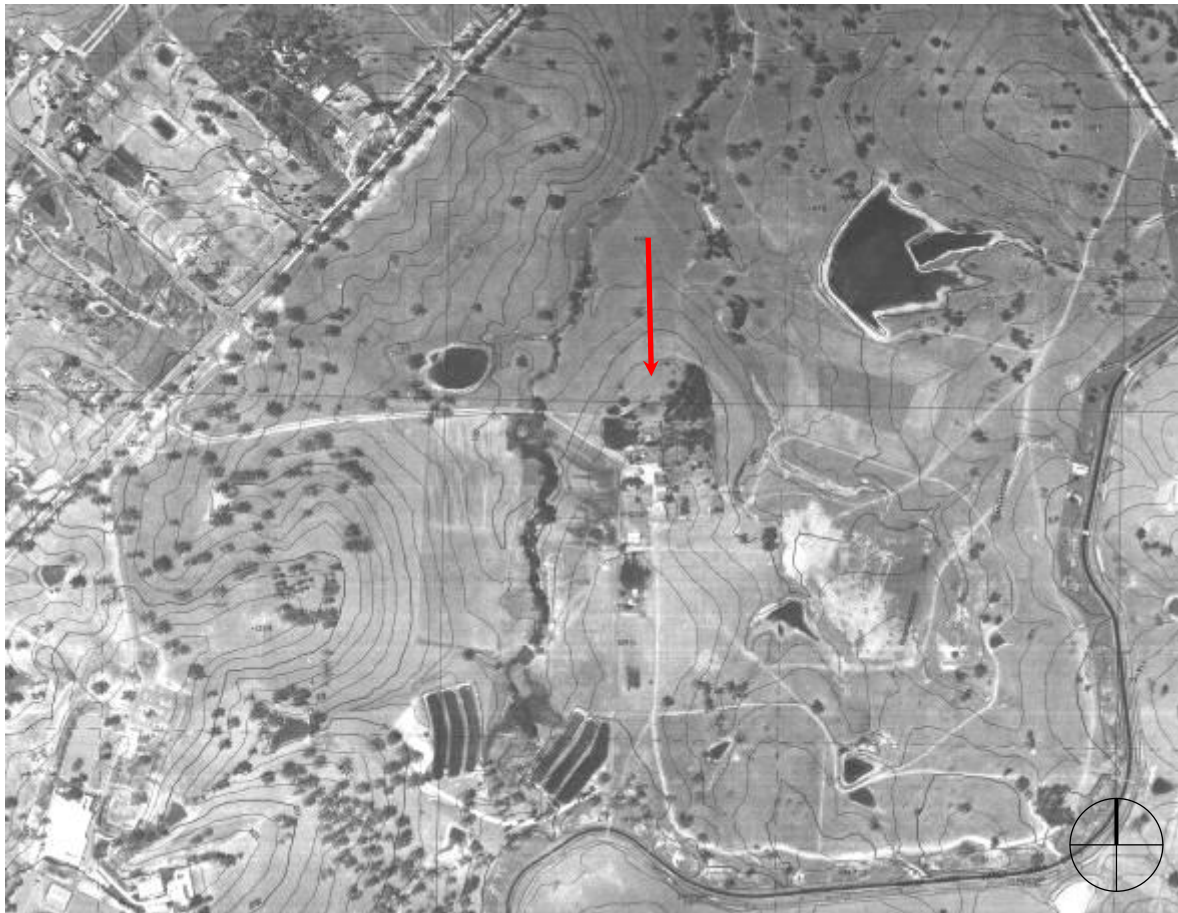
Figure 3.46 View of 1982 orthophoto—Gledswood homestead is shown arrowed.

By 1982 the estate core shows many changes in access arrangements and landuses, with the most obvious of the latter being the introduction of vineyards to former paddock areas to the west and the two tripartite effluent recycling pond areas to the south. Other observations that can be made from this image (see Figure 3.46) include:

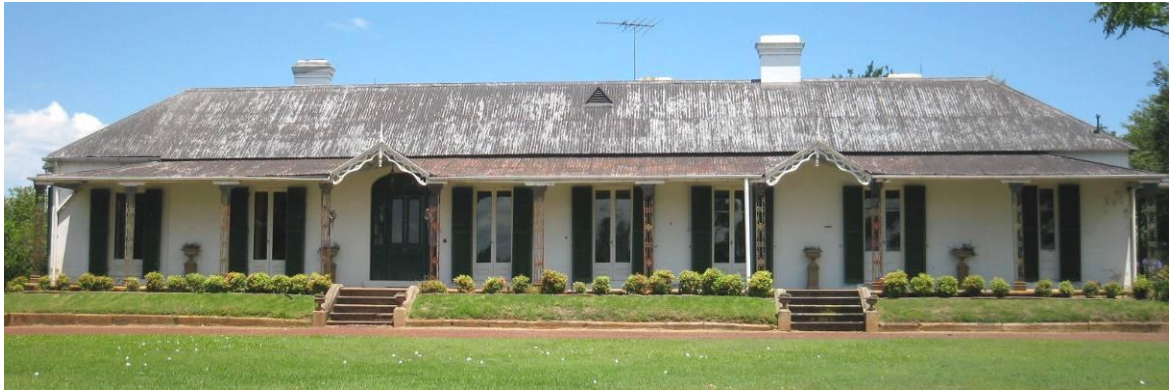
Figure 4.1 View of Gledswood homestead constructed in c1830—northern (front) elevation. Note the gravel drive to the front.

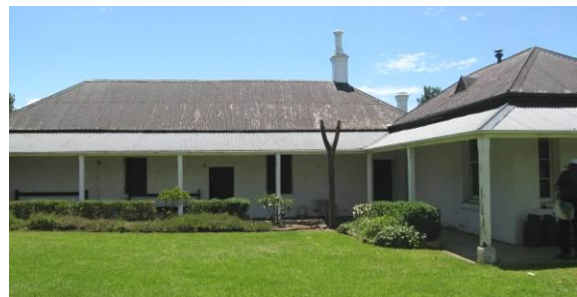
The exterior of the homestead is generally in moderate to good condition. Structural cracks are evident on all sides of the homestead, particularly the c1810 building. The cracks are possibly due to settlement and poor drainage. There is also evidence of rising damp on most walls and most of the external joinery requires urgent repair/replacement. The stone flagging and paving around the homestead is uneven and requires realigning and the corrugated steel roof requires repainting. In addition, some sections of the corrugated steel roof, gutters and downpipes require immediate attention (refer to work schedule in Appendix A).

Figure 4.2 c1812 building (centre) with c1890 addition to the right.

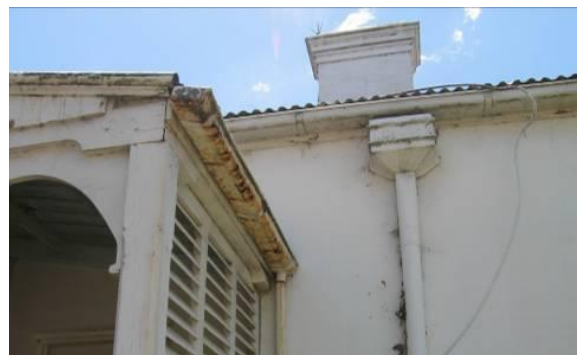
Figure 4.3 View of deterioration to gutters.

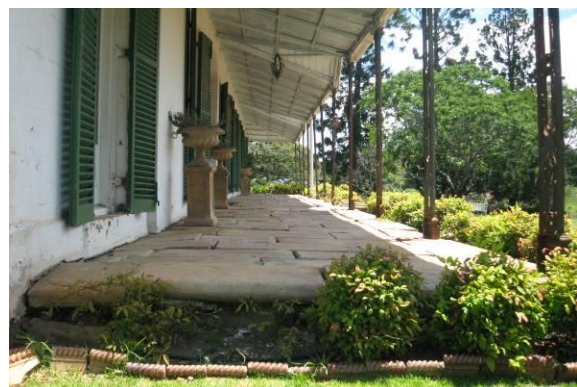
Figure 4.4 View of verandah to northern elevation showing uneven stone flagging.

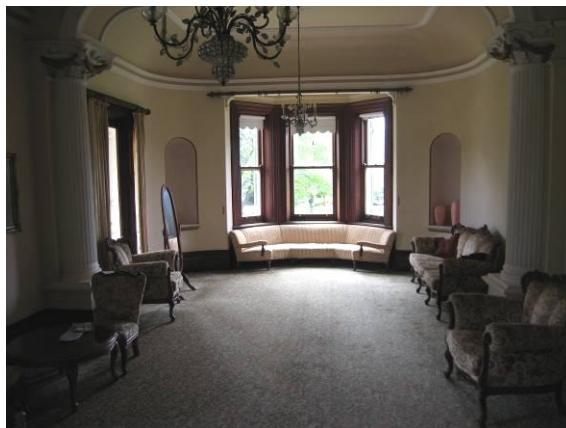
The interior of the homestead is generally in good condition and the original spaces of the building are still legible. The carpet is in need of replacement in most areas and the timber floor appears to be in moderate to good condition, although there is evidence of dry rot and timber borer activity from below the floor boards. Repainting of walls and ceiling is required in some areas.

Figure 4.5 View of interior of the northernmost bay.

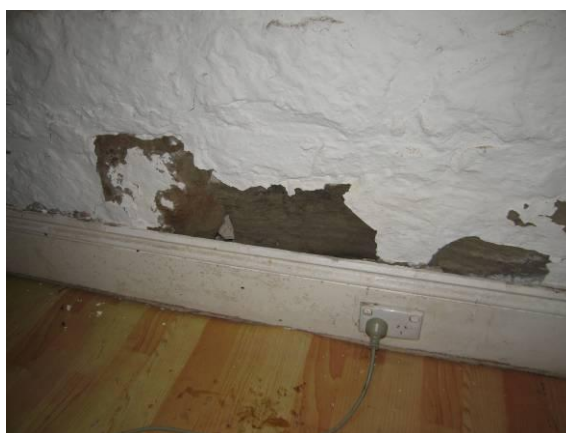
Figure 4.6 Damage caused by rising damp in the c1810 building.

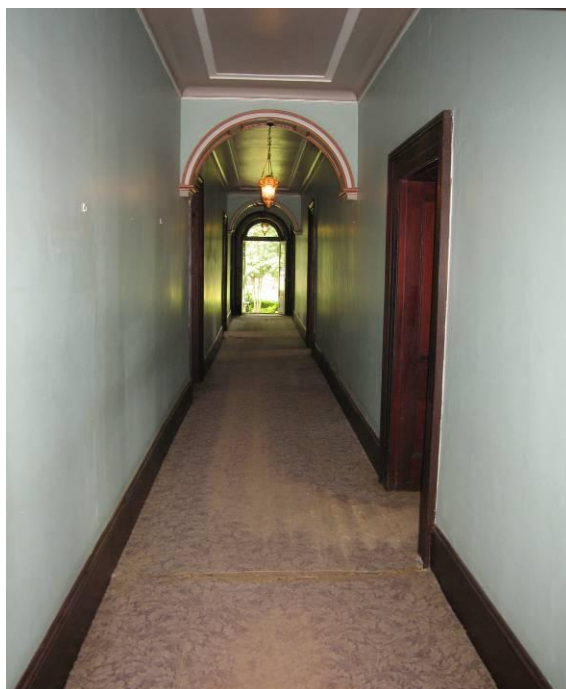
Figure 4.7 View of hallway showing the threadbare carpet.

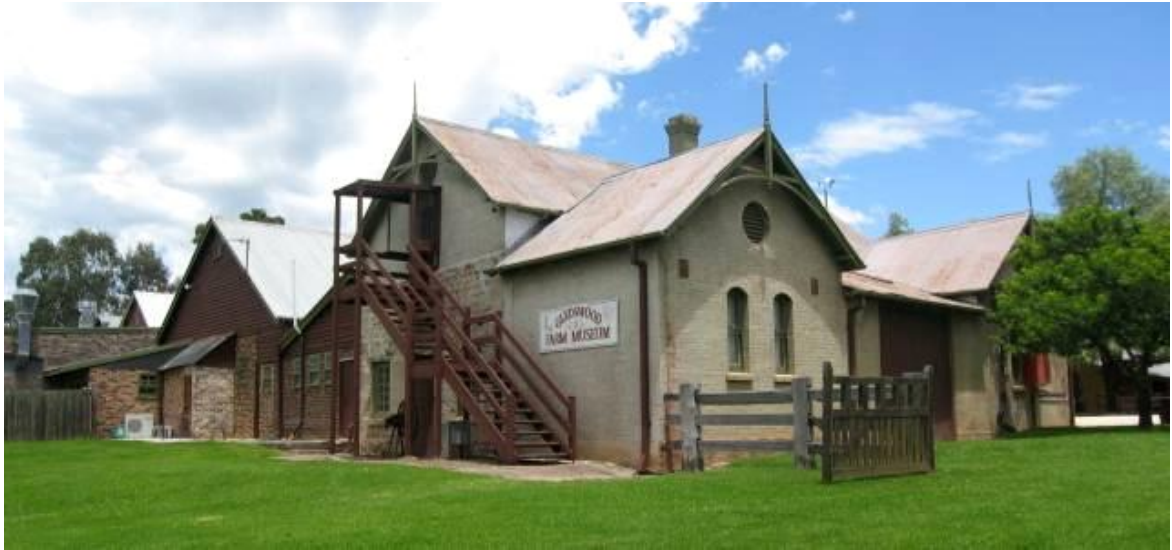
Figure 4.8 View of former coach-house and stables constructed in c1812—southwestern elevation.

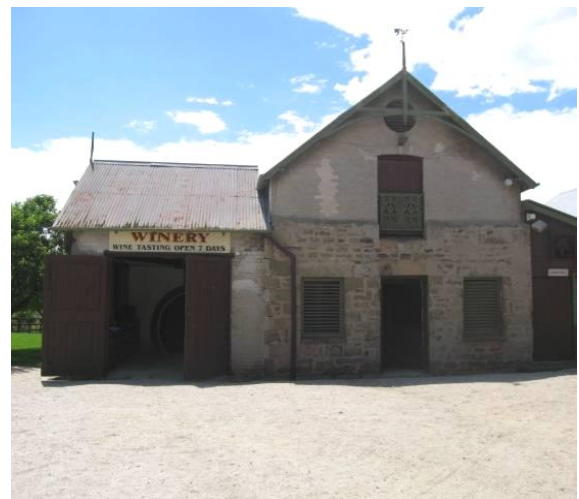
The exterior of the building is generally in good condition. Some cracks are evident, appearing mostly where stonework has been joined to the brickwork. Stonework to the eastern facade has been inappropriately repaired with cement and one of the stone sills to this facade is showing signs of weathering and deterioration.

Figure 4.9 Western (front) elevation showing the former coach-house to the left and the stables to the right.

The brick chimney requires recoping and stabilisation and some of the external joinery, including the timber staircase, requires urgent repair/replacement.

The corrugated steel roof sheeting is in moderate condition and requires some resheeting and refixing. In addition, some sections of the gutters and downpipes require attention (refer to work schedule in Appendix A).

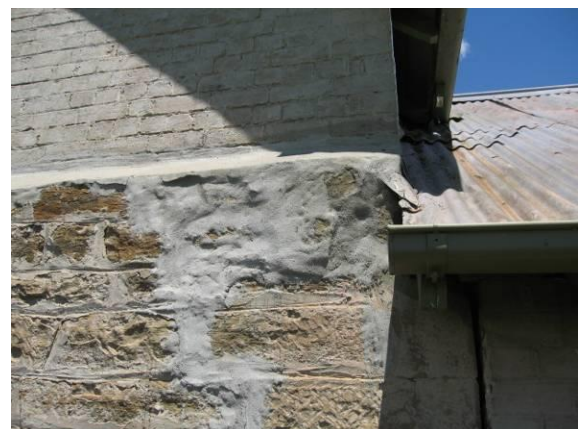
Figure 4.10 Section of eastern (rear) elevation showing inappropriate cement repair work.

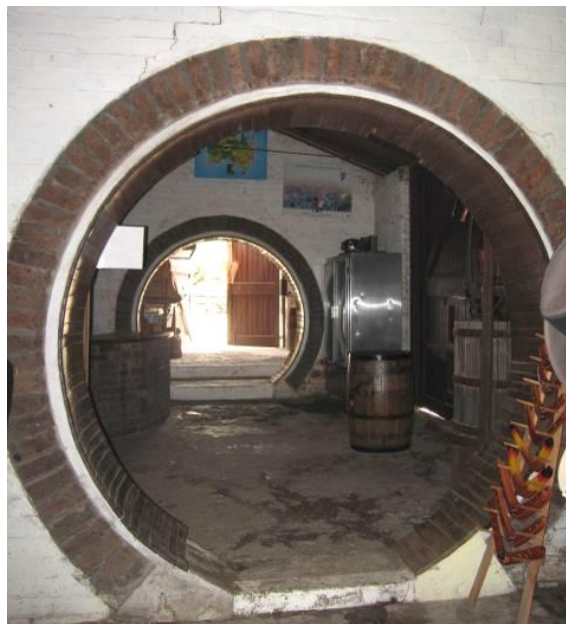
Figure 4.11 View of ground floor of coach-house showing the internal 'moon gates'.

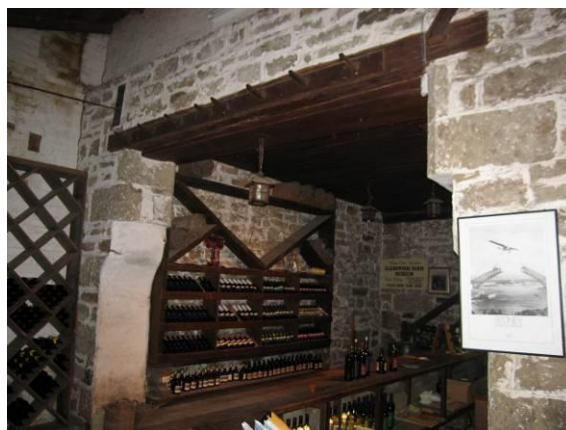
The internal connection between the stables and the coach house appears to be early (see Figure 4.12). It is likely that the connection replaced an earlier door to the stone stables building. This area has been significantly refurbished with shelving, wine bar and timber staircase to the top floor of the stables. The top floor of the stables is currently used to store movable heritage items associated with Gledswood.

Figure 4.12 View of internal connection between the stables and the coach-house.

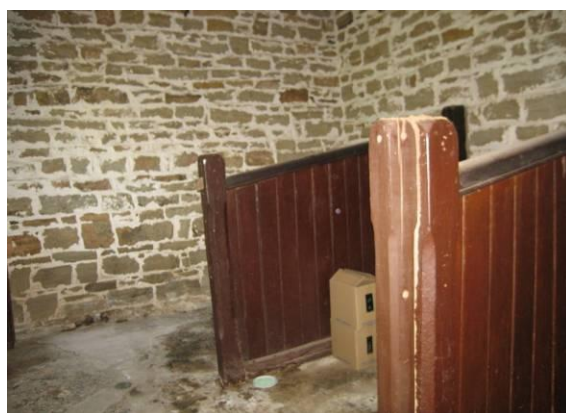
The interior of the homestead is generally in good condition, however there is some cracking to the walls, generally in locations where stonework and brickwork join, and around new openings. The concrete and timber floors appear to be in good condition, however there appears to be an issue with ground drainage in the easternmost stables room.

There is evidence of timber borer activity in one of the timber posts of the stall dividers.

Figure 4.13 View of ground floor of stables—note the damp areas to the concrete floor and the boring activity in the front timber post.

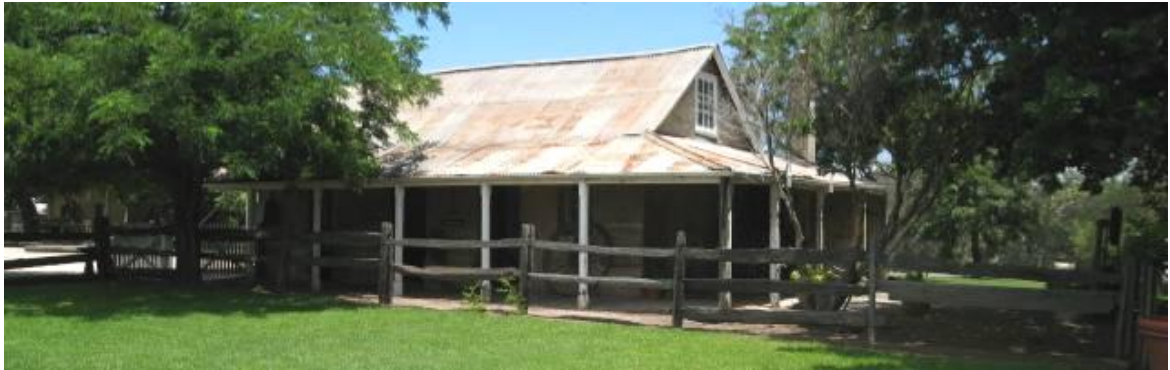
Figure 4.14 View of former convict lockup, constructed in c1810, situated to the south of the homestead—northeastern elevation.

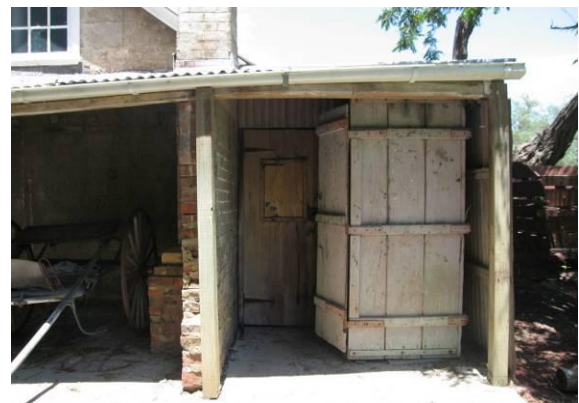
The exterior of the structure is generally in moderate to good condition. Structural cracks are evident on all sides of the building. The cracks are possibly due to settlement and poor drainage. There is also evidence of rising damp on most walls and deterioration of stone due to delamination. The brickwork to the addition is in poor condition and requires stabilisation.

Figure 4.15 View showing brick and timber addition to the northeastern corner of the building.

The paving around the building is uneven and will need to be reset in some areas. The corrugated metal roof has significant rust and will need replacing in the near future. In addition, gutters and downpipes require immediate attention (refer to work schedule in Appendix A).

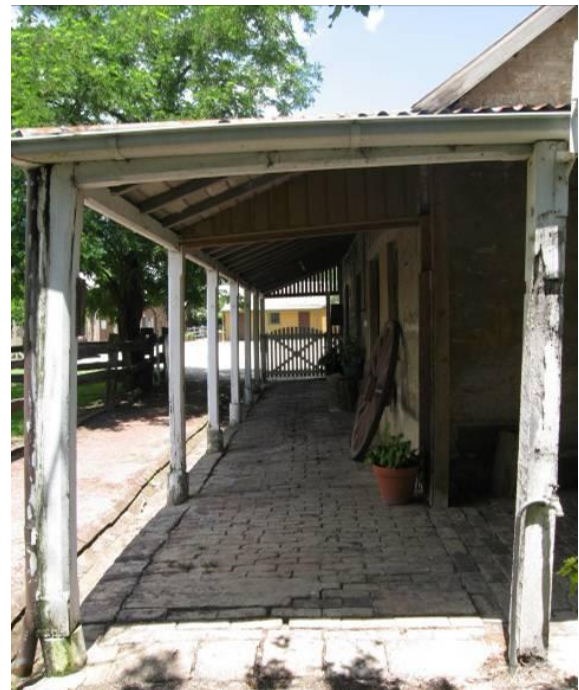
Other alterations to the building over time include inappropriate cement render and repair works to the eastern facade. The northernmost door and window openings to this facade appear to have been altered. Services have also been obtrusively installed to the eastern facade.

Figure 4.16 View looking south along the eastern elevation.

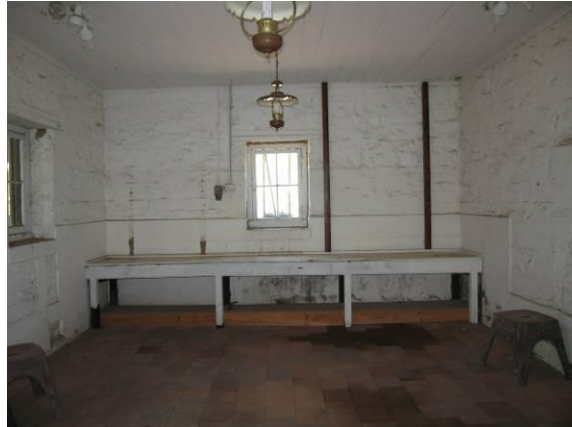
The internal walls of the two rooms to the building have been painted. The southern room has a timber-panelled ceiling while the roof structure is exposed in the northern room, revealing the timber shingles and battens. Timber beams also run across the roof space in the northern room. The doors and paving to both rooms are later elements.

Figure 4.17 View of interior of southernmost room.

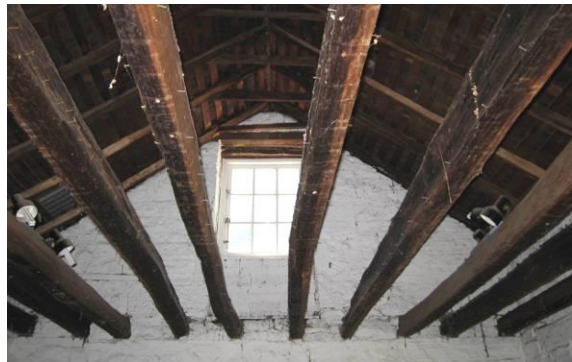
Figure 4.18 View of roof structure in northernmost room.

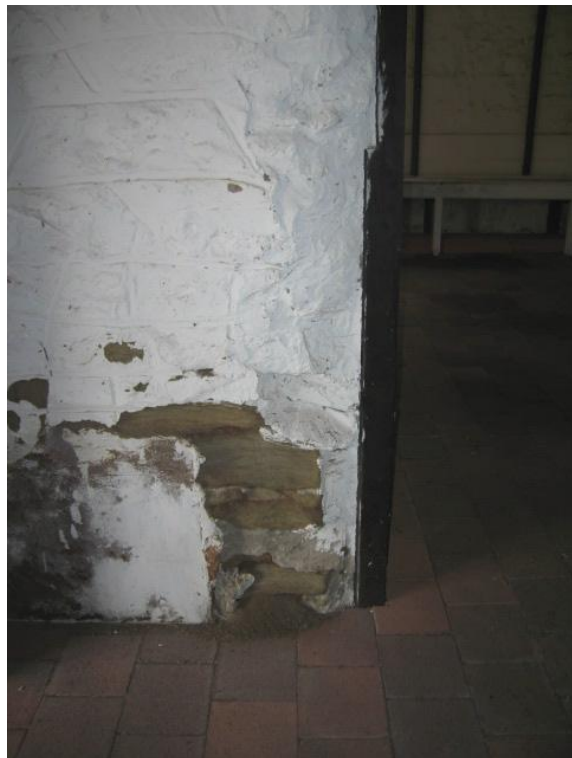
The interior is generally in good condition and the original spaces of the building are still visible. Some of the stonework is showing signs of deterioration as a result of rising damp and delamination.

Figure 4.19 View of deterioration to stonework due to rising damp and delamination.

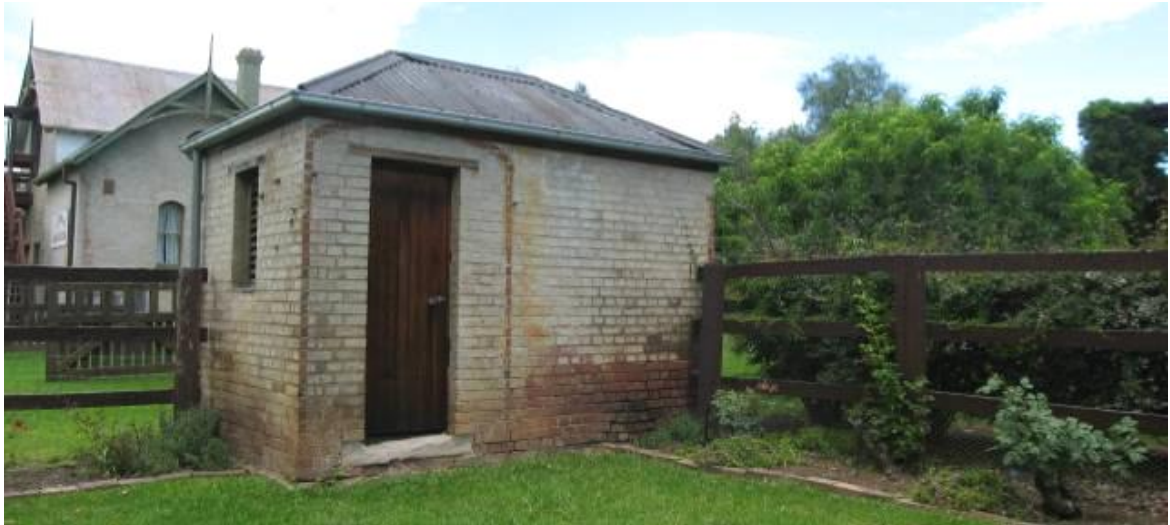
Figure 4.20 View of early privy situated to the south of the homestead—northern elevation.

The exterior of the building is generally in moderate to good condition. Mortar is missing to the brickwork adjacent to the garden bed, most likely as a result of the installation of a water sprinkler adjacent to the building. The gutters and downpipe appear to have been replaced recently and are in good condition. The joinery to the window is in poor condition (refer to work schedule in Appendix A).

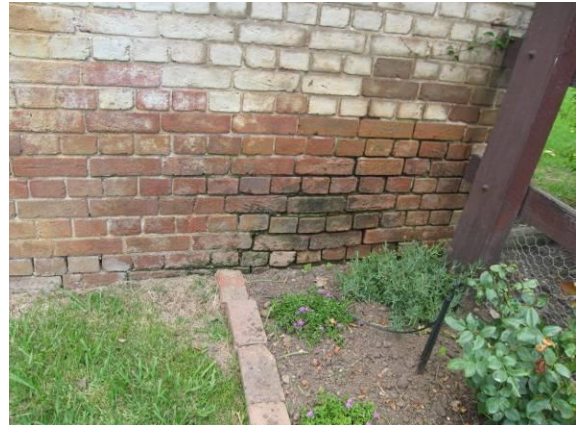
Figure 4.21 View of missing mortar to brickwork adjacent to garden bed and sprinkler.

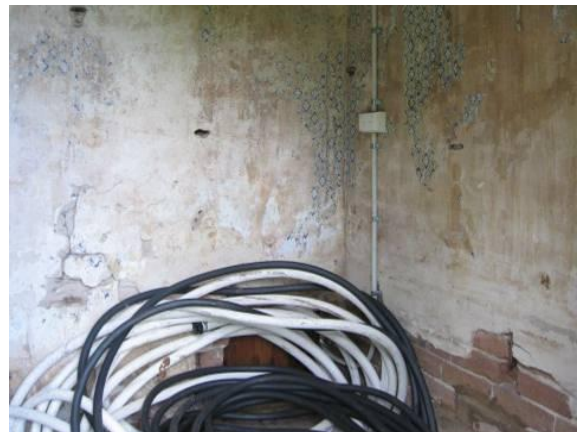
The interior of the building is generally in poor to moderate condition. The plaster is missing in some areas and the sandstone threshold is showing signs of deterioration and weathering.

Figure 4.22 View of interior showing early wallpaper over the early plaster finish.

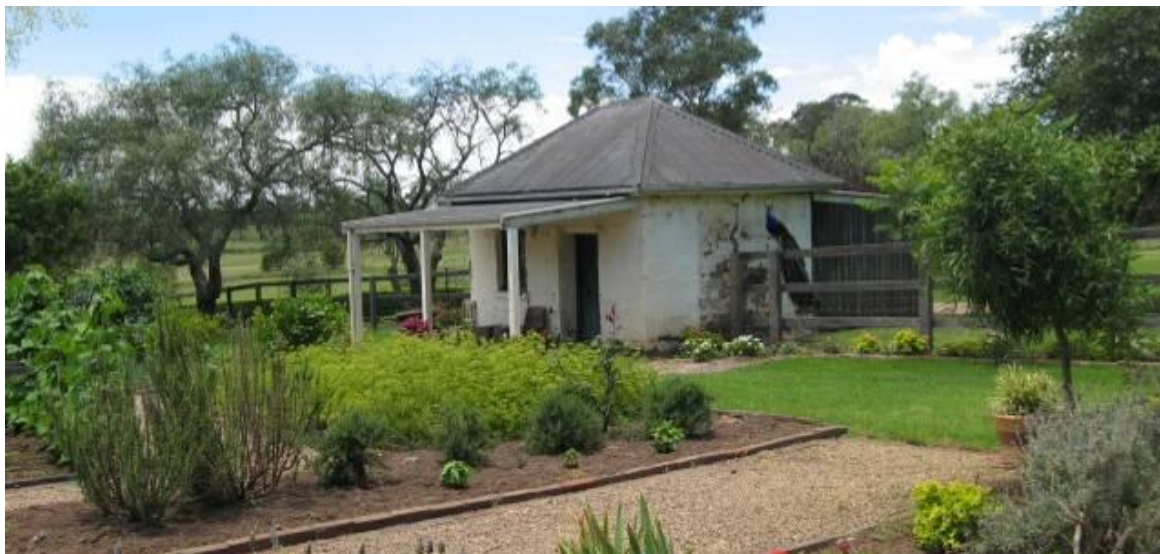
Figure 4.23 View of early stone gardener's cottage to the southeast of the homestead—northwestern elevation.

The exterior of the building is in moderate condition, with some cracking to the stonework and mortar missing in some sections. The guttering and downpipes are in good condition, having been recently replaced, however the windows are rotten and require repair/replacement.

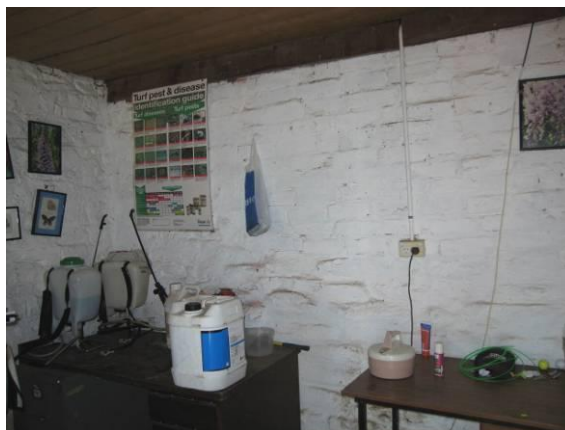
The door and paving to the room are later elements and part of the rear (southern) wall has been patched with bricks, following the removal of an early fireplace in this location.

The interior is in moderate condition.

Figure 4.25 View of interior.

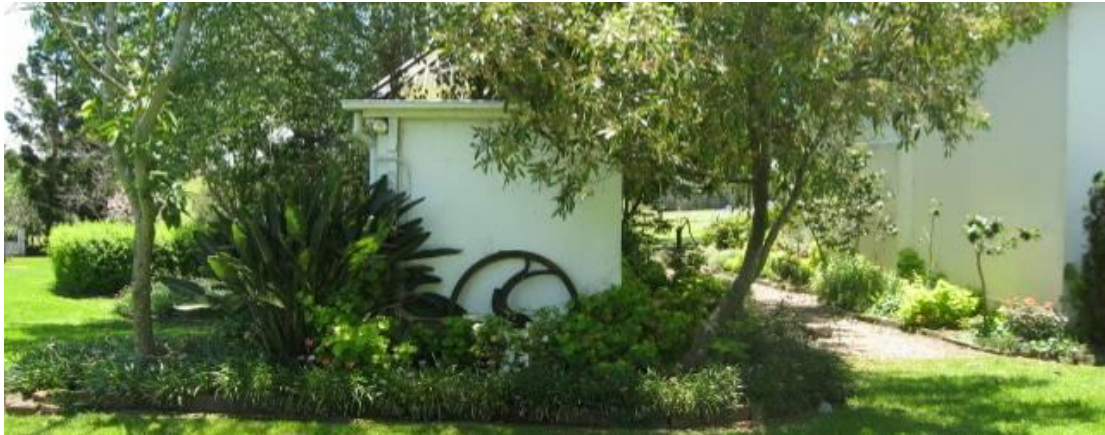
Figure 4.26 View of later privy situated to the west of the homestead—southern elevation.

This early (c1870s) painted masonry toilet with corrugated metal hipped roof is located to the west of the homestead. A timber slat window/vent with timber lintel is located on the western facade and a later four-panelled door exists to the northern facade.

The exterior of the building is generally in good condition. The roof, gutters and downpipes appear to have been replaced recently and are in good condition. The door requires repainting.

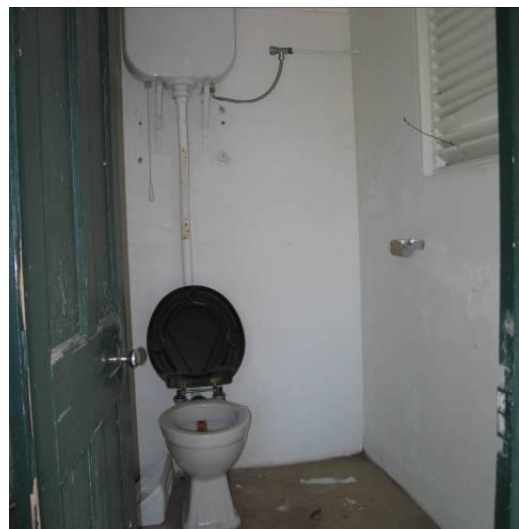
A later concrete floor has been installed. The threshold also appears to be a later replacement.

The interior is generally in good condition.

Figure 4.28 View of interior.

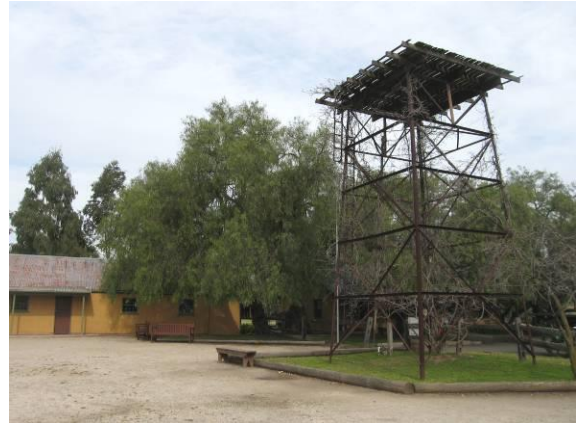
The metal frame structure of the tower supports a timber board platform.

The tower is still in good condition, although there is no longer a water tank atop the timber platform.

Figure 4.29 View of northwestern elevation.

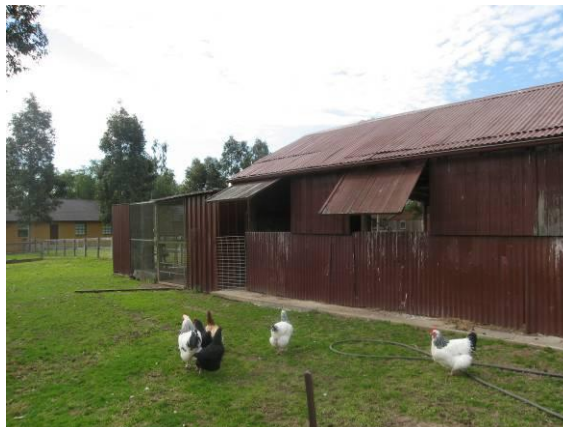
The animal shelter is a recent rectangular timber structure with a flat corrugated metal roof and mesh gates.

The structure appears to be generally in moderate condition.

Figure 4.38 View of western elevation (the recent animal shelter is the larger structure to the right).

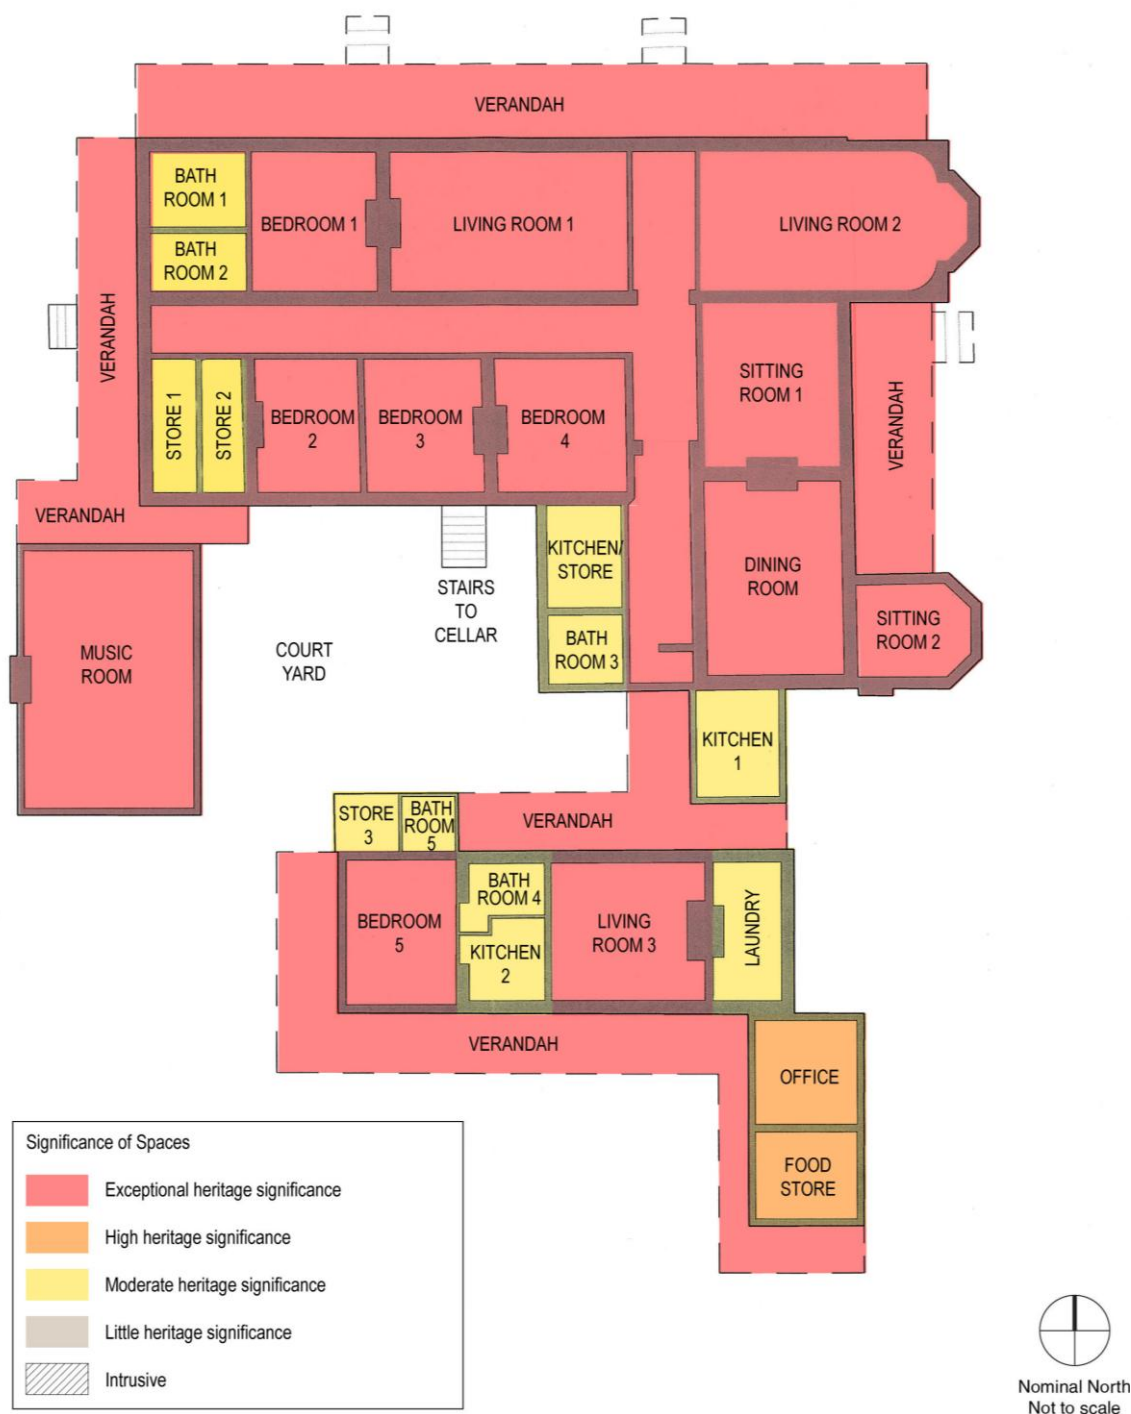
Figure 5.5 Relative significance of rooms within the homestead building.

Figures 5.5 and 5.6 illustrate the relative significance of rooms within the homestead, the former coach-house and stables and the convict lockup. The gradings reflect the extent to which rooms retain and/or contribute to the overall cultural heritage significance of the place and may include an assessment of how recent fitouts have impacted some spaces. In these situations significance may be recovered by the restoration of the original/early configuration of those spaces.

1. Extant buildings including both internal and external fabric should be retained and conserved in accordance with the grading of significance identified in Figures 5.4 to 5.6, Tables 5.4 to 5.11 and Policy 7.4.3..
