GTE1355 – Preliminary Contamination And Salinity Report

19 October 2017

**RE: PRELIMINARY CONTAMINATION AND SALINITY ASSESSMENT at No.121-133 Prairie Valley Road,  
Bossley Park**

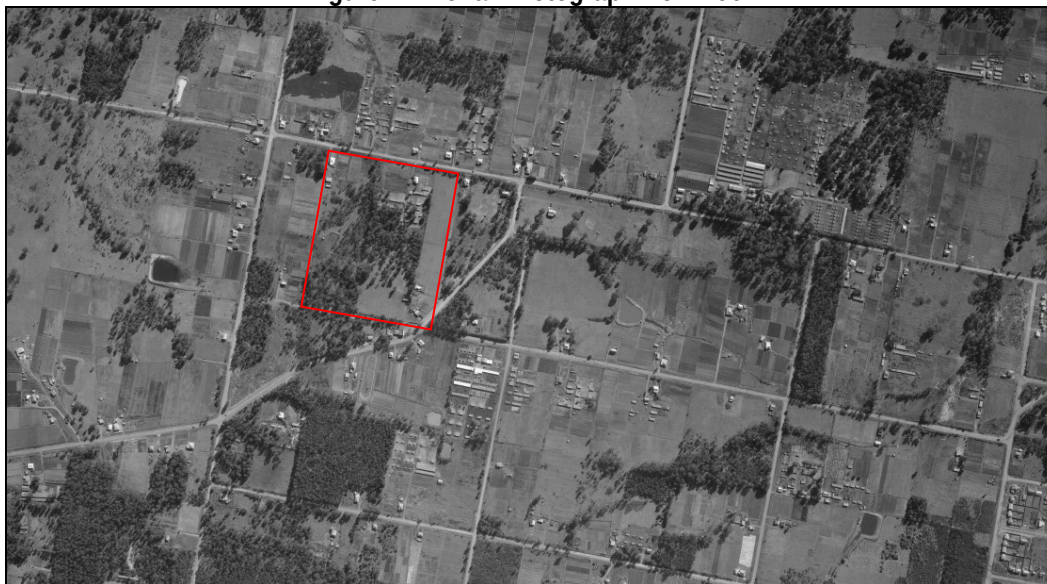
**Figure 2 – Aerial Photograph from 1961**

1961 – In 1961 the subject site was predominatly covered with vegetation(trees), however there appears to be a small house and some sheds at the north-west portion of the site facing Restwell Road. There appears to be a water body at the south-west portion of the site. The area surrounding the site appears to be predominately undeveloped. The approximate location of the subject site is highlighted in figure 2.

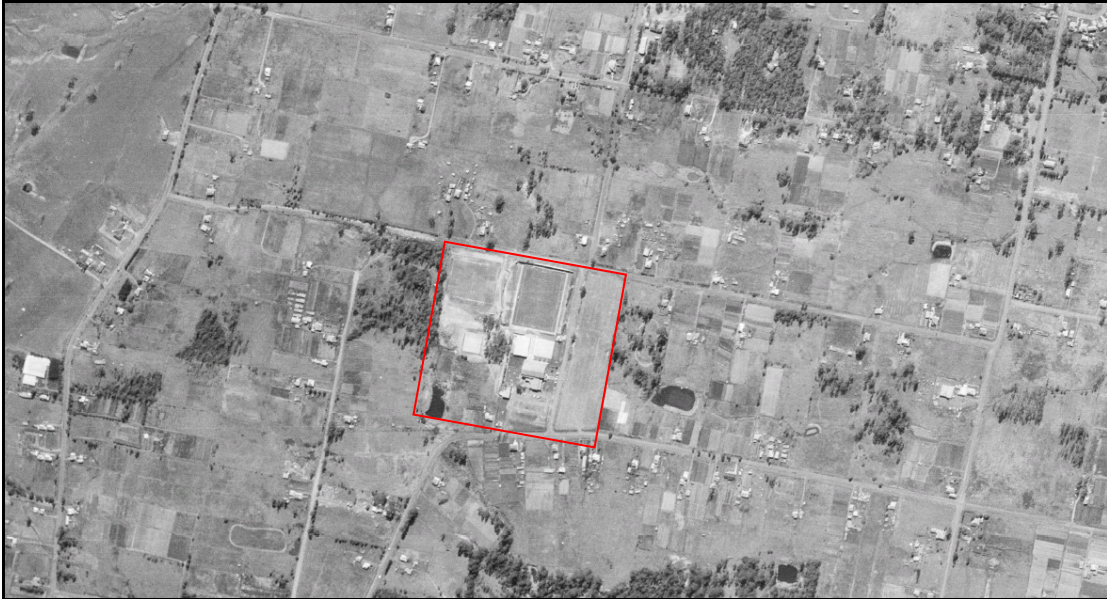
**Figure 3 – Aerial Photograph from 1975**

1975 – In 1975, the house and structures have been demolished. The site has been cleared off trees and has been developed. A building (club building) is present on the central portion of the site. The water body at the south-west portion of the site is still present on site. The remainder of the site has been cleared and remain unsealed with sparse vegetation. There also appears to be a structure at the rear of the club building. The area surrounding the site appears to be predominately undeveloped. The subject site is highlighted in figure 3.

From the aerial photographs it can be inferred that part of the fill was placed at the site some time between 1975 and 1984. The source of the fill material is unknown, and as such presents a contamination risk. Potential contamination exists in the form of heavy metals, petroleum hydrocarbons (TPH), polynuclear aromatic hydrocarbons (PAH) and asbestos.

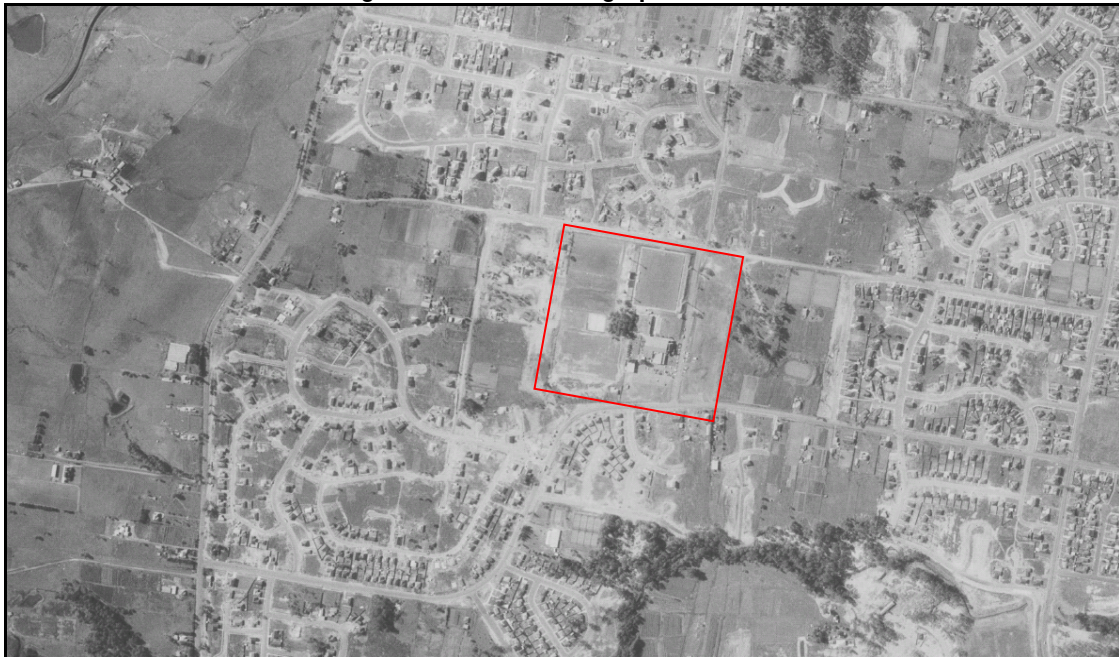
**Figure 4 – Aerial Photograph from 1984**

1984 – In 1984 the water body(dam) at the south west corner of the site appear to be back filled. The area to the west of the property has been cleared off trees. Some houses have been constructed to the north and south of the property. The subject site is highlighted in figure 4.

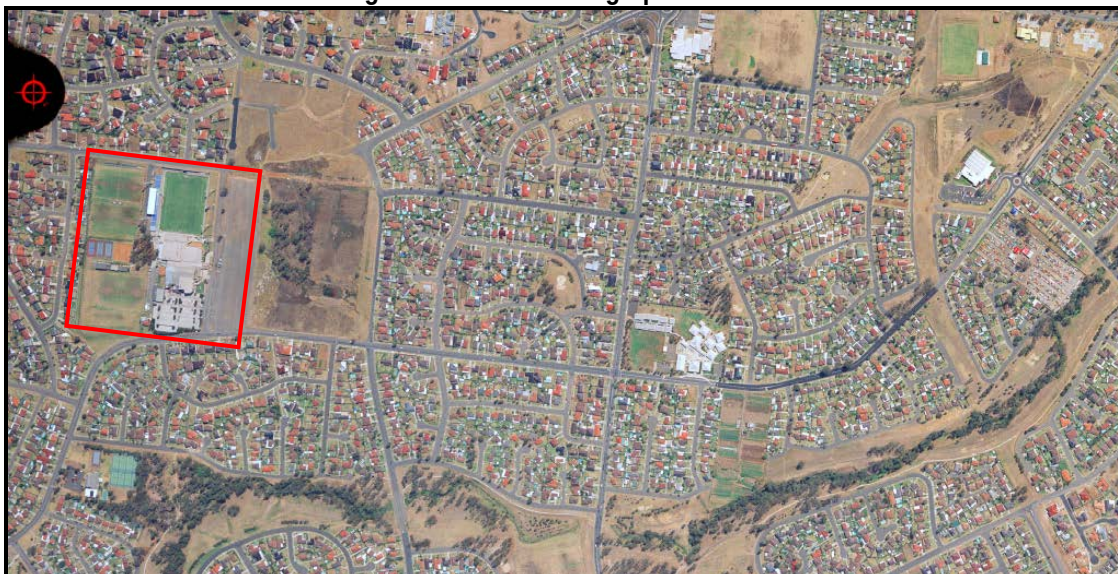
**Figure 5 – Aerial Photograph from 1994**

1994 – In 1994, there has been further development at the site. There are other structures that appear within the site. There also appears to be a building on the south east corner of the property where currently part of the carpark is located. The playing fields and courts also appear on site. Further residential development of land surrounding the site has occurred, since the 1987 aerial photograph was taken. The subject site is highlighted in figure 5.

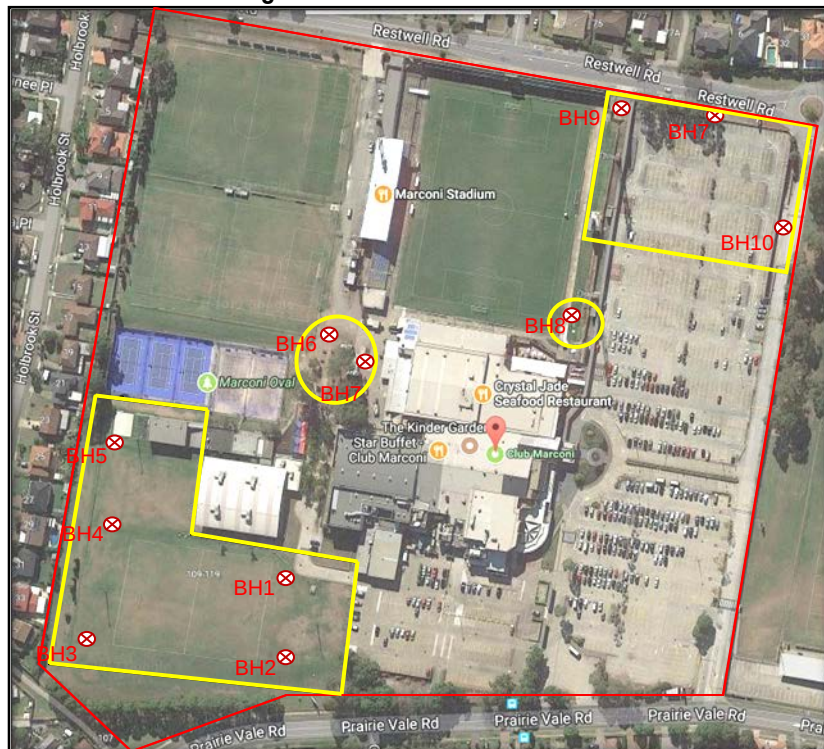
Figure 6- Location of Boreholes

The sampling regime for this investigation was advised by the client. As part of this investigation, eleven (11) boreholes were drilled across the site (see Figure 6). Twenty four (24) discrete samples were recovered from within the fill for chemical analysis, eleven (11) composite samples were recovered from the fill for asbestos identification and eight (8) samples were recovered for salinity / aggressivity analysis from within the fill and natural soil profile.

(Note: This investigation is limited to the areas marked in yellow)

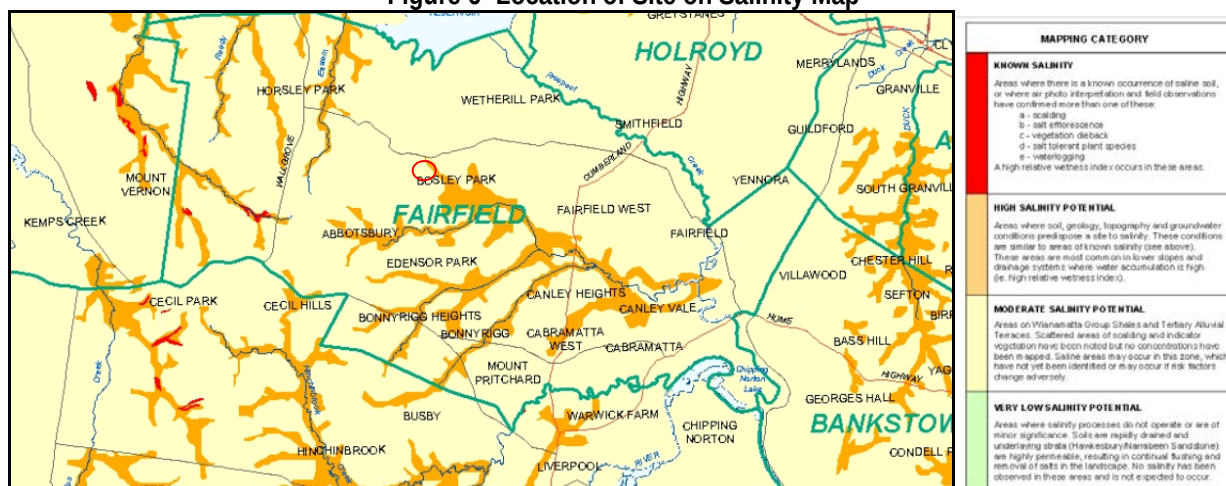
Figure 6- Location of Site on Salinity Map

The Department of Infrastructure and Planning (2002) Salinity Potential in Western Sydney map “Salinity Potential in Western Sydney 2002” indicates that the subject site is situated in a region with a moderate to high risk of saline soils. The moderate classification is attributed to scattered areas of scalding and vegetation indicators in areas where the concentrations have not been mapped. There is the possibility of encountering saline areas which were not identified due to localised factors. Saline soils could occur within areas of lower slopes and drainage systems where water accumulation is high or where movement of water through the soil profile is low.
