Report on
Geotechnical Investigation

Oakdale East Industrial Estate
224-398 Burley Road, Horsley Park

Prepared for
Goodman Pty Ltd

Project 86545.01
December 2018

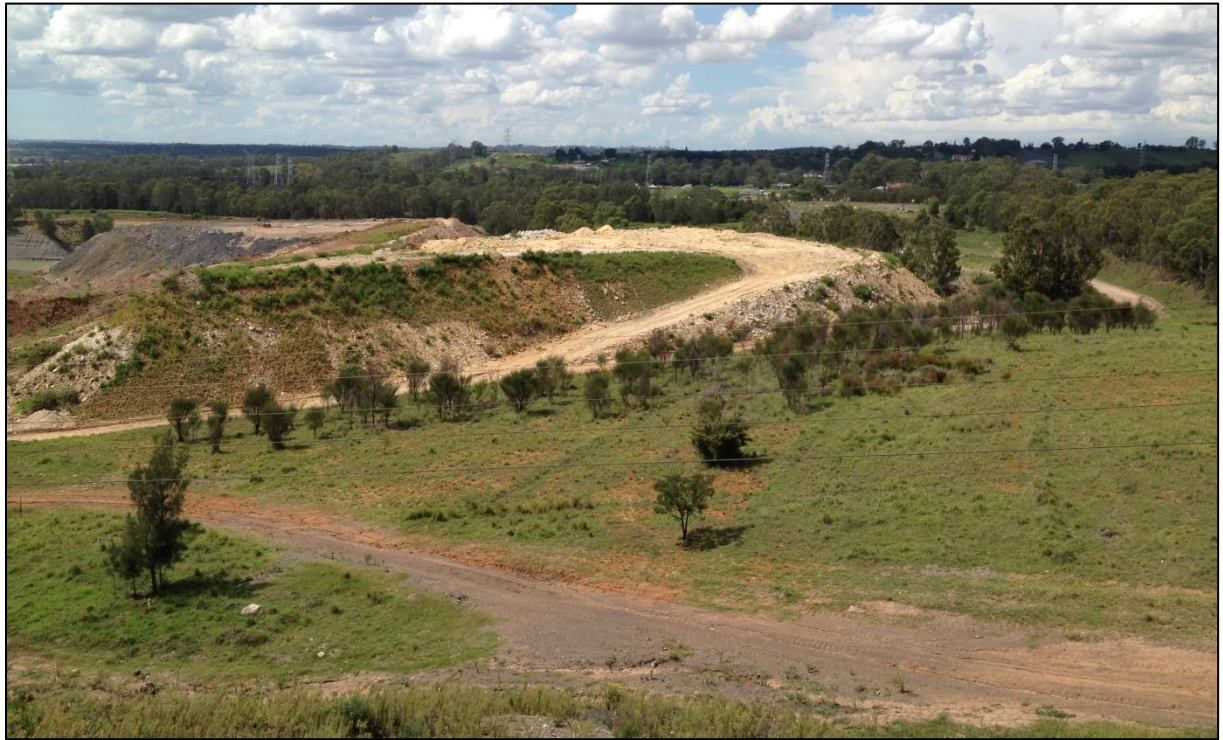
Figure 1: View to East Overlooking Land to the East of the Proposed Subdivision Area

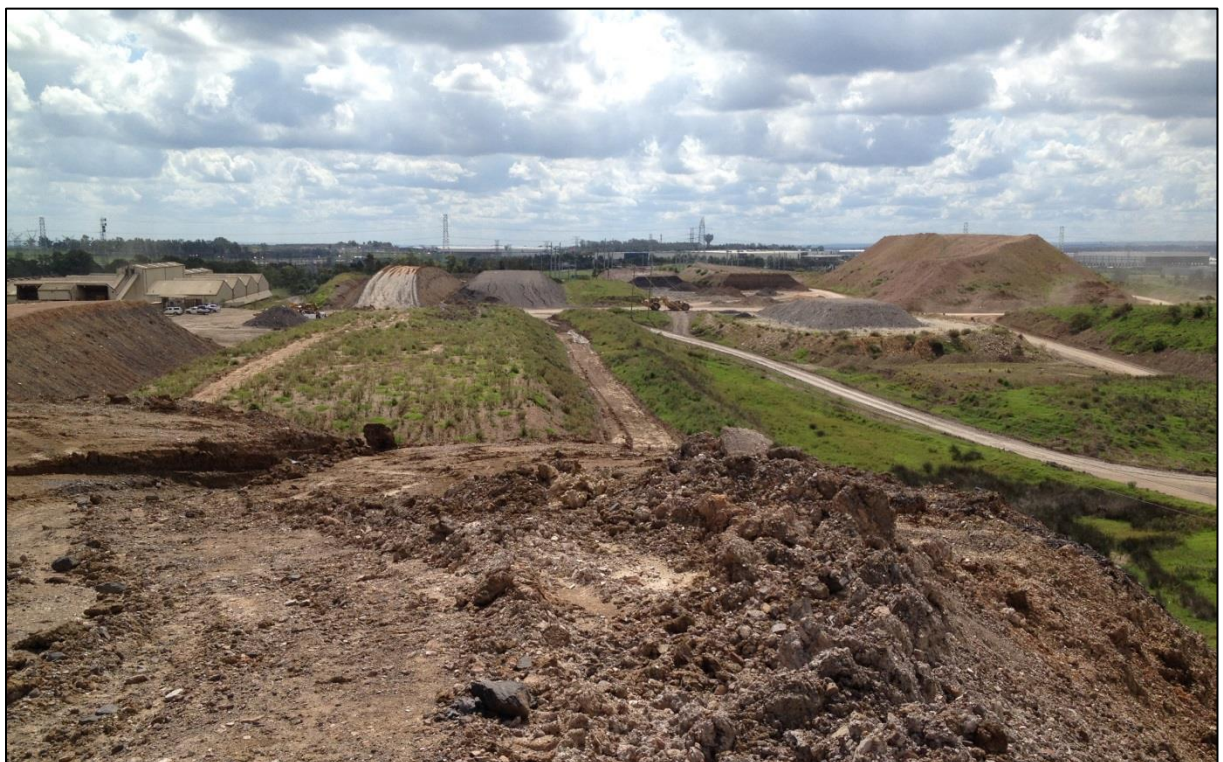
Figure 2: View to North Overlooking the Eastern Part of the Proposed Subdivision Area

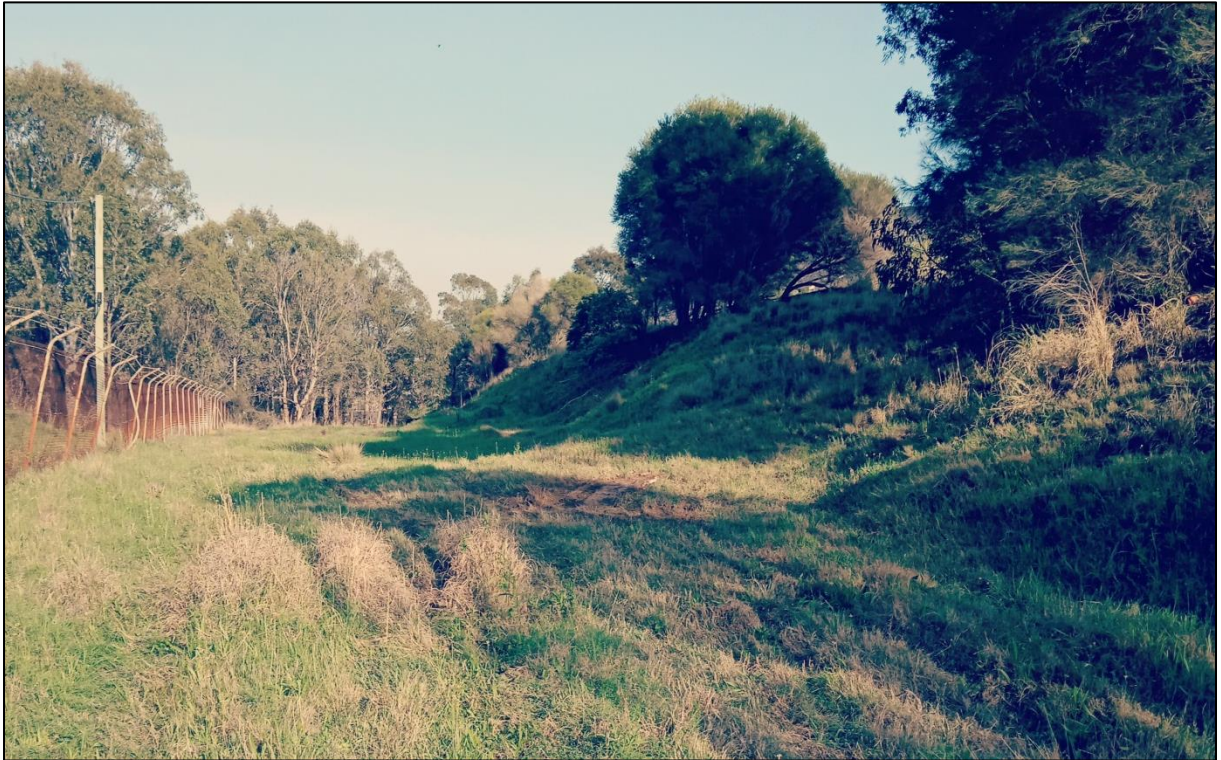
Figure 3: View to West along Southern Site Boundary

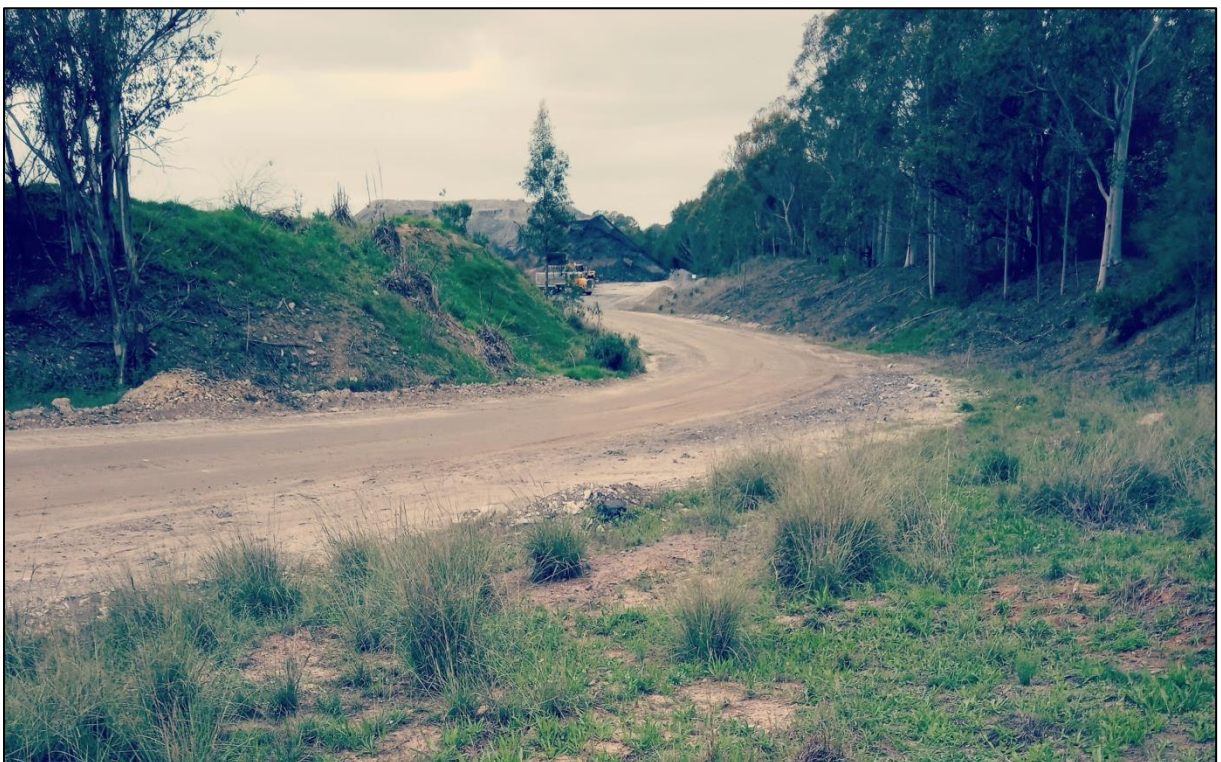
Figure 4: View of Typical Site Access Track near Test Pit TP12

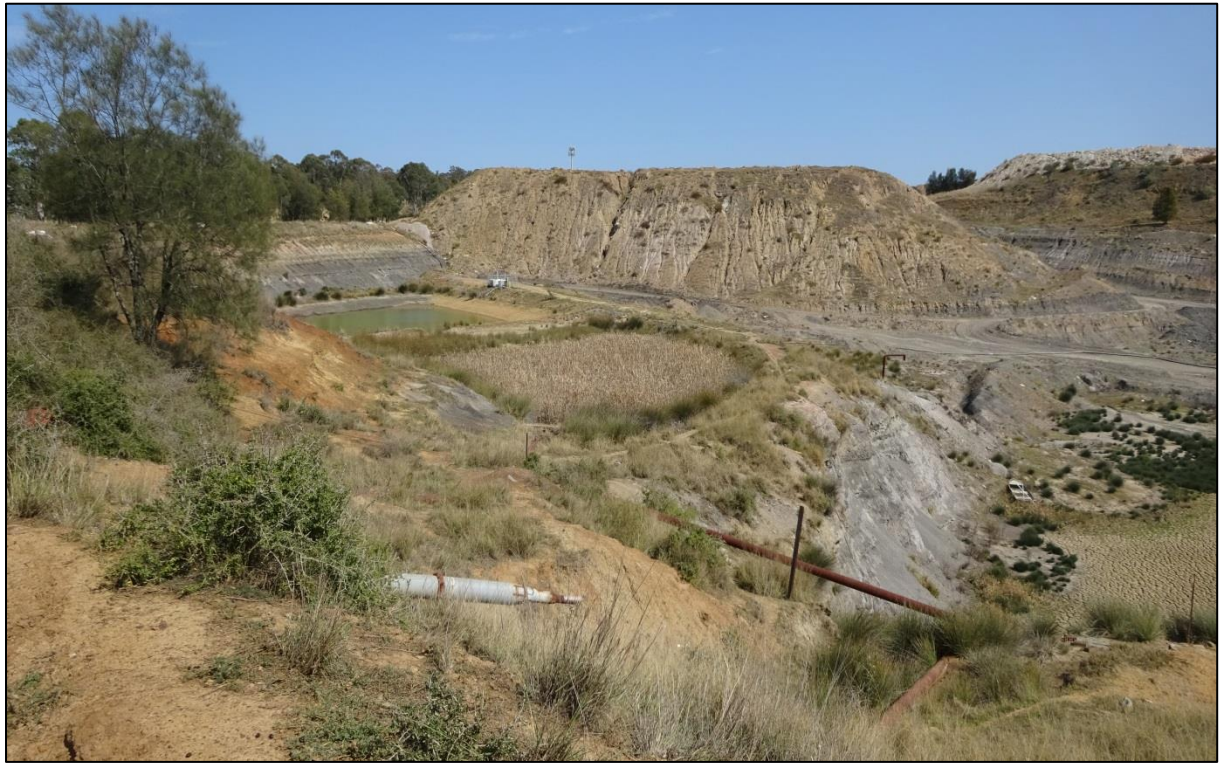
Figure 5: View to South West Overlooking the South-Western Part of the Existing Quarry

Standing water levels in the quarry to the north-east of the site are noted to vary considerably, mostly due to rainfall and local catchment runoff. Historical aerial photographs and previous site observations dating back several years has generally indicated times of water storage in the quarry base and the associated settling ponds, however, there is little to no evidence of significant water seepage through the quarry walls or floor. Currently, the quarry is essentially dry, although it is noted that several pumps are present at various locations across the quarry.

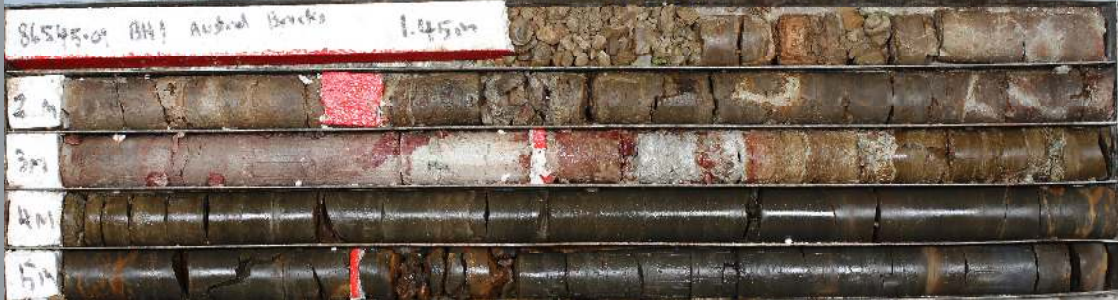
Project No: 86545-01
BH ID: BH 1
Depth: 1.45 - 6.00m
Core Box No.: 1

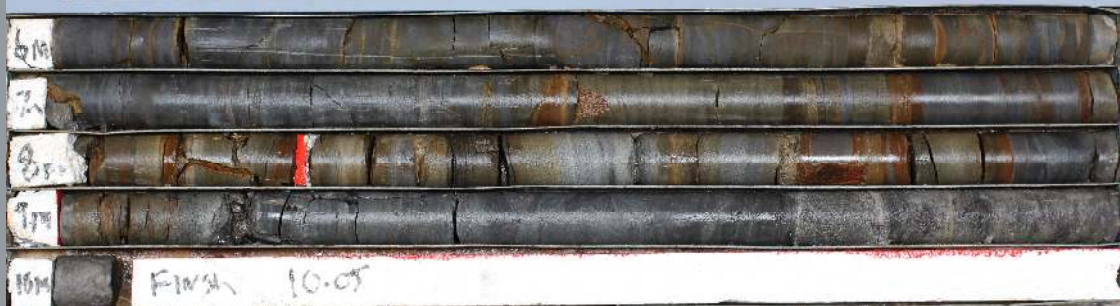
6.0 - 10.05m

Project No: 86545-01
BH ID: BH 1
Depth: 6.00 - 10.05
Core Box No.: 2

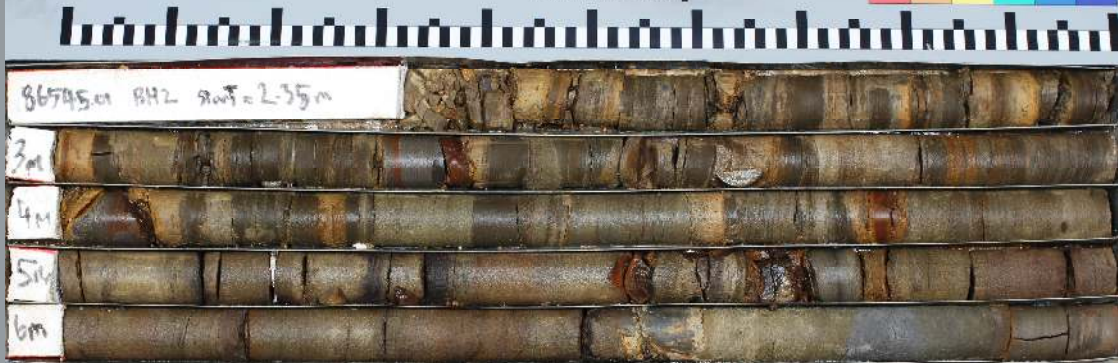
2.35 - 7.00m

Project No: 86545.01
BH ID: BH 2
Depth: 2.35 - 7.00 m
Core Box No.: 1

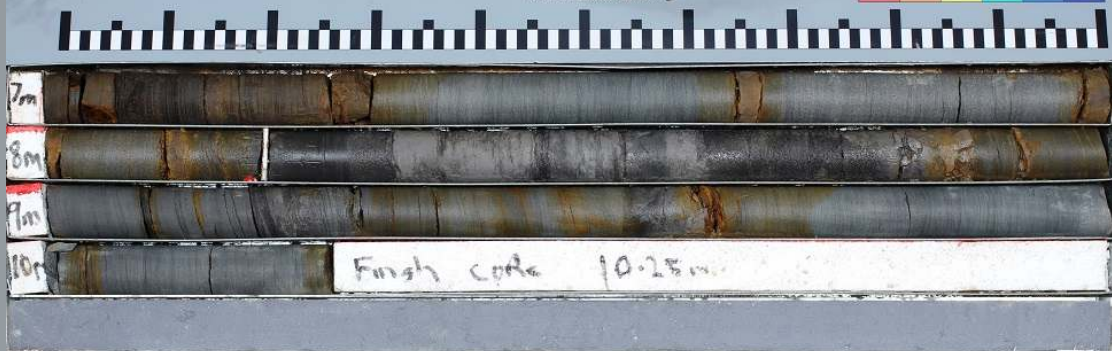
7.0 - 10.25m

Project No: 86545.01
BH ID: BH 2
Depth: 7.00 - 10.25 m
Core Box No.: 2
