Preliminary Site Investigation

22-32 Queen Street, Campbelltown NSW

Report No: E24711.E01_Rev1

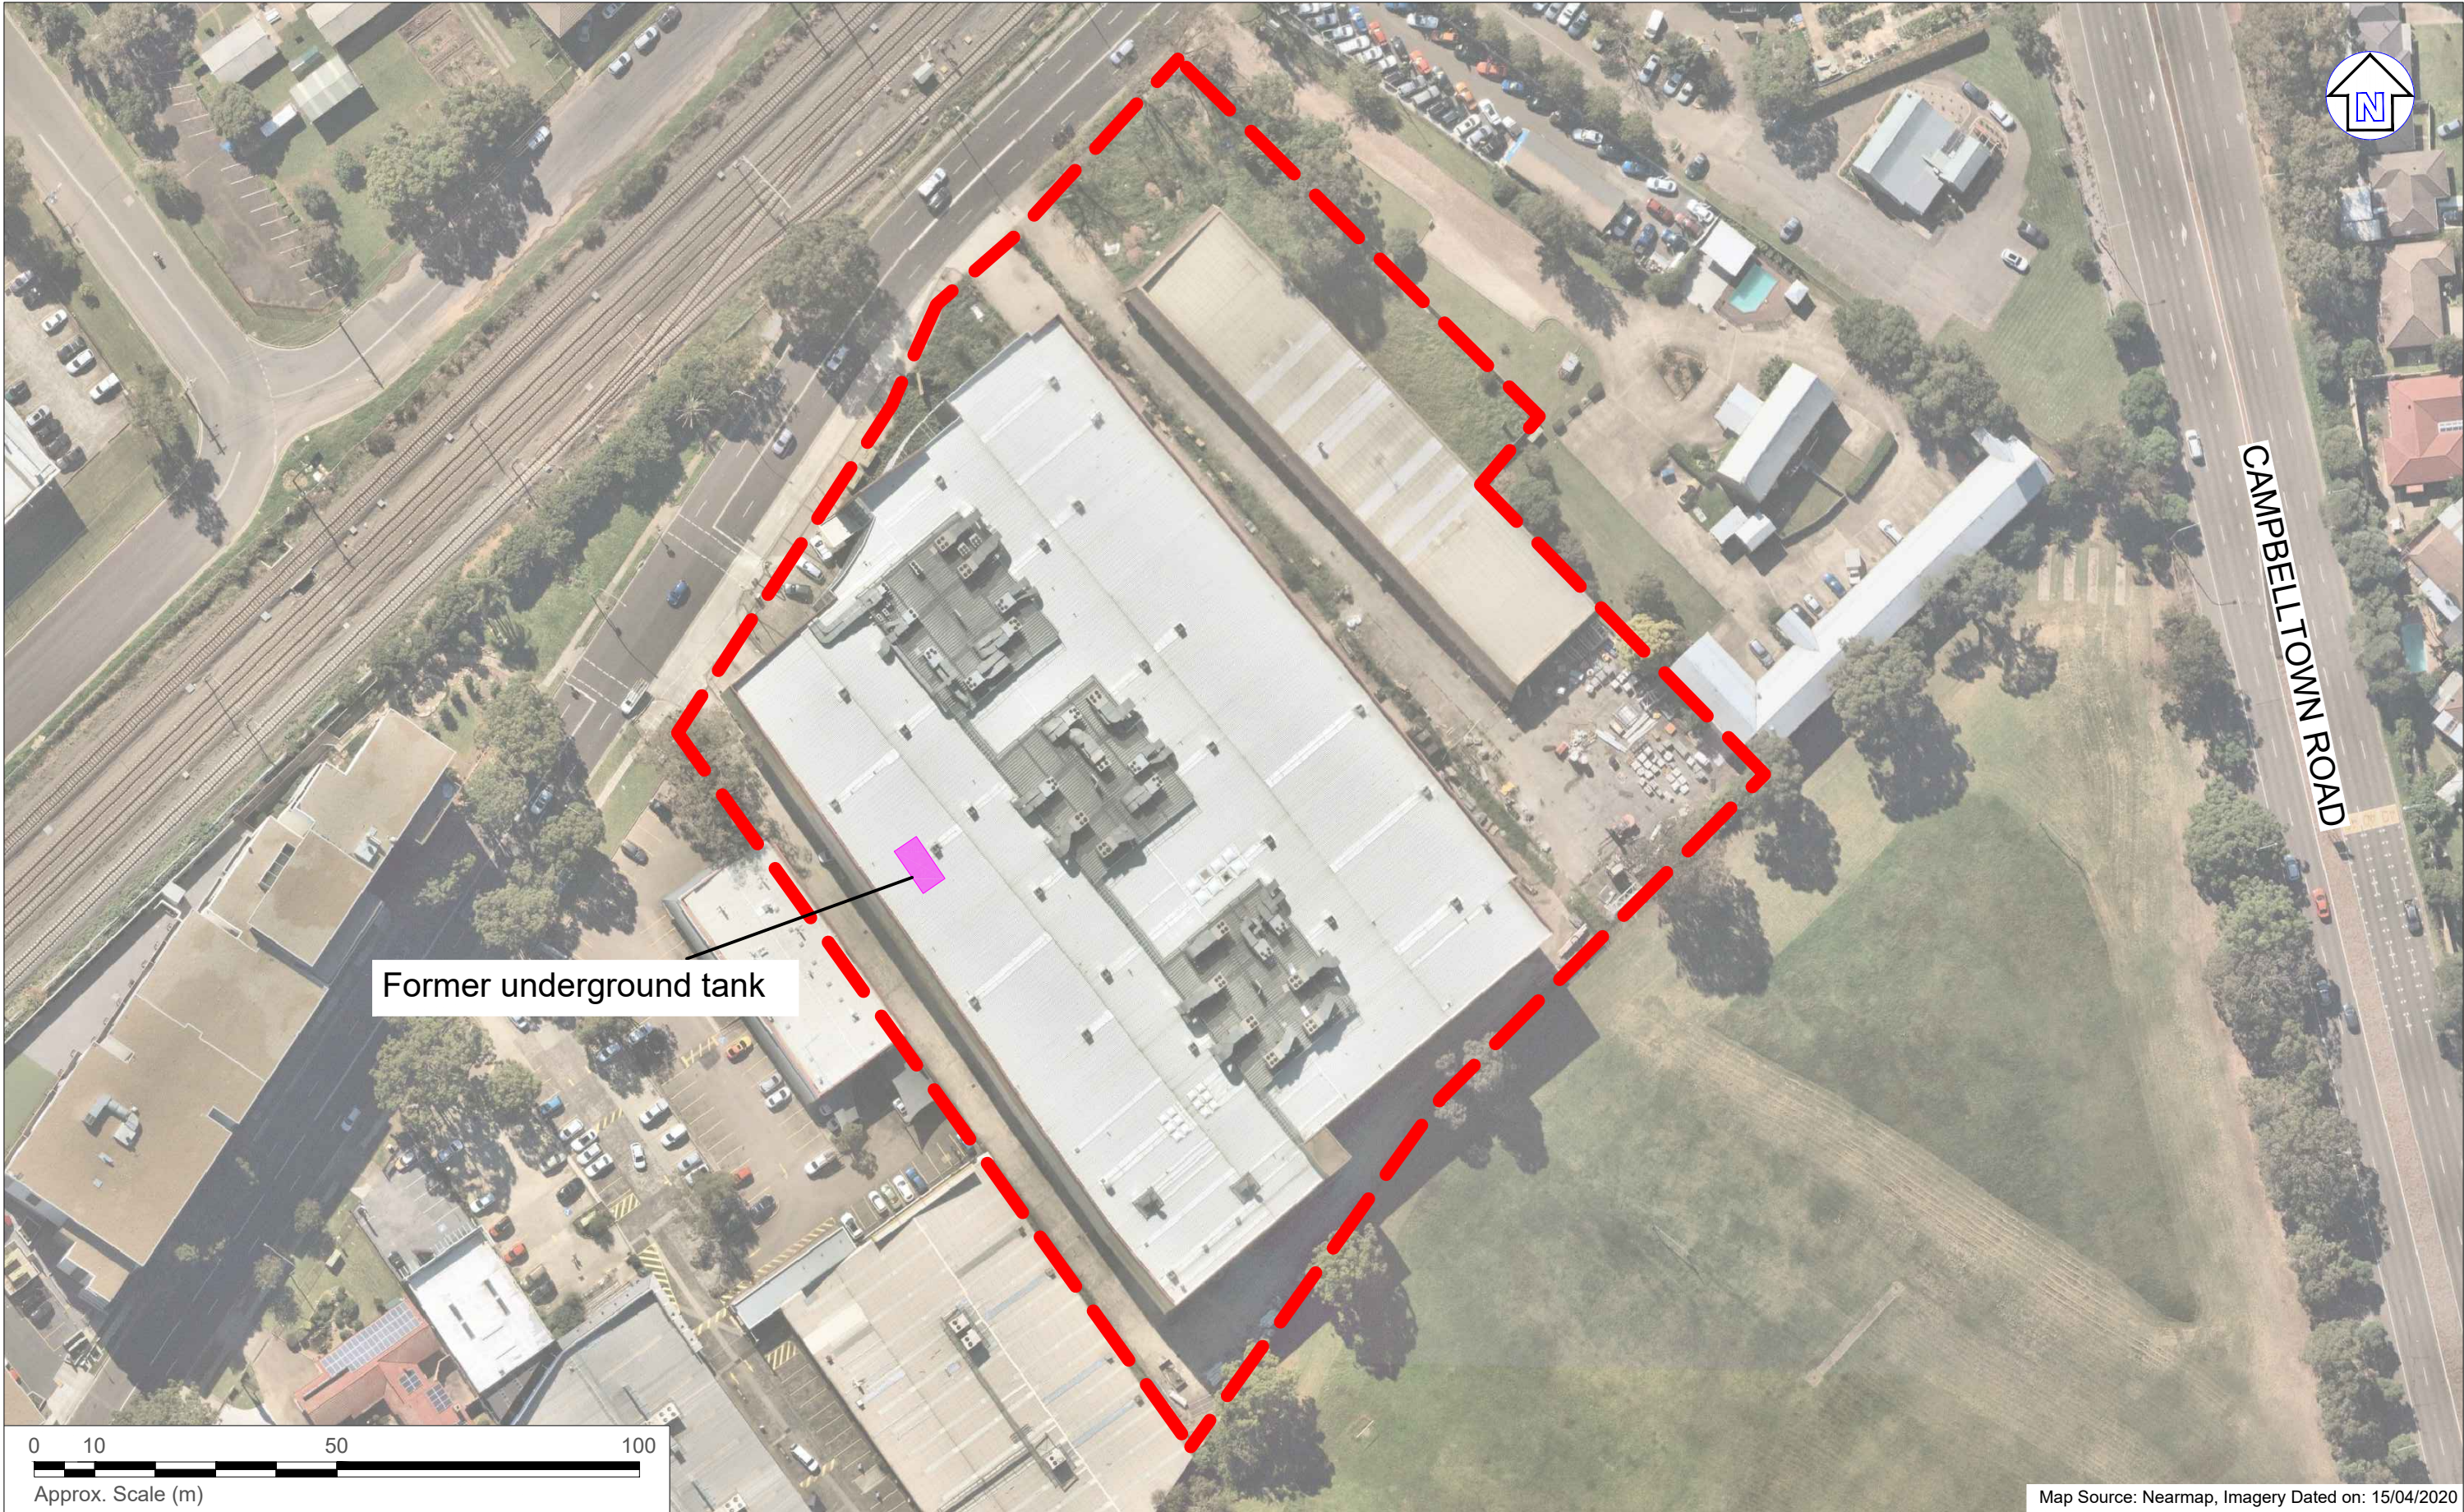
- - - Approximate site boundary
- █ Approximate location of the former underground tank

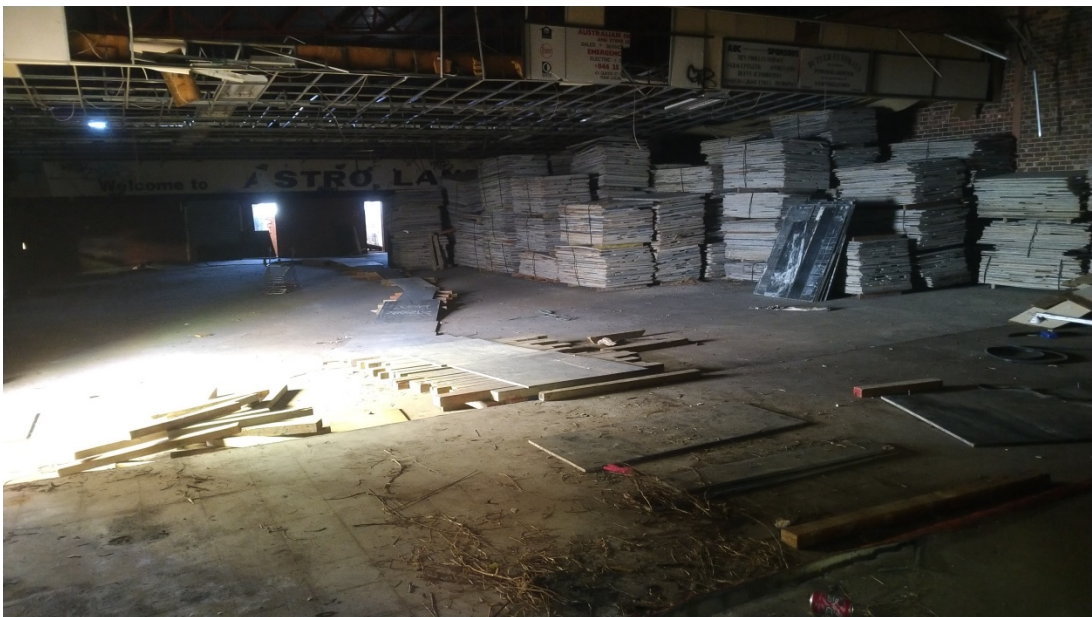
Photograph 2: 24 Queen Street.

- Fragments of fibre cement sheeting (FCS), potentially asbestos-containing materials (ACM), were observed in front of the building (i.e. in the northern site corner).

- Before commencement of any demolition works, a Hazardous Materials Survey (HMS) should be completed by a suitably qualified consultant, to identify any hazardous materials present within the existing building fabrics.

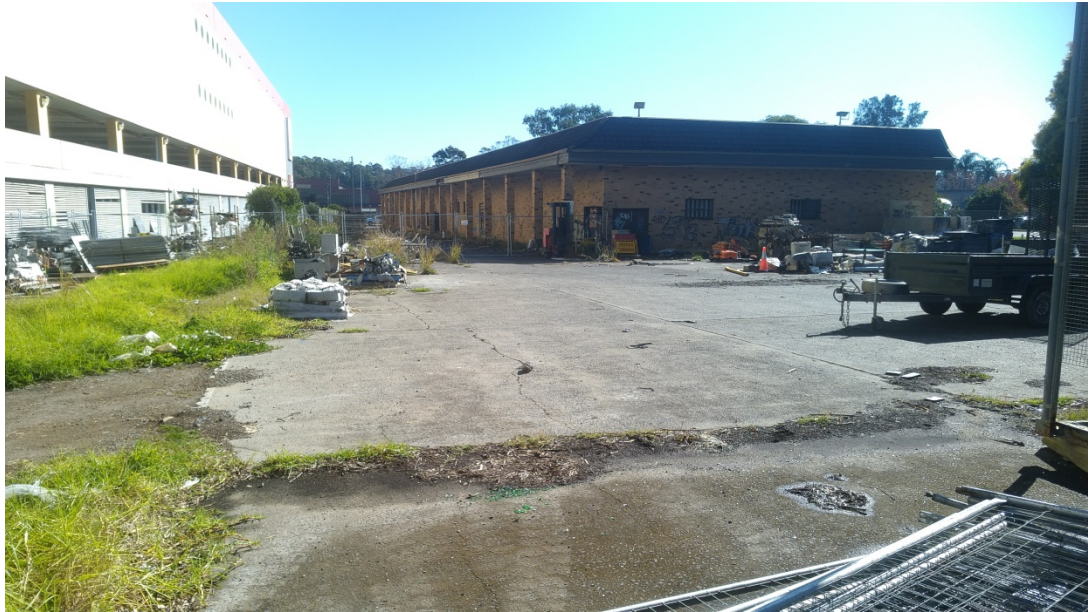
Photograph 3: Rear portion of 24 Queen Street.

- Building wastes were noted at the rear (south eastern) portion of this property.
- A range of plants, including small to large, mature trees, shrubs, grasses and weeds, was observed across the non-built / paved parts of the site, none of which appeared to be distressed. The diversity and health of the vegetation suggested that phytotoxicity of local soils was not a concern.
