Acid Sulfate Soil Management Plan

The Store Redevelopment
854 Hunter Street, Newcastle West

Prepared for
Bloc (ACT) Pty Ltd

Project 81811.06
July 2018

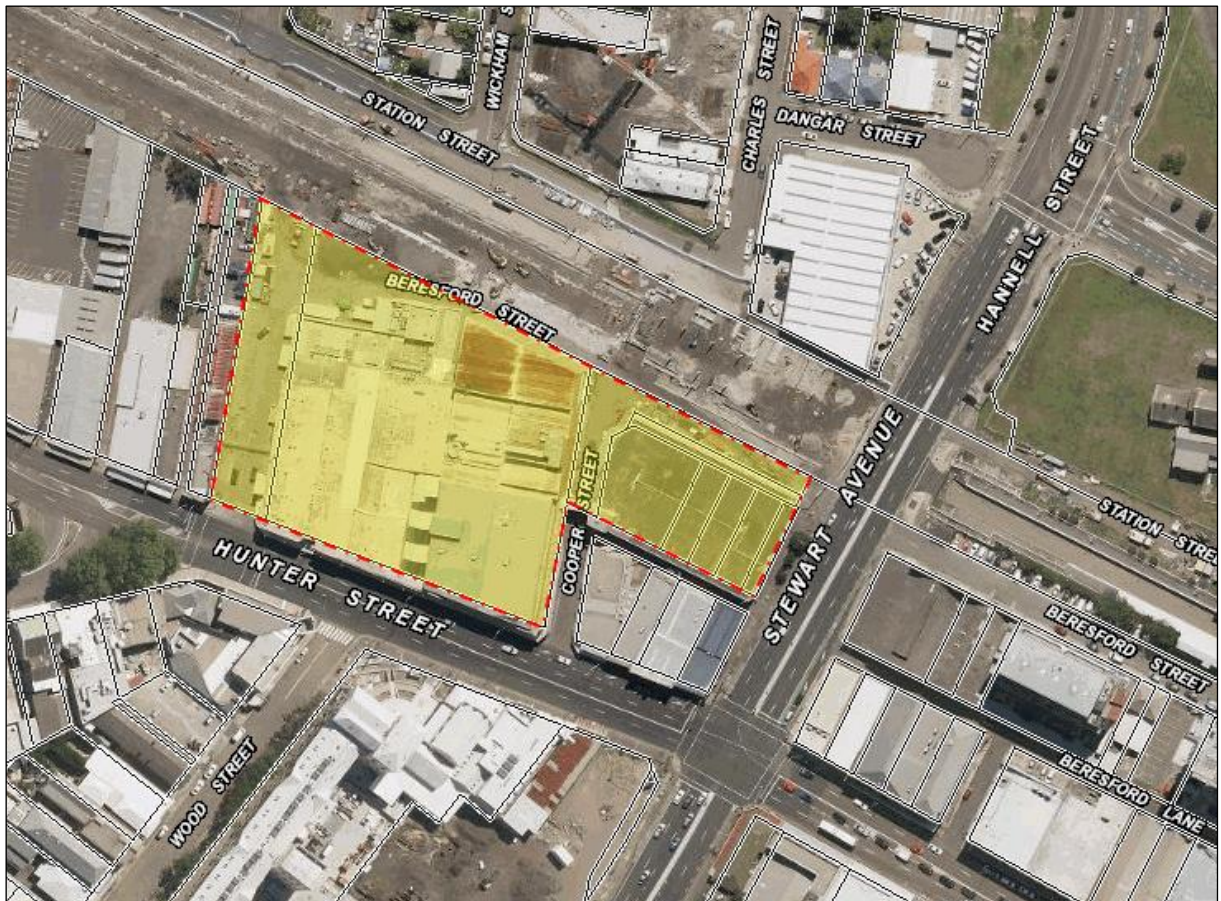
Figure 1: Site locality

The site is bounded to the north by the Newcastle Rail Corridor, to the east by Stewart Avenue and Cooper Street, to the south by Hunter Street and to the west by commercial/retail premises. The site is an irregular shape and covers an area of approximately 1.2 ha.

The site known as “The Store” is defined as 854 Hunter Street, Newcastle West, New South Wales as shown on Drawing 1, Appendix C and in Figure 1 below, and comprises the following lots:

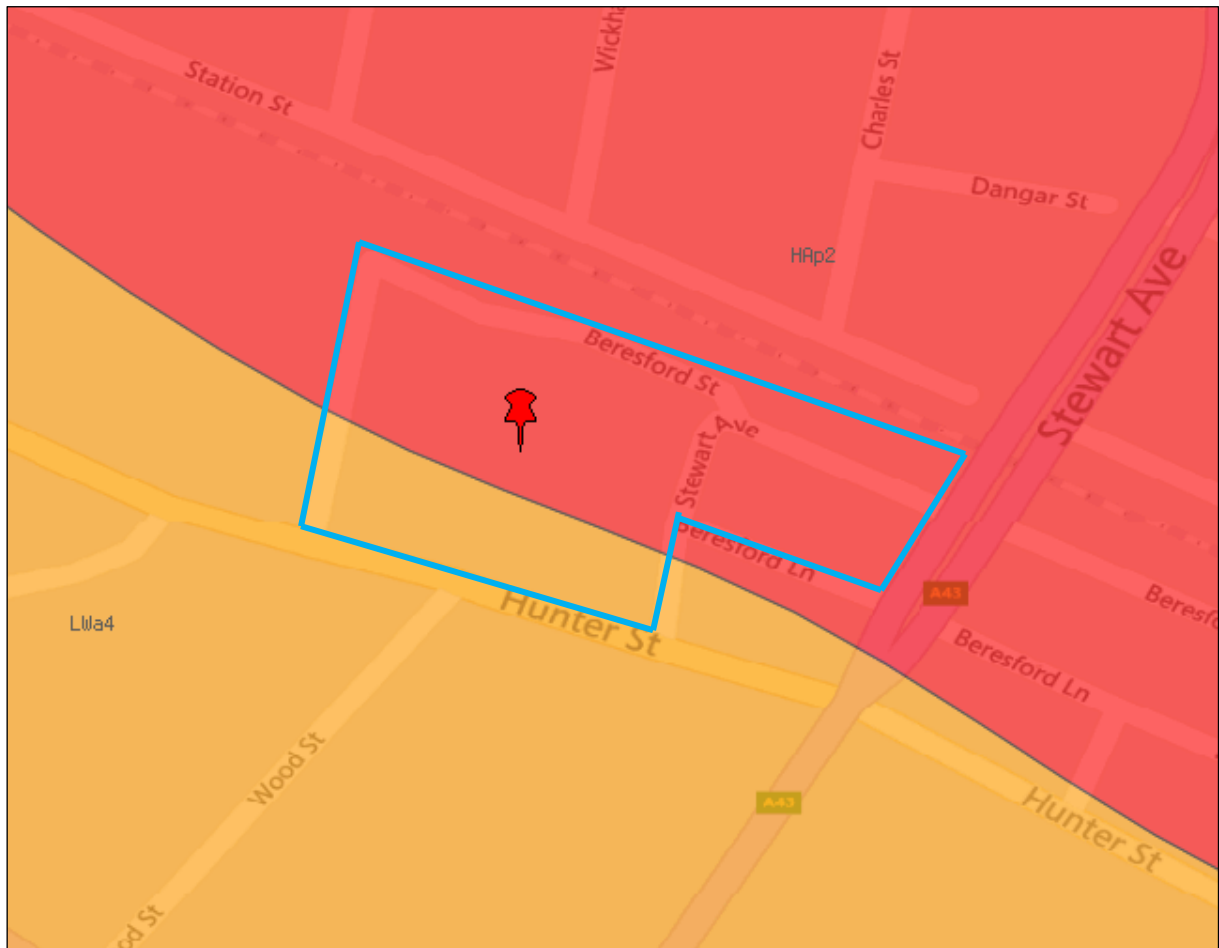
Figure 2: Approximate site extent (blue), high probability ASS (red) and low probability ASS (orange)

Reference to the Acid Sulfate Soil Risk Map, prepared by the Department of Land and Water Conservation (DLWC) indicates the north-east half of the site lies within an area mapped as having a high probability of acid sulfate soil (ASS) occurrence between 1 m and 3 m below the ground surface. The south-south-west half of the site is identified as low probability of ASS >3 m.

The approximate site extent relative to the ASS map is shown in Figure 2 below.

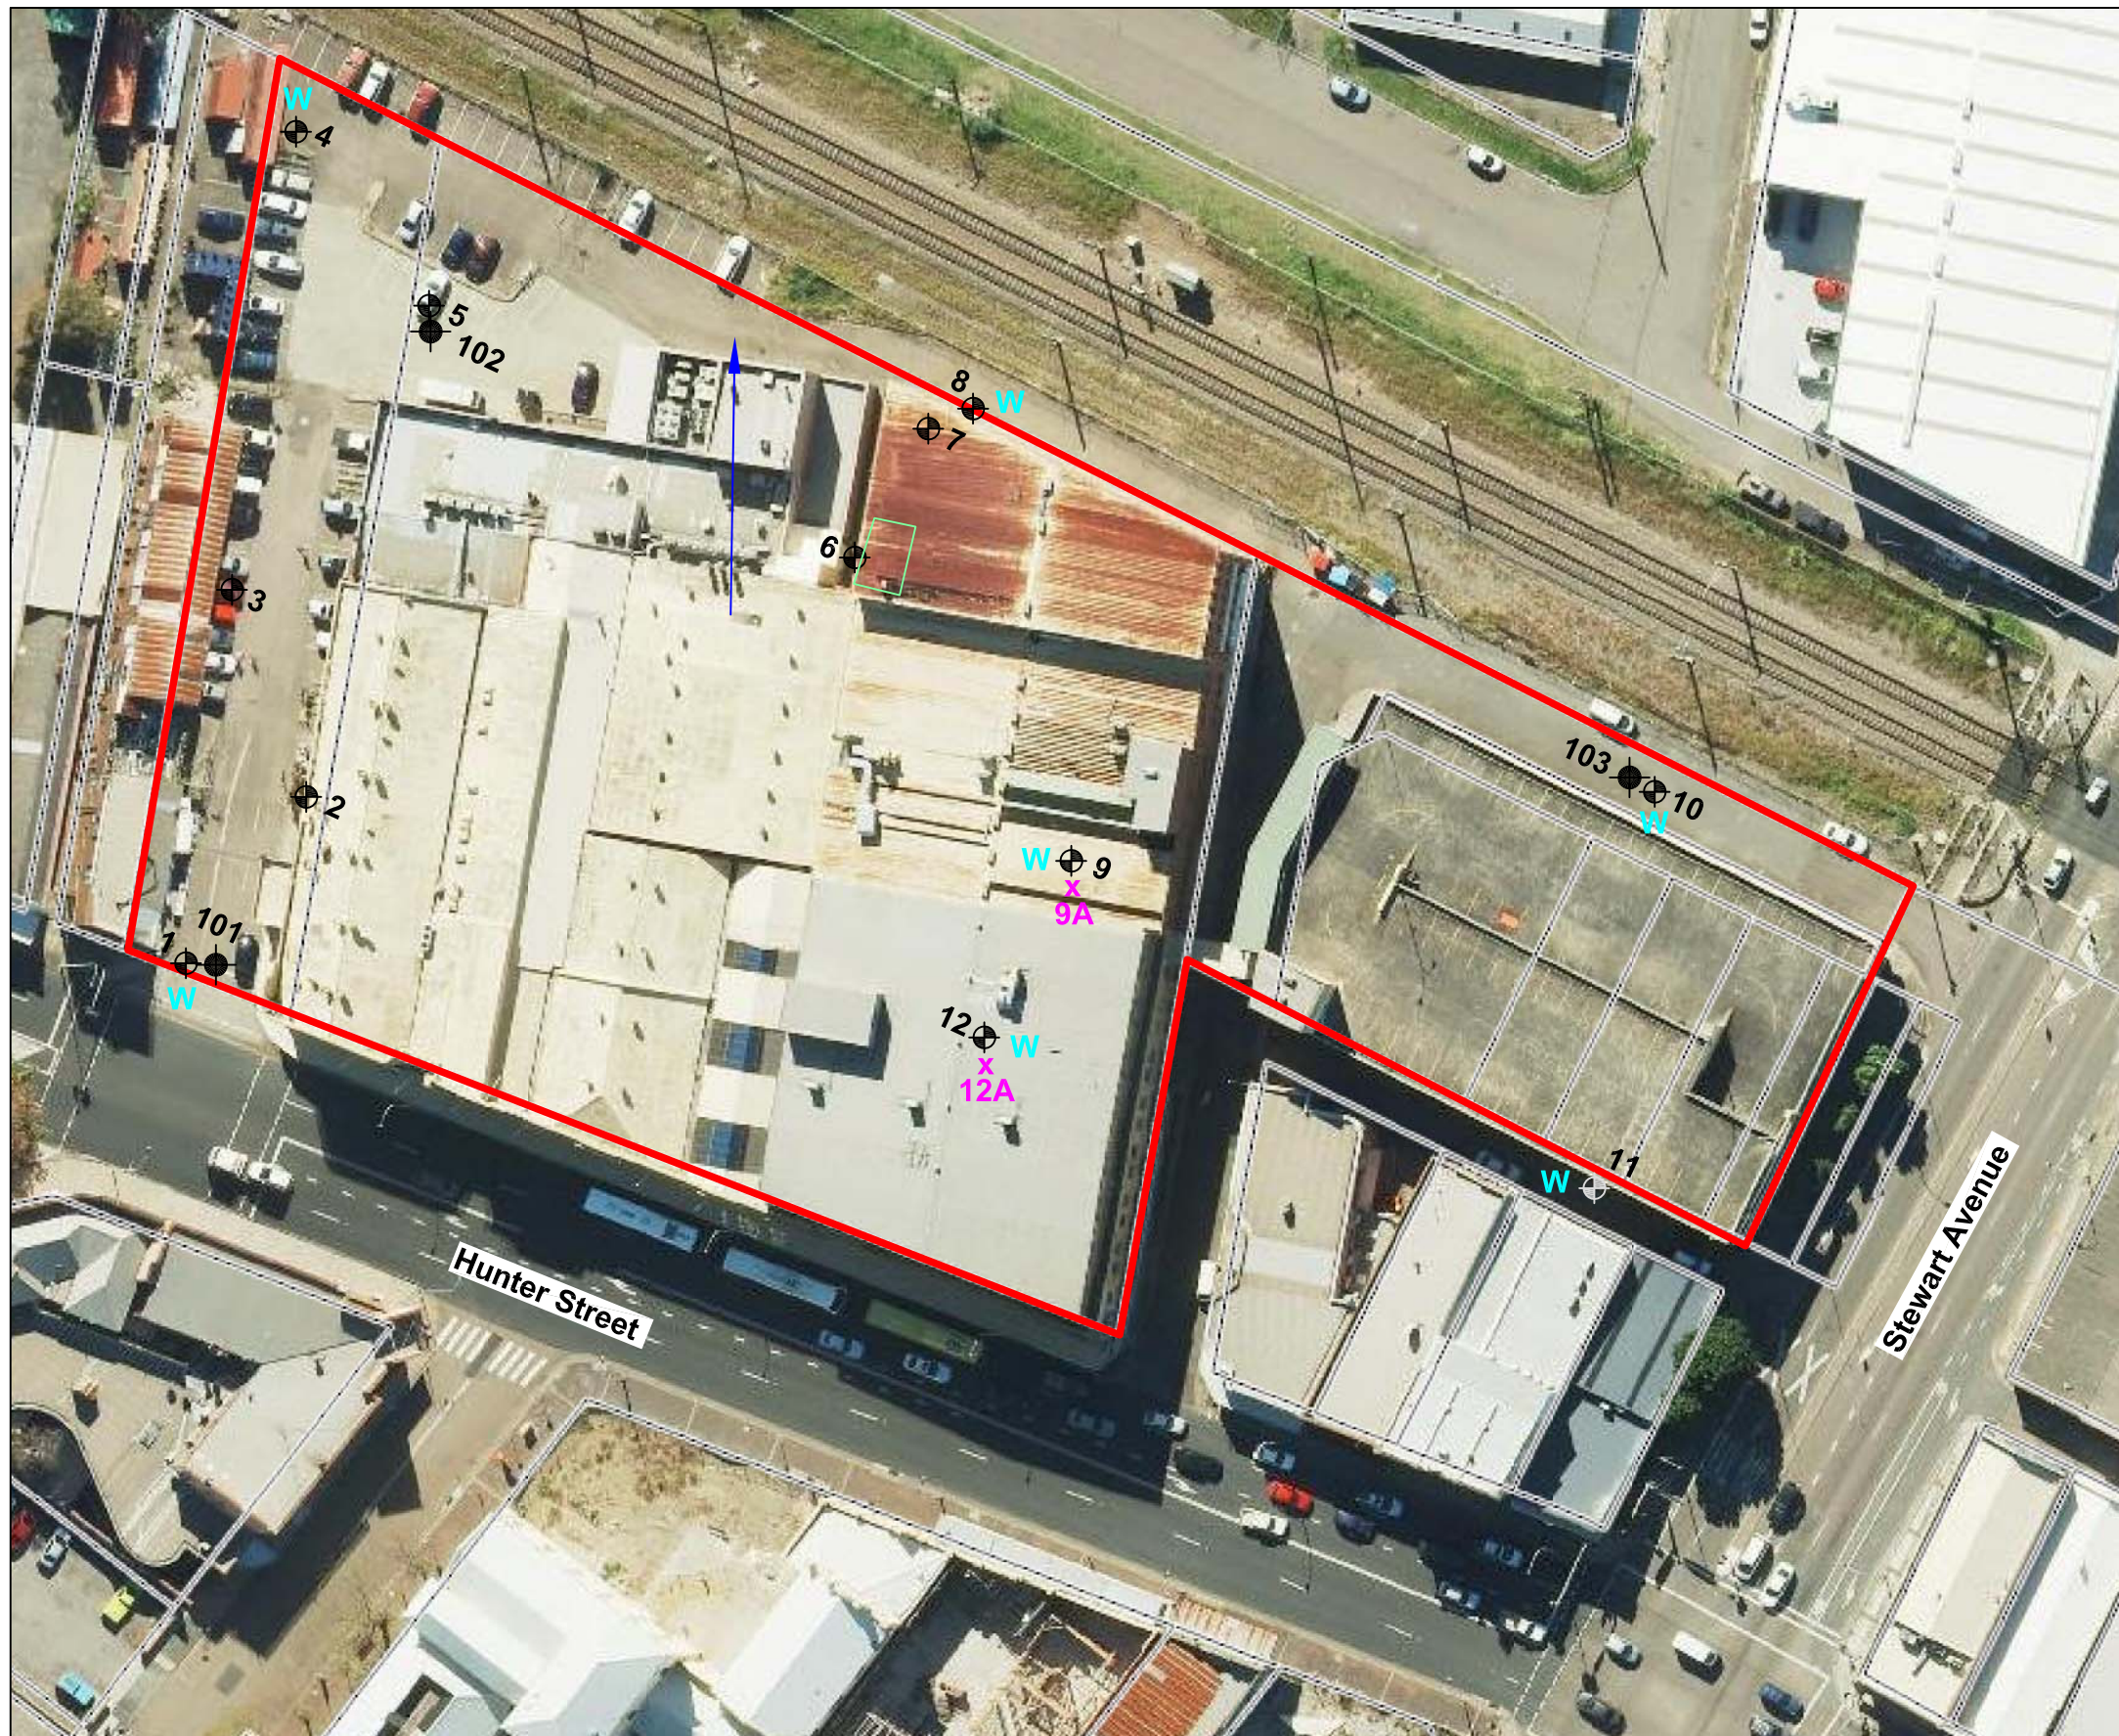
Drawing 1 – Test Location Plan
Architectural Drawings – Bates Smart (Project No. S12133)

- Approximate Site Boundary
- Approximate Borehole Location
- W Groundwater Monitoring Well Installed at Borehole Location
- Approximate CPT Location
- X Approximate Basement Well Location
- Observed Possible Asbestos Containing Materials at the Surface
- ← Approximate Inferred Groundwater Flow Direction

The investigation area (the site) and test location plans from previous DP assessment is shown on Drawing 1, Appendix C.

Subsequent inferred groundwater flow directions based on DP investigations at the site are shown on Drawing 1, Appendix C, and generally indicate groundwater flows in a northerly direction.
