Coastal Process Assessment & Dune Management Report

4226 Nelson Bay Road, Anna Bay

GEOTECHNICAL & GROUNDWATER INVESTIGATION Proposed Sand Mine at 4226 Nelson Bay Road, Anna Bay

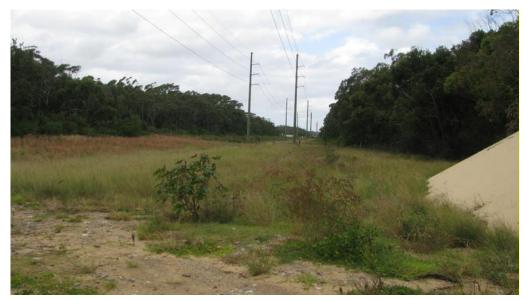
Figure 1-1: View East along 33kV Electricity Network: Poles, Wires, Easement and Part of Sand Incursion

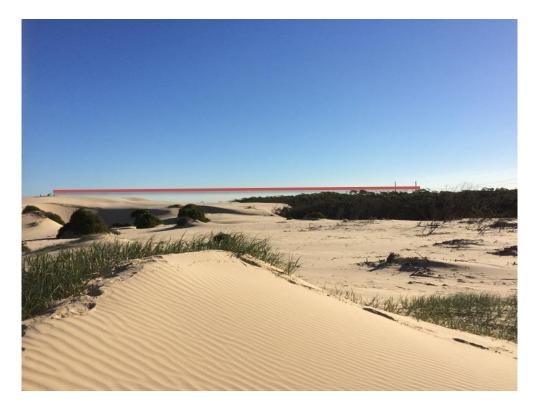
From Figure 1-2 below it can be seen that the height of the dune system approaches the top of the electricity network poles.

Figure 1-2: View North-West from Distant Sand Dunes: 33kV Electricity Network in Background

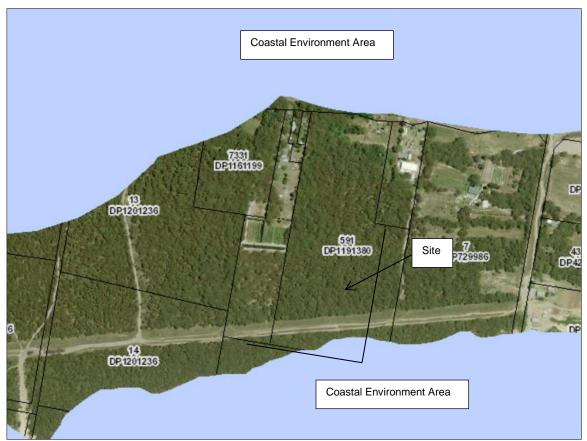
Figure 1-3: Coastal Environment Area Map and Relevance to Subject Land

The section of the site with dune encroachment where proposed sand mining is to occur is mapped as a Coastal Environment Area in SEPP (Coastal Management) 2018 as shown in Figure 1-3 below.

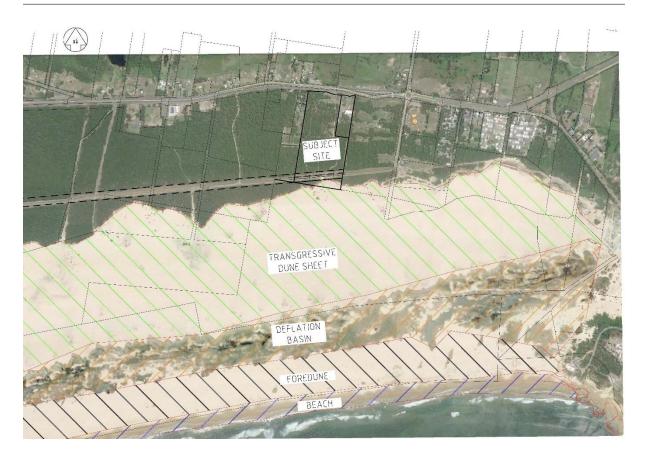
The mobile sand dunes can be broken into four main sections:

- 1 Transgressive Dune Sheet
- 2 Deflation Basin
- 3 Foredune
- 4 Beach

Figure 2-3: Coastal Dune System Sections

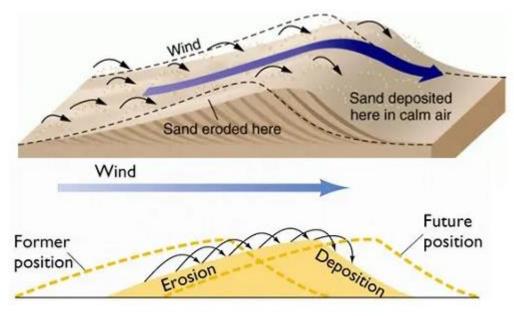
The prevailing onshore winds and lack of vegetation cause the sand dunes to develop and migrate through aeolian transportation as shown in Figure 2-4. The width of the transgressive dune sheet south of the subject site is approximately 750m if supply of sediment from the beach and foredune systems is not taken into account the sand resource would not be exhausted for approximately 150 years which is outside the planning scope for this development

Figure 2-4: Dune Migration through Aeolian Transport Source: GeoCon <u>https://geologyconcepts.com/3334/</u>

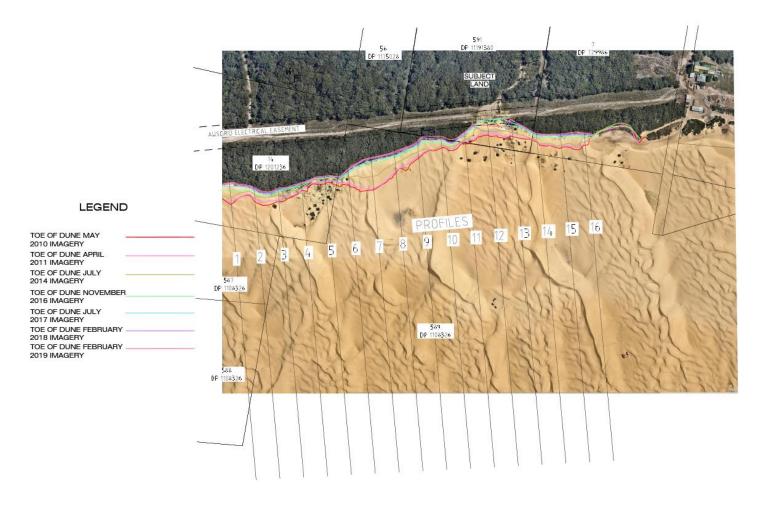
Figure 3-1: 2019 Satellite Imagery with Toe of Dune Measured.

A series of satellite images were obtained from Nearmap(2019) showing the landward margin of the transgressive dune system in the vicinity of the site from 2010 to 2019. These images were aligned to survey measurements of the power lines in the Ausgrid Easement and the toe of the dunes were traced for each image. **Figure 3-1** shows a sample image with the toe of the dune face traced. Images for each year have been included in higher resolution in Appendix A.

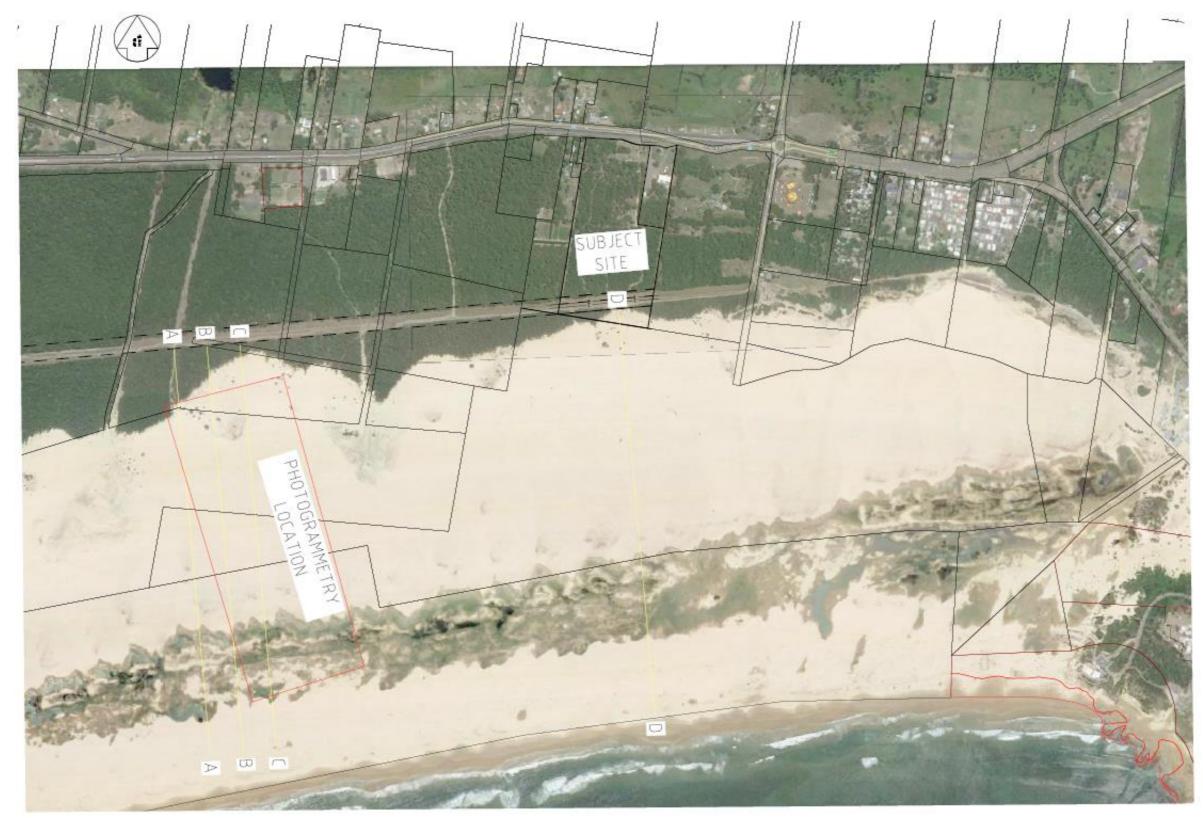
Figure 3-2: Photogrammetry Location with respect to Subject Site

Photogrammetry survey for a nearby site (Figure 3-2) on the same dune system has been used to compare the height of the dune systems and their progression towards the Ausgrid elecricity easement. Whilst this data was not collected originally for this use and as such does not include the landward margin of the dune system, it is approximately 800m west of the subject site and can be used to make some comparisons between 2012 and 2020.

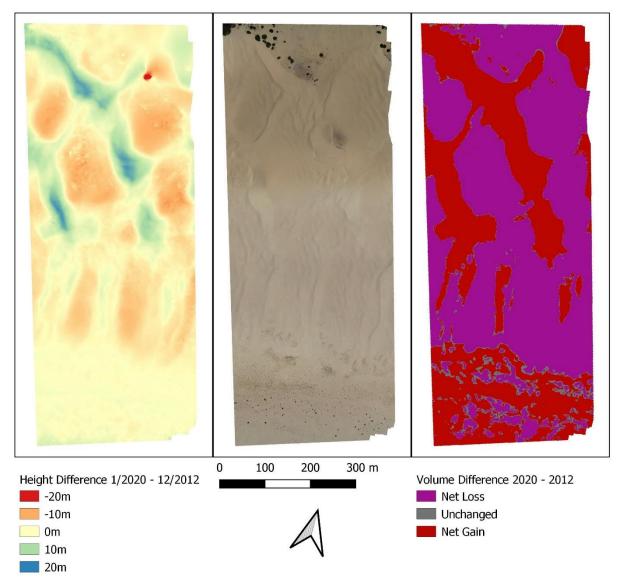
Using QGIS GIS software, the 2012 DEM from LIDAR was compared to the 2020 DEM from Photogrammetry by use of a subtractive algorithm (difference = 2020 Elevation – 2012 Elevation). The result of the algorithm is shown in false colour below in Figure 3-3 where; positive values denote accretion, and negative values denote erosion.

Figure 3-3: QGIS Subtractive Analysis (2012-2020)

This image shows the general northward trend of the dune system with the ridges eroding and accreting whilst maintaining a similar profile in a NNE direction. Sections through the photogrammetry site show the northward progression of the dune faces. Figure 3-4 shows that the dune faces are maintaining elevation as they migrate northwards at a rate of 5 to 7.5m per year. This is consistent with the rate of transgression identified in Section 3.1 of this report and other literature. Section D is from our site towards the beach and only has data from the 2012 LiDAR information. Whilst the height of the current transgressive face is approximately 16m AHD the next ridge of the system is approximately 25m AHD. If the profile here matches the profiles of the nearby site this face could join the proposed face of the mine site within the next 30 years. This would be significantly higher than the current high voltage transmission lines which are approximately 19m AHD.

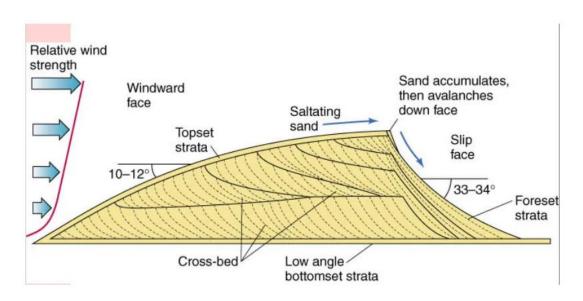
The proposed extraction will halt the northward progression of the face but will have no impact on this natural process. The face will continue to develop at the angle of repose and avalanche past the 5m buffer zone until the sand resources to the south of the site are exhausted or stabilised.

Figure 4-1: Dune Face Stability

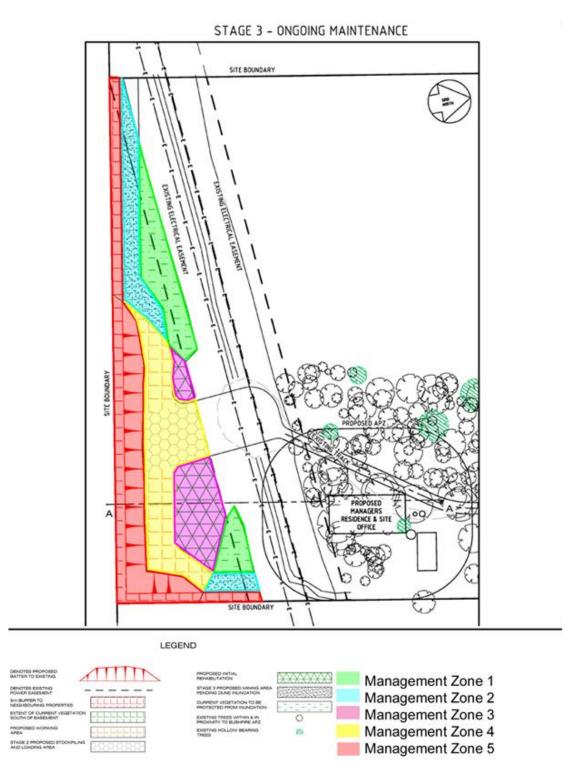
- Zone 1 Existing vegetation to be protected from dune inundation by the proposed sand extraction operation
- Zone 2 Existing Vegetation that will be subject to sand extraction operations pending dune inundation
- Zone 3 Proposed initial rehabilitation area
- Zone 4 Final rehabilitation area: Smooth-barked Apple Blackbutt heathy open forest
- Zone 5 Final Rehabilitation Area: Spinifex beach strand grassland

Figure 5-1: Rehabilitation Management Zones

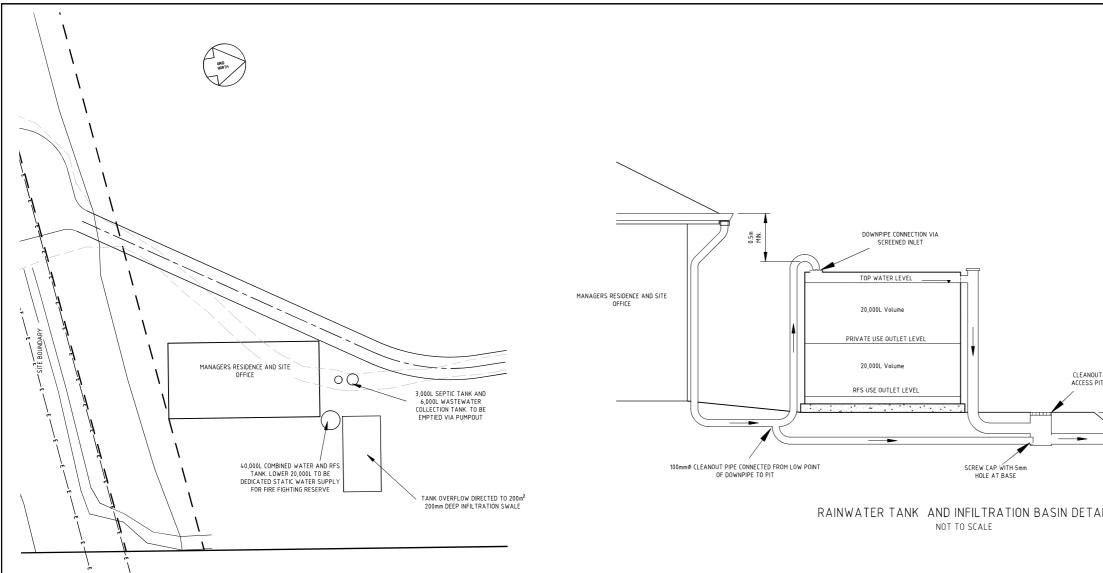
Roof Area	800	m²	
Infiltration Area	200	m²	
Infiltration Rate	0.0004	m/s	× INFILTRATION RATE FROM GEOTECHNICAL
Infiltration FOS	5		INVESTIGATION BY RCA AUSTRALIA ref 13280-201/2
Design Infiltration Rate	0.00008	m/s	
Q _{infiltration}	0.016	m³/s

AEP	%	100	100	100	100	100	100	100	100
Duration	min	1	5	10	20	30	45	60	90
Intensity	mm/hr	485	334	267	194	155	121	101	76.9
Intensity	m/s	1.3E-04	9.3E-05	7.4E-05	5.4E-05	4.3E-05	3.4E-05	2.8E-05	2.1E-05
Q _{inflow}	m³/s	0.108	0.074	0.059	0.043	0.034	0.027	0.022	0.017
Vol Runoff	m³	6.47	22.27	35.60	51.73	62.00	72.60	80.80	92.28
Q _{Net} (Q _{Inflow} -Q _{infiltration})	m³/s	0.092	0.058	0.043	0.027	0.018	0.011	0.006	0.001
Net Volume	m ³	5.51	17.47	26.00	32.53	33.20	29.40	23.20	5.88
Depth Req	mm	28	87	130	163	166	147	116	29

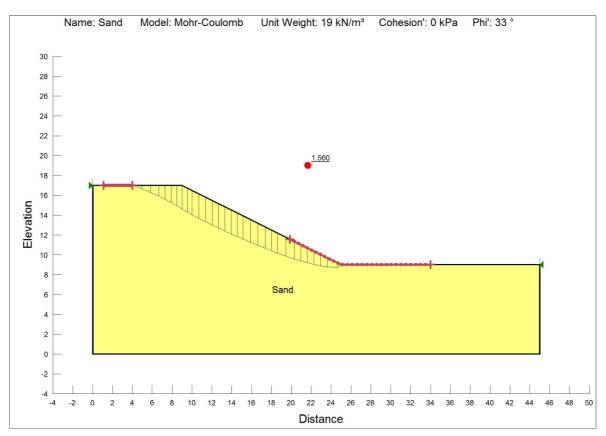
Figure 13 Plot of Factor of safety against mass rotational slumping of 2H:1V batter slope

The factor of safety against mass rotational slumping of a 2H:1V batter slope is in excess of 1.5 and this is considered acceptable for the proposed situation.

In regard to geotechnical stability of batter associated with the sand mine, it is suggested that when the mine is not actively loading out that batters be limited to a maximum of 1.5H:1V and for long term stability against mass failure that the slopes be battered at a maximum 2H:1V.
