GEOTECHNICAL & GROUNDWATER INVESTIGATION Proposed Sand Mine at 4226 Nelson Bay Road, Anna Bay

Prepared for Tattersall Lander Prepared by RCA Australia RCA ref 13280-201/2 August 2018

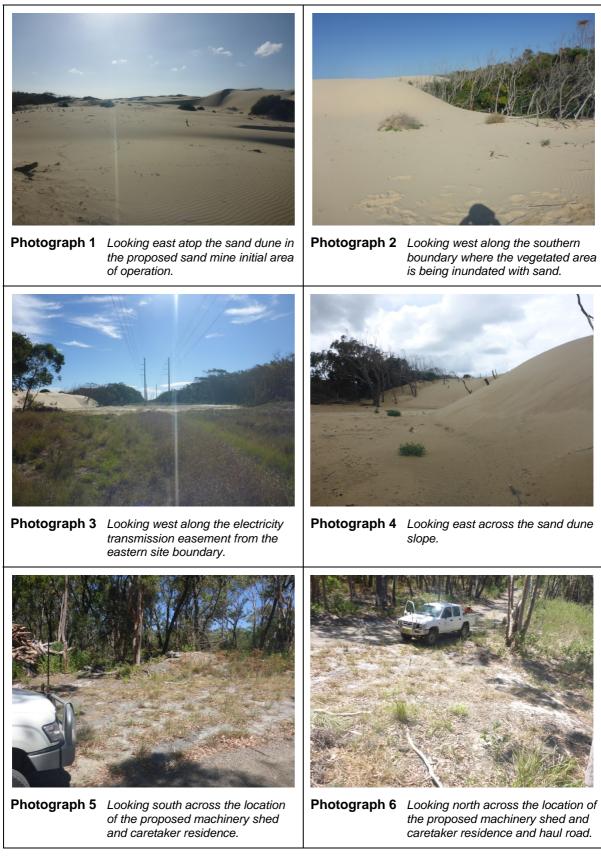
Vegetation on the site at the time of the field investigation comprised mostly mature trees with visible treetops protruding through the inundating sand dune system. Some bitou bush was located atop the sand dune system. Grass and small plants including the protected diuris praecox orchid was found in the electricity transmission easement where the trees had been cleared.

Figure 1Site Photographs taken on 30 January 2018.

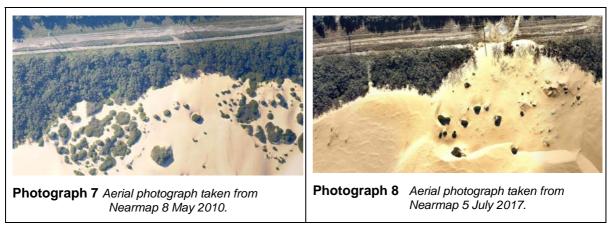
As may be seen from Photographs 7 & 8 in **Figure 2** the sand dune system is advancing to the north towards the electricity easement at the south-eastern corner of the property. It is understood that sand mining is proposed to control the advancement of the dunes.

Figure 2 Aerial photographs showing the dynamic nature of the sand dune systemshowing the northward advancement of the sand dunes during the time between the photographs.

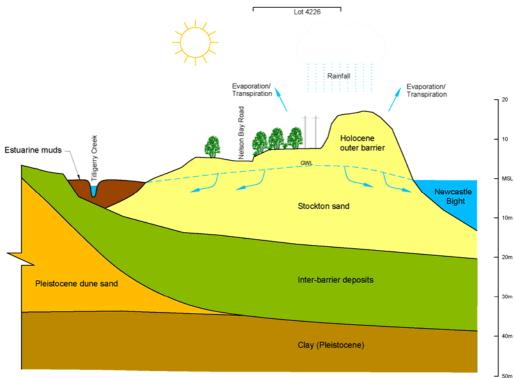
Schematic Cross-Section of Geological Hydrological Conceptual Model (N.T.S) Adapted from Roy & Bold 1996

The groundwater beneath the coastal dune system forms a groundwater divide between the ocean and Tilligerry Creek. Groundwater recharge is primarily from rainfall infiltrating the dune system and discharges by evapotranspiration and from groundwater discharge down gradient to the ocean and tidal estuary/ floodplain drains.

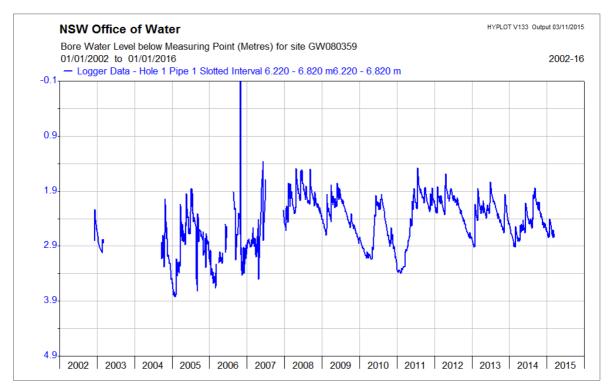
Figure 4 Plot of water depth in GW080359 (copied from OoW database) from 2002 to 2015

The spread sheet that accompanies the plot in the OoW data set indicates that the water level was deepest at 3.816m in earlier 2005 and spiked to 0.535m/0.498m on the 28/29 October 2006. The resulting maximum water level fluctuation is 3.318m from the lowest record over the period for which there is data. It is noted however that the rainfall records of stations (see **Figure 5** as an example) in the vicinity of the site do not record the occurrence of a significant rainfall event. Accordingly the cause of the spike is not known.

With reference to **Figure 4** it may be seen that in the absence of the spike in late 2006 the groundwater surface appears to have varied up to 2.5m in depth over the years of monitoring for which data is available.

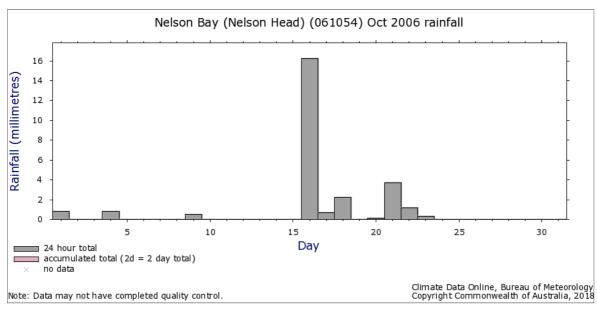
Figure 5 Daily Rainfall Nelson Bay October 2006 from BOM site

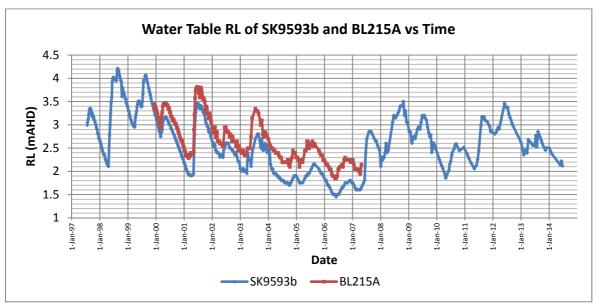
The monitoring results are presented on Figure 6.

Figure 6Plot of groundwater level monitoring data at SK9593b and BL215A (Hunter
Water data)

It is noted that HW no longer monitors these sites and that the above is a complete data set apart from the removal of erroneous readings.

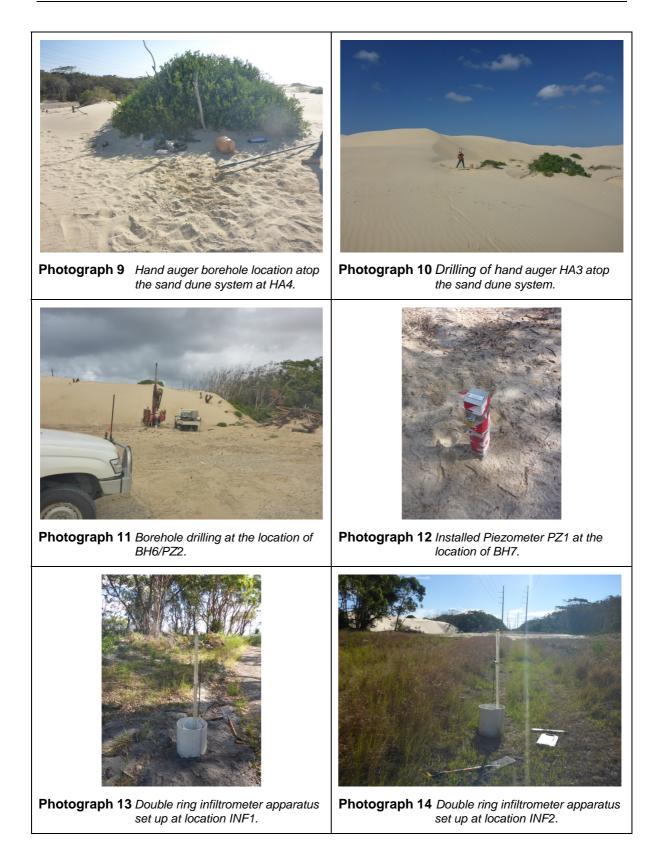
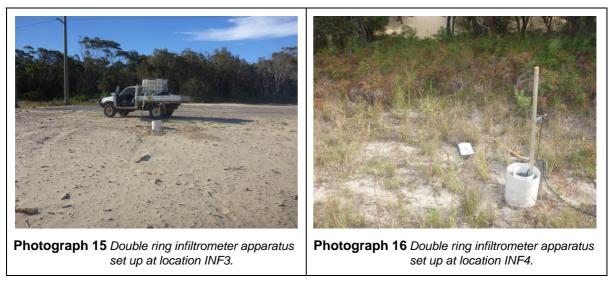
Photographs of selected investigation locations are shown below on Photographs 9 to 16 in **Figure 7**.

Figure 7Photographs of selected fieldwork test locations

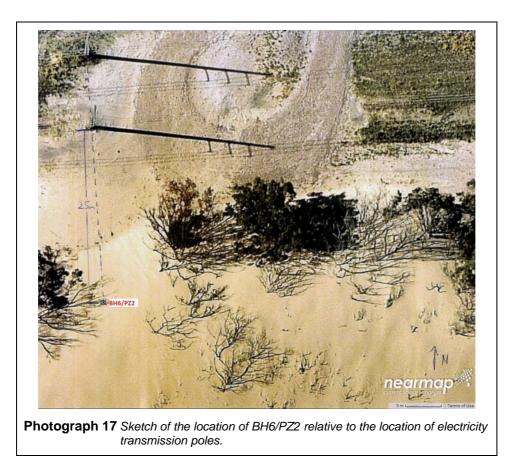
As noted above groundwater monitoring wells PZ1 and PZ2 were installed at the locations of BH7 and BH6 respectively. PZ1 is fitted with an automatic down-hole data logger taking readings of air and water pressure at half hour intervals and is finished above ground level within a lockable, galvanised steel monument. The groundwater monitoring well PZ2 was installed where heavy machinery is likely to traffic during the operation of the sand mine and is finished 0.3m below ground level with a concrete encased gaiter cover. PZ2 was installed as a precautionary measure; in case of damage to or the vandalisation of PZ1 prior to the completion of the requirement for groundwater monitoring. The location of PZ2 is 25.0m from the closest edge of the electricity transmission pole on an imaginary line extending through the centre of both electricity transmission poles, as shown in **Photograph 17**.

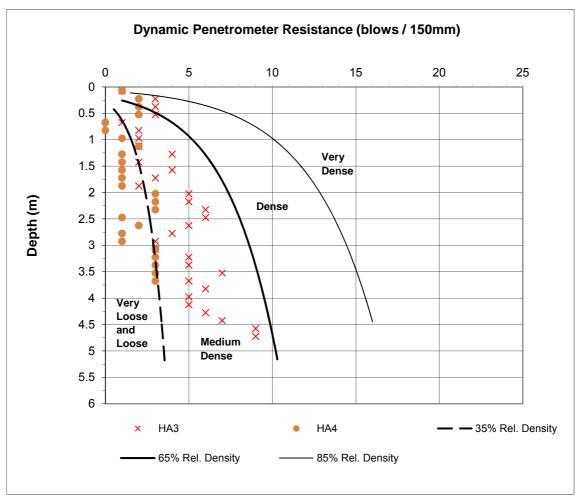
A plot of the dynamic penetration testing from the top of the dune sand at HA3 & HA4 is shown on **Figure 8** together with the interpreted relative density.

Dynamic penetrometer testing indicates that the density of the sand is generally medium dense in HA3 and varies from very loose to loose/medium dense with depth in HA4.

Figure 8 Plot of dynamic penetrometer resistance test carried out from the top of the sand dunes at the location of hand augers HA3 & HA4 (density curves from Ref [5])

The angle of repose of a sand batter is a measure of the shear strength friction angle of the sand in its loose state. With reference to **Figure 8** it may be seen that at least parts of the dune sand are composed of loose sand. Accordingly, it is considered that the angle of repose of the batter provides a good estimate of the shear strength friction angle of the sand.

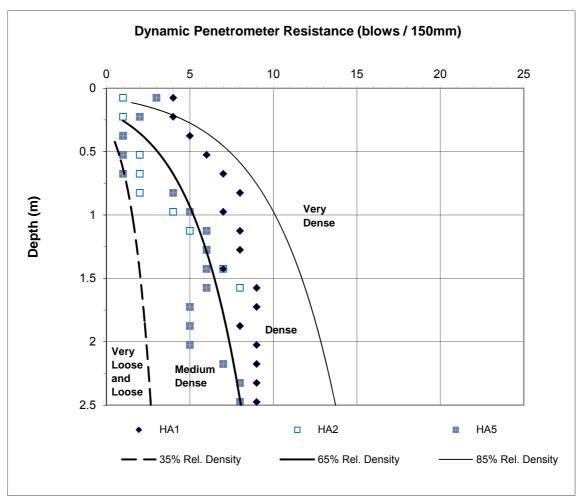
Dynamic penetrometer test results carried out at the location of HA 1, 2 & 5 are plotted on **Figure 9.**

With reference to **Figure 9** the density of the near surface sands is variable but generally medium dense (ie relative density index between 35% to 65%) or better below a depth of 0.7m.

Figure 9Plot of dynamic penetrometer resistance at the location of hand augers
HA1, HA2 & HA5 (density curves from Ref [5])

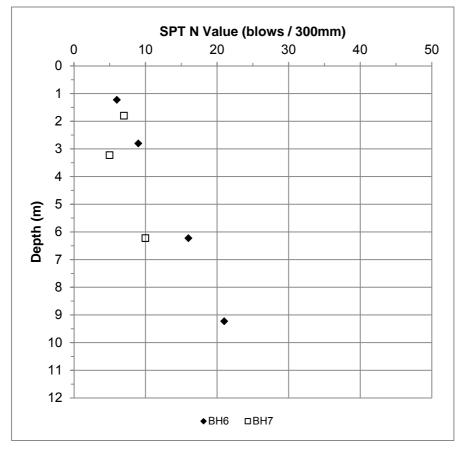
The results of the Standard penetration testing (SPT) in BH6 & 7 are plotted on **Figure 10.** The results indicate that the sands are loose to medium dense in the upper zone and medium dense with depth.

Figure 10 Summary of SPT testing in BH6 and BH7

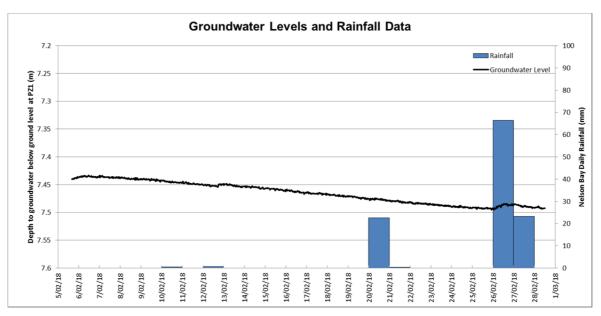
The automatic down-hole data logger installed in BH7/PZ1 commenced taking readings on the 5 February 2018 and the data was downloaded on 28 February 2018 after some rainfall. The water level in PZ1 is recorded in **Figure 11** along with rainfall data from the Nelson Bay (Nelson Head) weather station approximately 12km away.

Figure 11 Continuous groundwater measurements throughout February 2018.

The depth to groundwater has steadily decreased by a total of approximately 50mm across the 23 days recorded. After significant rainfall on 26 February the groundwater level rose by 10mm however returned the next day to the downward trend.

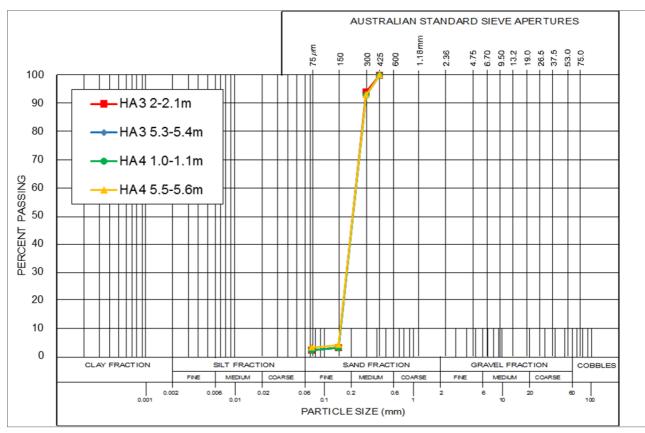
Laboratory testing results are attached in **Appendix C** and are plotted and summarised in **Figure 12** and **Table 3** respectively.

Figure 12 Particle Size Distribution Test Results

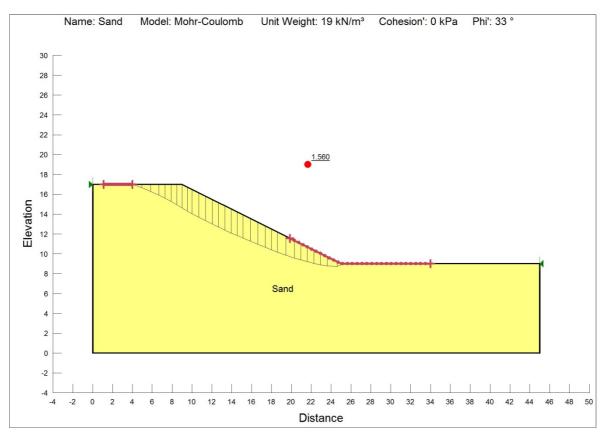
The factor of safety against mass rotational slumping of a 2H:1V batter slope extending behind the batter crest has been analyzed using commercially available stability program SlopeW and the parameters discussed in Section 5.4.1. The result is shown on **Figure 13**.

Figure 13 Plot of Factor of safety against mass rotational slumping of 2H:1V batter slope

The factor of safety against mass rotational slumping of a 2H:1V batter slope is in excess of 1.5 and this is considered acceptable for the proposed situation.

In regard to geotechnical stability of batter associated with the sand mine, it is suggested that when the mine is not actively loading out that batters be limited to a maximum of 1.5H:1V and for long term stability against mass failure that the slopes be battered at a maximum 2H:1V.

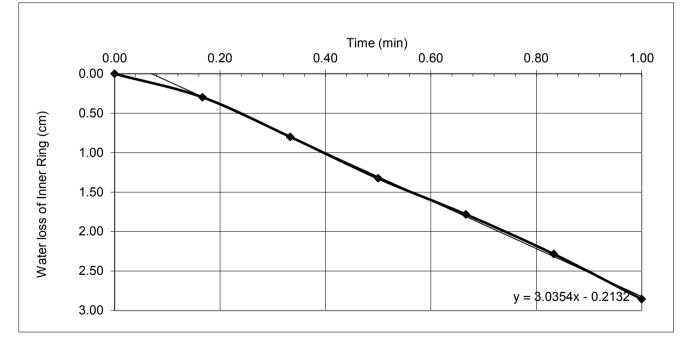
TEST METHOD: Constant Head		RESULTS			
		Time	Elapsed	Water level	Water loss
BORE DETAILS			time (min)	in Mariotte	from inner
Test No:	INF1a			tube (cm)	ring (cm)
Depth:	10 cm	4:35:00 PM	0.00	143.0	0.00
Depth of water in rings:	20 cm	4:35:10 PM	0.17	130.0	0.30
Internal diameter of inner ring:	24 cm	4:35:20 PM	0.33	108.0	0.80
Internal diameter of outer ring:	38.5 cm	4:35:30 PM	0.50	85.0	1.33
Area of inner ring:	452 cm ²	4:35:40 PM	0.67	65.0	1.78
Area of annular space between rings:	712 cm ²	4:35:50 PM	0.83	43.0	2.28
Internal diameter of Mariotte tube:	3.75 cm	4:36:00 PM	1.00	18.0	2.86
External diameter of air inlet tube:	0.95 cm				
Area of water in Mariotte tube:	10.3 cm ²				
Soil Moisture at Time of Test:	Wet				
Son moisture at time of test.	WEL				
			1		1
			1		1

3.04E+00 cm / min 5.1E-04 m / sec

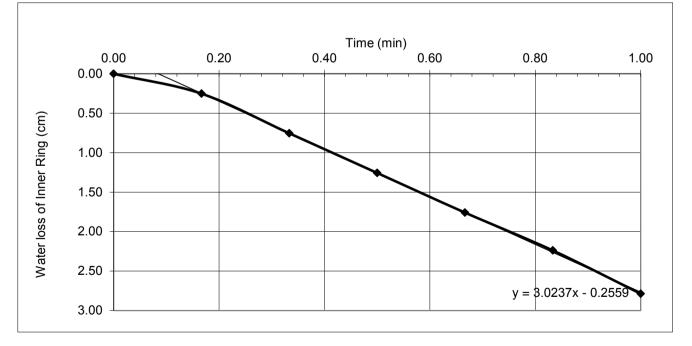
TEST METHOD: Constant Head		RESULTS			
		Time	Elapsed	Water level	Water loss
BORE DETAILS			time (min)	in Mariotte	from inner
Test No:	INF1b			tube (cm)	ring (cm)
Depth:	10 cm	4:48:00 PM	0.00	124.0	0.00
Depth of water in rings:	20 cm	4:48:10 PM	0.17	113.0	0.25
Internal diameter of inner ring:	24 cm	4:48:20 PM	0.33	91.0	0.75
Internal diameter of outer ring:	38.5 cm	4:48:30 PM	0.50	69.0	1.26
Area of inner ring:	452 cm ²	4:48:40 PM	0.67	47.0	1.76
Area of annular space between rings:	712 cm ²	4:48:50 PM	0.83	26.0	2.24
Internal diameter of Mariotte tube:	3.75 cm	4:49:00 PM	1.00	2.0	2.79
External diameter of air inlet tube:	0.95 cm				
Area of water in Mariotte tube:	10.3 cm ²				
Soil Moisture at Time of Test:	Wet				
			1		1

3.02E+00 cm / min 5.0E-04 m / sec

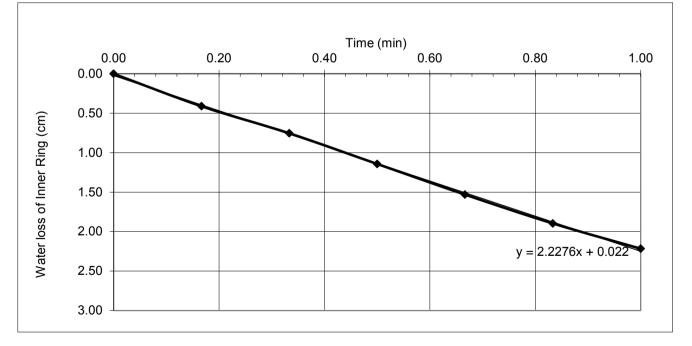
TEST METHOD: Constant Head		RESULTS			
		Time	Elapsed	Water level	Water loss
BORE DETAILS			time (min)	in Mariotte	from inner
Test No:	INF2a			tube (cm)	ring (cm)
Depth:	10 cm	5:27:00 PM	0.00	124.0	0.00
Depth of water in rings:	25 cm	5:27:10 PM	0.17	106.0	0.41
Internal diameter of inner ring:	24 cm	5:27:20 PM	0.33	91.0	0.75
Internal diameter of outer ring:	38.5 cm	5:27:30 PM	0.50	74.0	1.14
Area of inner ring:	452 cm ²	5:27:40 PM	0.67	57.0	1.53
Area of annular space between rings:	712 cm ²	5:27:50 PM	0.83	41.0	1.90
Internal diameter of Mariotte tube:	3.75 cm	5:28:00 PM	1.00	27.0	2.22
External diameter of air inlet tube:	0.95 cm				
Area of water in Mariotte tube:	10.3 cm ²				
Soil Moisture at Time of Test:	Wet

2.22E+00 cm / min 3.7E-04 m / sec

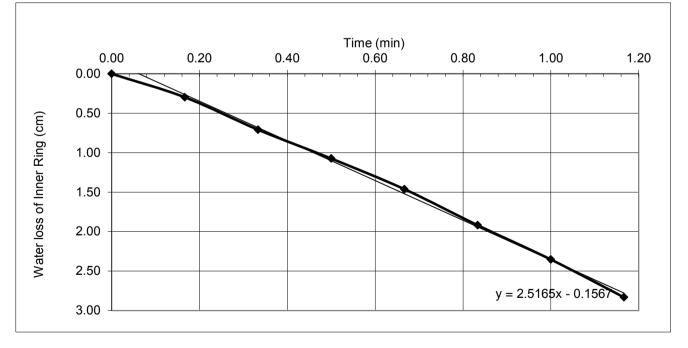
TEST METHOD: Constant Head		RESULTS			
		Time	Elapsed	Water level	Water loss
BORE DETAILS			time (min)	in Mariotte	from inner
Test No:	INF2b			tube (cm)	ring (cm)
Depth:	10 cm	5:35:00 PM	0.00	133.0	0.00
Depth of water in rings:	25 cm	5:35:10 PM	0.17	120.0	0.30
Internal diameter of inner ring:	24 cm	5:35:20 PM	0.33	102.0	0.71
Internal diameter of outer ring:	38.5 cm	5:35:30 PM	0.50	86.0	1.07
Area of inner ring:	452 cm ²	5:35:40 PM	0.67	69.0	1.46
Area of annular space between rings:	712 cm ²	5:35:50 PM	0.83	49.0	1.92
Internal diameter of Mariotte tube:	3.75 cm	5:36:00 PM	1.00	30.0	2.35
External diameter of air inlet tube:	0.95 cm	5:36:10 PM	1.17	9.0	2.83
Area of water in Mariotte tube:	10.3 cm ²				
Soil Moisture at Time of Test:	Wet

2.51E+00 cm / min 4.2E-04 m / sec

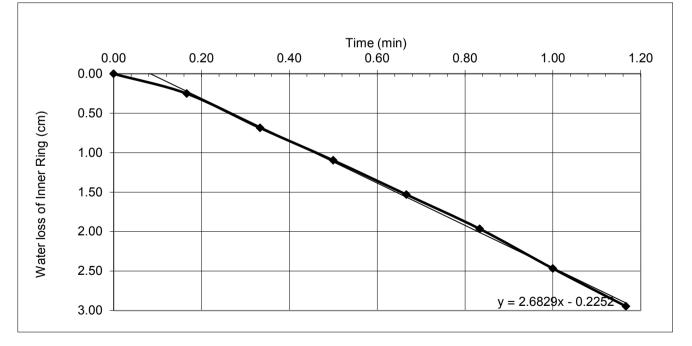
TEST METHOD: Constant Head		RESULTS			
		Time	Elapsed	Water level	Water loss
BORE DETAILS			time (min)	in Mariotte	from inner
Test No:	INF3a			tube (cm)	ring (cm)
Depth:	10 cm	5:58:00 PM	0.00	138.0	0.00
Depth of water in rings:	20 cm	5:58:10 PM	0.17	127.0	0.25
Internal diameter of inner ring:	24 cm	5:58:20 PM	0.33	108.0	0.69
Internal diameter of outer ring:	38.5 cm	5:58:30 PM	0.50	90.0	1.10
Area of inner ring:	452 cm ²	5:58:40 PM	0.67	71.0	1.53
Area of annular space between rings:	712 cm ²	5:58:50 PM	0.83	52.0	1.96
Internal diameter of Mariotte tube:	3.75 cm	5:59:00 PM	1.00	30.0	2.47
External diameter of air inlet tube:	0.95 cm	5:59:10 PM	1.17	9.0	2.95
Area of water in Mariotte tube:	10.3 cm ²				
Soil Moisture at Time of Test:	Wet

2.68E+00 cm / min 4.5E-04 m / sec

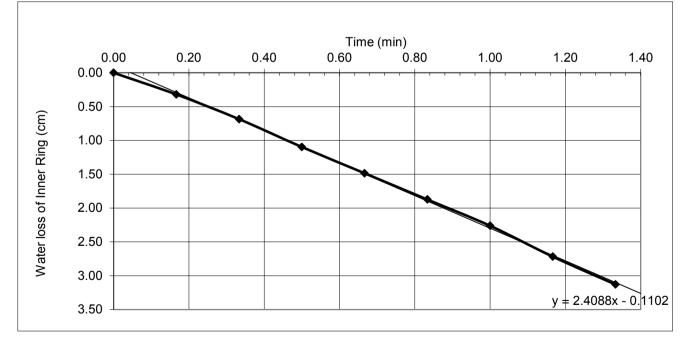
TEST METHOD: Constant Head		RESULTS			
		Time	Elapsed	Water level	Water loss
BORE DETAILS			time (min)	in Mariotte	from inner
Test No:	INF3b			tube (cm)	ring (cm)
Depth:	10 cm	6:05:00 PM	0.00	137.0	0.00
Depth of water in rings:	20 cm	6:05:10 PM	0.17	123.0	0.32
Internal diameter of inner ring:	24 cm	6:05:20 PM	0.33	107.0	0.69
Internal diameter of outer ring:	38.5 cm	6:05:30 PM	0.50	89.0	1.10
Area of inner ring:	452 cm ²	6:05:40 PM	0.67	72.0	1.49
Area of annular space between rings:	712 cm ²	6:05:50 PM	0.83	55.0	1.87
Internal diameter of Mariotte tube:	3.75 cm	6:06:00 PM	1.00	38.0	2.26
External diameter of air inlet tube:	0.95 cm	6:06:10 PM	1.17	18.0	2.72
Area of water in Mariotte tube:	10.3 cm ²	6:06:20 PM	1.33	0.0	3.13
Soil Moisture at Time of Test:	Wet

2.41E+00 cm / min 4.0E-04 m / sec

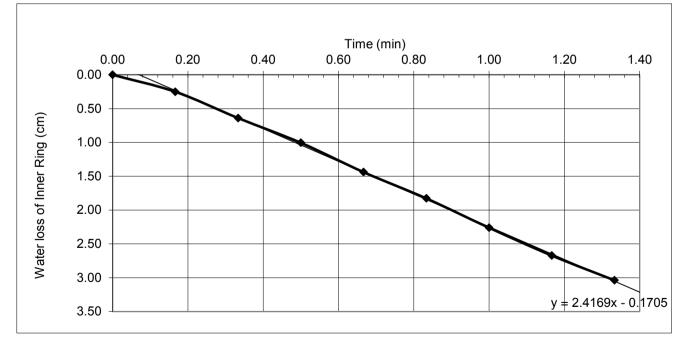
TEST METHOD: Constant Head		RESULTS			
		Time	Elapsed	Water level	Water loss
BORE DETAILS			time (min)	in Mariotte	from inner
Test No:	INF4a			tube (cm)	ring (cm)
Depth:	10 cm	5:35:00 PM	0.00	143.0	0.00
Depth of water in rings:	30 cm	5:35:10 PM	0.17	132.0	0.25
Internal diameter of inner ring:	24 cm	5:35:20 PM	0.33	115.0	0.64
Internal diameter of outer ring:	38.5 cm	5:35:30 PM	0.50	99.0	1.01
Area of inner ring:	452 cm ²	5:35:40 PM	0.67	80.0	1.44
Area of annular space between rings:	712 cm ²	5:35:50 PM	0.83	63.0	1.83
Internal diameter of Mariotte tube:	3.75 cm	5:36:00 PM	1.00	44.0	2.26
External diameter of air inlet tube:	0.95 cm	5:36:10 PM	1.17	26.0	2.67
Area of water in Mariotte tube:	10.3 cm ²	5:36:20 PM	1.33	10.0	3.04
Soil Moisture at Time of Test:	Wet

2.42E+00 cm / min 4.0E-04 m / sec

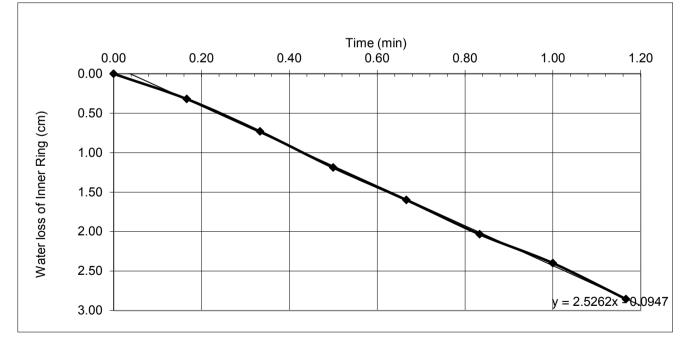
TEST METHOD: Constant Head		RESULTS			
		Time	Elapsed	Water level	Water loss
BORE DETAILS			time (min)	in Mariotte	from inner
Test No:	INF4b			tube (cm)	ring (cm)
Depth:	10 cm	5:45:00 PM	0.00	140.0	0.00
Depth of water in rings:	35 cm	5:45:10 PM	0.17	126.0	0.32
Internal diameter of inner ring:	24 cm	5:45:20 PM	0.33	108.0	0.73
Internal diameter of outer ring:	38.5 cm	5:45:30 PM	0.50	88.0	1.19
Area of inner ring:	452 cm ²	5:45:40 PM	0.67	70.0	1.60
Area of annular space between rings:	712 cm ²	5:45:50 PM	0.83	51.0	2.03
Internal diameter of Mariotte tube:	3.75 cm	5:46:00 PM	1.00	35.0	2.40
External diameter of air inlet tube:	0.95 cm	5:46:10 PM	1.17	15.0	2.86
Area of water in Mariotte tube:	10.3 cm ²				
Soil Moisture at Time of Test:	Wet				
			ļ ļ

2.53E+00 cm / min 4.2E-04 m / sec
