Proposed Redevelopment
of St Michaels School
Additional Geotechnical
Assessment

12 Sproule Street,
Nelson Bay NSW

NEW19P-0150-AE
24 June 2020

**RE: PROPOSED REDEVELOPMENT OF ST MICHAELS SCHOOL
12 SPROULE STREET, NELSON BAY
ADDITIONAL GEOTECHNICAL ASSESSMENT**

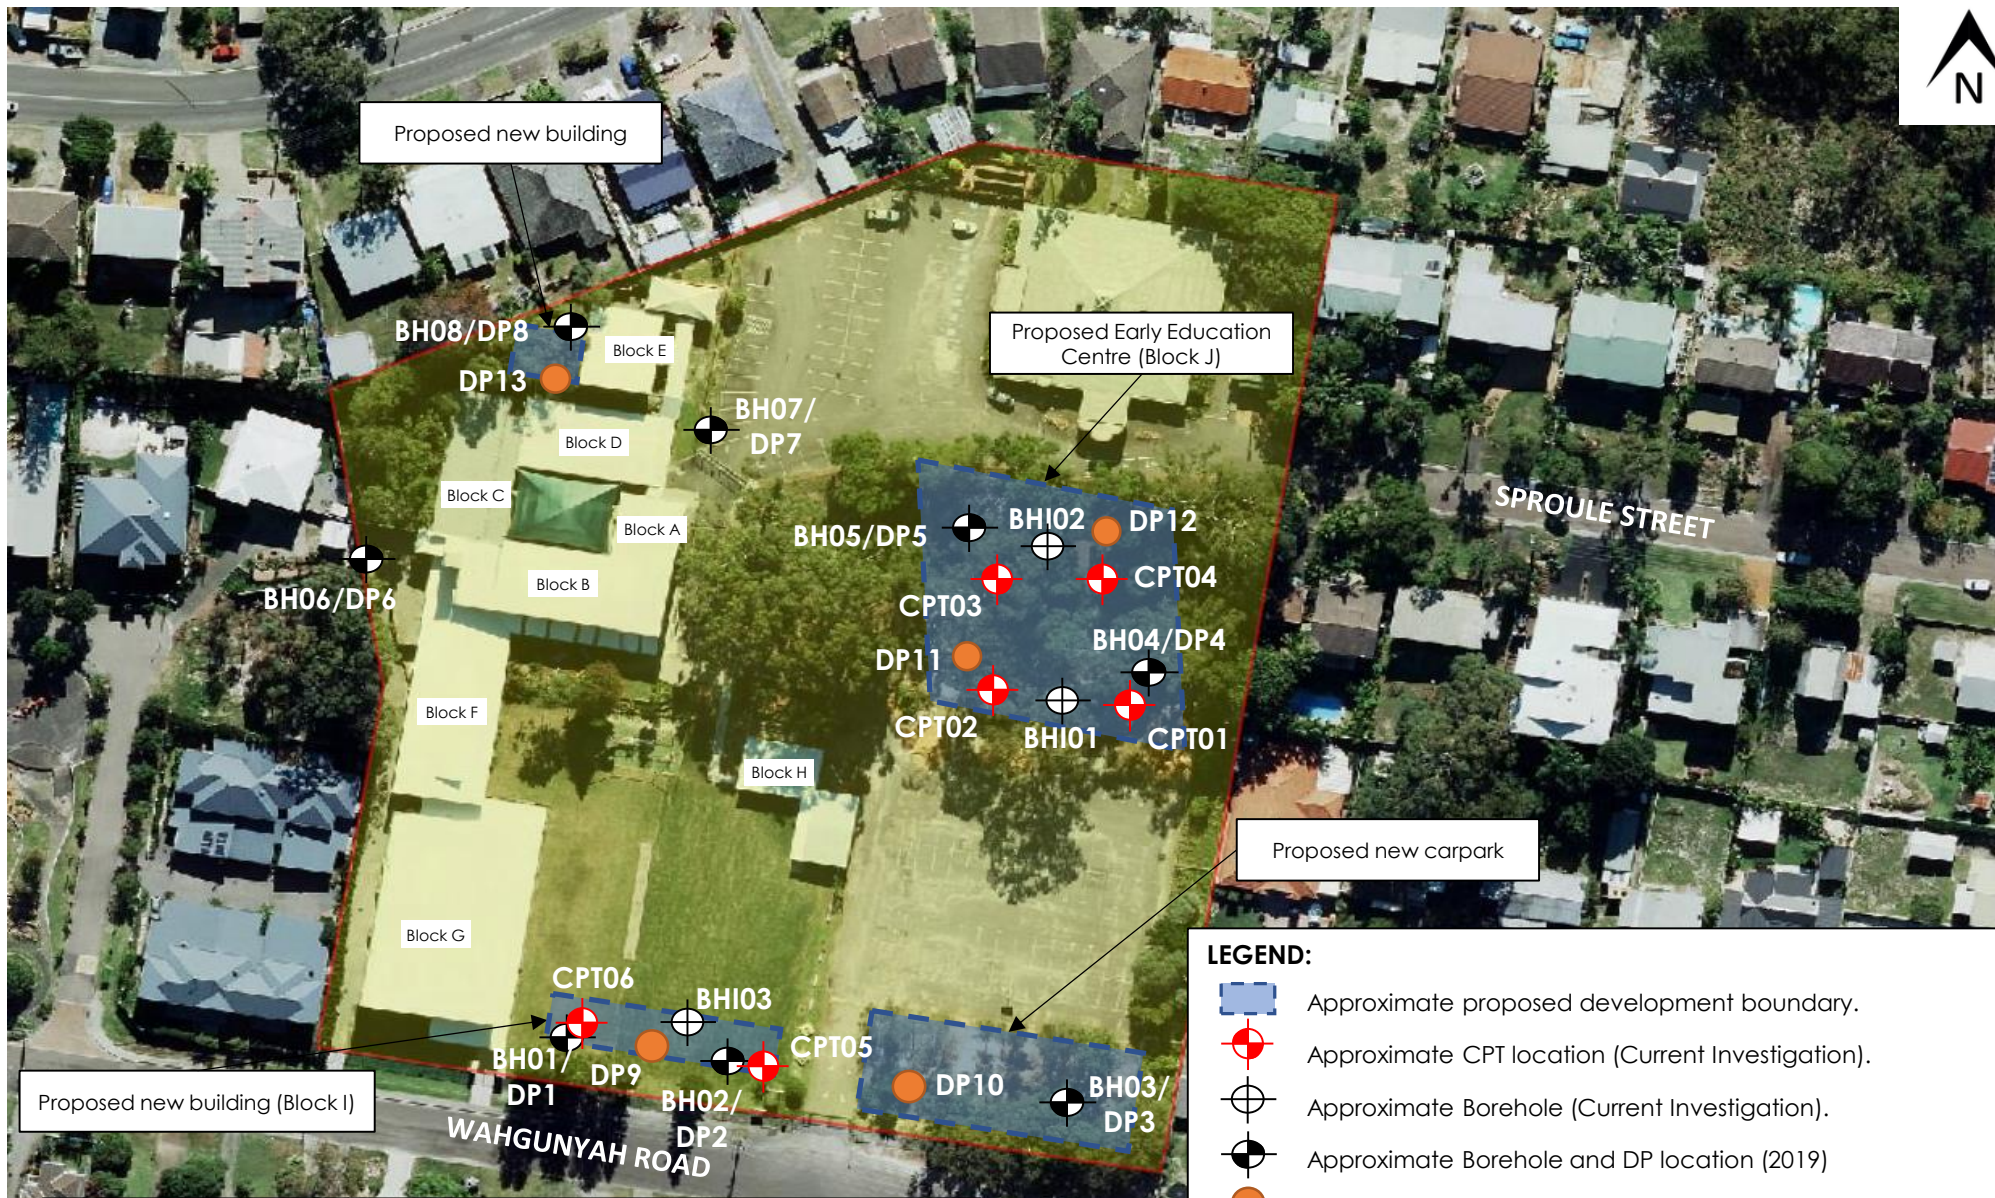
FIGURE AE1:

Approximate CPT and borehole locations are shown on the attached Figure AE1 together with locations of previous testing by Qualtest. CPT results and engineering logs of boreholes are presented in Appendix A.

Site Plan and Approximate Test Locations

The subject site comprises the proposed development areas shown on Figure AE1 within Lot 2 DP 216064, known as 12 Sproule Street, Nelson Bay. The lot is an irregular but roughly trapezoidal shaped lot with a total area of approximately 2.1ha. The lot is bounded by residential lots to the east, north and west, and by Wahgunyah Road to the south. The lot is accessed by Wahgunyah Road, and from the western end of Sproule Street.
