Acid Sulfate Soils Assessment

Proposed Manufactured Home Estate

40-80 Chapmans Road, Tuncurry

Report No. RGS03137.1-AB

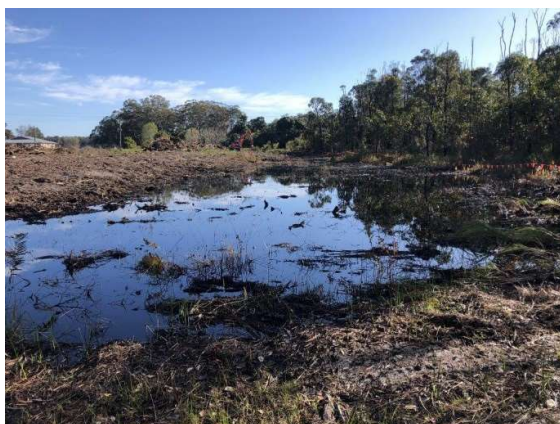
Looking north across the eastern part of the site which had been recently cleared. Surface water was ponding in this area.

The eastern part of the site had recently been cleared of a thick stand of vegetation at the time of the field work. Some surface water was ponding in this area at the time of the field investigations.

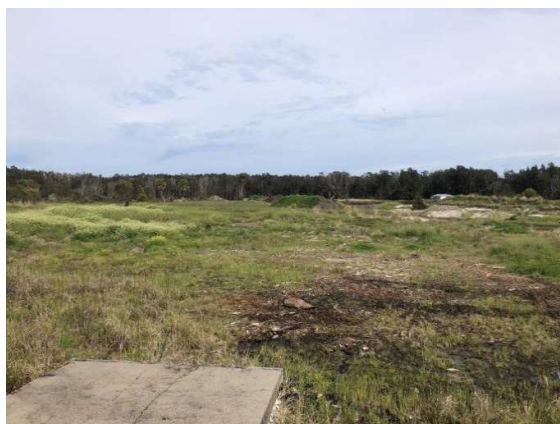
Looking across the central part of the site showing the various stockpiles of dredged sand.

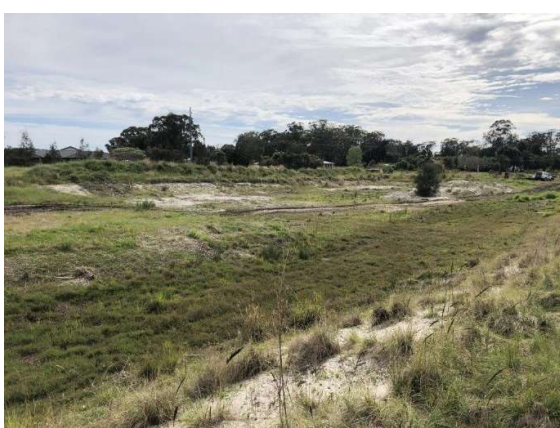
Looking north-east from the southern part of the site. Stockpiles of dredged sand were up to 2m in height.

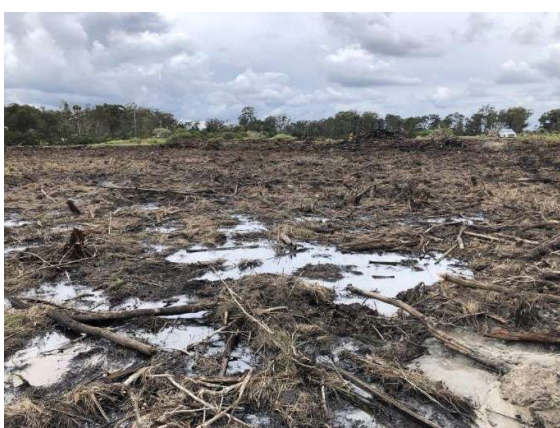
Looking east across the western part of the site which had been recently cleared. Surface water was ponding in this area.

Similarly, clearing had recently been undertaken and mulching works were in progress at the western end of the site at the time of the field investigations. This area was previously inaccessible due to the presence of the steep fill batter grading down to the low-lying swampy natural ground level which was heavily vegetated. Surface water was ponding in this area also. Slopes to the west were 8° to 10° at the southern end of the fill batter, 6° to 8° and 4° to 6° along the central and northern parts of the fill batter respectively.

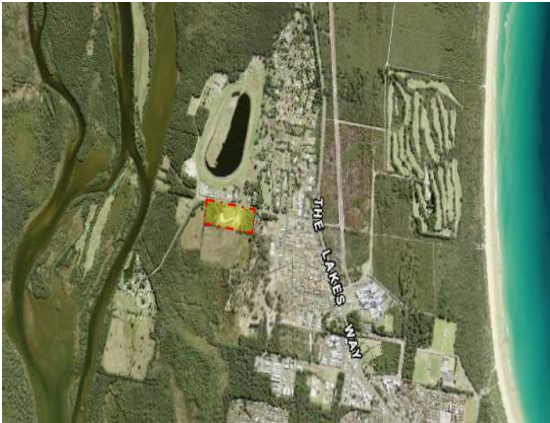
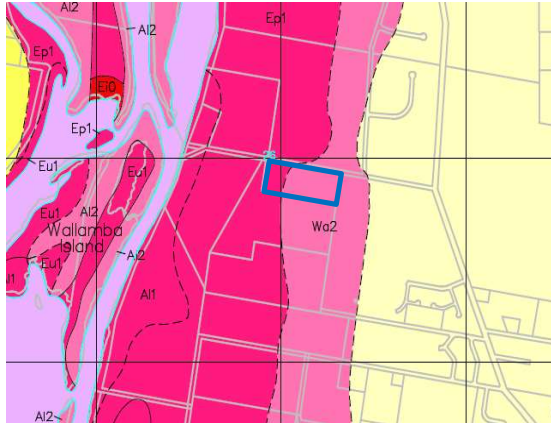
<p><i>Approximate location of site shown in red as indicated by Google Earth image.</i></p>	<p><i>Extract from the Coolongolook 1:25,000 ASS Risk Map indicates the site to be within an area with a high probability of ASS within 1m to 3m below natural ground.</i></p>

Reference to the Coolongolook 1:25,000 Acid Sulfate Soil Risk Map indicates that the low-lying swampy western part of the site is situated in an area with a high probability of ASS within 1m of the ground surface. The map indicates the central and eastern parts of the site to also be within an area with a high probability of ASS between 1m and 3m below the ground surface.
