Report on
Groundwater Study

Proposed Manufactured Housing Estate
40-80 Chapmans Road, Tuncurry

Project 219536.00
July 2023

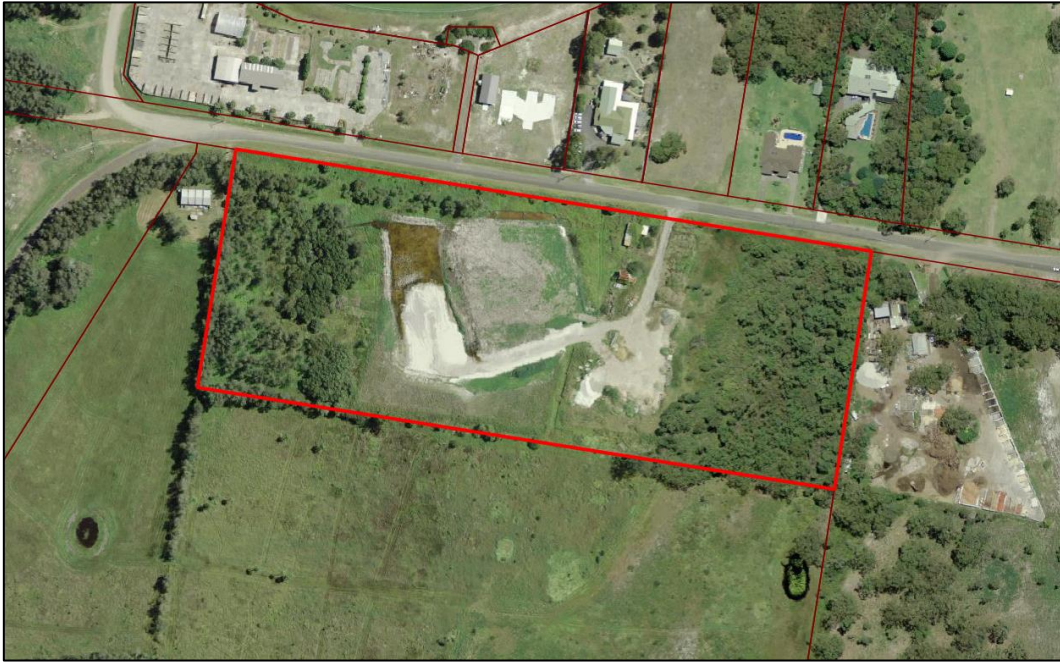
Figure 3: The 'site' shown in red (base map from Sixmaps)

Site location is shown in Figure 3 with general site condition shown in Figure 4.

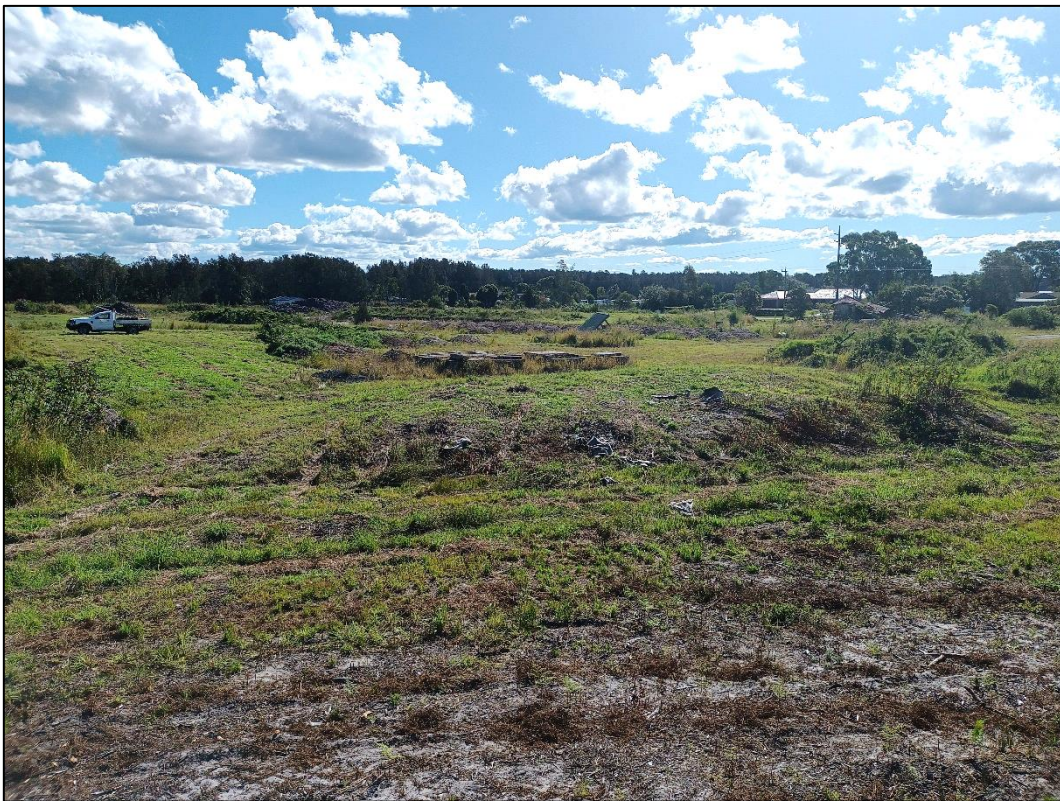
Figure 4: Typical site condition, south-eastern corner of the site looking north-west

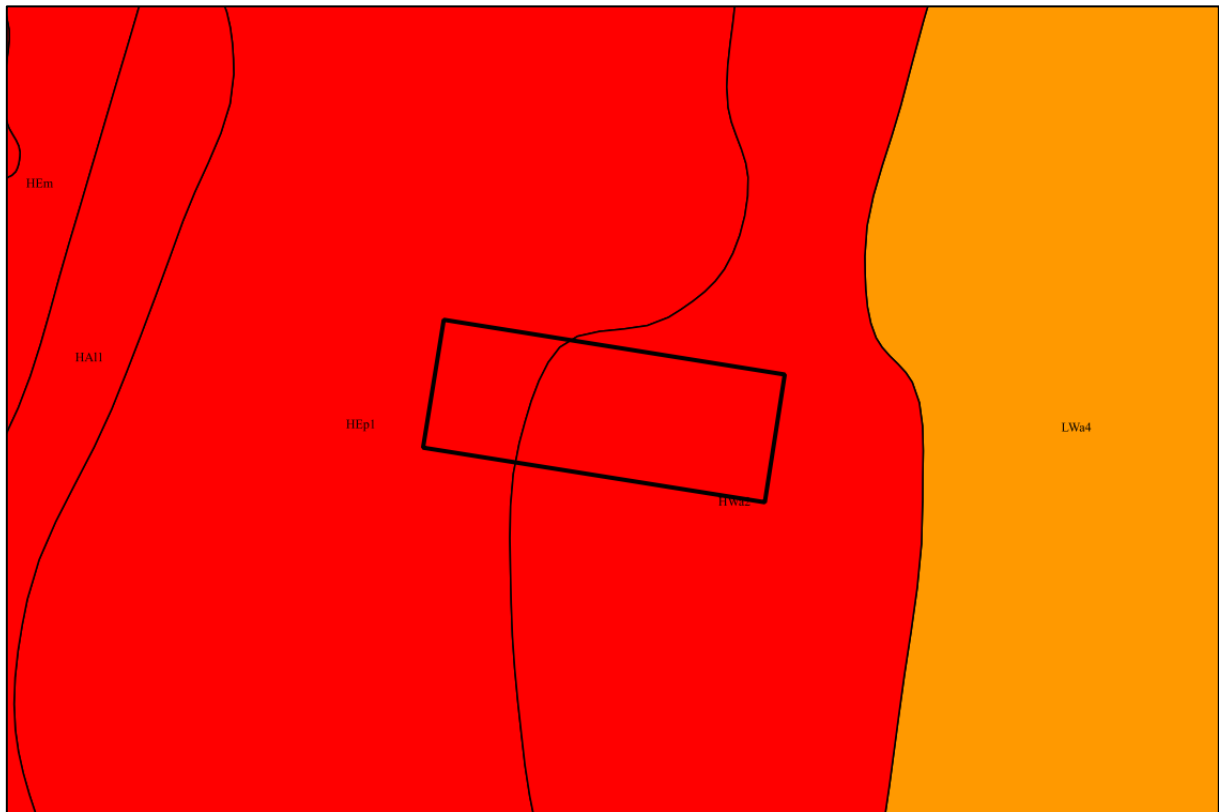
Figure 7: High probability of ASS (in red), low probability of ASS (in orange), site boundary shown in black

Reference to NSW Acid Sulfate Soil Risk map indicates that there is a high probability of acid sulfate soil occurrence between 1 m and 4 m below the ground level at the site (see Figure 7).

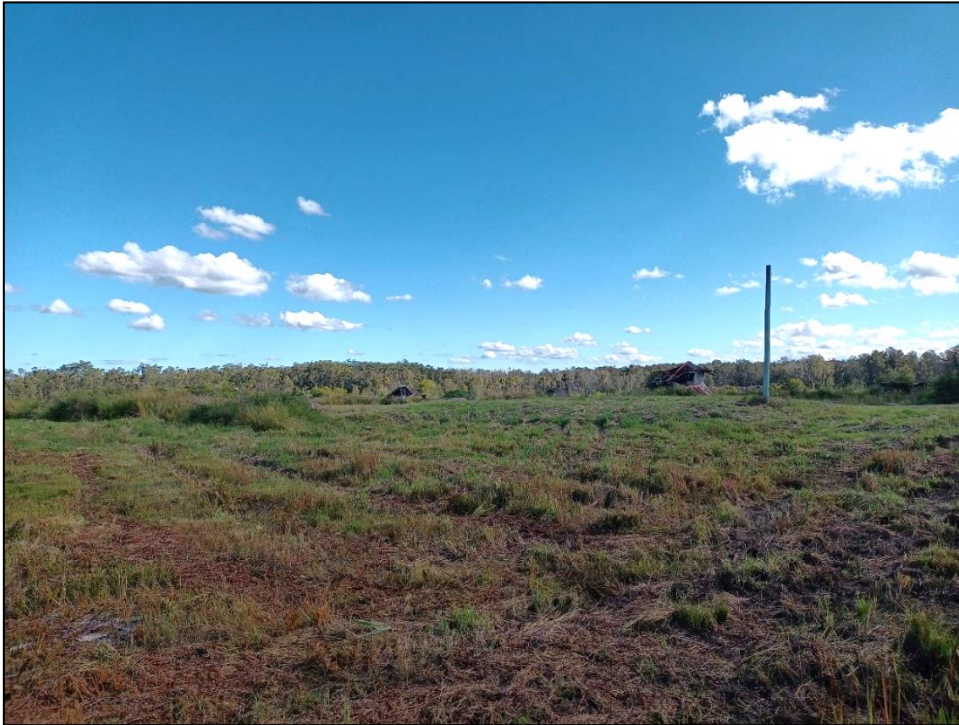
Figure 9: Typical site condition, north-eastern corner of the site, looking south-west.

- The site is a vacant, relatively flat parcel of land with filling of approximately 1 m in the central portion of the site (Figure 9);
- Various stockpiles of soils and materials within the central portion of the site (Figure 10 and Figure 11);

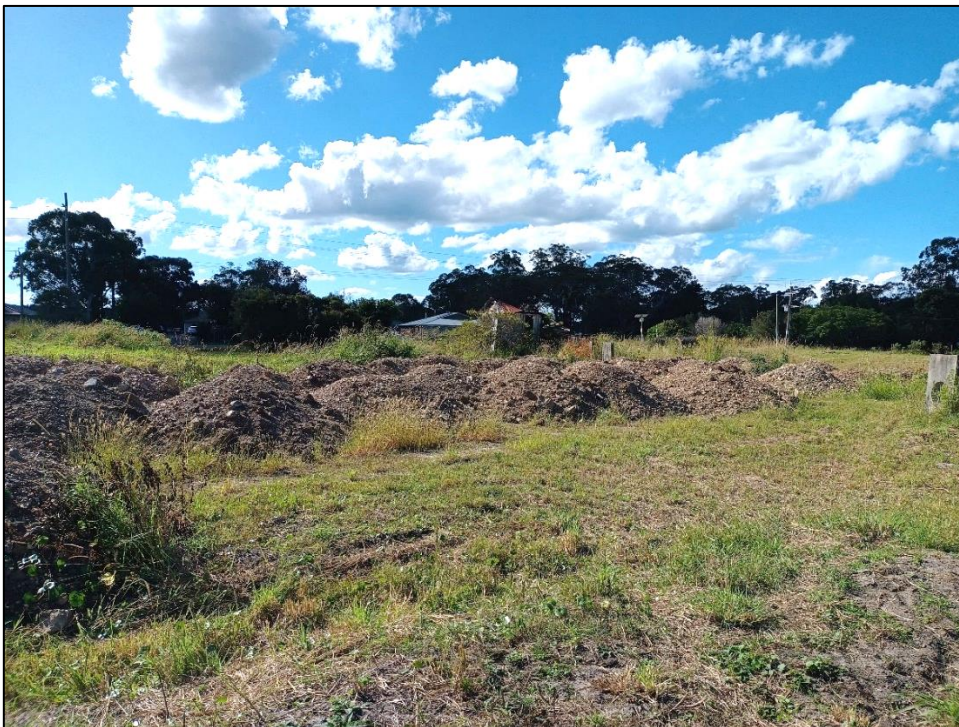
Figure 10: 'End dump' stockpiles, central portion of the site, looking north.

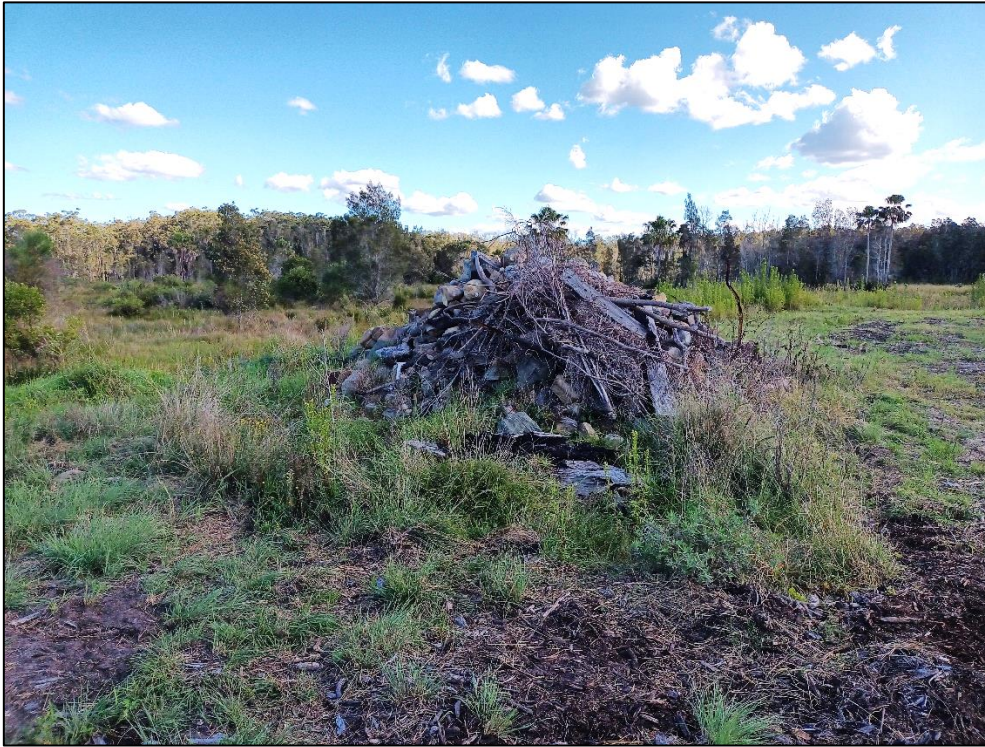
Figure 11: Boulder and wood stockpile, central portion of the site, looking south-west.

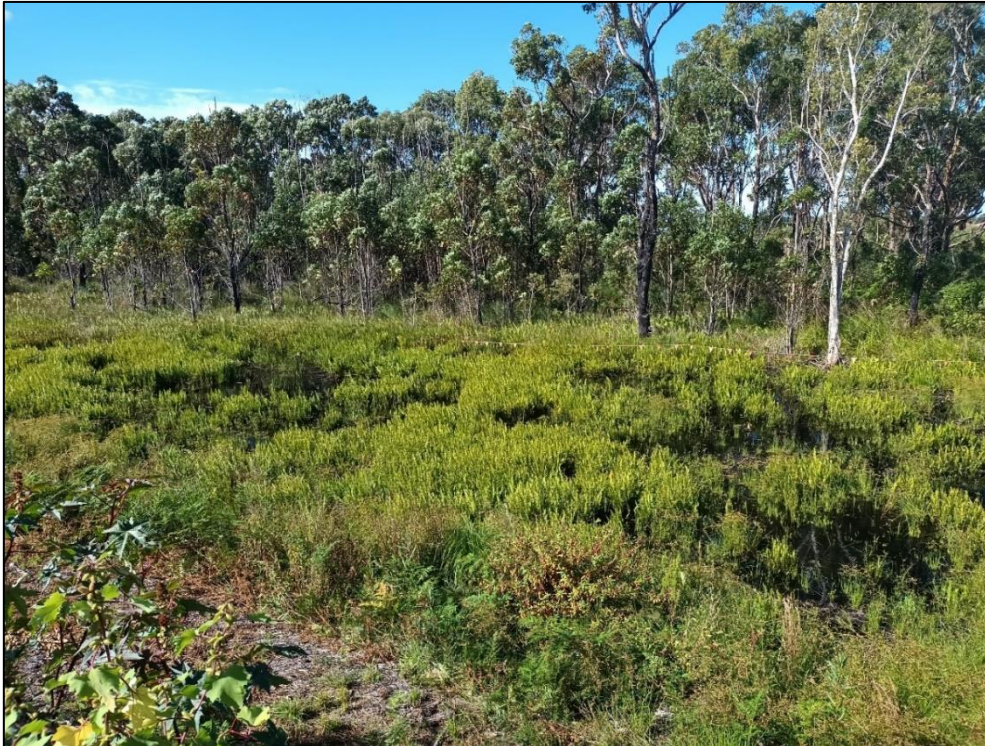
Figure 12: Low-lying area, western portion of the site, looking west.

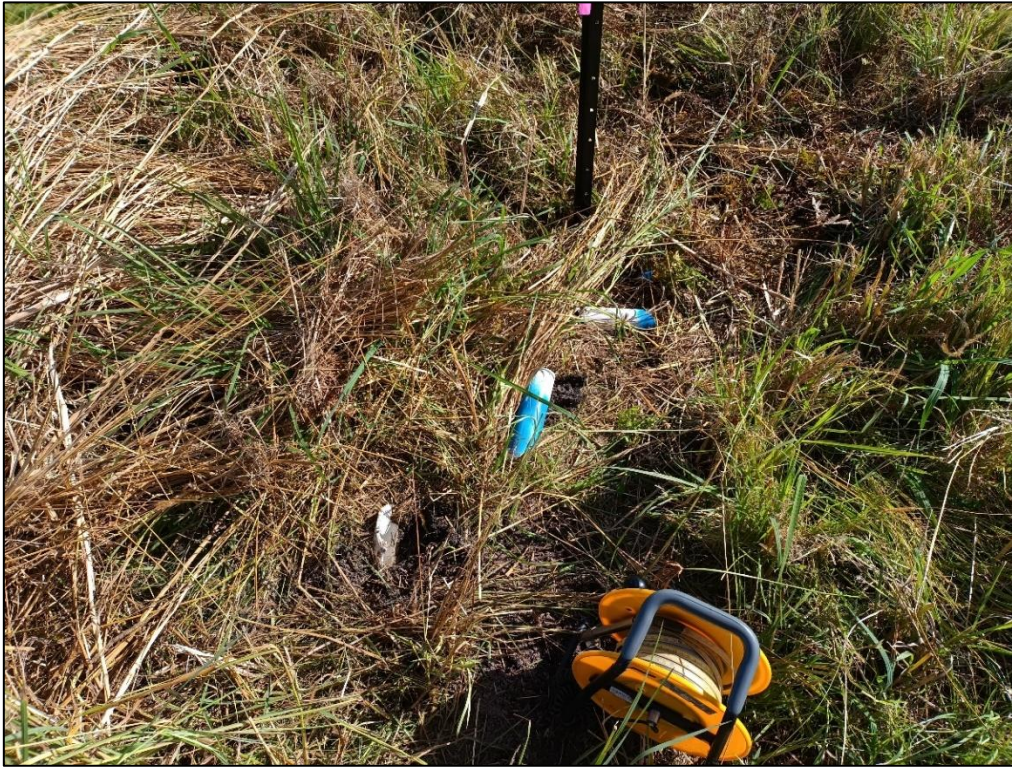
Figure 13: Former MW2 location, southern portion of the site.

- Monitoring well MW2 could not be located during site walkover, however, broken PVC pipe indicative of former monitoring well could be found (Figure 13);

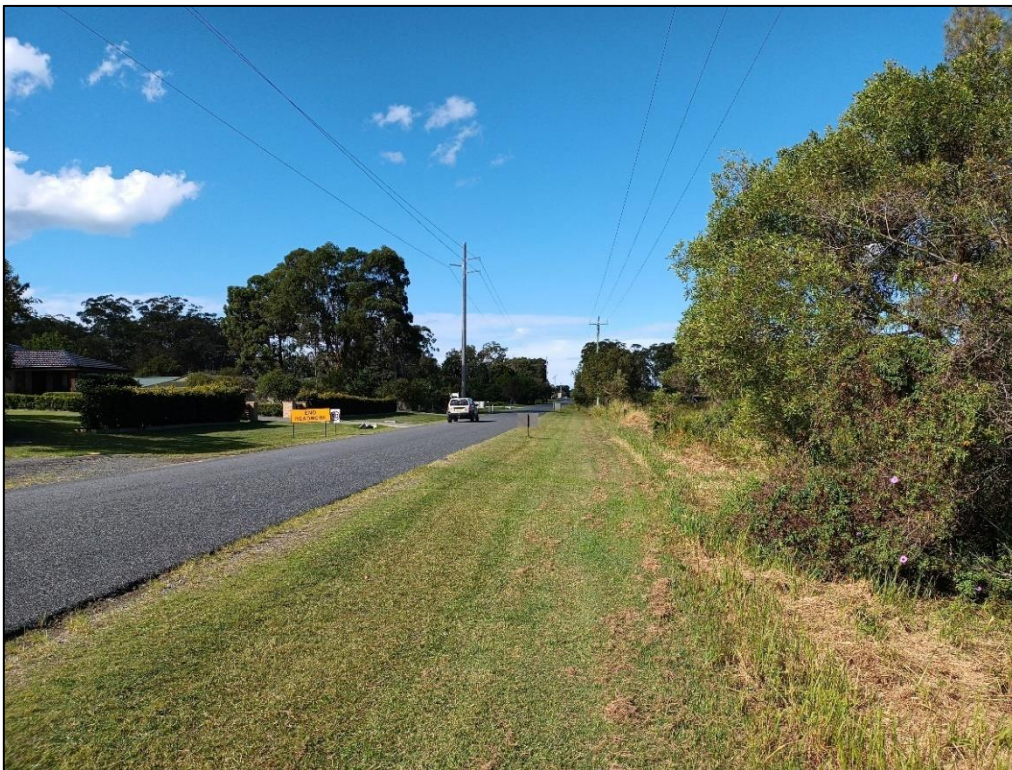
Figure 14: Table drain, north of the site adjacent to Chapmans Road, looking east.

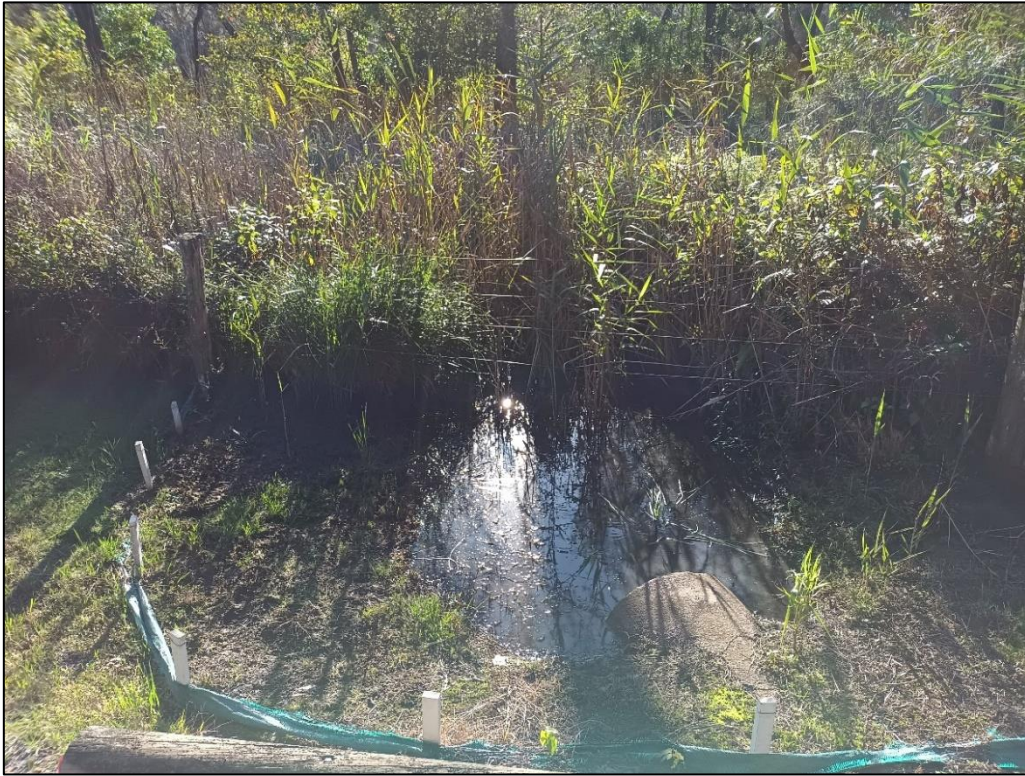
Figure 15: Low-lying area and pipe culvert, north of Chapmans Road, looking north.

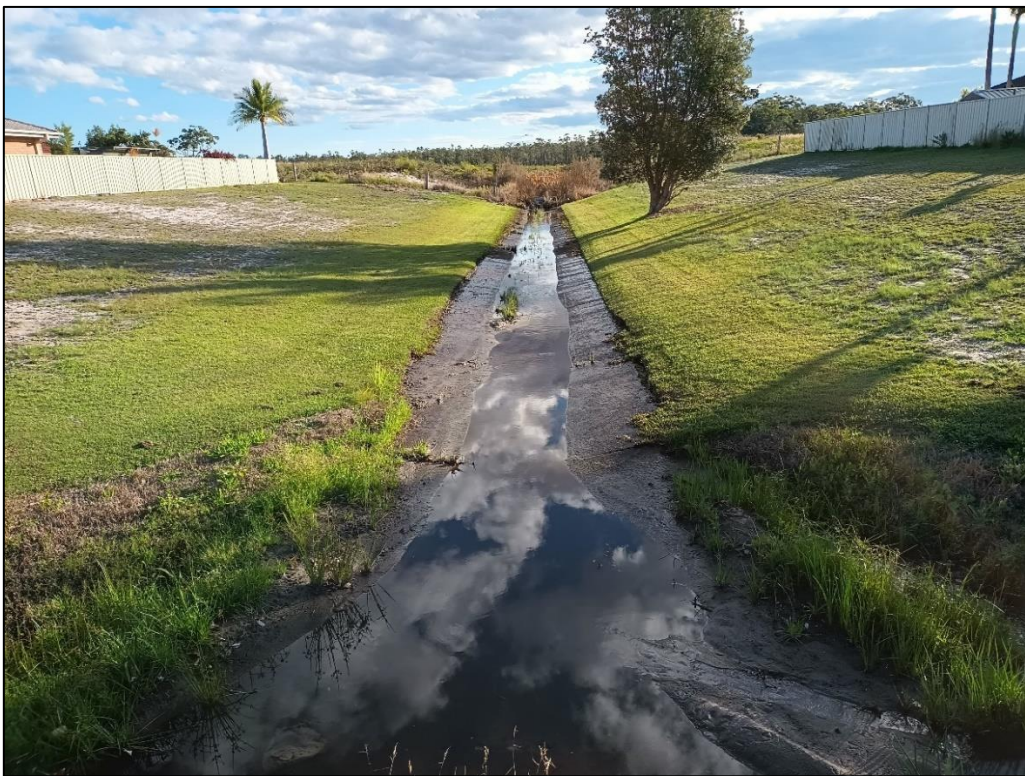
Figure 16: Unnamed water course, adjacent to Grandis Drive foot bridge, looking west.

- Unnamed water course, adjacent to Grandis Drive footbridge (Figure 16). From aerial imagery this water course is presumed to flow from Grandis Drive along open fields/wetland areas and eventually discharges directly into Wallamba River. This water course is assumed to collect stormwater from the nearby residential area.

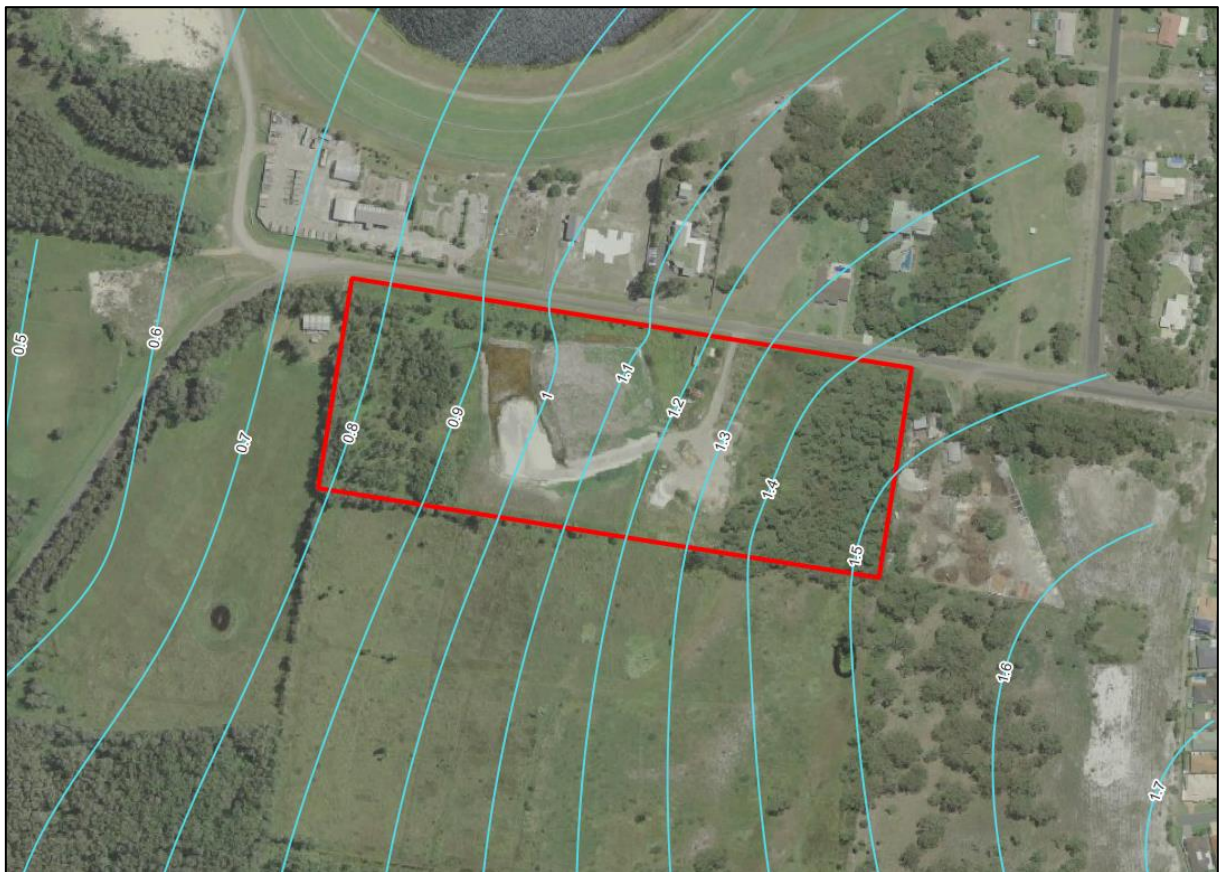
Figure 18: Estimated groundwater contours 1 May 2023 in blue, site boundary shown in red.

Estimated groundwater contours based on groundwater levels measured at MW1, MW3 and MW4 as well as level at surface water screening locations W1 to W13 on 1 May 2023. It is understood that groundwater level within groundwater monitoring wells are representative of level in the unconfined aquifer and therefore are connected to surface water features. These contours are shown in Figure 18.

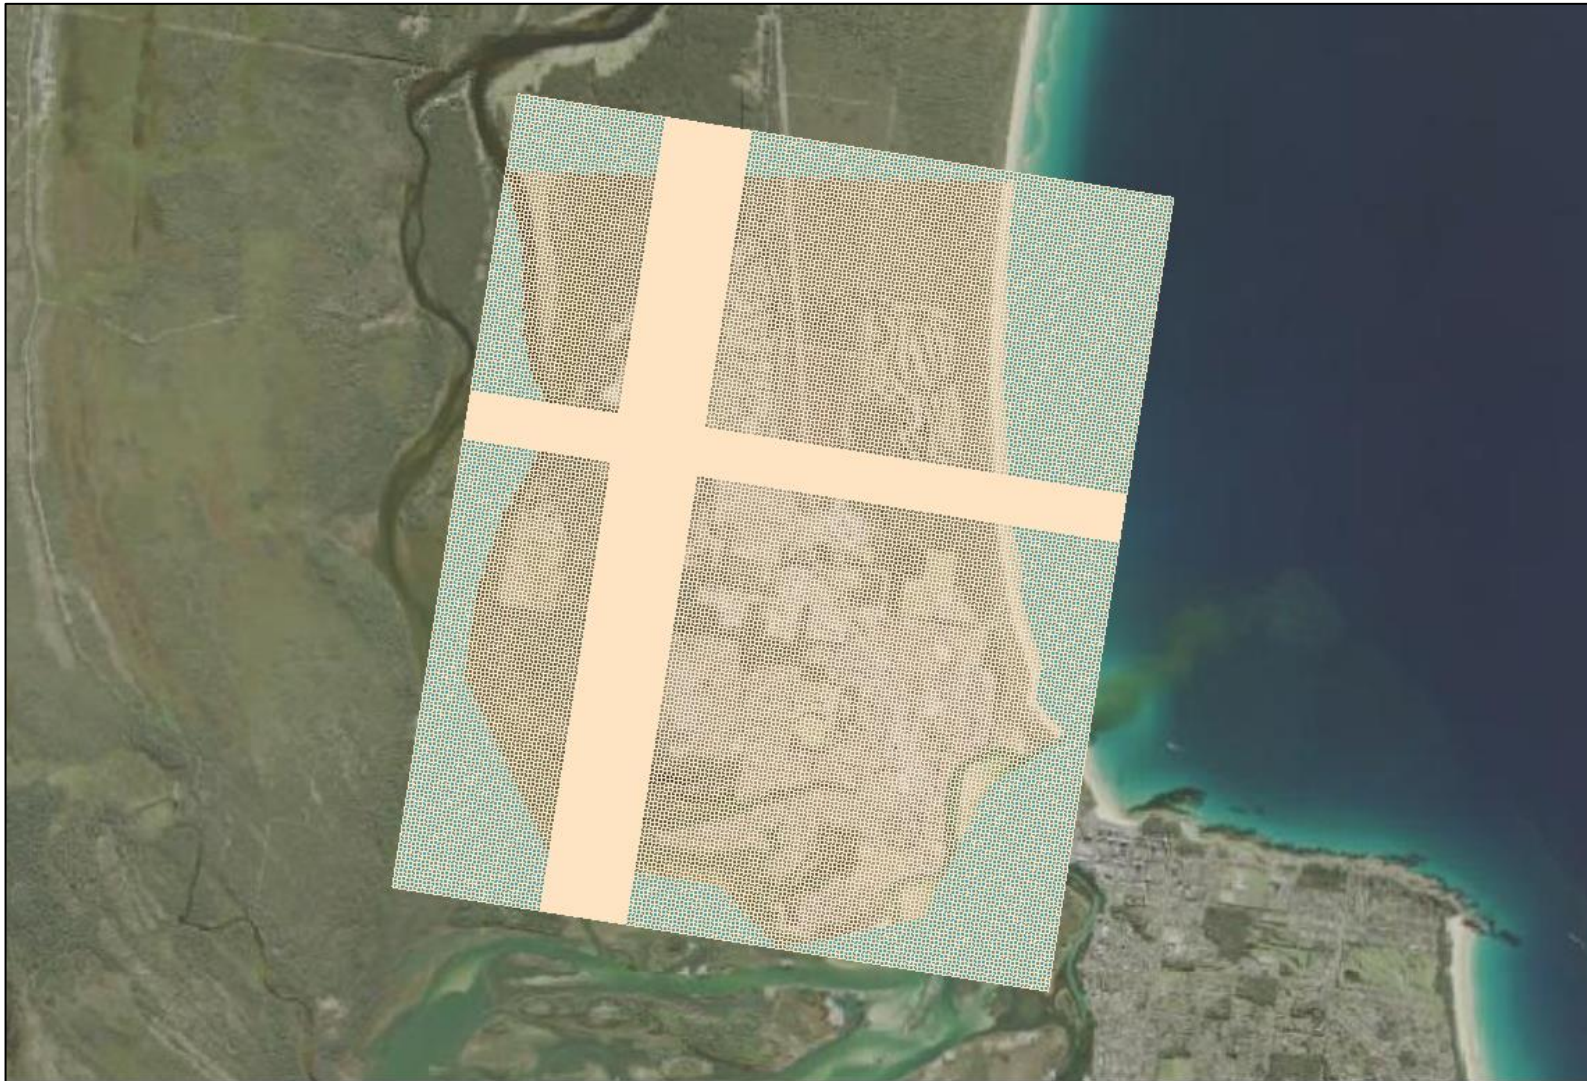
Figure 22: Model grid, site shown in yellow.

The overall size of the model was 4000 m from the east to west and 4900 m from the north to south, discretised using a non-uniform grid (focused on the site becoming coarser with distance from the site) of 151 columns and 177 rows, with a minimum cell size of 5 m by 5 m. The size of the grid was selected to allow reasonable representation of the site, site specific features and proposed features (stormwater drains and proposed development). The model grid is shown below in Figure 22 and Figure 23.

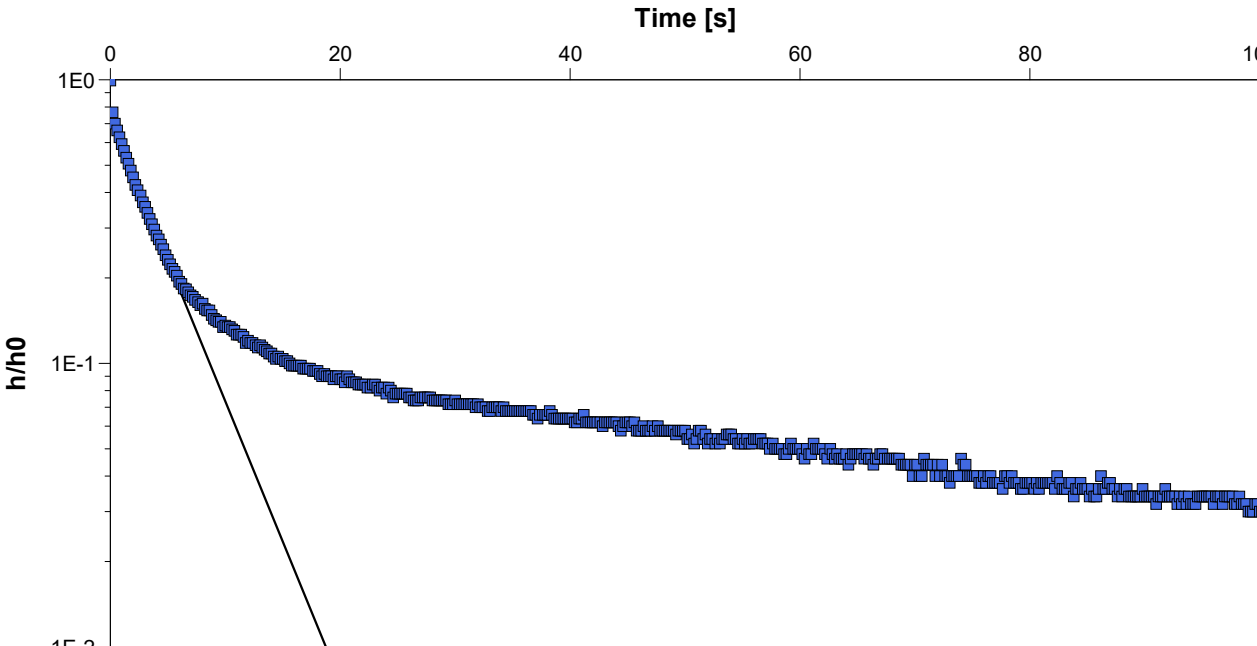
Douglas Partners <i>Geotechnics Environment Groundwater</i></div>		Slug Test Analysis Report	
		Project: Proposed Manufactured Housing Estate	
		Number: 219536.00	
		Client: Allam Property Group	
Location: 40-80 Chapmans Road, TUNCURRY		Slug Test: MW1-1	Test Well: MW1
Test Conducted by: JCL		Test Date: 2/05/2023	
Analysis Performed by: JCL		MW1-1	Analysis Date: 11/05/2023
Aquifer Thickness:			
<div><p>Time [s]</p>

</div>			
Calculation using Hvorslev			
Observation Well	Hydraulic Conductivity [m/s]		
MW1	2.40×10^{-4}

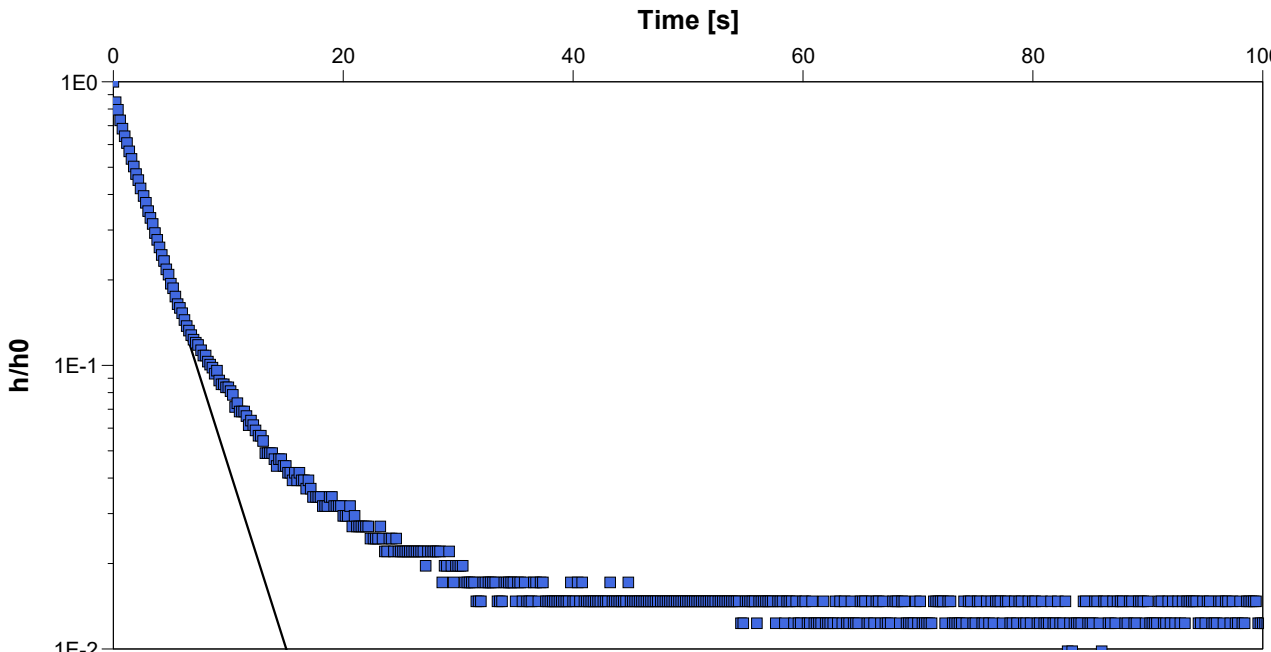
<div> Douglas Partners Geotechnics Environment Groundwater </div> </div>		Slug Test Analysis Report	
		Project: Proposed Manufactured Housing Estate	
		Number: 219536.00	
		Client: Allam Property Group	
Location: 40-80 Chapmans Road, TUNCURRY		Slug Test: MW1-3	Test Well: MW1
Test Conducted by: JCL		Test Date: 2/05/2023	
Analysis Performed by: JCL		MW1-3	Analysis Date: 11/05/2023
Aquifer Thickness:			
<div>

</div>			
Calculation using Hvorslev			
Observation Well	Hydraulic Conductivity [m/s]		
MW1	3.10 × 10 ⁻⁴

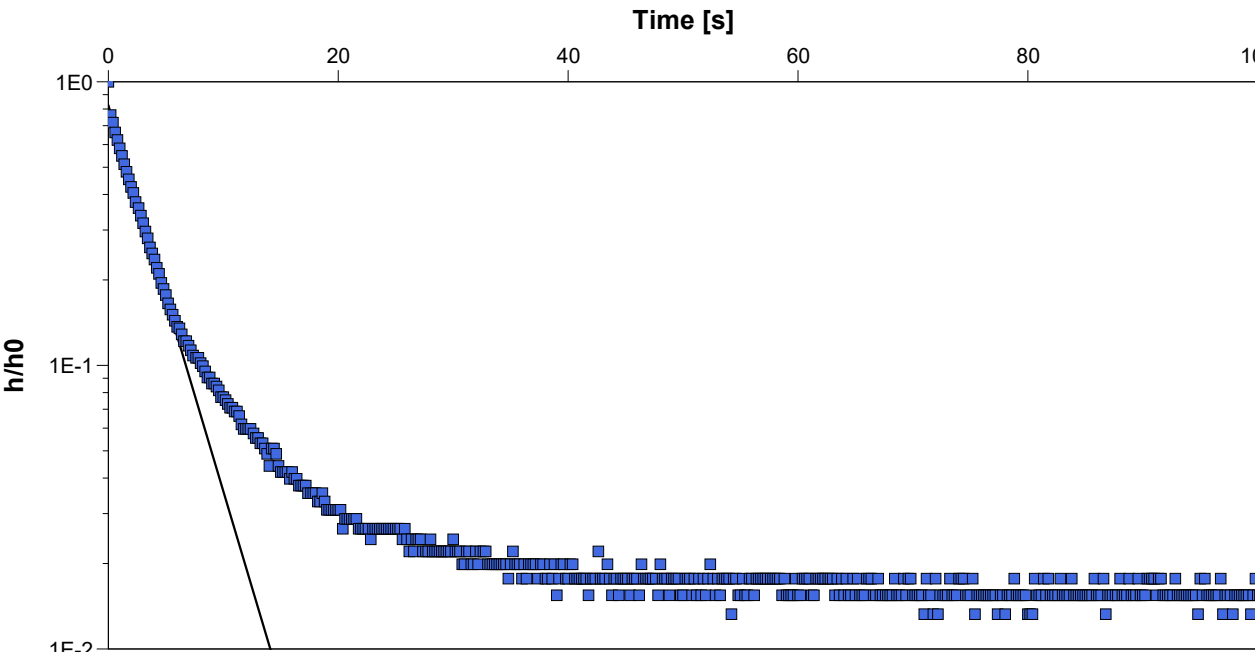
Douglas Partners Geotechnics Environment Groundwater</div>		Slug Test Analysis Report	
		Project: Proposed Manufactured Housing Estate	
		Number: 219536.00	
		Client: Allam Property Group	
Location: 40-80 Chapmans Road, TUNCURRY		Slug Test: MW1-4	Test Well: MW1
Test Conducted by: JCL		Test Date: 2/05/2023	
Analysis Performed by: JCL		MW1-4	Analysis Date: 11/05/2023
Aquifer Thickness:			
<div><p>Time [s]</p>

</div>			
Calculation using Hvorslev			
Observation Well	Hydraulic Conductivity [m/s]		
MW1	3.30×10^{-4}

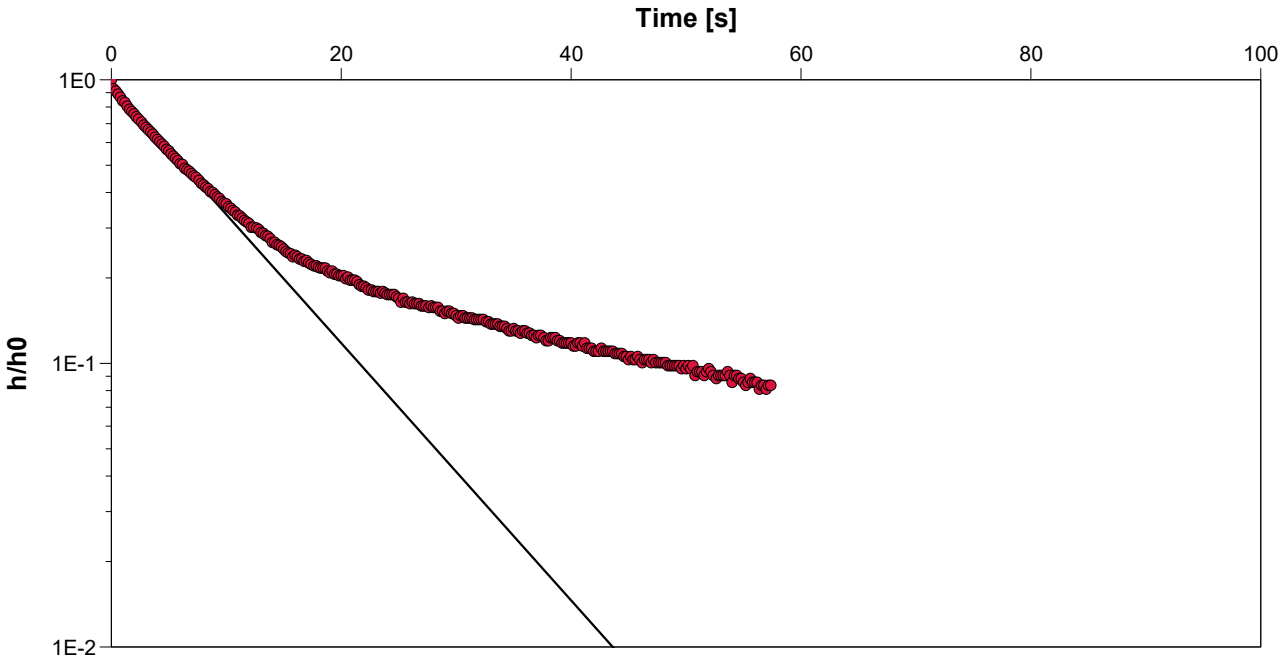
<div> Douglas Partners Geotechnics Environment Groundwater </div> </div>		Slug Test Analysis Report	
		Project: Proposed Manufactured Housing Estate	
		Number: 219536.00	
		Client: Allam Property Group	
Location: 40-80 Chapmans Road, TUNCURRY		Slug Test: MW3-1	Test Well: MW3
Test Conducted by: JCL		Test Date: 2/05/2023	
Analysis Performed by: JCL		MW3-1	Analysis Date: 11/05/2023
Aquifer Thickness:			
<div>

</div>			
Calculation using Hvorslev			
Observation Well	Hydraulic Conductivity [m/s]		
MW3	1.10 × 10 ⁻⁴

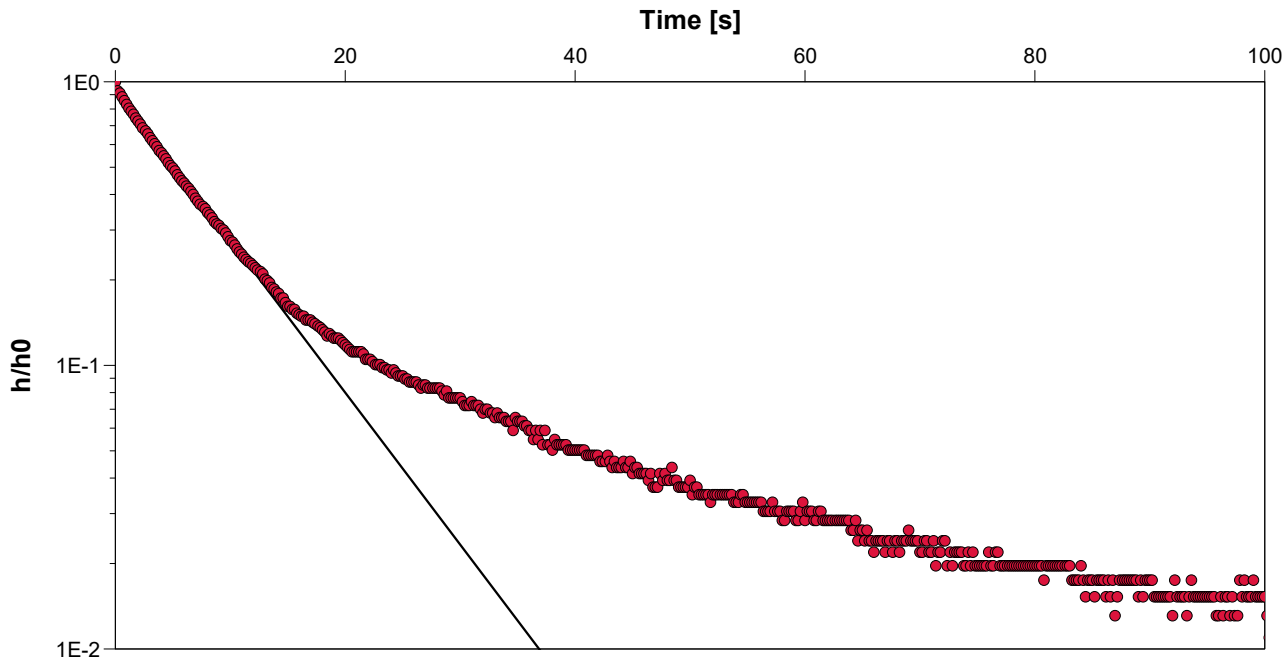
Douglas Partners Geotechnics Environment Groundwater</div>		Slug Test Analysis Report	
		Project: Proposed Manufactured Housing Estate	
		Number: 219536.00	
		Client: Allam Property Group	
Location: 40-80 Chapmans Road, TUNCURRY		Slug Test: MW3-2	Test Well: MW3
Test Conducted by:		Test Date: 11/05/2023	
Analysis Performed by: JCL		MW3-2	Analysis Date: 11/05/2023
Aquifer Thickness:			
<div><p>Time [s]</p>

</div>			
Calculation using Hvorslev			
Observation Well	Hydraulic Conductivity [m/s]		
MW3	1.30×10^{-4}

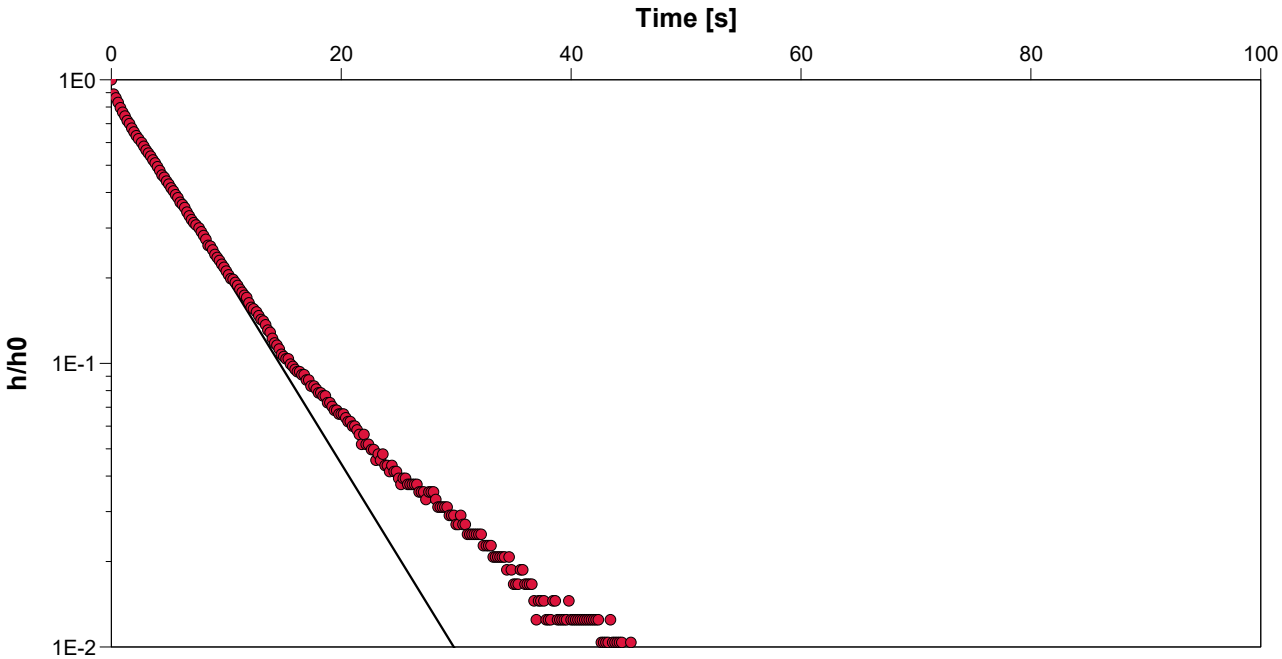
<div> Douglas Partners Geotechnics Environment Groundwater </div> </div>		Slug Test Analysis Report	
		Project: Proposed Manufactured Housing Estate	
		Number: 219536.00	
		Client: Allam Property Group	
Location: 40-80 Chapmans Road, TUNCURRY		Slug Test: MW3-3	Test Well: MW3
Test Conducted by: JCL		Test Date: 2/05/2023	
Analysis Performed by: JCL		MW3-3	Analysis Date: 11/05/2023
Aquifer Thickness:			
<div>

</div>			
Calculation using Hvorslev			
Observation Well	Hydraulic Conductivity [m/s]		
MW3	1.60 × 10 ⁻⁴

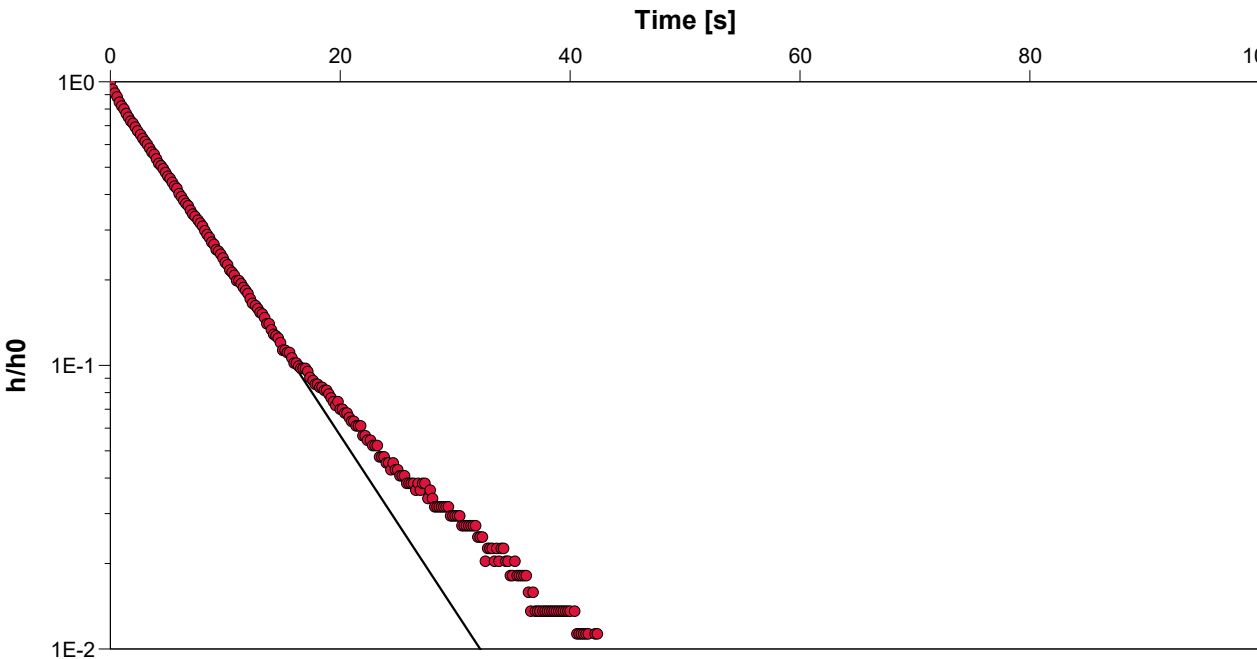
Douglas Partners Geotechnics Environment Groundwater</div>		Slug Test Analysis Report	
		Project: Proposed Manufactured Housing Estate	
		Number: 219536.00	
		Client: Allam Property Group	
Location: 40-80 Chapmans Road, TUNCURRY		Slug Test: MW3-4	Test Well: MW3
Test Conducted by: JCL		Test Date: 2/05/2023	
Analysis Performed by: JCL		MW3-4	Analysis Date: 11/05/2023
Aquifer Thickness:			
<div><div>Time [s]</div><div>

</div></div>			
Calculation using Hvorslev			
Observation Well	Hydraulic Conductivity [m/s]		
MW3	1.50 × 10 ⁻⁴

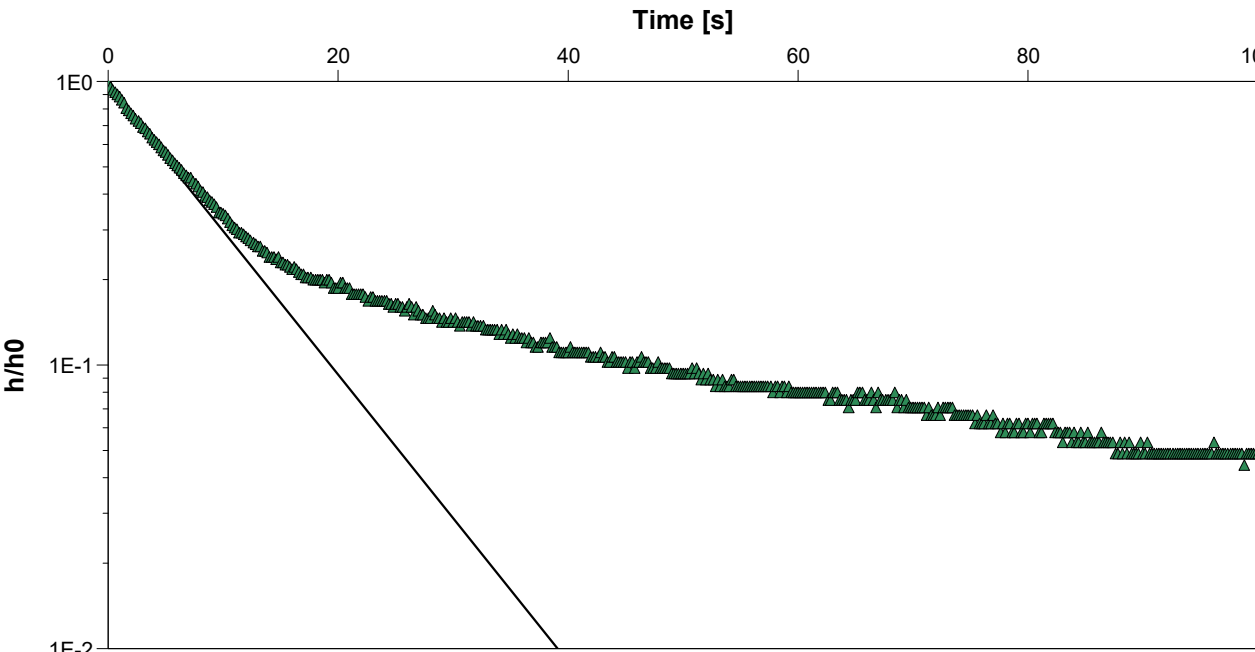
Douglas Partners Geotechnics Environment Groundwater</div>		Slug Test Analysis Report	
		Project: Proposed Manufactured Housing Estate	
		Number: 219536.00	
		Client: Allam Property Group	
Location: 40-80 Chapmans Road, TUNCURRY		Slug Test: MW4-1	Test Well: MW4
Test Conducted by: JCL		Test Date: 2/05/2023	
Analysis Performed by: JCL		MW4-1	Analysis Date: 11/05/2023
Aquifer Thickness:			
<div><p>Time [s]</p>

</div>			
Calculation using Hvorslev			
Observation Well	Hydraulic Conductivity [m/s]		
MW4	1.00×10^{-4}

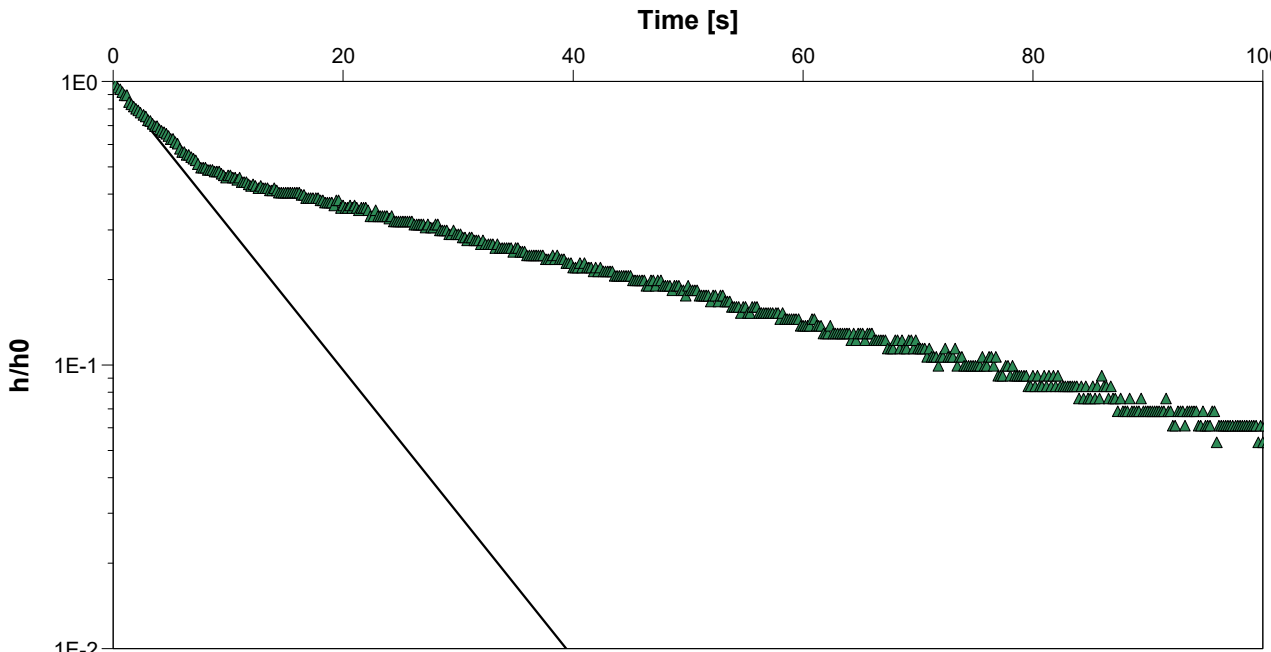
<div> Douglas Partners Geotechnics Environment Groundwater </div> </div>		Slug Test Analysis Report	
		Project: Proposed Manufactured Housing Estate	
		Number: 219536.00	
		Client: Allam Property Group	
Location: 40-80 Chapmans Road, TUNCURRY		Slug Test: MW4-2	Test Well: MW4
Test Conducted by: JCL		Test Date: 2/05/2023	
Analysis Performed by: JCL		MW4-2	Analysis Date: 2/05/2023
Aquifer Thickness:			
<div>

</div>			
Calculation using Hvorslev			
Observation Well	Hydraulic Conductivity [m/s]		
MW4	1.00 × 10 ⁻⁴

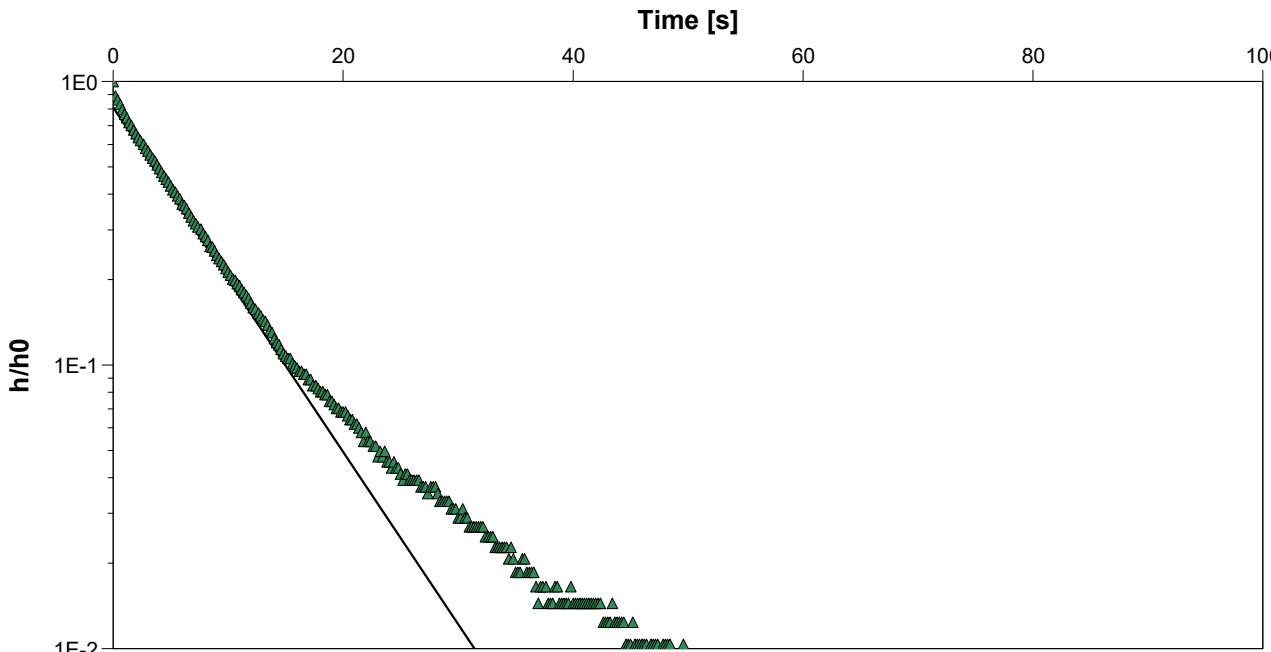
<div> Douglas Partners Geotechnics Environment Groundwater </div> </div>		Slug Test Analysis Report	
		Project: Proposed Manufactured Housing Estate	
		Number: 219536.00	
		Client: Allam Property Group	
Location: 40-80 Chapmans Road, TUNCURRY		Slug Test: MW4-3	Test Well: MW4
Test Conducted by: JCL		Test Date: 2/05/2023	
Analysis Performed by: JCL		MW4-3	Analysis Date: 11/05/2023
Aquifer Thickness:			
<div>

</div>			
Calculation using Hvorslev			
Observation Well	Hydraulic Conductivity [m/s]		
MW4	1.20 × 10 ⁻⁴

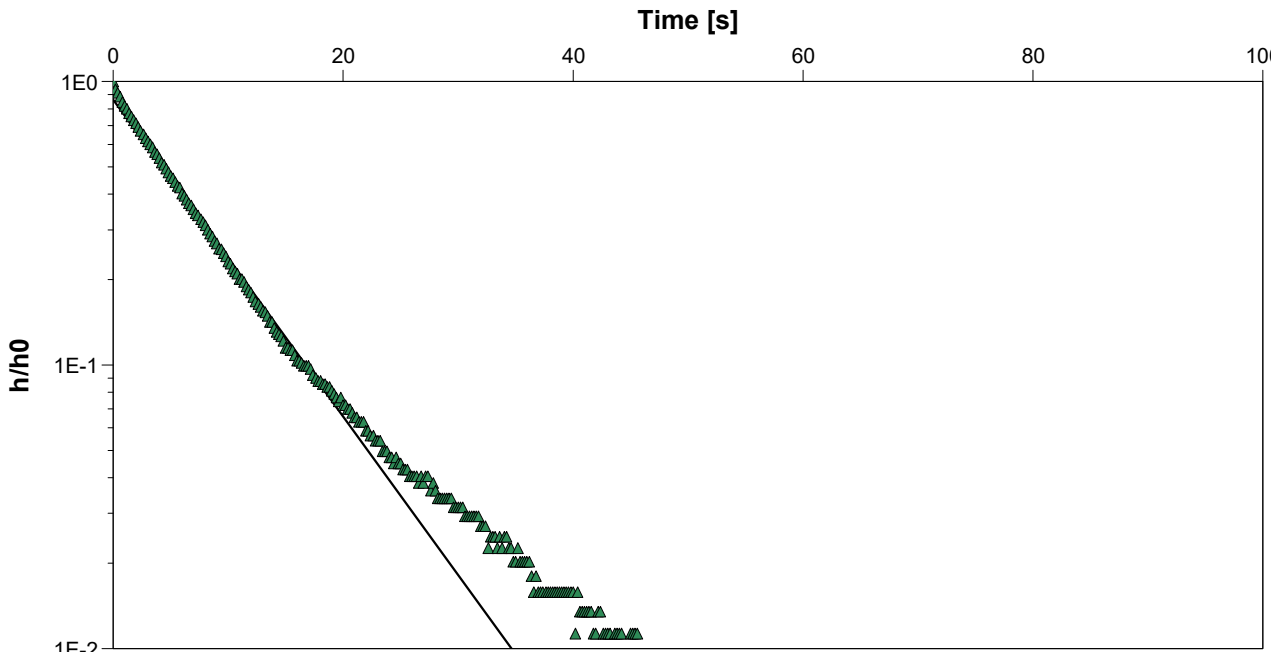
<div> Douglas Partners Geotechnics Environment Groundwater </div> </div>		Slug Test Analysis Report	
		Project: Proposed Manufactured Housing Estate	
		Number: 219536.00	
		Client: Allam Property Group	
Location: 40-80 Chapmans Road, TUNCURRY		Slug Test: MW4-4	Test Well: MW4
Test Conducted by: JCL		Test Date: 2/05/2023	
Analysis Performed by: JCL		MW4-4	Analysis Date: 11/05/2023
Aquifer Thickness:			
<div>

</div>			
Calculation using Hvorslev			
Observation Well	Hydraulic Conductivity [m/s]		
MW4	1.10 × 10 ⁻⁴
