Report on
Groundwater Study

Proposed Manufactured Housing Estate
40-80 Chapmans Road, Tuncurry

Project 219536.00
July 2023

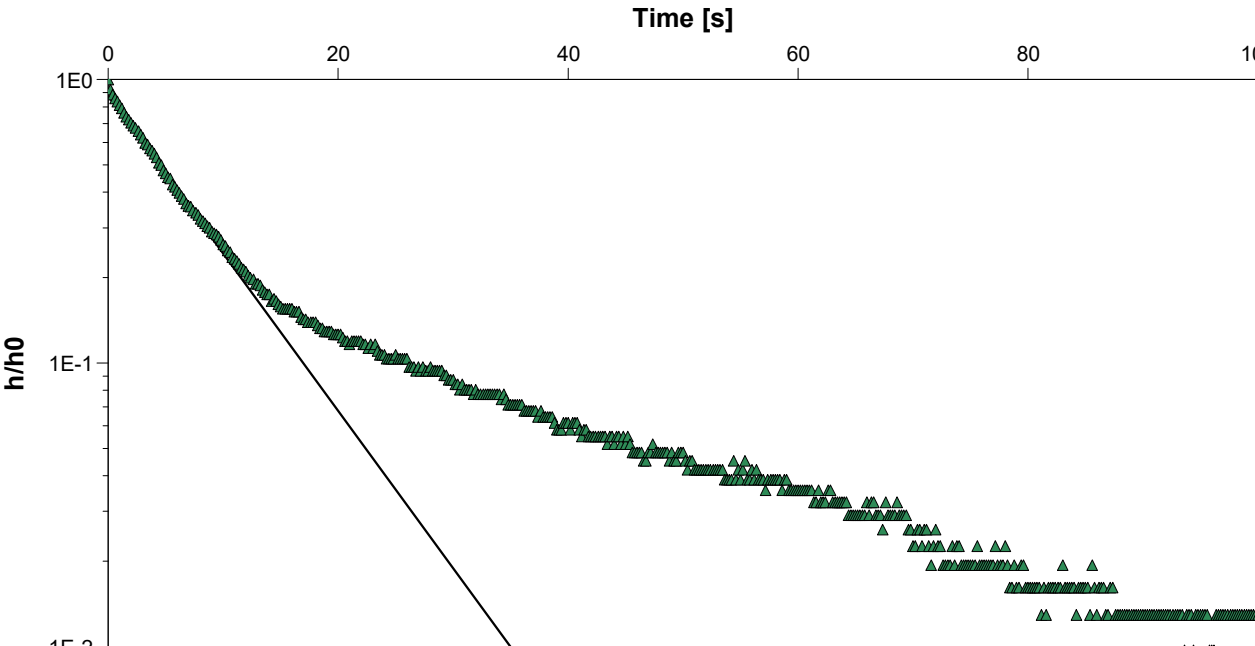
Douglas Partners Geotechnics Environment Groundwater</div>		Slug Test Analysis Report	
		Project: Proposed Manufactured Housing Estate	
		Number: 219536.00	
		Client: Allam Property Group	
Location: 40-80 Chapmans Road, TUNCURRY		Slug Test: MW4-6	Test Well: MW4
Test Conducted by: JCL		Test Date: 2/05/2023	
Analysis Performed by: JCL		MW4-6	Analysis Date: 11/05/2023
Aquifer Thickness:			
<div><p>Time [s]</p>

</div>			
Calculation using Hvorslev			
Observation Well	Hydraulic Conductivity [m/s]		
MW4	1.10×10^{-4}

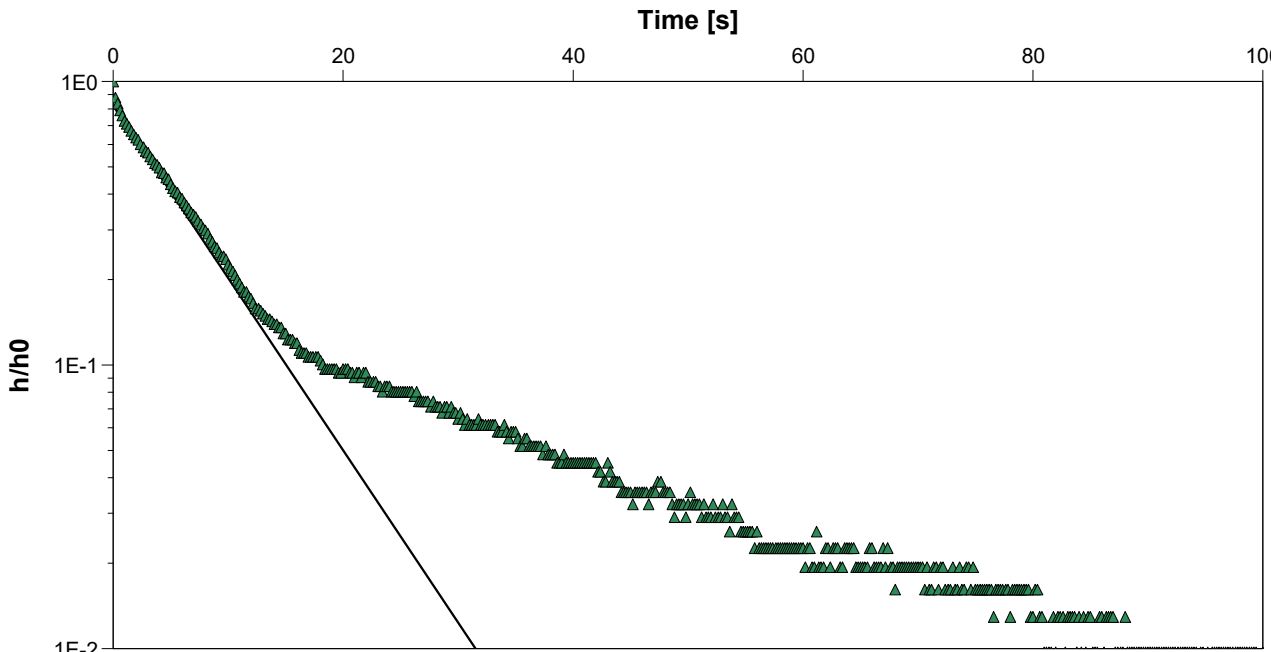
<div> Douglas Partners Geotechnics Environment Groundwater </div> </div>		Slug Test Analysis Report	
		Project: Proposed Manufactured Housing Estate	
		Number: 219536.00	
		Client: Allam Property Group	
Location: 40-80 Chapmans Road, TUNCURRY		Slug Test: MW4-7	Test Well: MW4
Test Conducted by: JCL		Test Date: 2/05/2023	
Analysis Performed by: JCL		MW4-6	Analysis Date: 11/05/2023
Aquifer Thickness:			
<div>

</div>			
Calculation using Hvorslev			
Observation Well	Hydraulic Conductivity [m/s]		
MW4	1.20 × 10 ⁻⁴

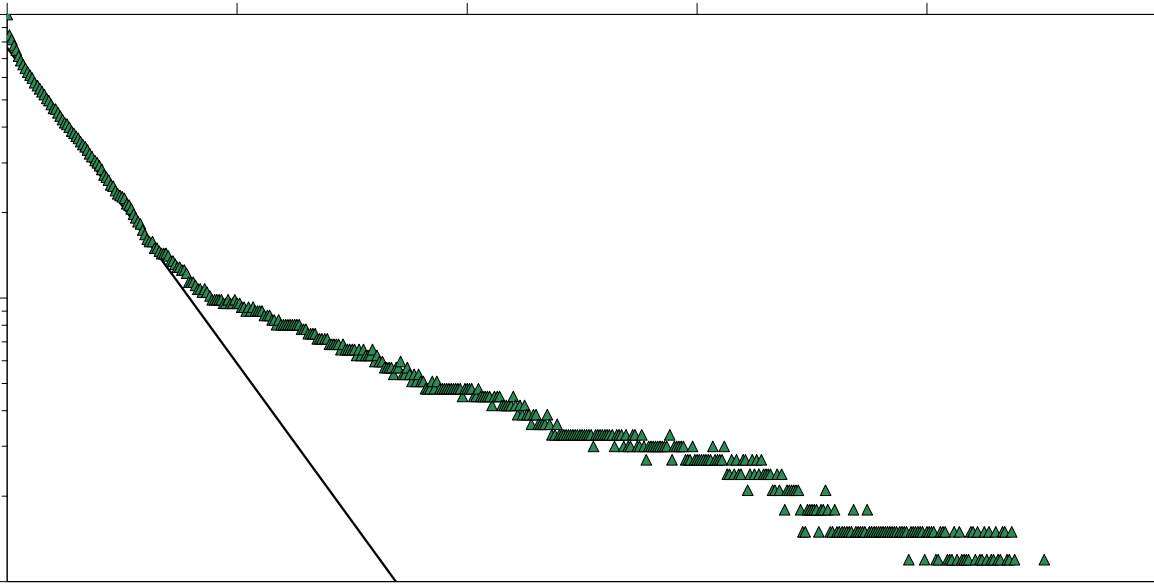
Douglas Partners Geotechnics Environment Groundwater</div>		Slug Test Analysis Report	
		Project: Proposed Manufactured Housing Estate	
		Number: 219536.00	
		Client: Allam Property Group	
Location: 40-80 Chapmans Road, TUNCURRY		Slug Test: MW4-8	Test Well: MW4
Test Conducted by: JCL		Test Date: 2/05/2023	
Analysis Performed by: JCL		MW4-8	Analysis Date: 11/05/2023
Aquifer Thickness:			
<div><div></div><div><div>Time [s]</div><div><div><div>0</div><div>20</div><div>40</div><div>60</div><div>80</div><div>100</div></div><div><div>1E0</div><div>1E-1</div><div>1E-2</div></div><div><div>h/h0</div></div></div>

</div></div>			
Calculation using Hvorslev			
Observation Well	Hydraulic Conductivity [m/s]		
MW4	1.10×10^{-4}
