# Newcastle Airport Arborist Report

Prepared for Cox Architecture  
May 2022

E220242 RP1

EMM Consulting have been engaged by Cox Architecture to undertake an assessment of trees located around the perimeter of an existing car park located adjacent to the airport terminal building. This report is in relation to proposed upgrades and reconfiguration of the existing car park and the impacts the proposal may have on existing trees.

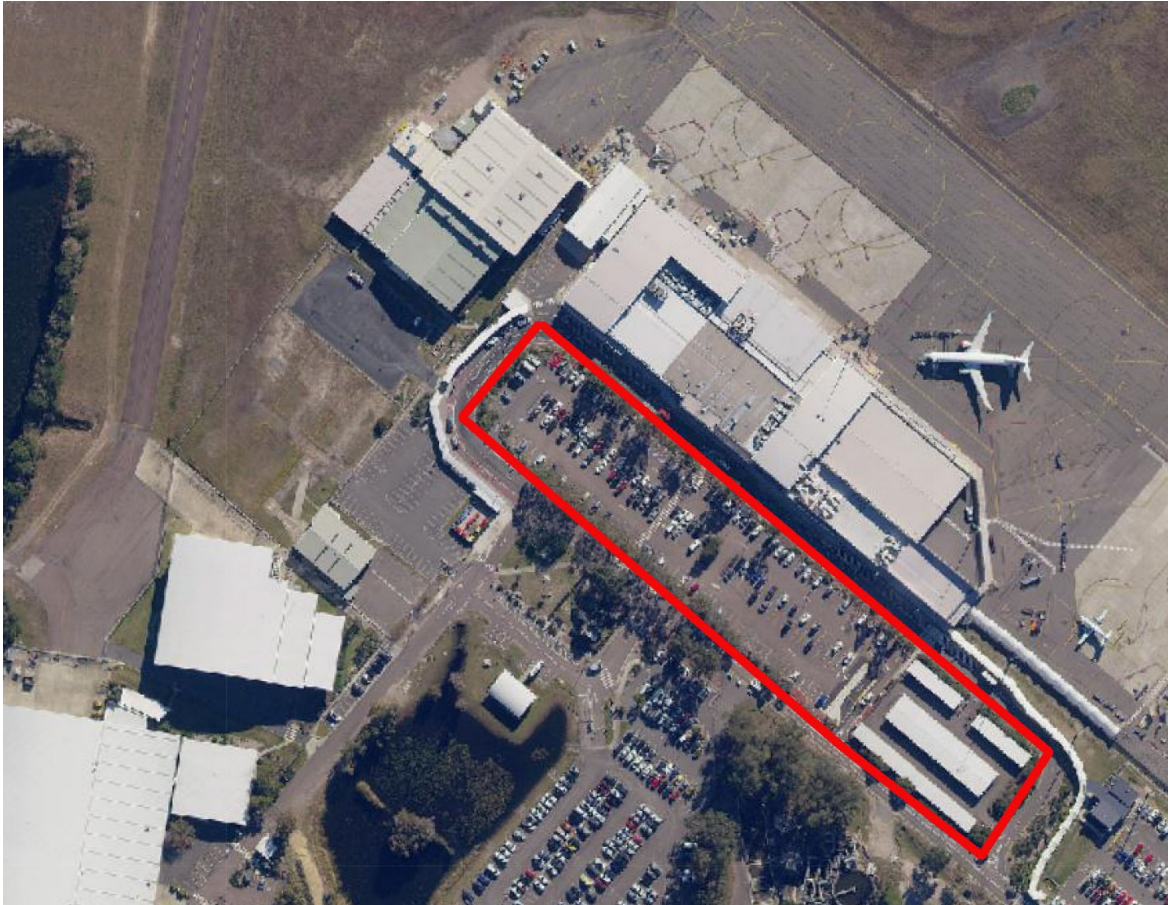
Figure 3.1 Study areas outlined red

The study area comprises of an existing car park located immediately to the south of the airport terminal building. Currently the existing car park is surrounded by a garden bed that contains mature trees, shrubs and groundcovers

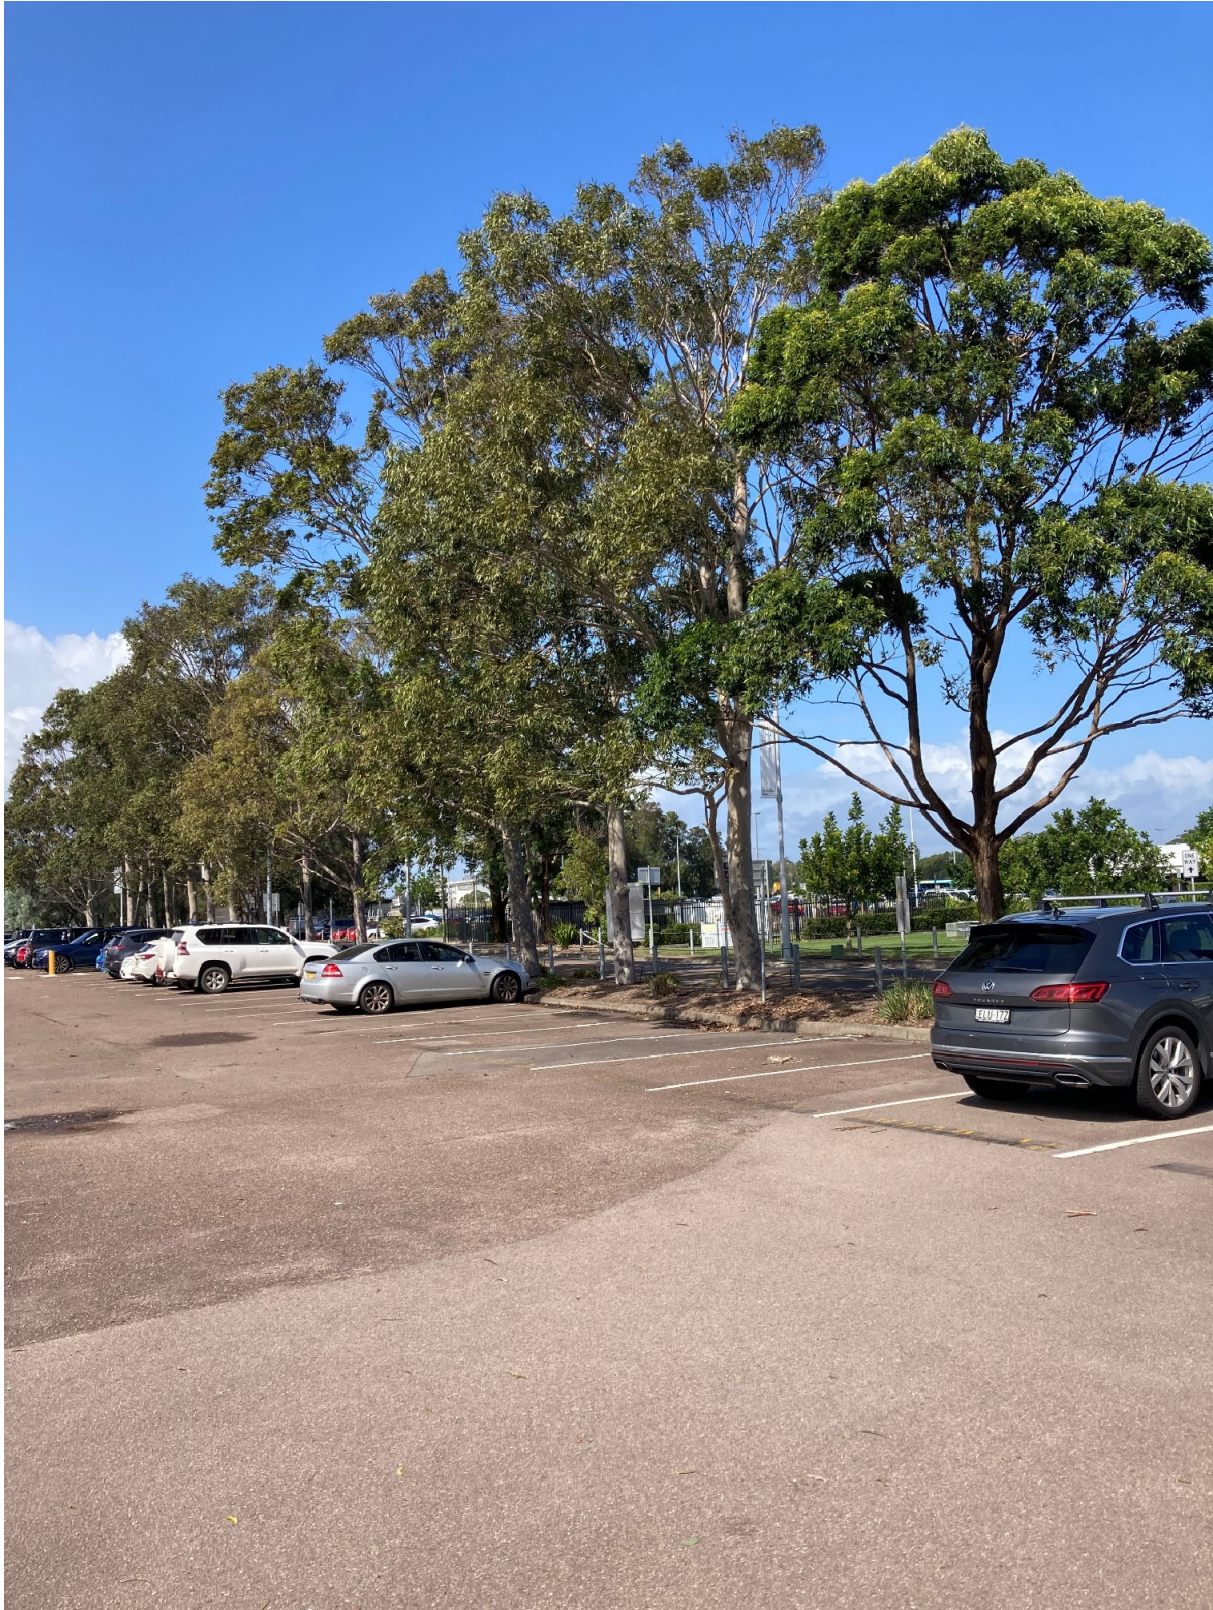
**Photograph 7.1**      **Corymbia and Eucalypt species along the southern side of the car park.**

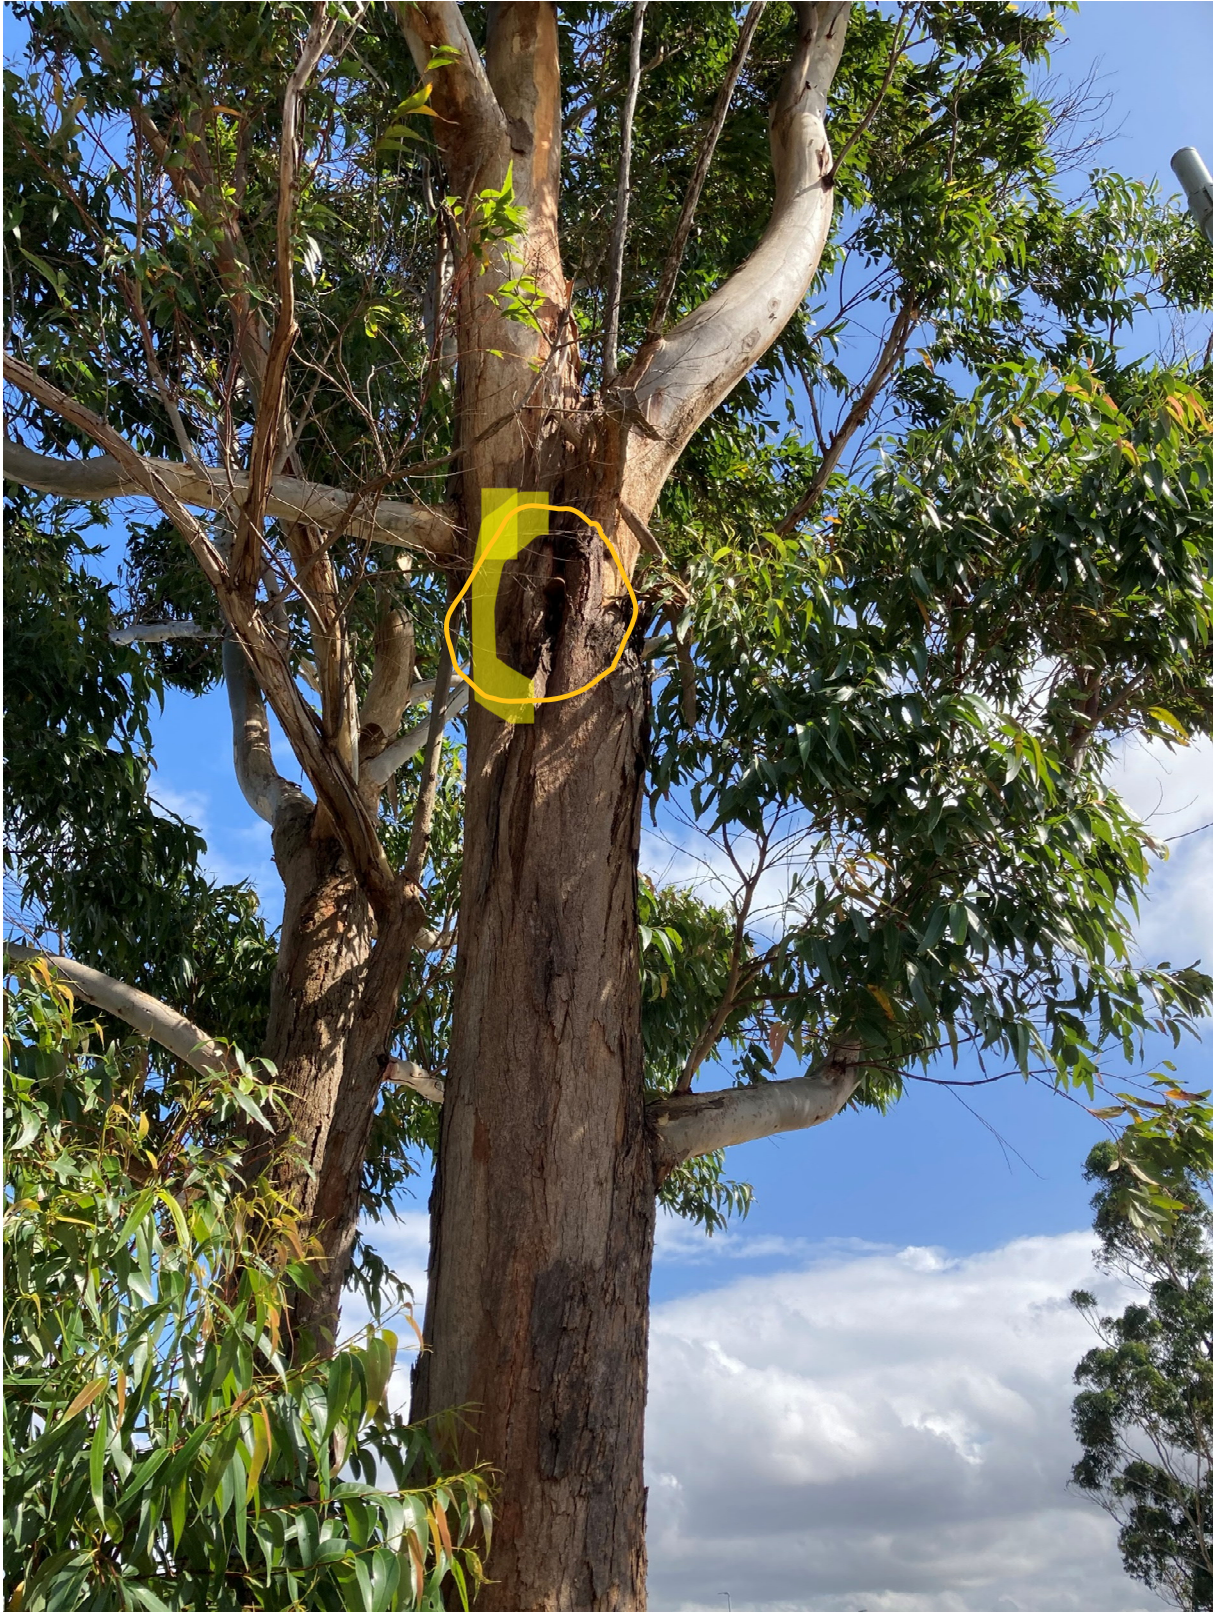
**Photograph 7.2**      *Phellinus* species on Tree 32.

The proposed works will require the removal of 41 trees. 18 of moderate retention value, 13 of low retention value and 10 of very low retention value. Trees located along the southern side of the car park will be impacted upon by the proposed canopy over the car park as will eight trees along the northern side of the car park. A further 3 trees are impacted by road realignments. A further 4 trees while not being impacted by the proposed works are proposed for removal due to their poor health. One tree in particular, Tree 32 has a fungal fruiting bracket located on its trunk. The tree is in decline and it is likely that there is a large area of associated decay. This tree poses a significant risk to pedestrians and a car parking area and should be removed ASAP.

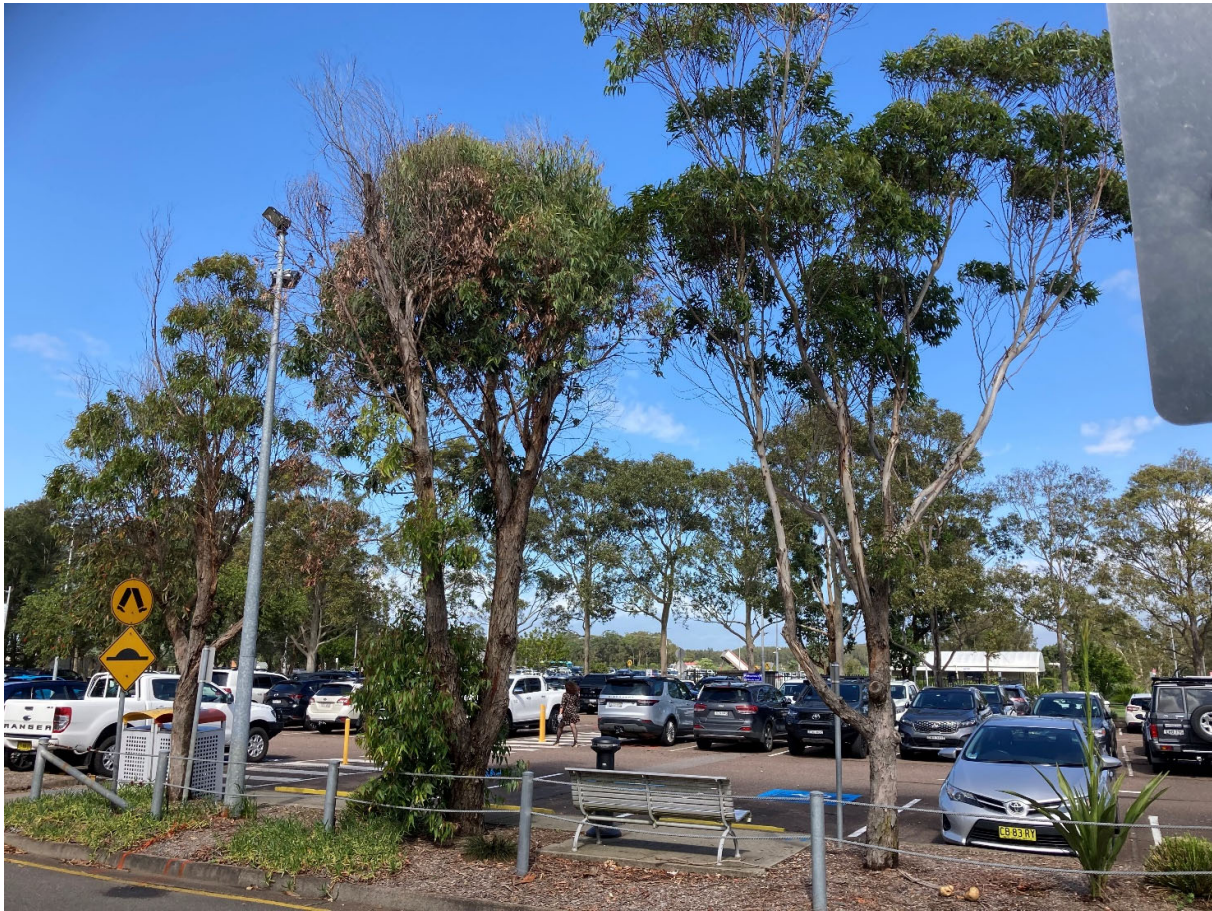
**Photograph 7.3** A number of trees on the northern side of the car park are of poor health.
