Report on
Preliminary Site Investigation (Contamination)

Proposed Industrial Building
Proposed Lot 109 Aerospace Avenue, Williamstown
Part Lot 11, DP 1036501

Prepared for
EJE Architecture

Project 39728.28
September 2022

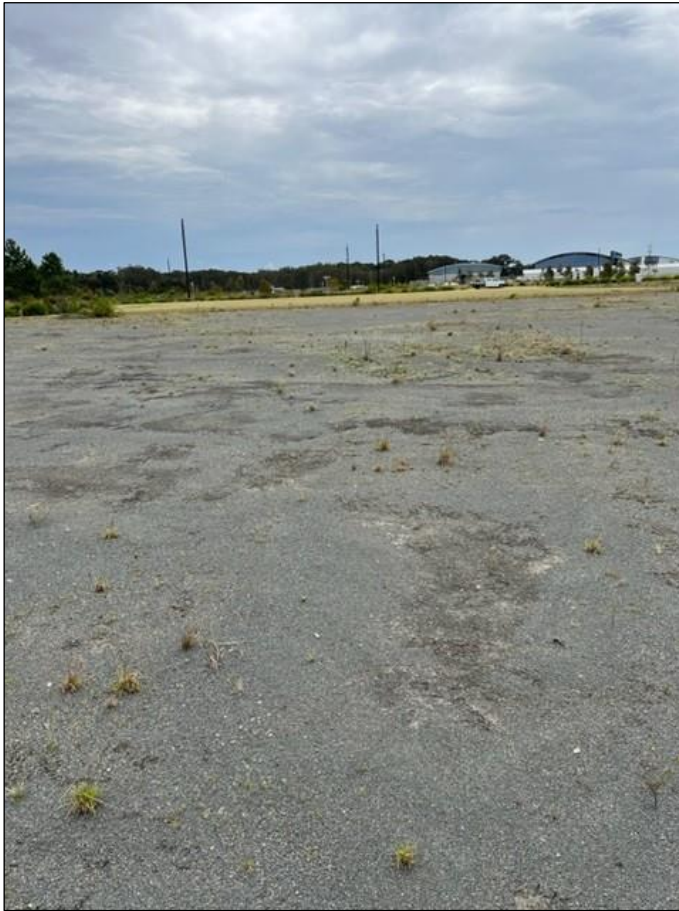
Figure 9: Lot 109, looking north from the southern boundary (15 September 2022)

Surface soils generally comprised sand and coarse sand to medium gravel sized gravel (igneous rock – possibly quarry source) (Figure 9). The site was observed to contain fill at the surface and had been raised compared to the conditions observed during previous investigations by DP that were conducted prior to subdivision construction.

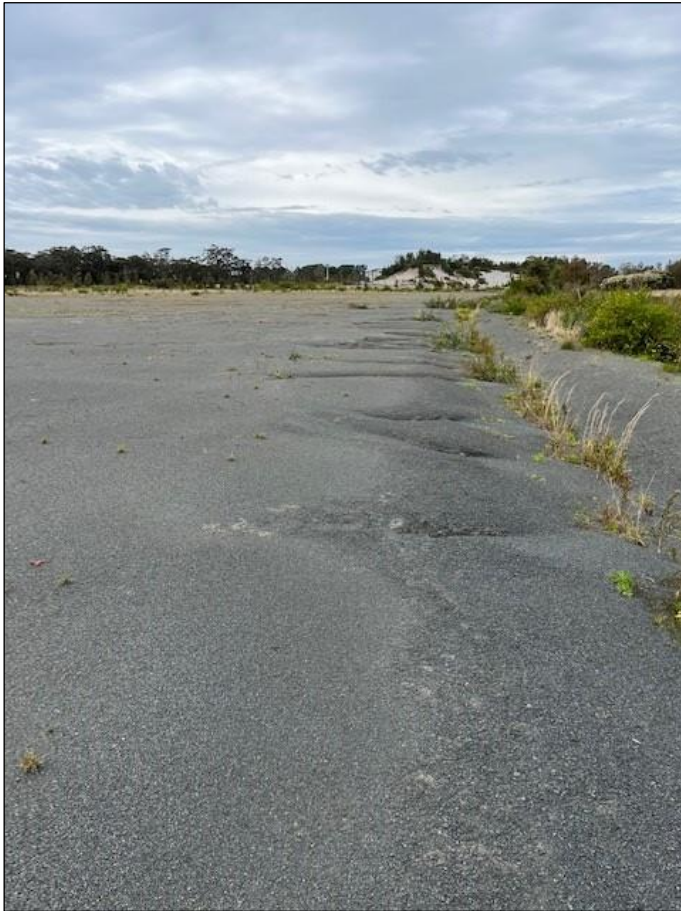
Figure 10: Localised erosion in the southern portion of the site (15 September 2022)

Some localised rutting and erosion were noted adjacent to the southern site boundary (Figure 10).

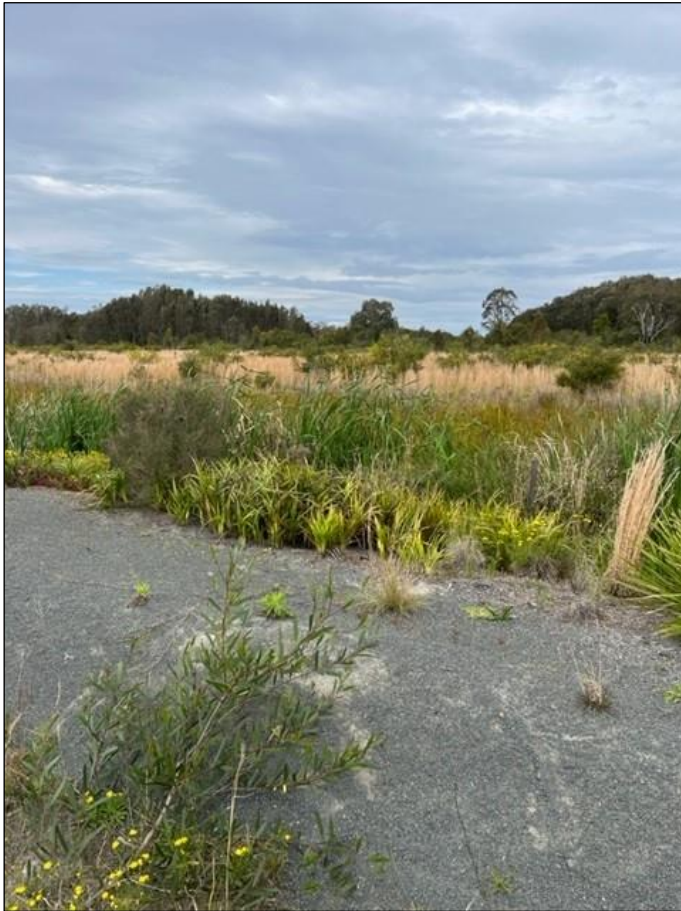
Figure 11: Surface water drain adjacent to the southern boundary of Lot 109

Surface water drains were observed adjacent to the western, southern and eastern boundaries of proposed Lot 109 (Figure 11).

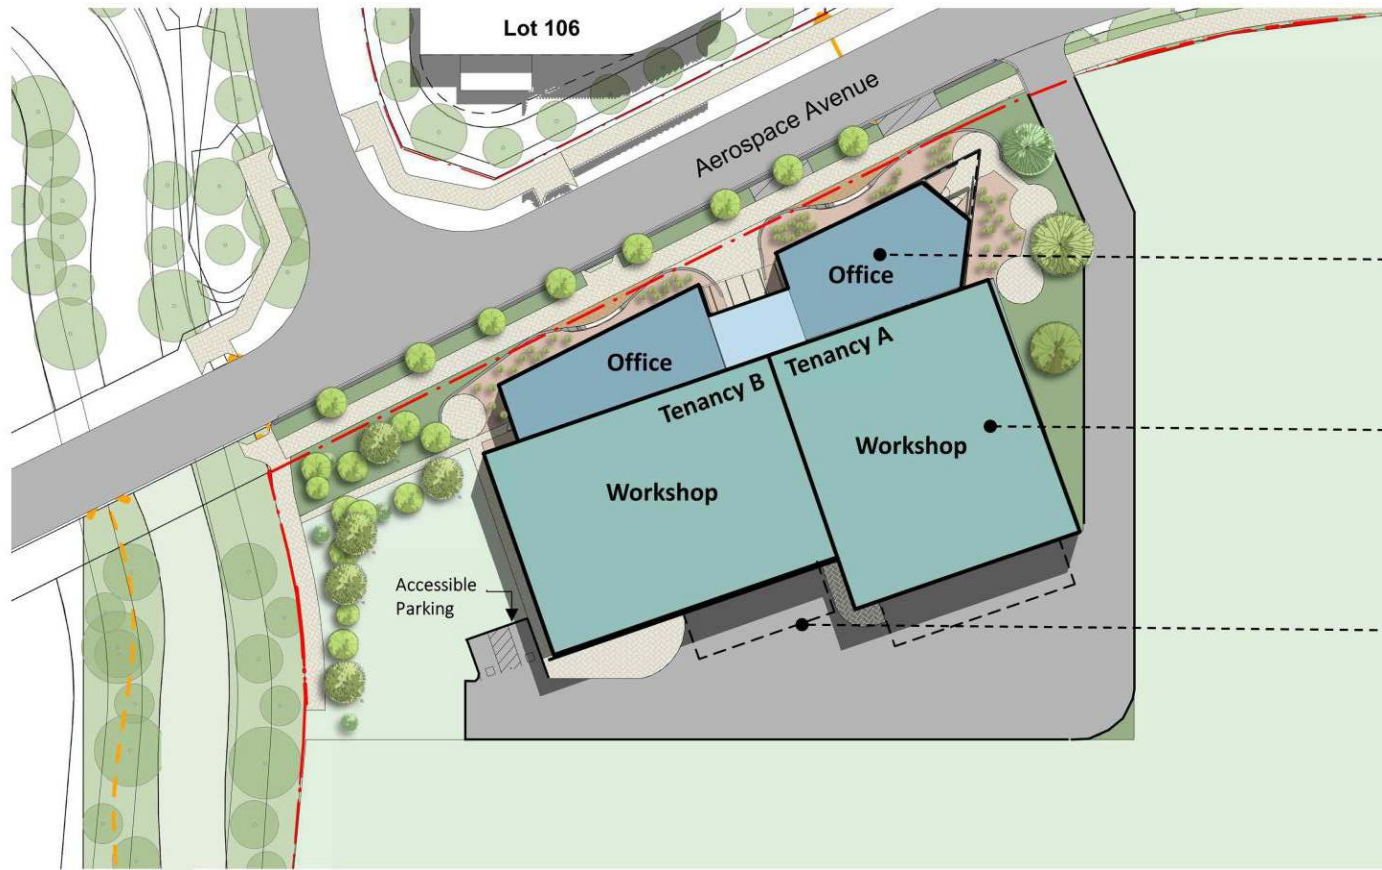
A s t r a A e r o l a b
W i l l i a m t o w n
Lot 109/1 - Facility
Overall Plan

Site Area	6,900m ²
Building Area	3,280m ²
Vehicle Movement	2,695m ²

2 Tenancies with 2 Levels Each
+ Shared Foyer

Potential Loading Bay Location
With 5-metre-deep cantilevered
awnings
