Report on
Preliminary Geotechnical Assessment

Proposed Commercial Building
Lot 106 Williamtown Drive, Williamtown

Prepared for
Cox Architecture Pty Ltd

Project 39728.27
September 2022

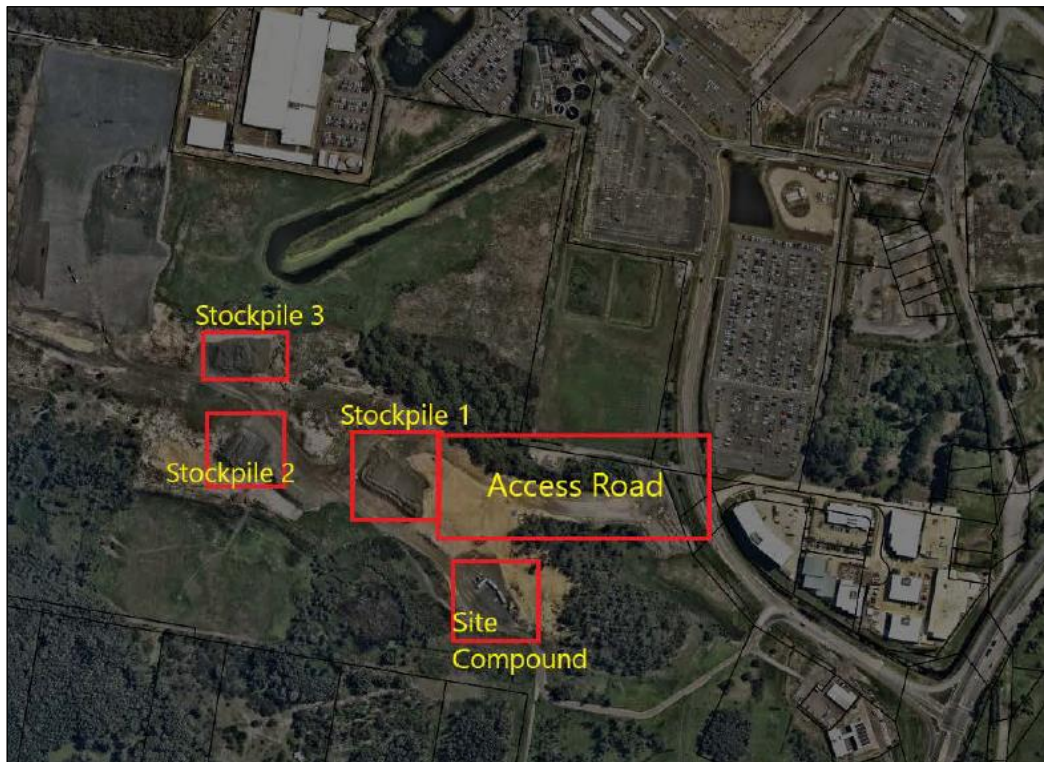
The approximate location of the areas subject to filling and testing in Valley Civilab (2020) is provided in Figure 5 below.

Figure 5: Approximate areas of fill and testing, Valley Civilab (2020)

It is noted, however, that the testing results provided in the report do not appear to cover all of the above areas, particularly Stockpile 2 and Stockpile 3 areas as indicated above.

- Fill, generally comprising crushed quarry-sourced igneous rock, or crushed sandstone, up to about 1.2 m. Fill has been placed within the overall Stage 1 area under Level 1 conditions, however, Qualtest (2020) stated that ‘uncontrolled’ fill was left in place in Lot 106, as instructed by the client. It is noted, however, that Valley Civilab (2020) reported Level 1 supervision and testing on fill placed in the vicinity of proposed Lot 106 as part of works prior to that reported in Qualtest (2020) (i.e. stockpile 2 and stockpile 3 in Figure 5 above);

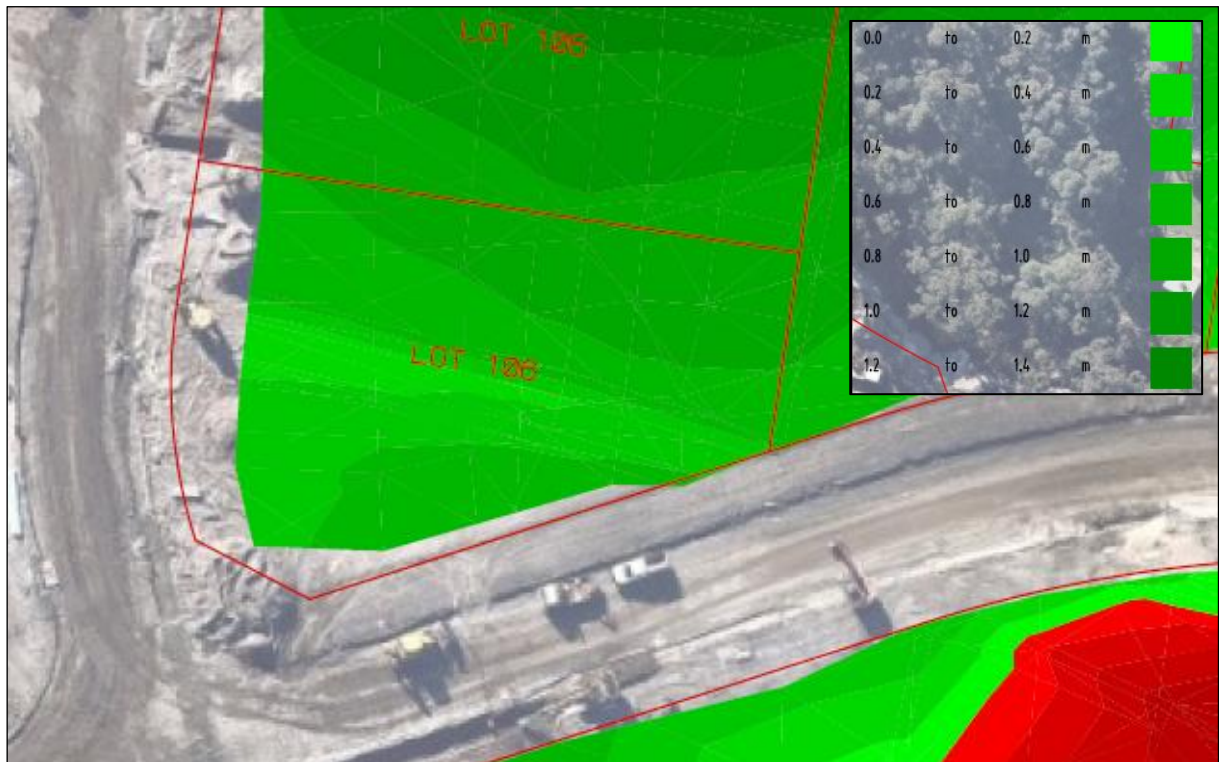
The Qualtest (2020) report also indicates the approximate fill/cut for the site prior to and following regrading works. An extract of the plan for the proposed Lot 106 is provided in Figure 7 below.

Figure 7: Approximate extent of fill on proposed Lot 106 (see legend insert)

It was noted in Qualtest (2020) that fill was placed within the proposed Lot 106 to a maximum thickness of 1.2 m.
