Report on Acid Sulfate Soil Management Plan

Proposed Commercial Development Proposed Lot 106 Williamtown Drive, Williamtown

> Prepared for Newcastle Airport Pty Limited

> > Project 39728.32 June 2023

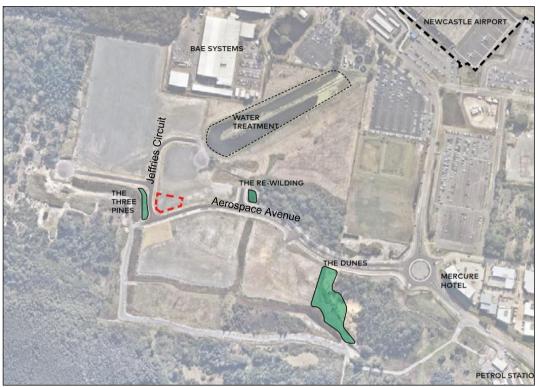
Figure 2: Site location (red outline), within the Astra Aerolab Stage 1 area

The approximate location of the proposed Lot 106 and Lot 107 is shown in Figure 1 below. Figure 2 shows the approximate development area within the current subdivision. Figure 3 shows the proposed development area ('the site'), including the eastern extent of the proposed development encroaching onto the western portion of the proposed Lot 107.

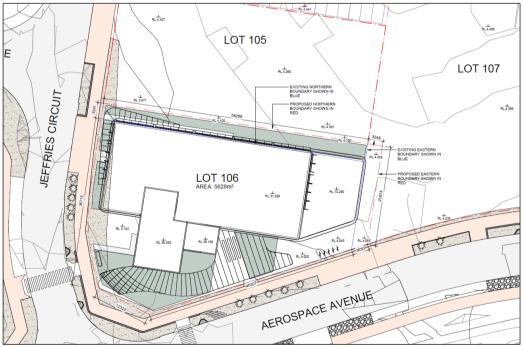
Figure 3: Proposed development area ('the site'), including extension of the proposed development into the western portion of the adjacent Lot 107

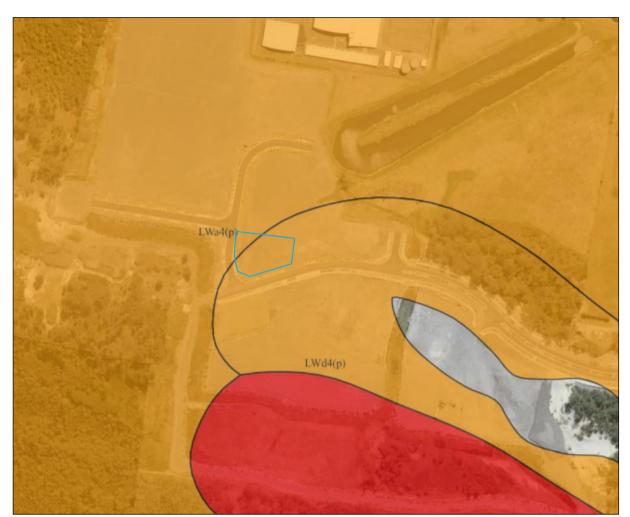
Figure 4: Acid sulfate soil mapping (site in blue) indicating low probability ASS below 3 m depth

Th current subject site is located with the low-risk area based on ASS mapping. Limited detailed ASS testing within the upper soils within the Astra Aerolab Stage 1 area suggested the absence of PASS in the soils tested within the subject site, however, it is noted that existing and potential sulfur results within soils within the Stage 1 Astra Aerolab area were variable, based on the results provided in DP (2009) and DP (2013).

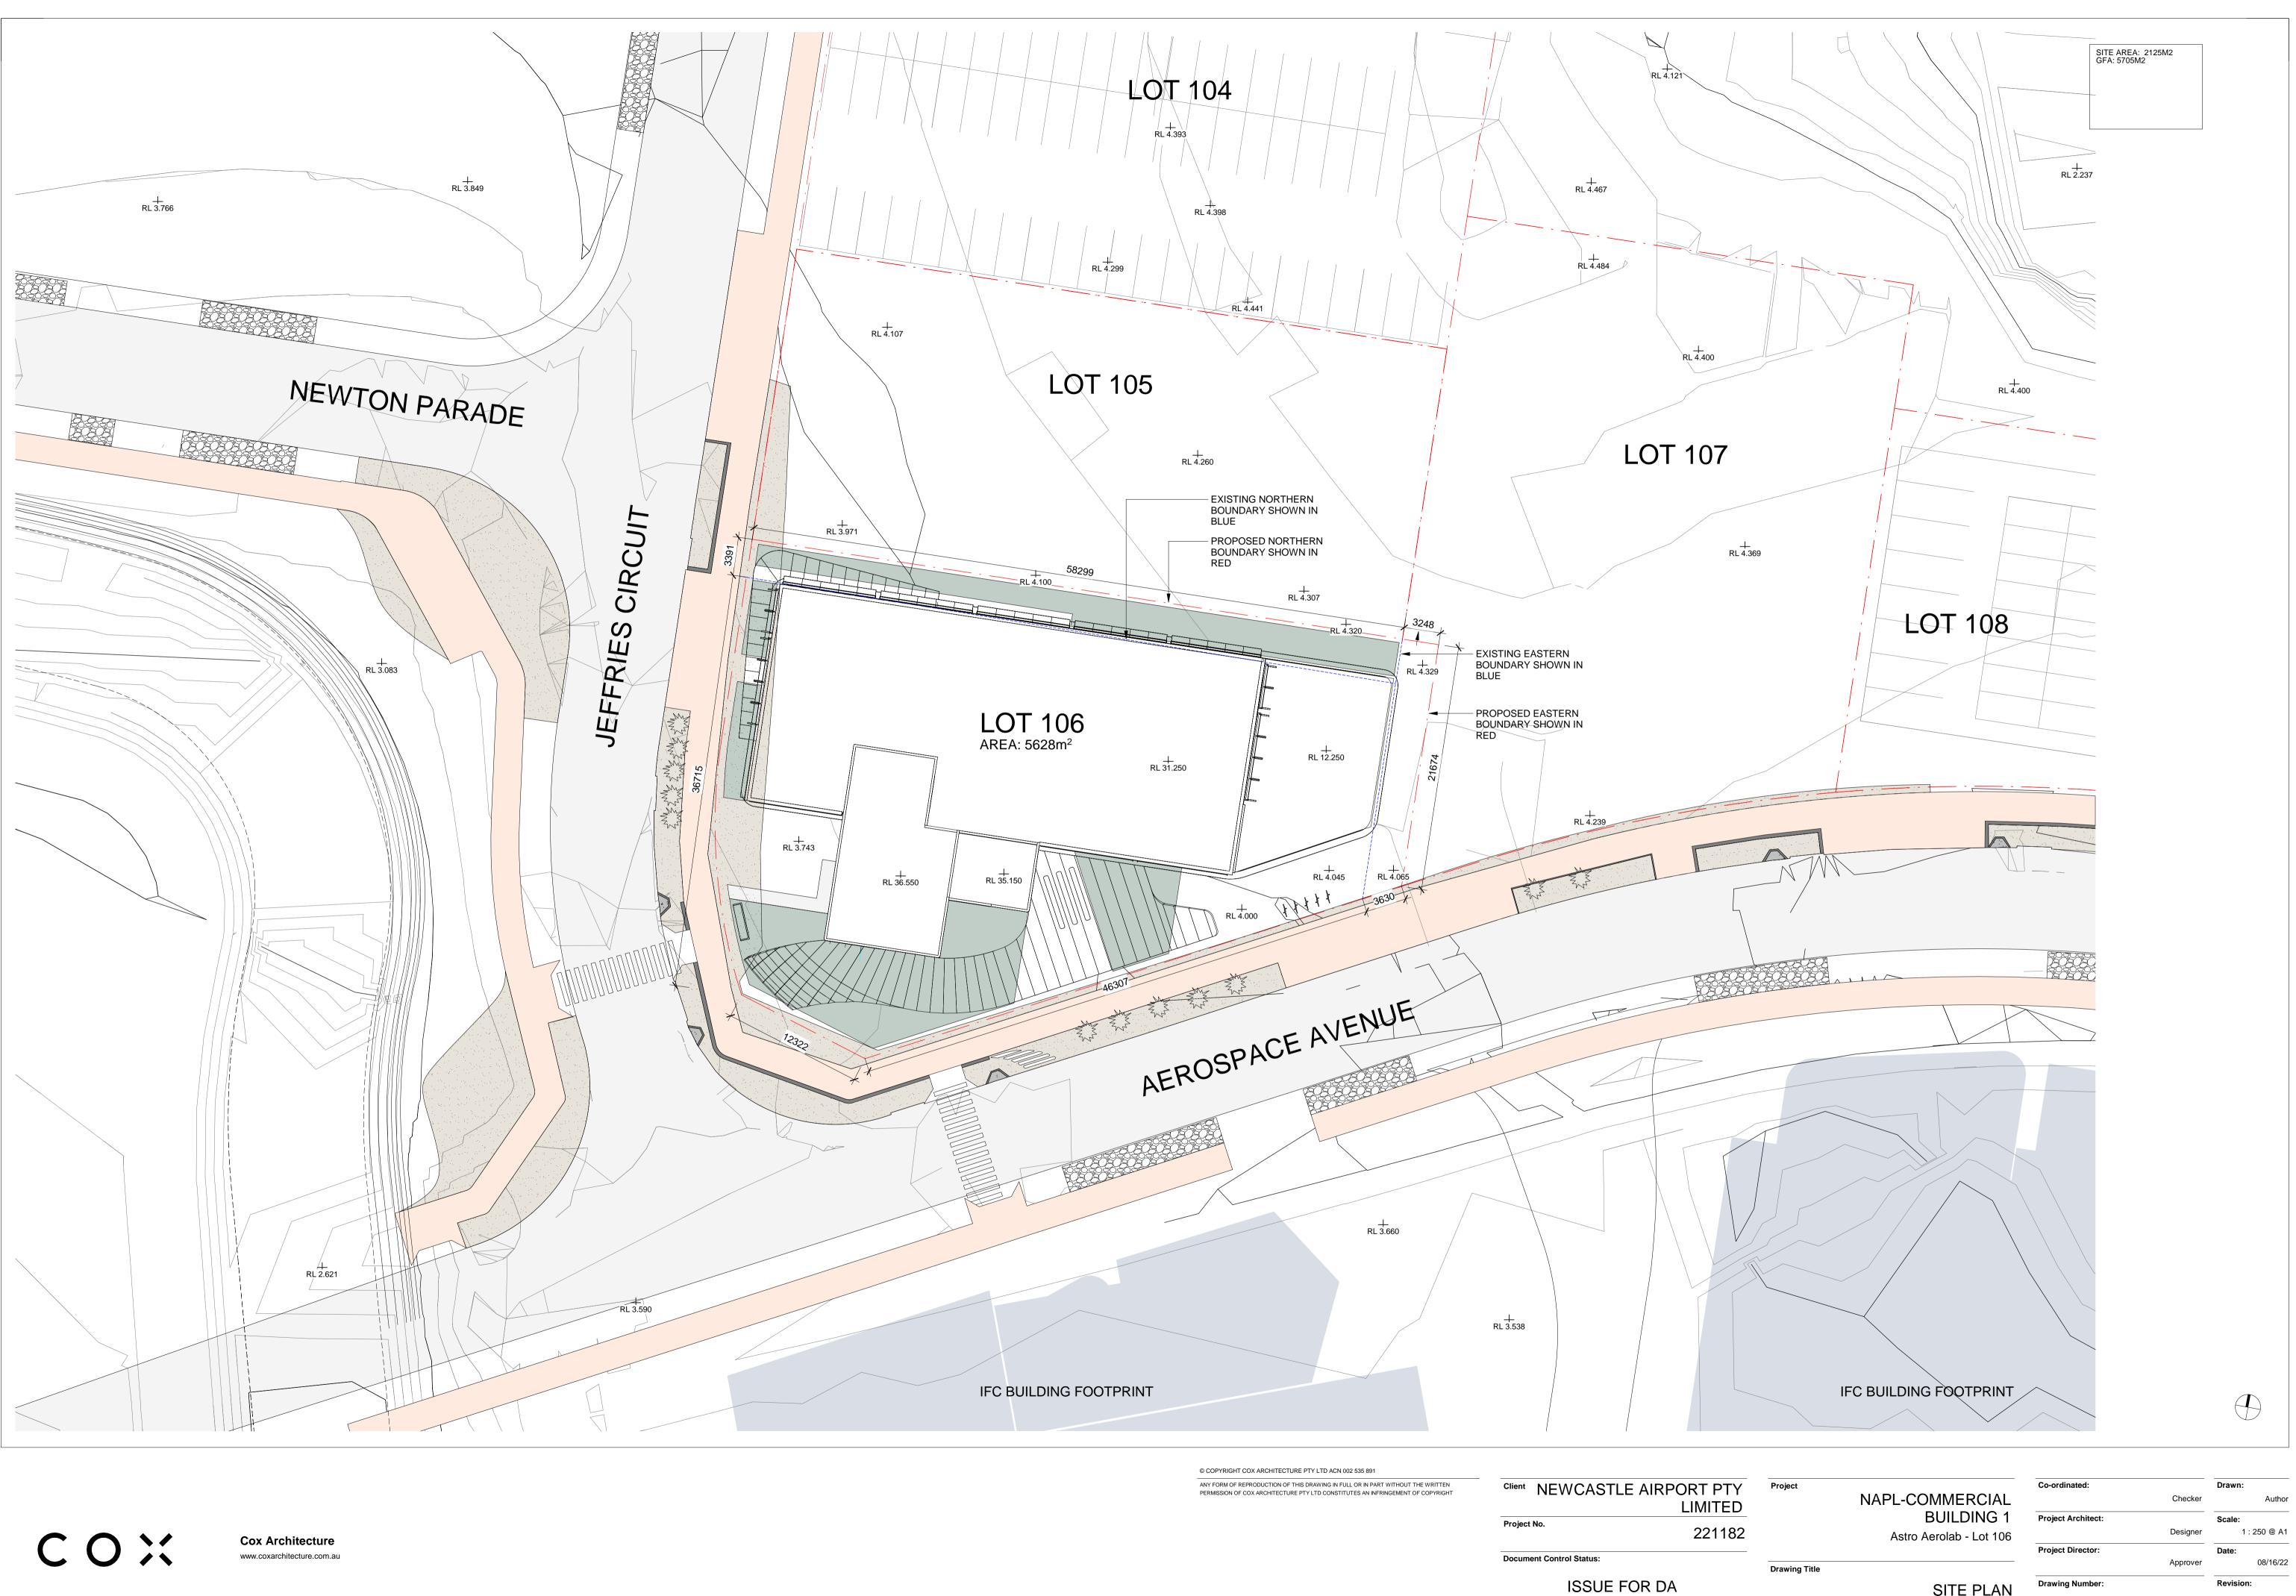
A-DA-1002

SITE PLAN

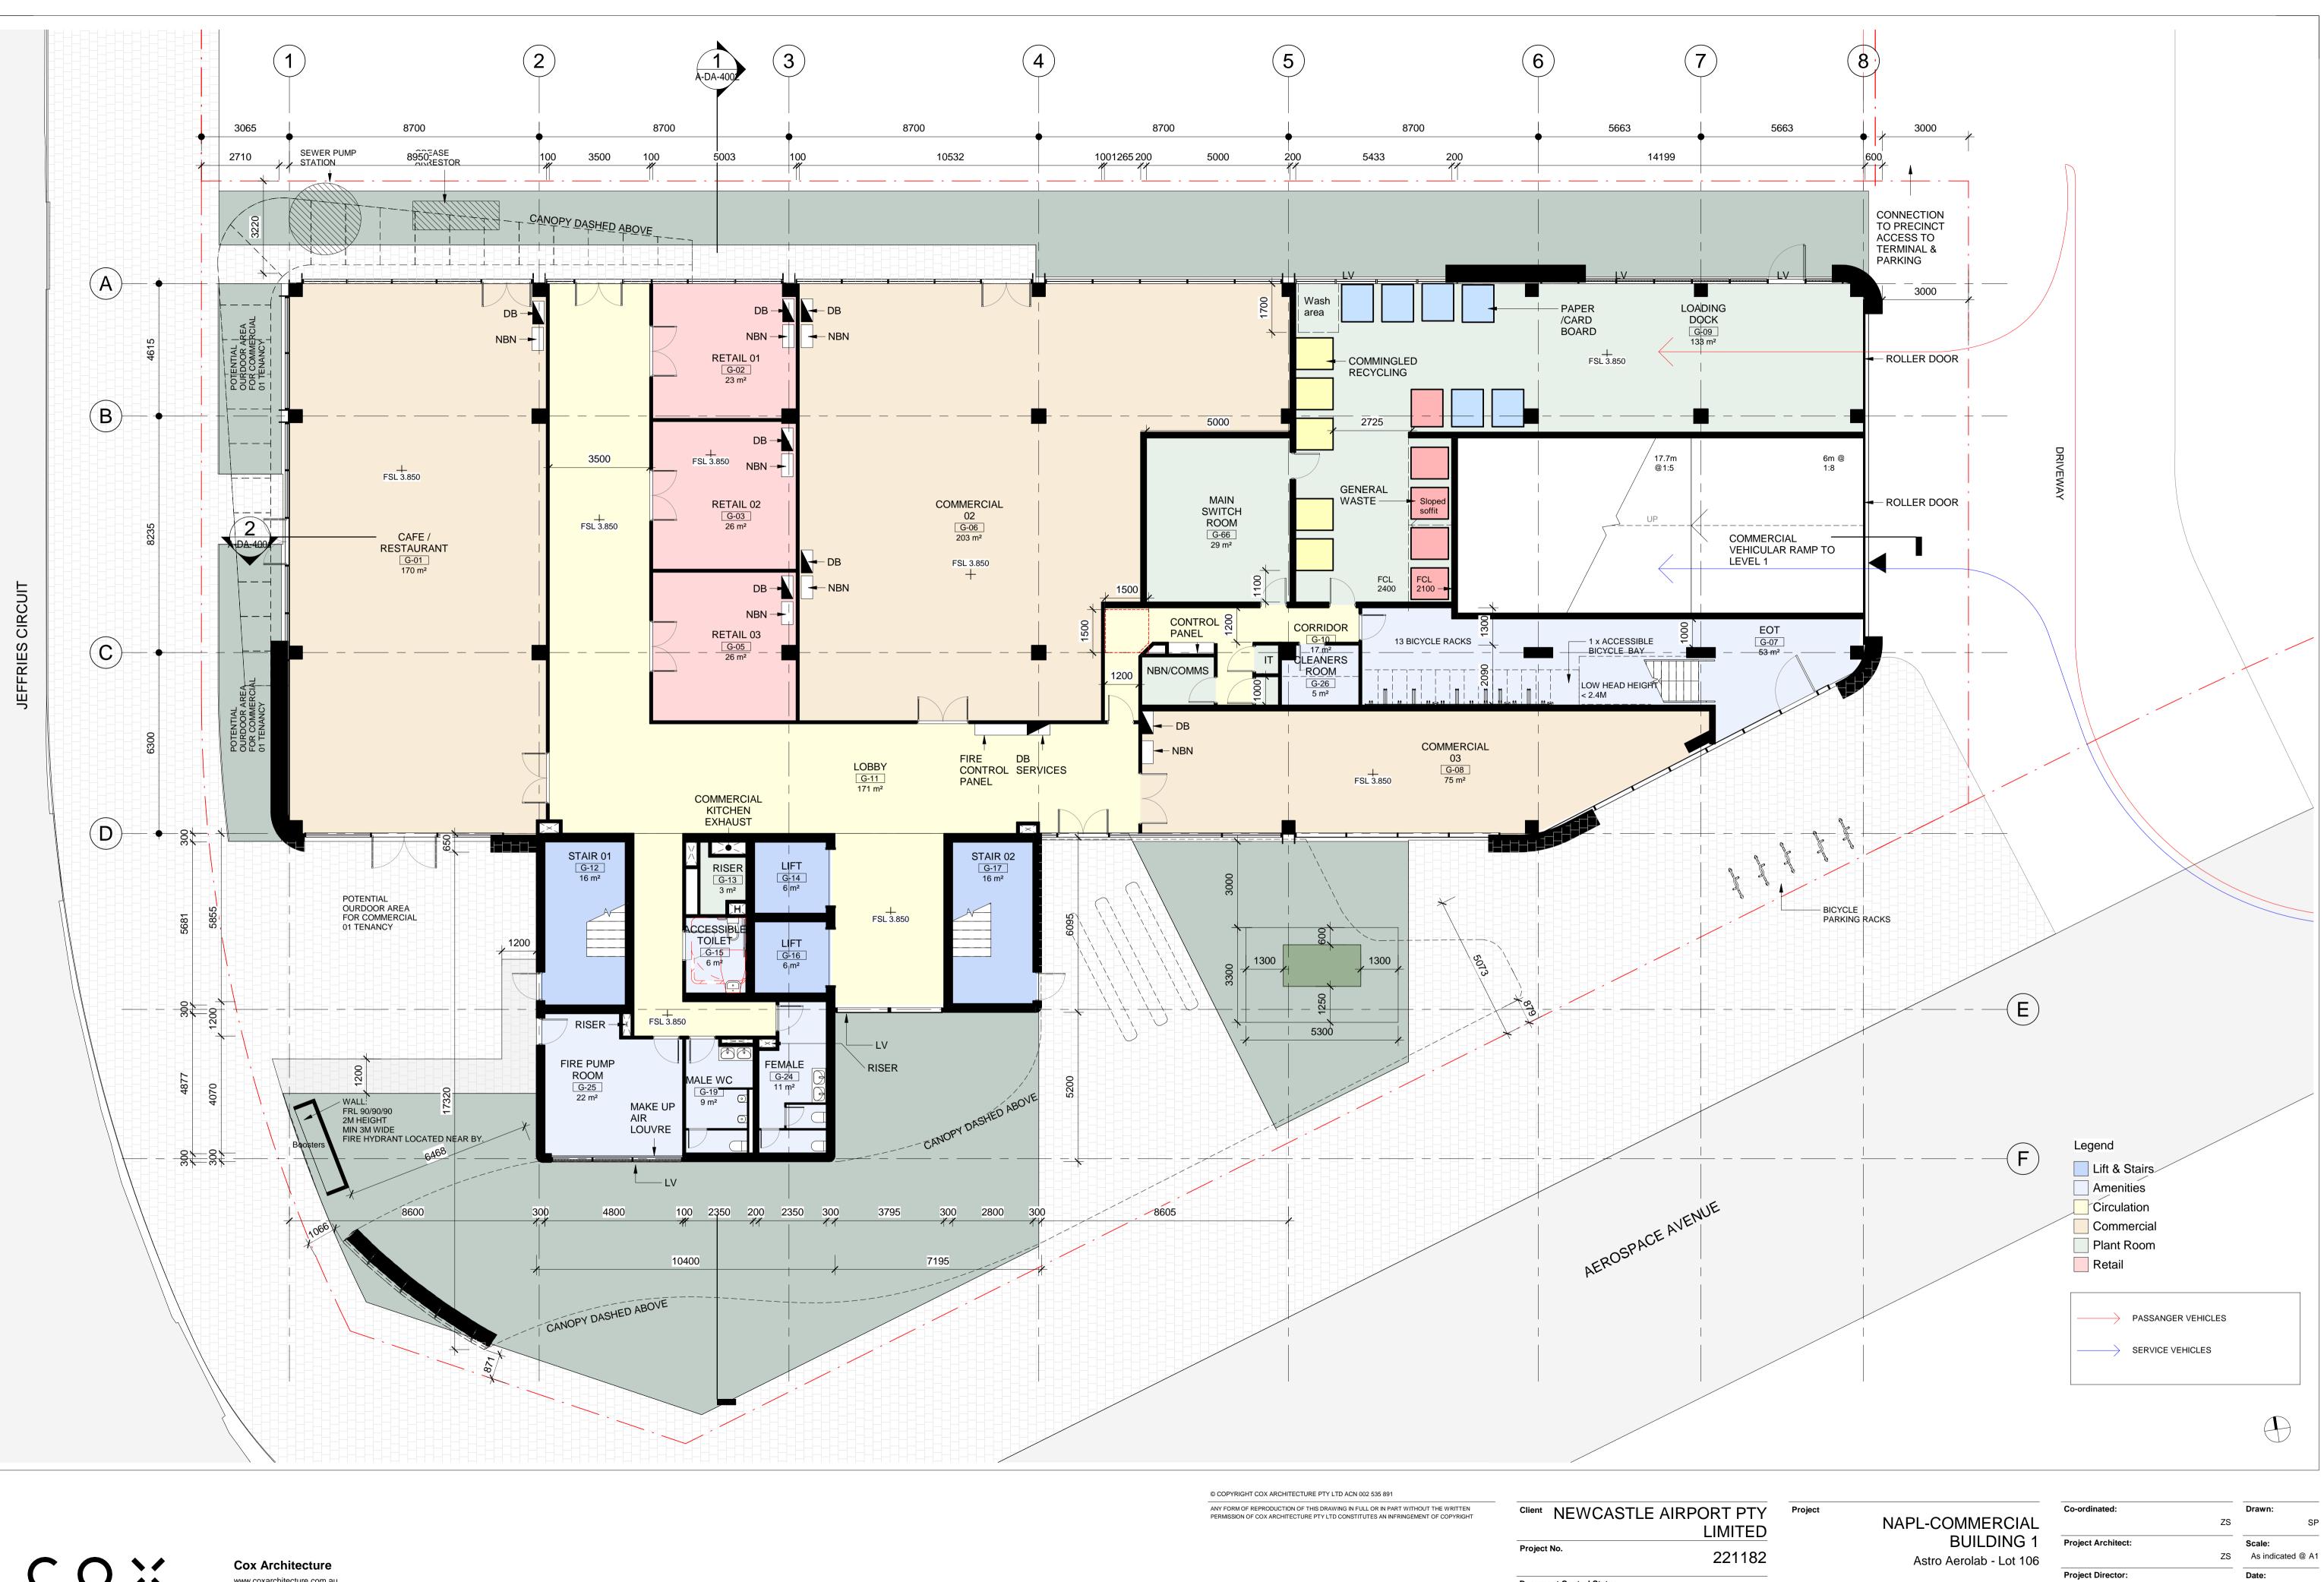
A-DA-2002

Drawing Title FLOOR PLAN - LEVEL 01

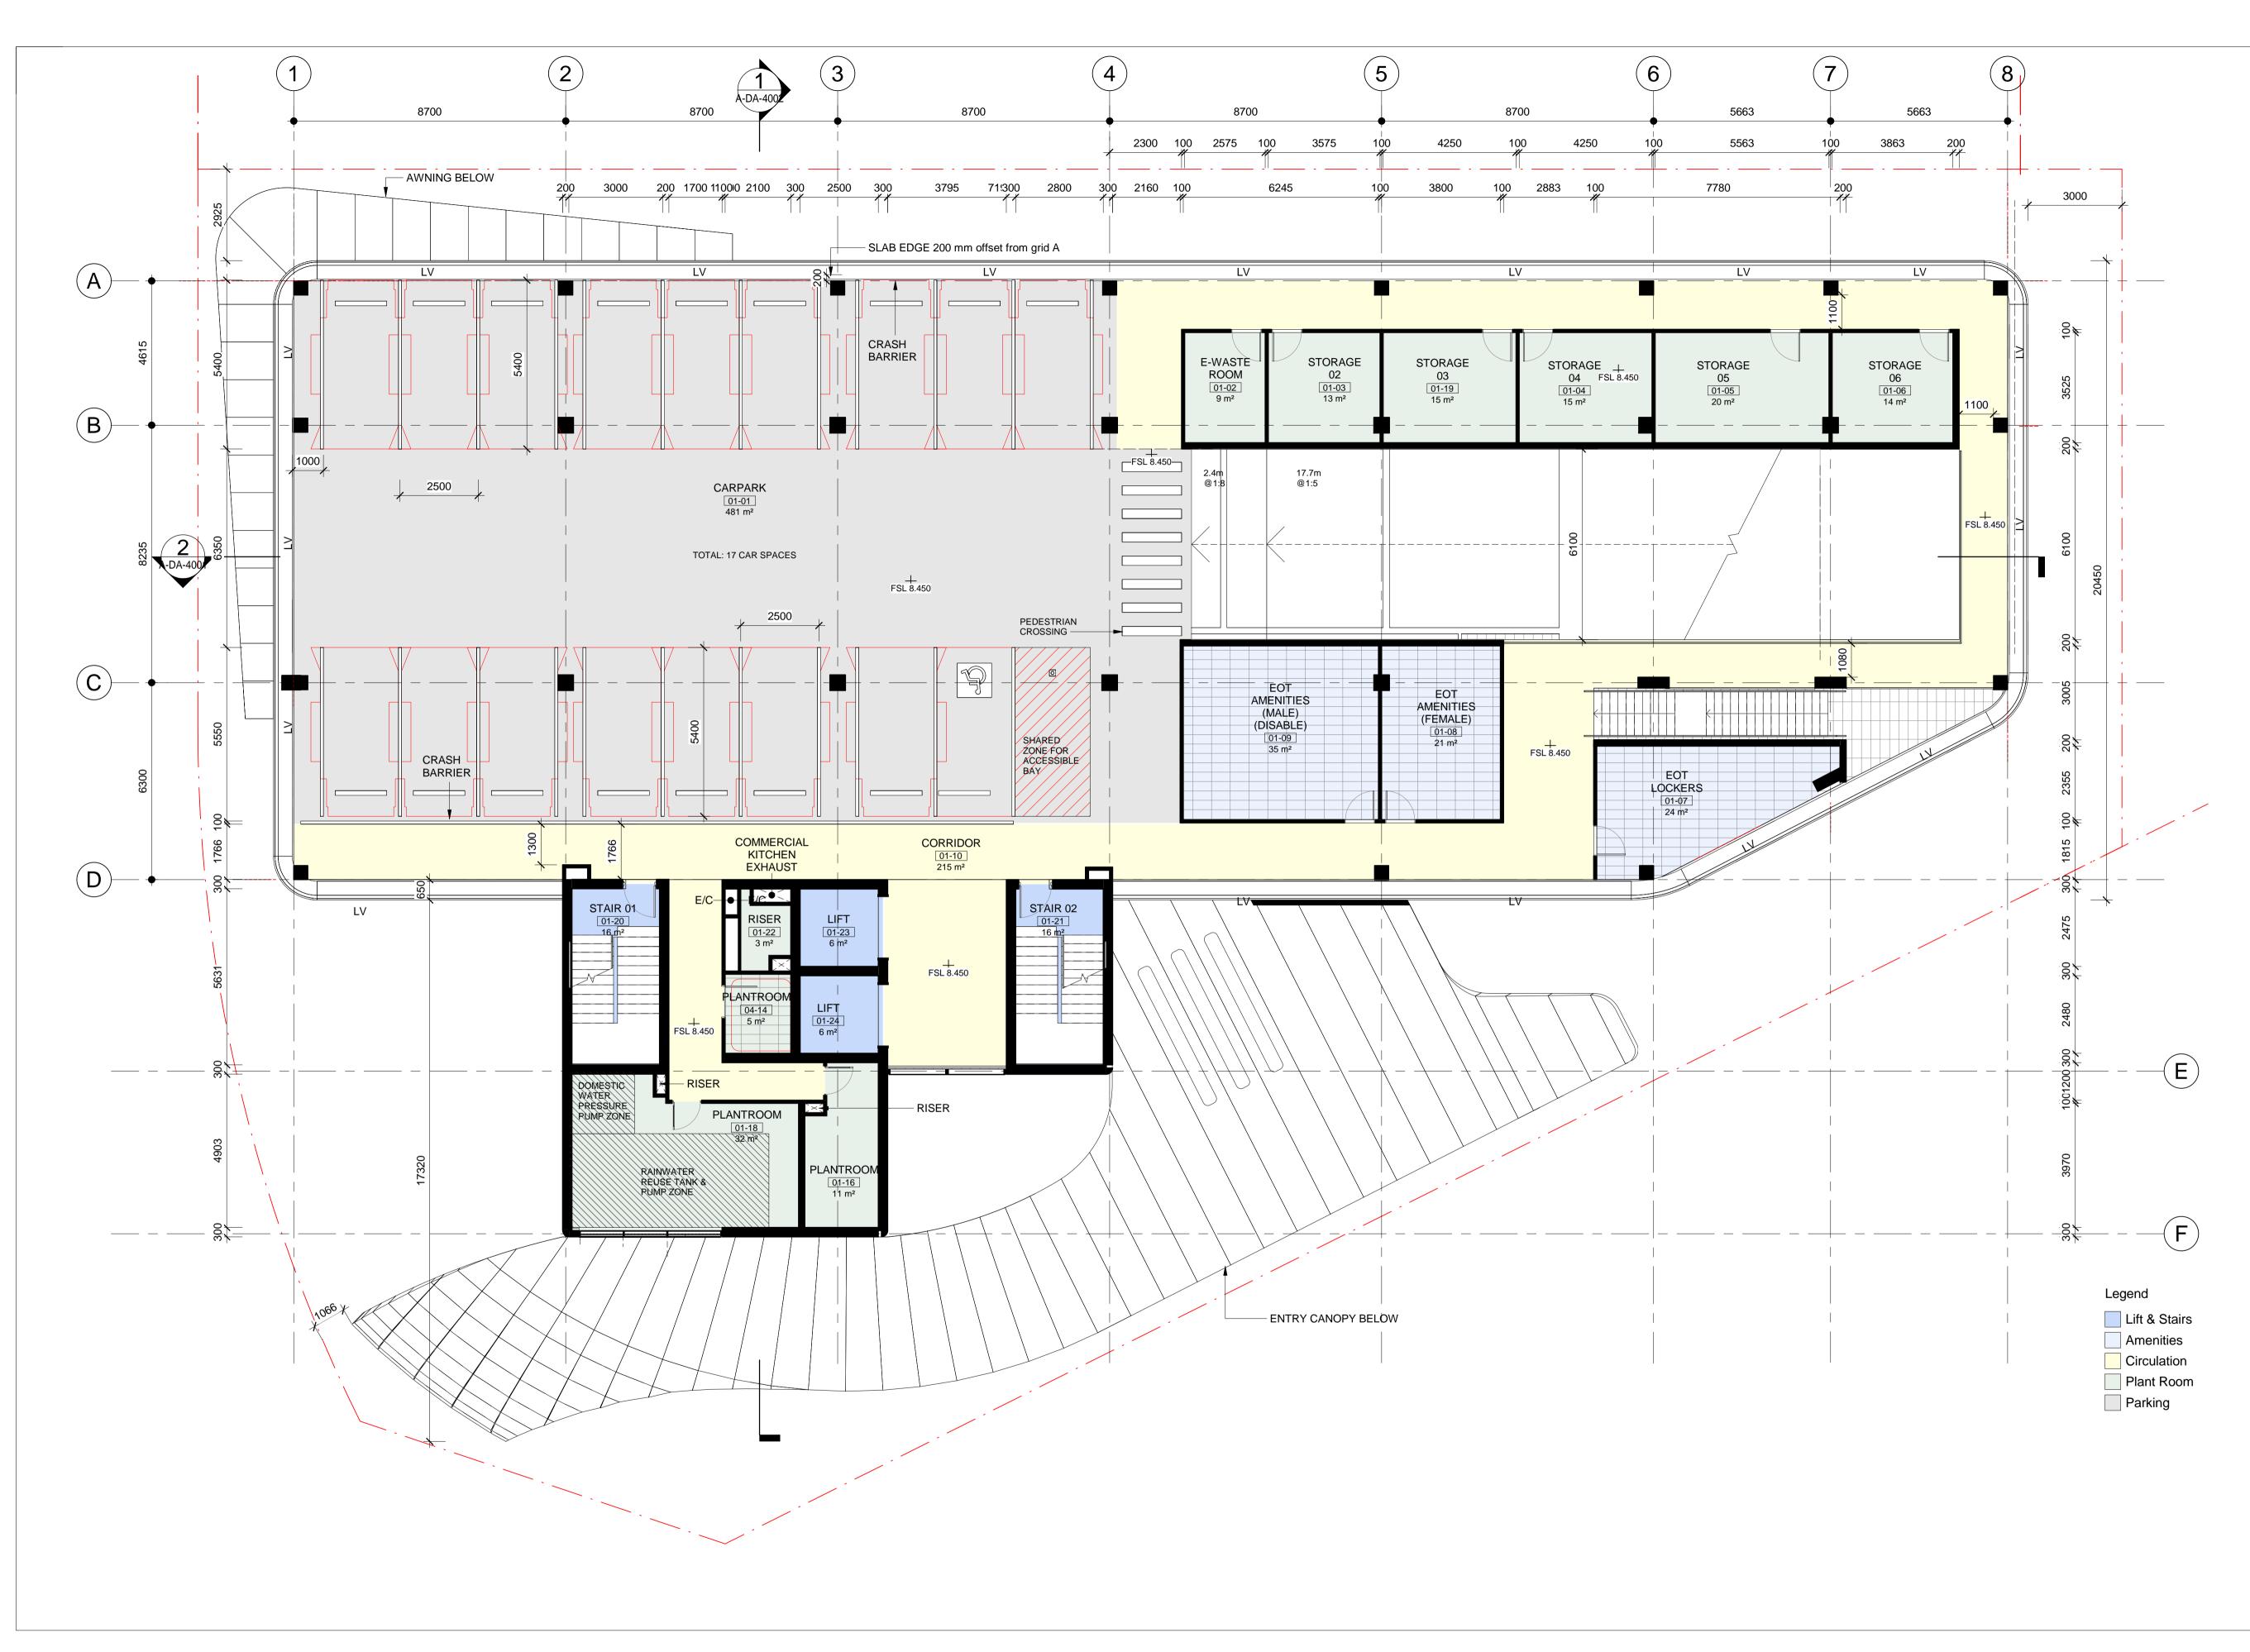
A-DA-2003

FLOOR PLAN - LEVEL 02

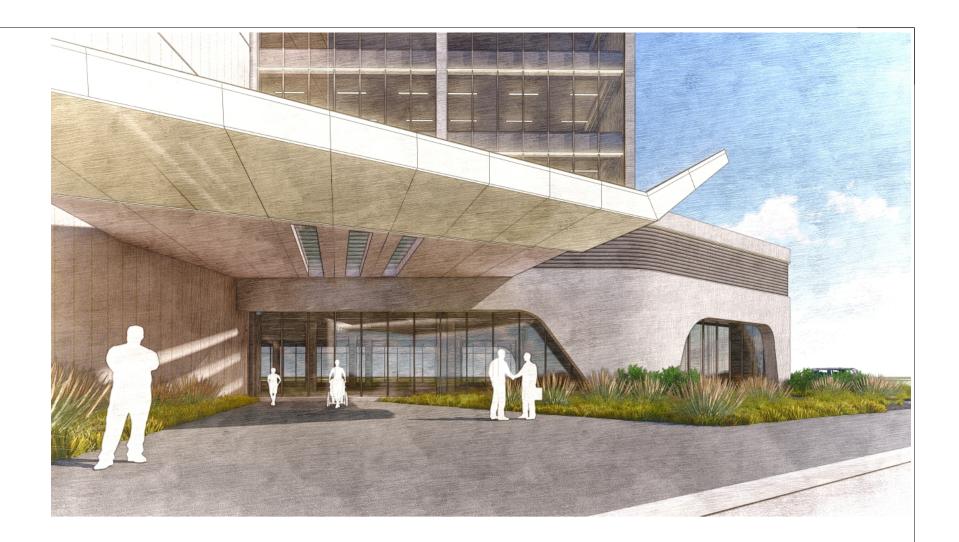
View of the Entry

Finishes - The building is a simple and robust design with off shutter concrete construction with aluminium framing to the double glazing andf shading devices while the canopies are finished equitone cladding panels
