BAESA - F35 MRO&U Facilities

Environment - Desktop Contamination Assessment

Client: Designin Sydney

05-Sep-2022

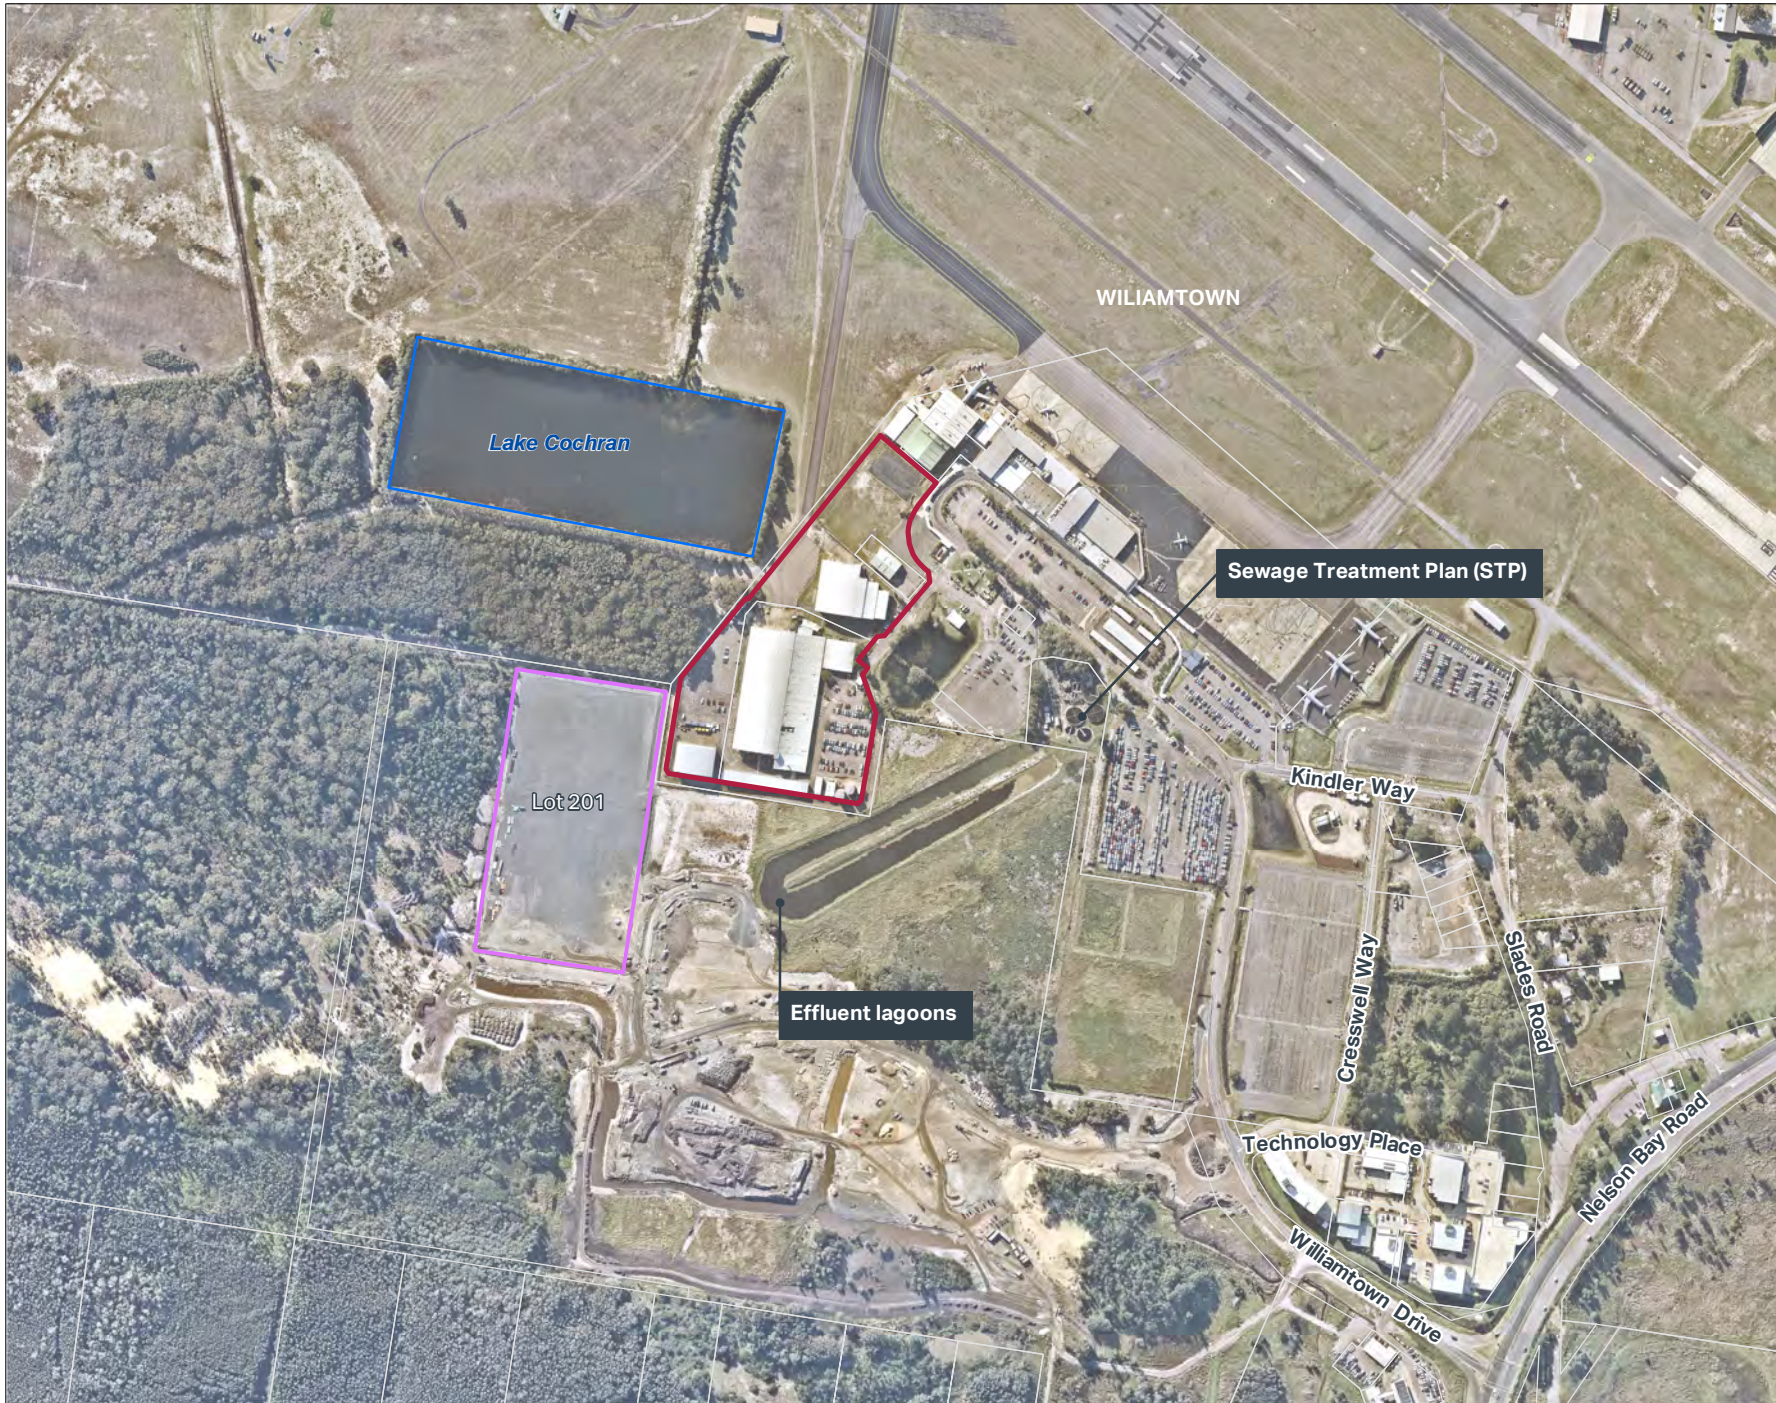
**BAE SYSTEMS AUSTRALIA
WILLIAMTOWN
FIGURE 2 - SITE LAYOUT**

AECOM Australia Pty Ltd (AECOM) has been engaged by Design Inc to undertake desktop contamination assessment of potential constraints associated with the proposed design options (options B1, B2 and C2) for the Phase 2A masterplan and 2B concept design input for the land within the current BAE footprint (here in referred to as the Site) and Lot 201 at RAAF Base Williamtown (here in referred to as the Base). The location of the Site and Lot 201 are shown on **Figure 1 (Appendix A)** and the Site layout and surrounding land use features are shown in **Figure 2 (Appendix A)**. AECOM understands the proposed design incorporates the following key elements:
