Proposed Mixed-Use Tower Development - 711 Hunter Street, Newcastle West

Preliminary Geotechnical Report

Hunter Street JV Co Pty Ltd

Reference: 754-NTLGE293239-AC.Rev1

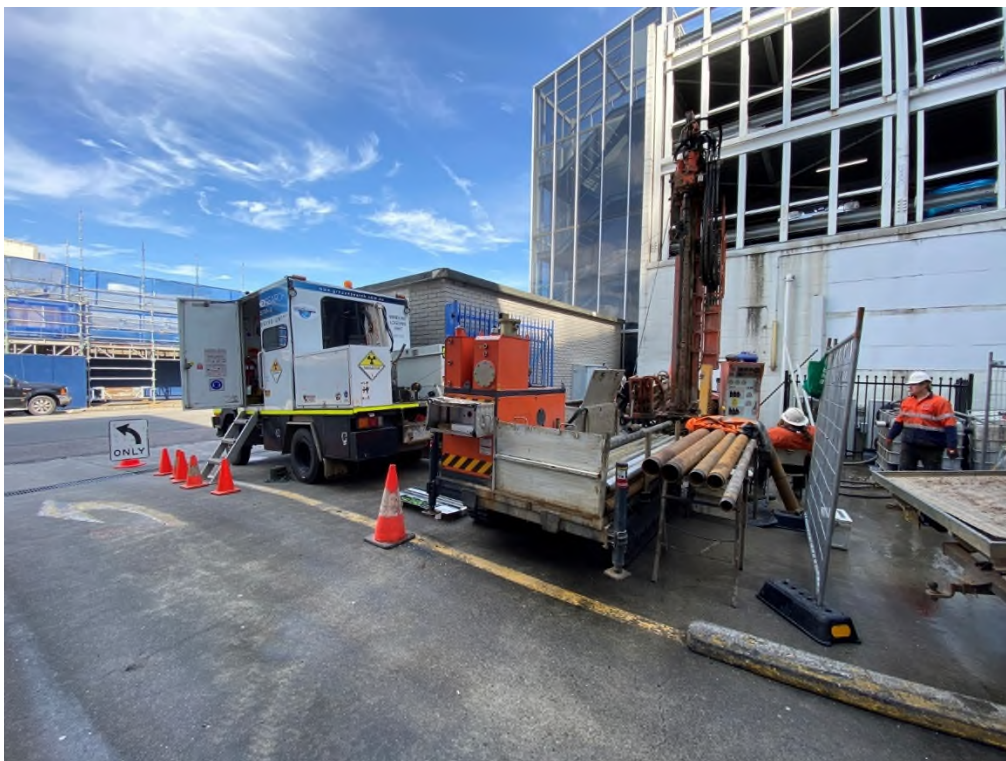
Photo 2: Facing East: Showing Borehole location, Northern wall of rear building and National Park Street

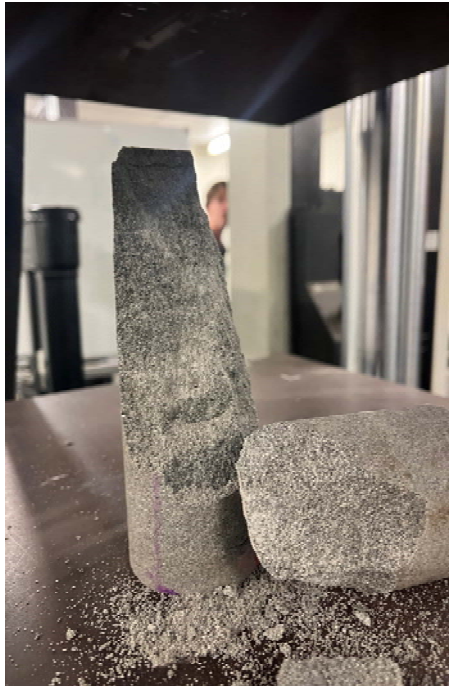
<p style="text-align: center;">Stress vs. Strain</p>

<p>Client: Coffey</p> <p>Job Reference: 754-NTLGE293239</p> <p>Test Date: 19-10-22</p> <p>Bore Hole: BH22-03</p> <p>Depth (m): 40.5 – 41.0mm</p>	<p>Test Methods: AS 4133.4.2.2-2013</p> <p>Test By: Lachlan Bates</p> <p>Reported By: Lachlan Bates</p>																
<p>Sample Description: Sandstone, Grey</p> <p>Length (mm):160.94</p> <p>Diameter (mm): 60.37</p> <p>Mass (g): 1112.54</p> <p>Water Content (%): 4.8</p> <p>Dry density (g/cm³): 2.304</p> <p>UCS (MPa) = 39.9</p>
