# Proposed Mixed-Use Tower Development - 711 Hunter Street, Newcastle West

## Preliminary Geotechnical Report

Hunter Street JV Co Pty Ltd

Reference: 754-NTLGE293239-AC.Rev1

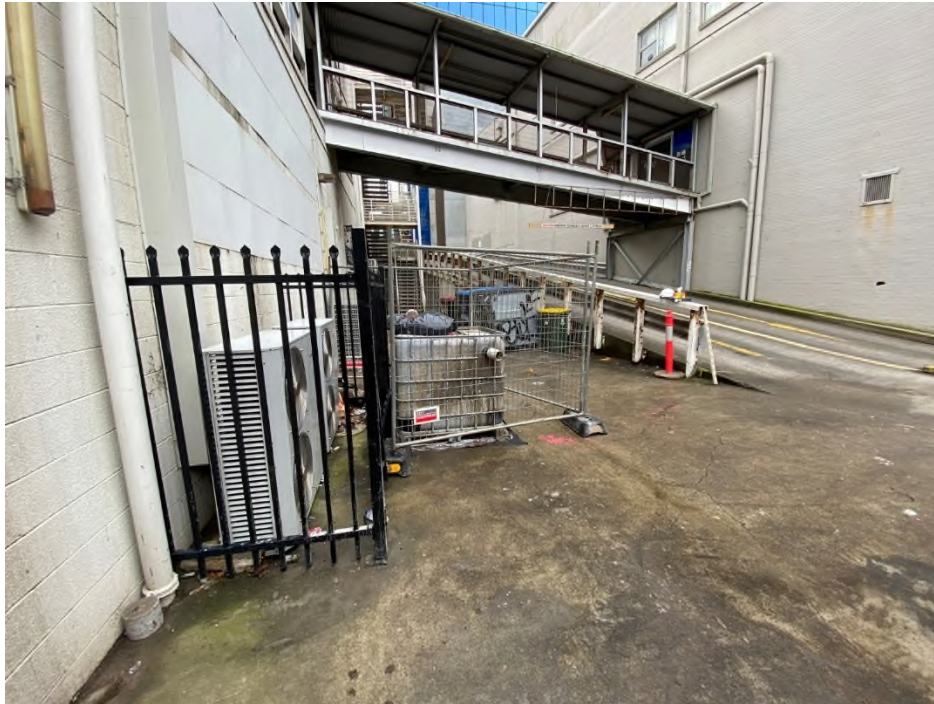
**Photo 1: Facing North-West: Showing southern wall of front building and driveway leading towards building on south**

The investigation area was generally flat with 130mm thick (approx.) concrete surface and an upward sloped driveway leading from the western side of the investigation area (southern portion of site) to an existing multi-

level carpark and a building on the southern end of site. The site also has an existing building in the front portion. Photos 1 and 2 below show the investigation location and surroundings.

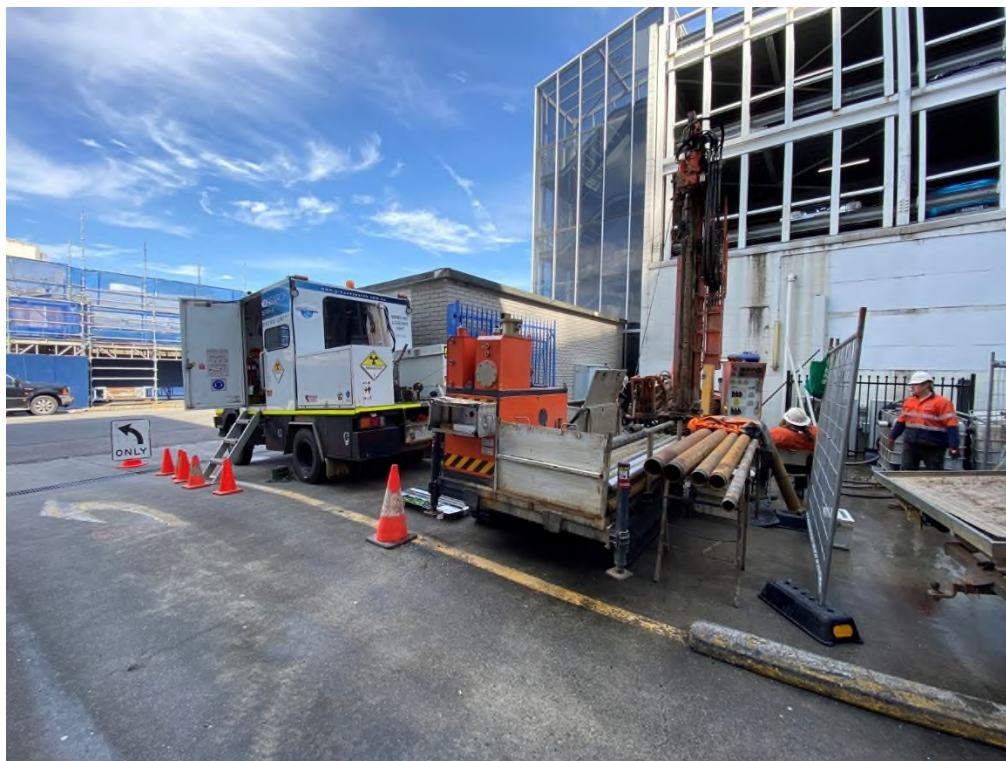
**Photo 2: Facing East: Showing Borehole location, Northern wall of rear building and National Park Street**

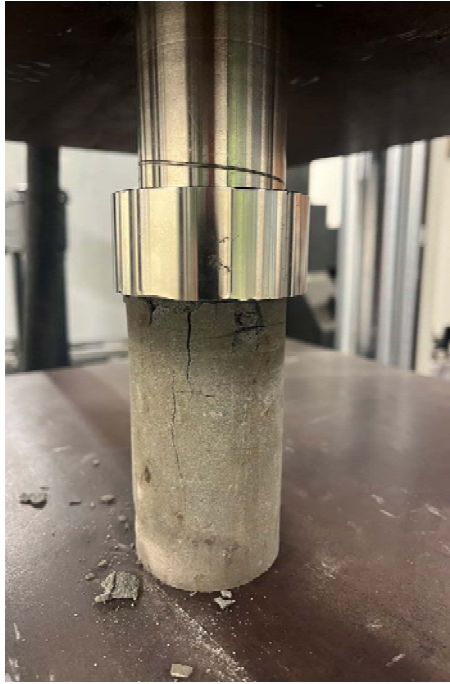
## UCS TEST REPORT

| <p>Client: Coffey</p> <p>Job Reference: 754-NTLGE293239</p> <p>Test Date: 19-10-22</p> <p>Bore Hole: BH22-03</p> <p>Depth (m): 39.7 – 39.9.0mm</p> | <p>Test Methods: AS 4133.4.2.2-2013</p> <p>Test By: Lachlan Bates</p> <p>Reported By: Lachlan Bates</p> | | | | | | | | | | | | | | | | |
|---|---|---|---|---|---|---|---|---|---|---|---|---|---|---|---|---|---|
| <p>Sample Description:<br/>Sandstone, Grey</p> <p>Length (mm): 93.37</p> <p>Diameter (mm): 60.12</p> <p>Mass (g): 645.50</p> <p>Water Content (%): 4.5</p> <p>Dry density (g/cm<sup>3</sup>): 2.33</p> <p>UCS (MPa) = 24.3</p> <p>*Length /Diameter ratio&lt;2</p>

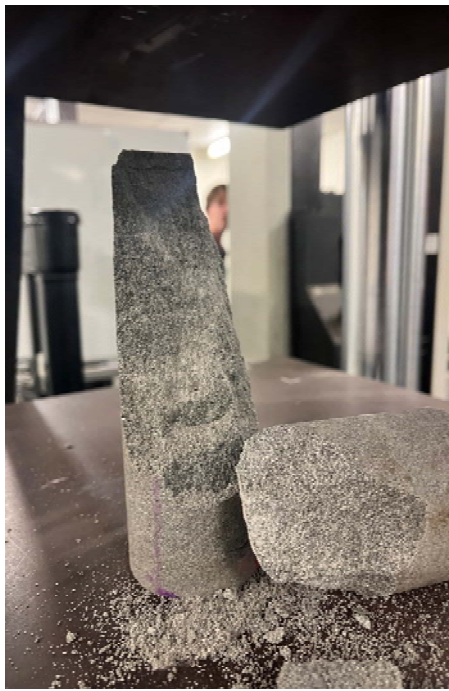
## UCS TEST REPORT

| <p>Client: Coffey</p> <p>Job Reference: 754-NTLGE293239</p> <p>Test Date: 19-10-22</p> <p>Bore Hole: BH22-03</p> <p>Depth (m): 40.5 – 41.0mm</p> | <p>Test Methods: AS 4133.4.2.2-2013</p> <p>Test By: Lachlan Bates</p> <p>Reported By: Lachlan Bates</p> | | | | | | | | | | | | | | | | |
|---|---|---|---|---|---|---|---|---|---|---|---|---|---|---|---|---|---|
| <p>Sample Description:<br/>Sandstone, Grey</p> <p>Length (mm):160.94</p> <p>Diameter (mm): 60.37</p> <p>Mass (g): 1112.54</p> <p>Water Content (%): 4.8</p> <p>Dry density (g/cm<sup>3</sup>): 2.304</p> <p>UCS (MPa) = 39.9</p>
